UNDERWATER BRIDGE INSPECTION REPORT

STRUCTURE NO. 2441  
FRANKLIN AVENUE (CSAH NO. 5)  
OVER THE  
MISSISSIPPI RIVER  
DISTRICT 5 - HENNEPIN COUNTY

PREPARED FOR THE  
MINNESOTA DEPARTMENT OF TRANSPORTATION  
BY  
COLLINS ENGINEERS, INC.  
JOB NO. 5221 (CEI 121)

MINNESOTA DEPARTMENT OF TRANSPORTATION  
UNDERWATER BRIDGE INSPECTION

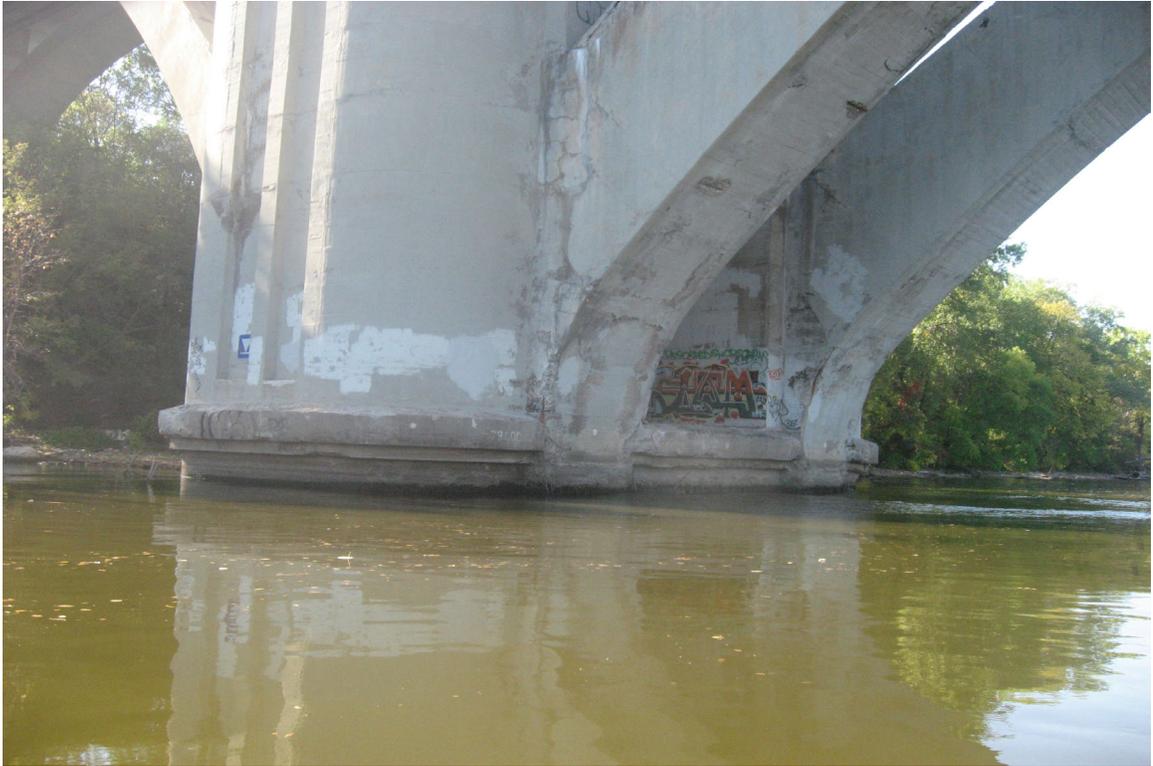
Photograph 1. View of Pier 2, Looking West.

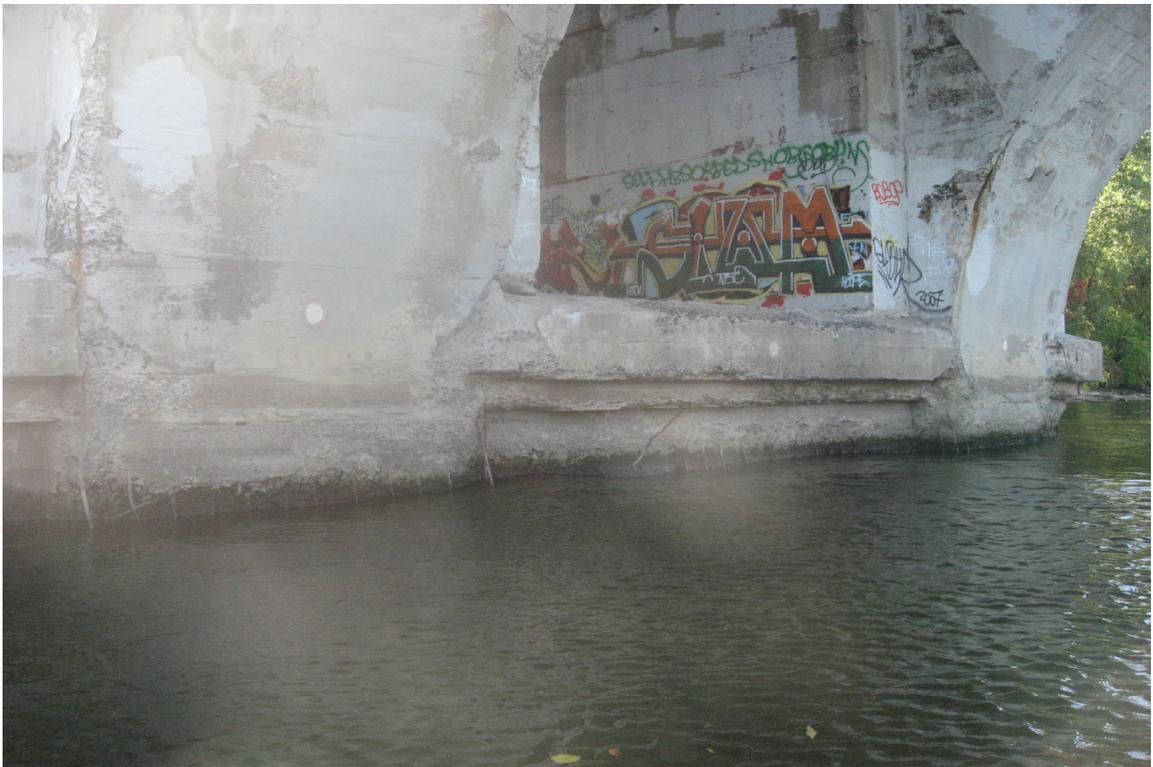
Photograph 2. View of Pier 2, Looking West.

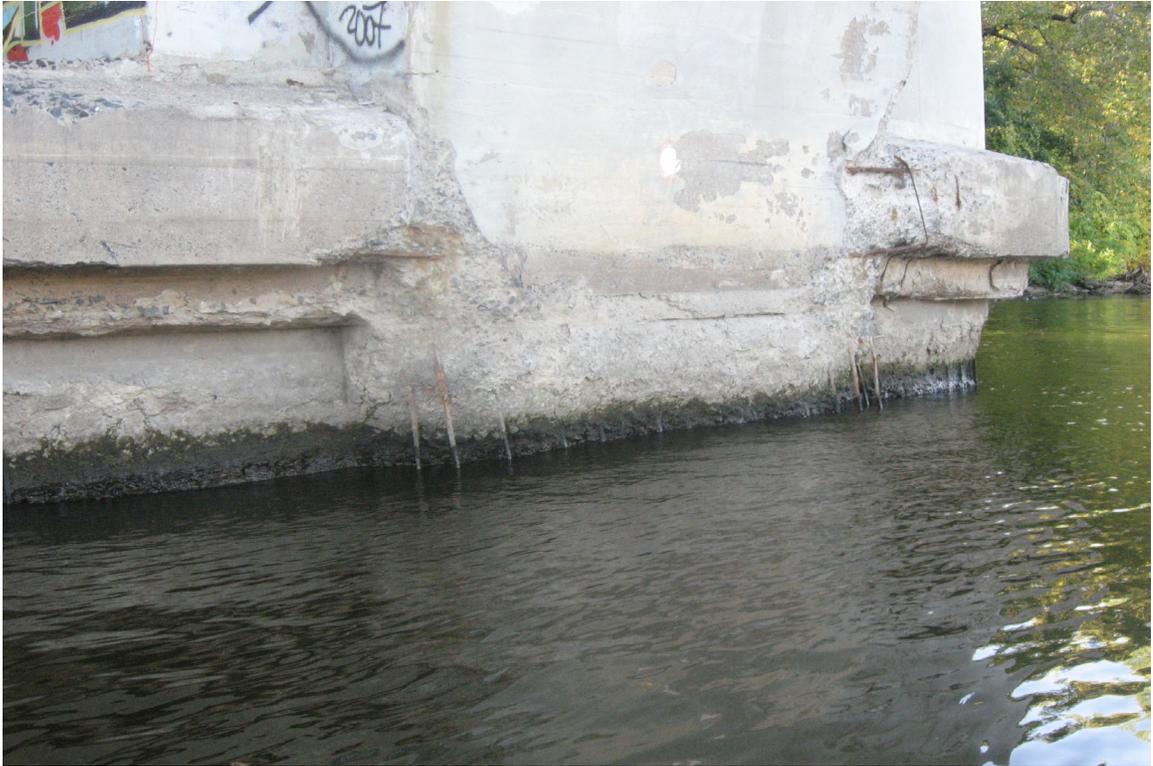
Photograph 3. View of the Upstream End of Pier 2, Looking West.

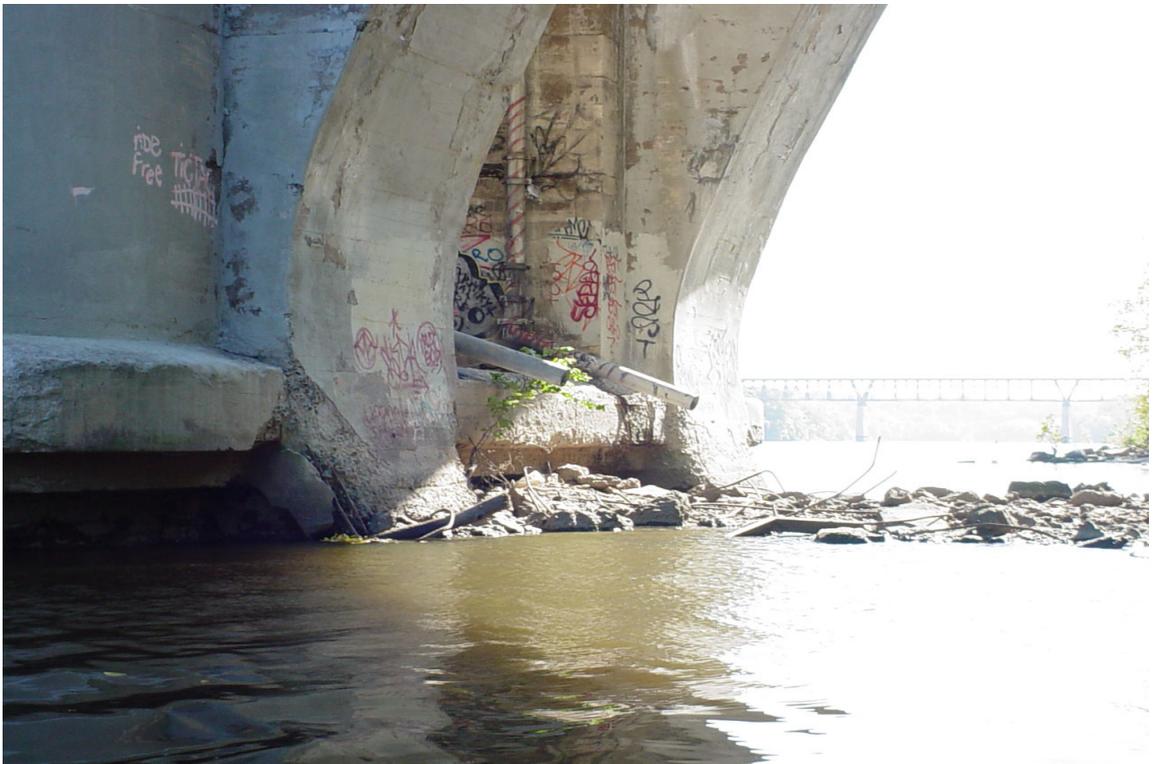
Photograph 4. View of Deterioration along the West Side of Pier 2, Looking South.

- 1 The concrete along the west face of Pier 2 was in fair to poor condition with extensive scaling and areas of section loss observed from approximately 4 feet above the waterline to the channel bottom. Typically, the areas of section loss exhibited exposed heavily corroded reinforcing steel and up to 14 inches of penetration.

At a minimum, the exposed reinforcing steel should be cleaned and covered with an epoxy grout. Due to the substantial loss of section, however, a more desirable repair would be to remove all loose and unsound concrete, clean the exposed reinforcing steel, and reform the concrete to the original dimensions and lines.

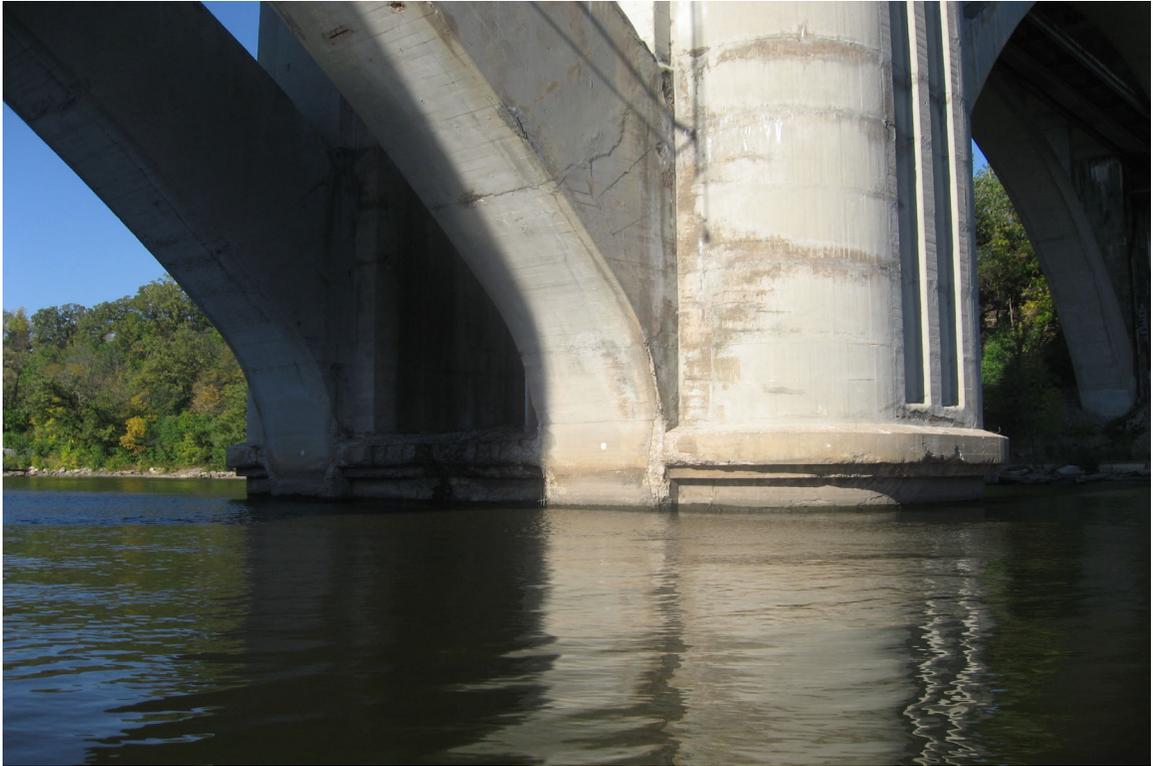
Photograph 5. View of Pier 3, Looking North.

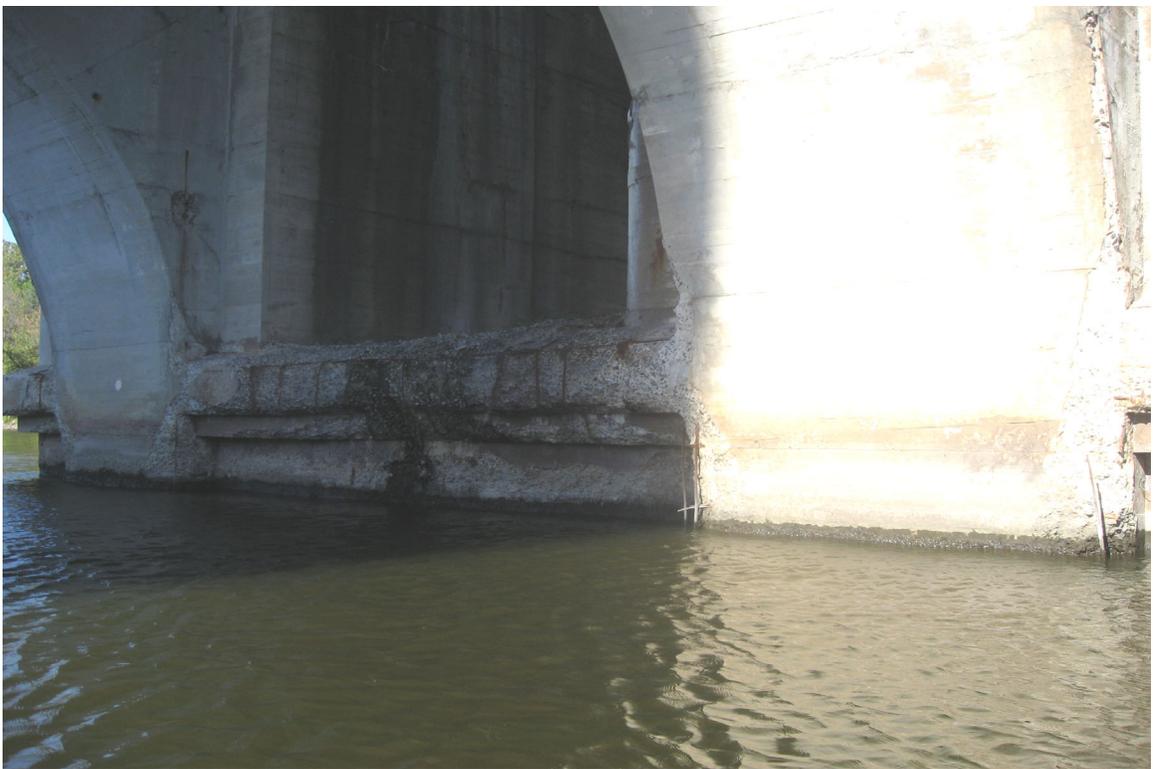
Photograph 6. View of the Heavy Deterioration and Section Loss along the West Side of Pier 3, Looking Northeast.

- 6 Heavy section loss was observed from 6 feet above the waterline to 3 feet below the waterline along the middle portion of the pier along both faces with exposed reinforcing steel and up to 1 foot of penetration.

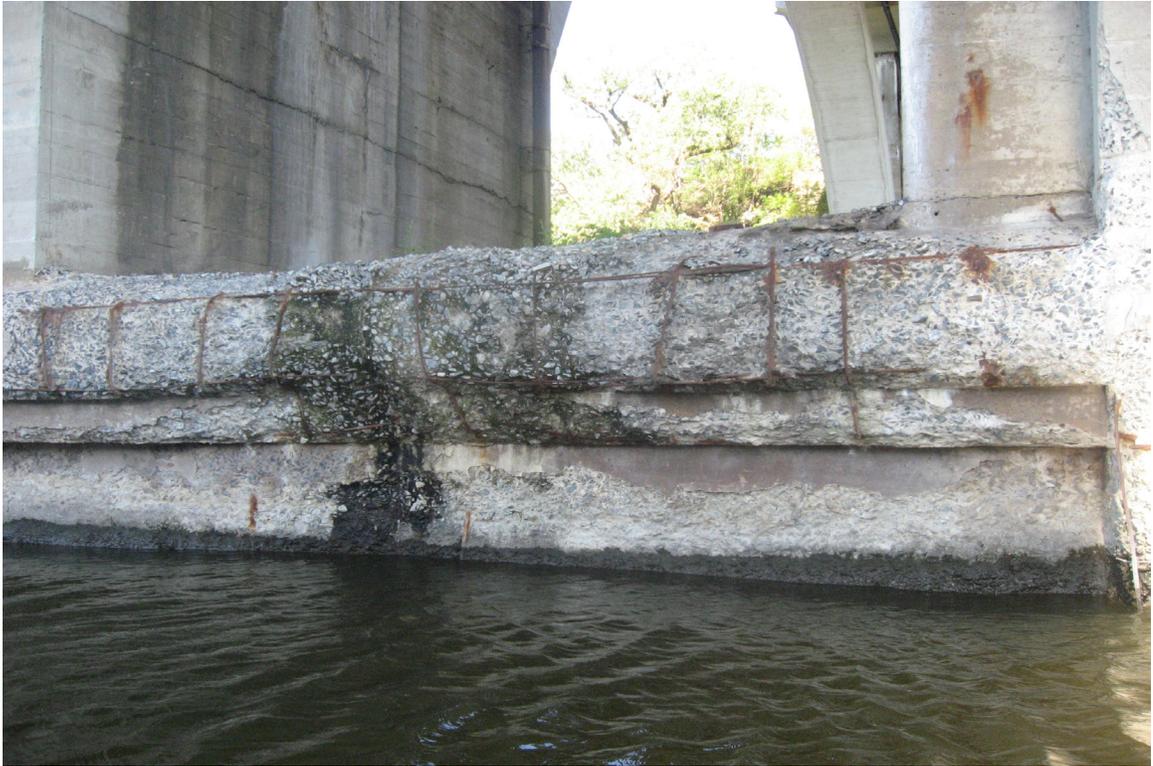
Photograph 7. View of the Heavy Deterioration and Section Loss along the East Side of Pier 3, Looking Northeast.

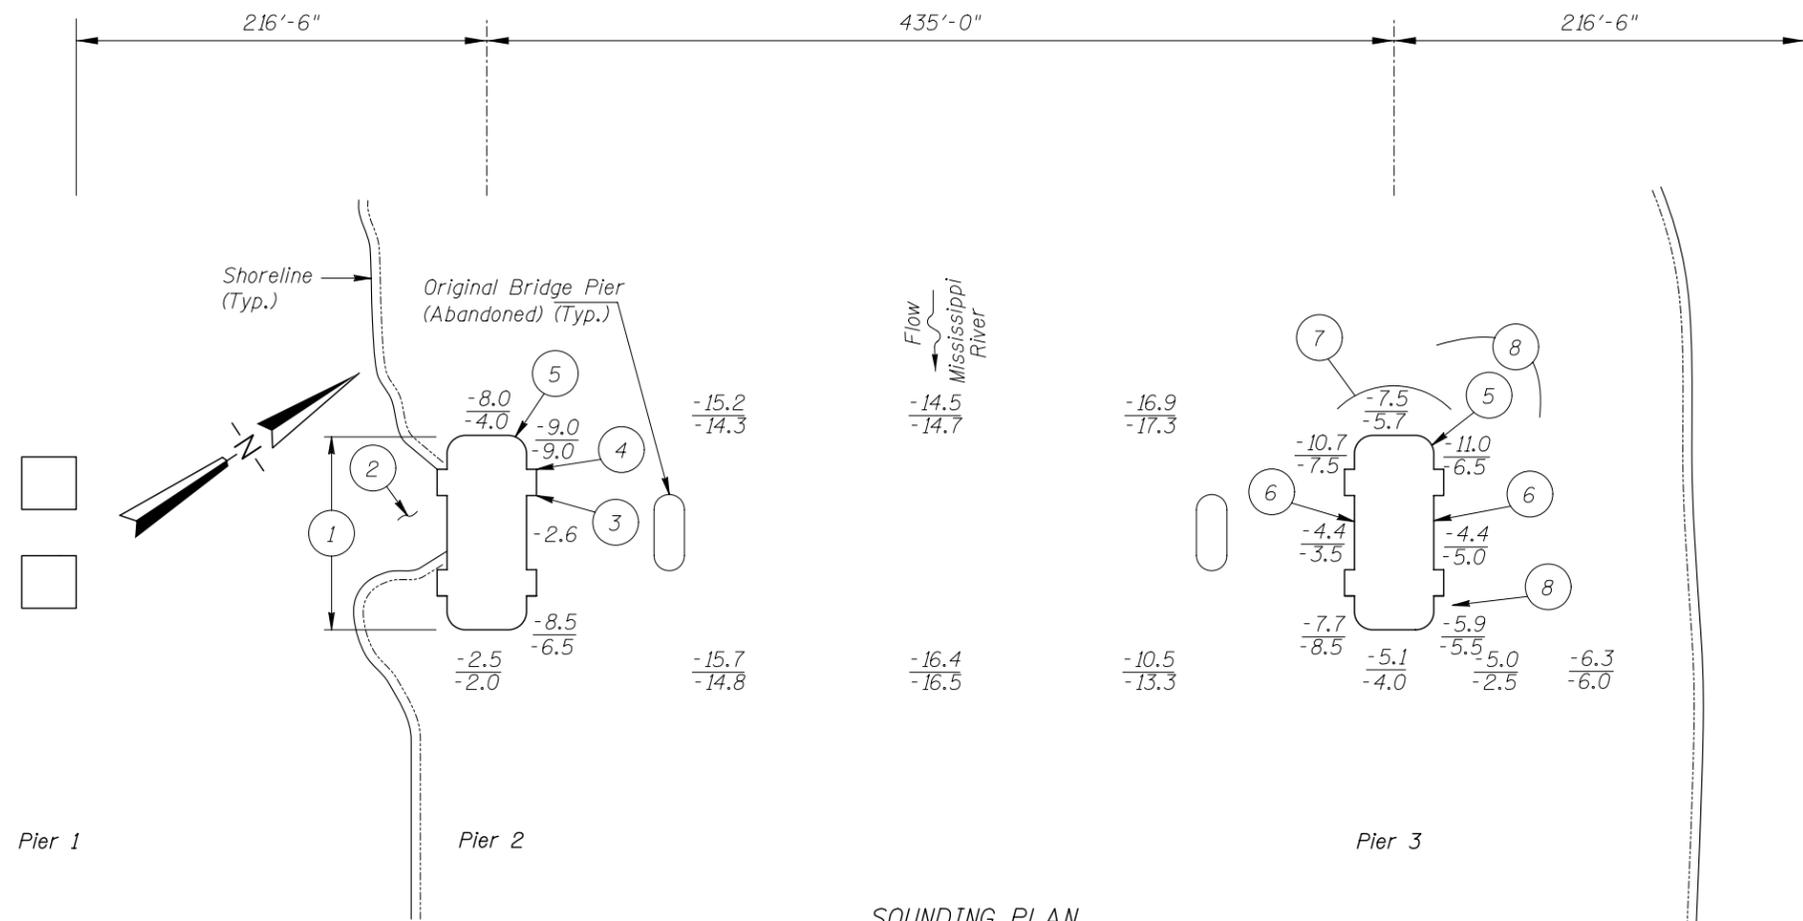
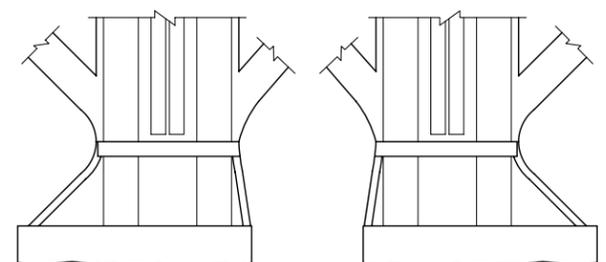
SOUNDING PLAN

- 2 Accumulation of concrete rubble and steel debris was observed around Pier 2 and extended approximately 1 foot above the waterline along the west face of the pier.

- 3 An area of section loss with exposed reinforcing steel was observed from 4 feet above the waterline to approximately 4 feet below the waterline with up to 10 inches of penetration.

- 4 An area of section loss with exposed reinforcing steel was observed from 4 feet above the waterline to approximately 5 feet below the waterline with up to 12 inches of penetration.

- 5 Typically, Piers 2 and 3 exhibited heavy scaling from 2 feet above the waterline to 3 feet below waterline with areas of exposed reinforcing steel and up to 8 inches of penetration.

- 7 Large diameter riprap has been stacked up in front of the upstream nose of Pier 3.
- 8 Rocks and boulders were observed on the channel bottom along the east side of Pier 3.
