UNDERWATER BRIDGE INSPECTION REPORT

STRUCTURE NO. 27608
BROADWAY AVENUE
OVER
THE MISSISSIPPI RIVER
DISTRICT 5 - HENNEPIN COUNTY

PREPARED FOR THE
MINNESOTA DEPARTMENT OF TRANSPORTATION
BY
COLLINS ENGINEERS, INC.
JOB NO. 5221 (CEI 116)

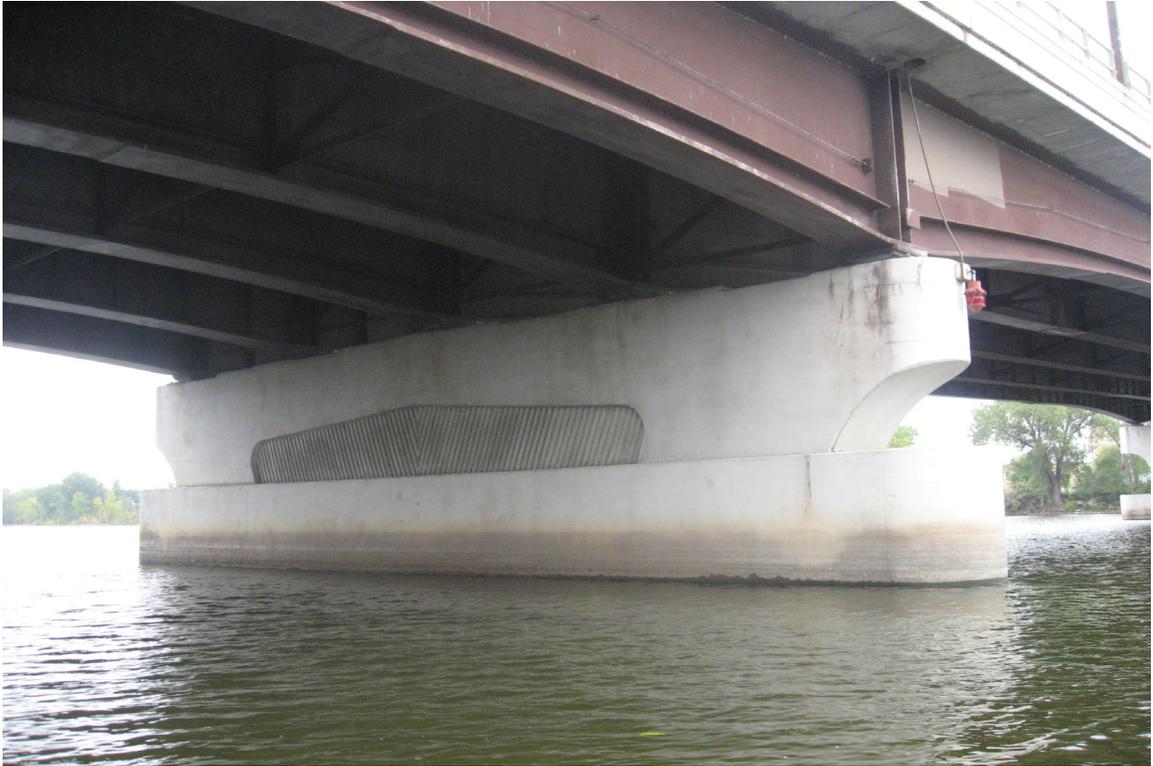
- (A) Piers 1 and 3 exhibited vertical hairline to 1/16 inch cracks at the midpoint and at the upstream and downstream quarter points of the pier shaft, extending from the top of the above water step to the waterline on both faces at Pier 1 and on west face only at Pier 3.
- (B) A light to moderate accumulation of timber debris located along the upstream nose and to the west side of Pier 1 was observed scattered along the channel bottom extending up 2 feet.
- (C) Timber debris consisting of two tree trunks, 2 feet in diameter, was observed along the east face of Pier 3.

Photograph 1. View of Pier 1, Looking Northeast.

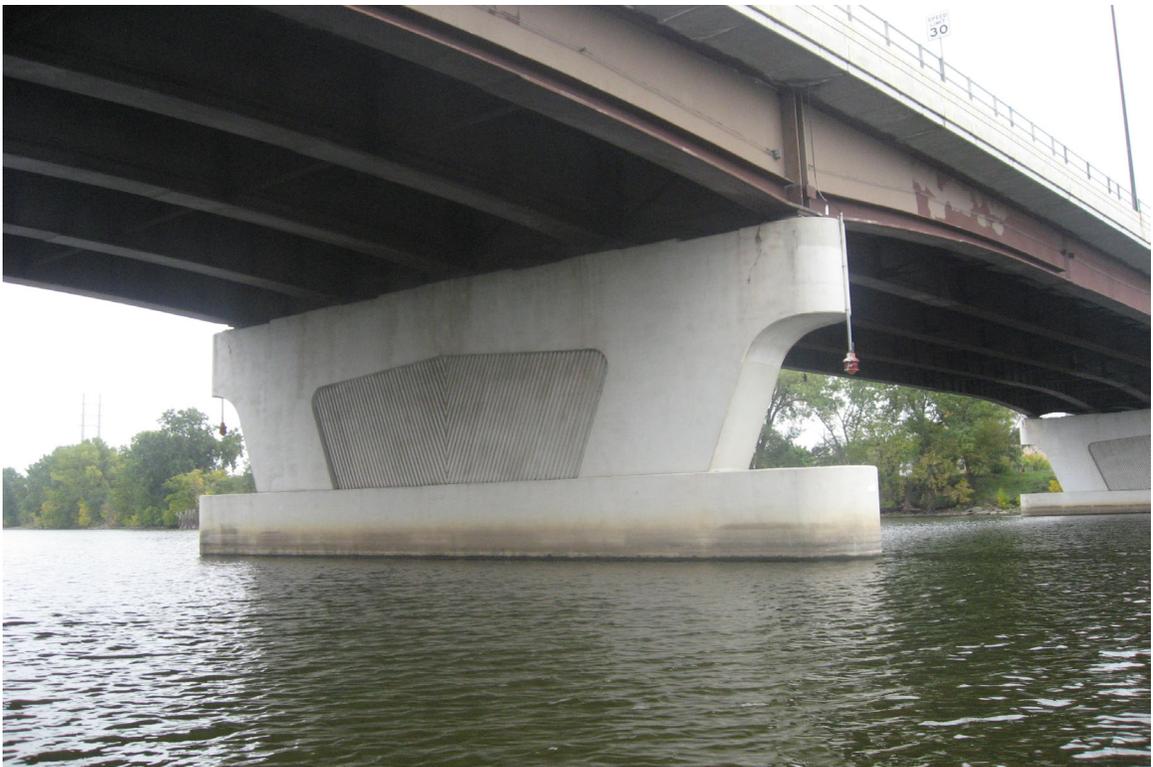
Photograph 2. View of Pier 2, Looking Northeast

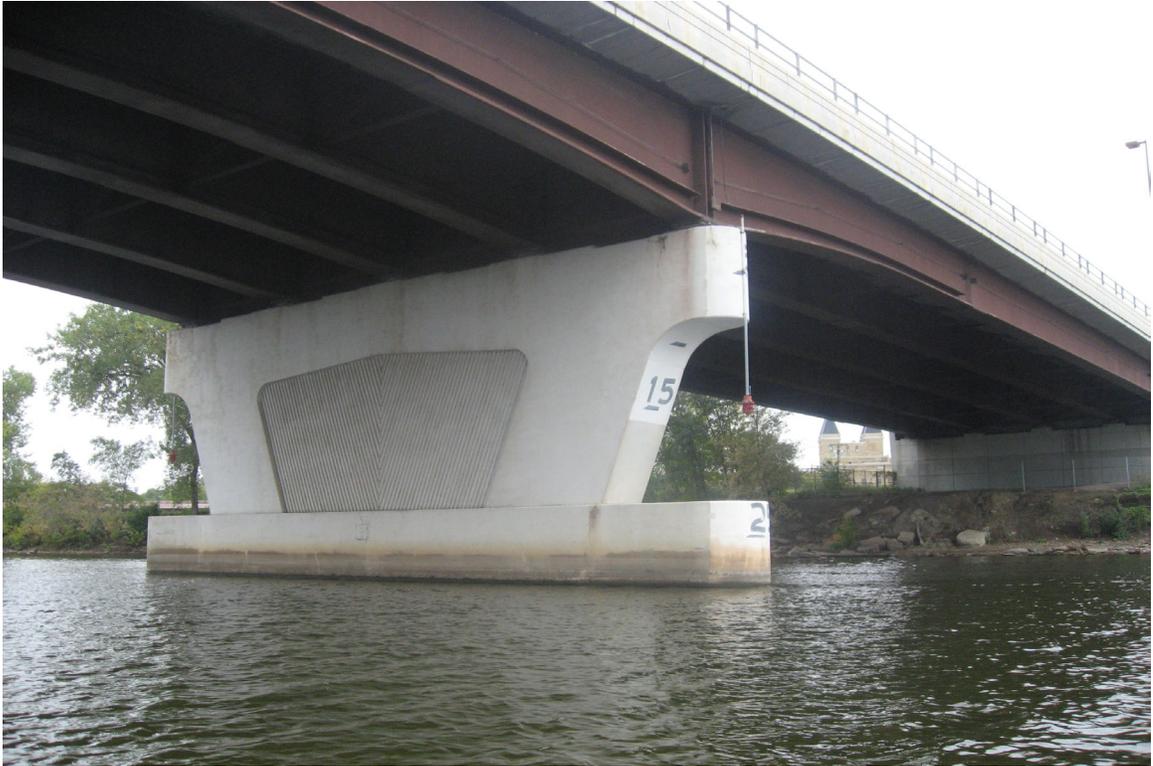
Photograph 3. View of Pier 3, Looking Northeast.

- (A) Monitor the timber debris at the piers, and if found to be increasing in the future, removal operations may become warranted.

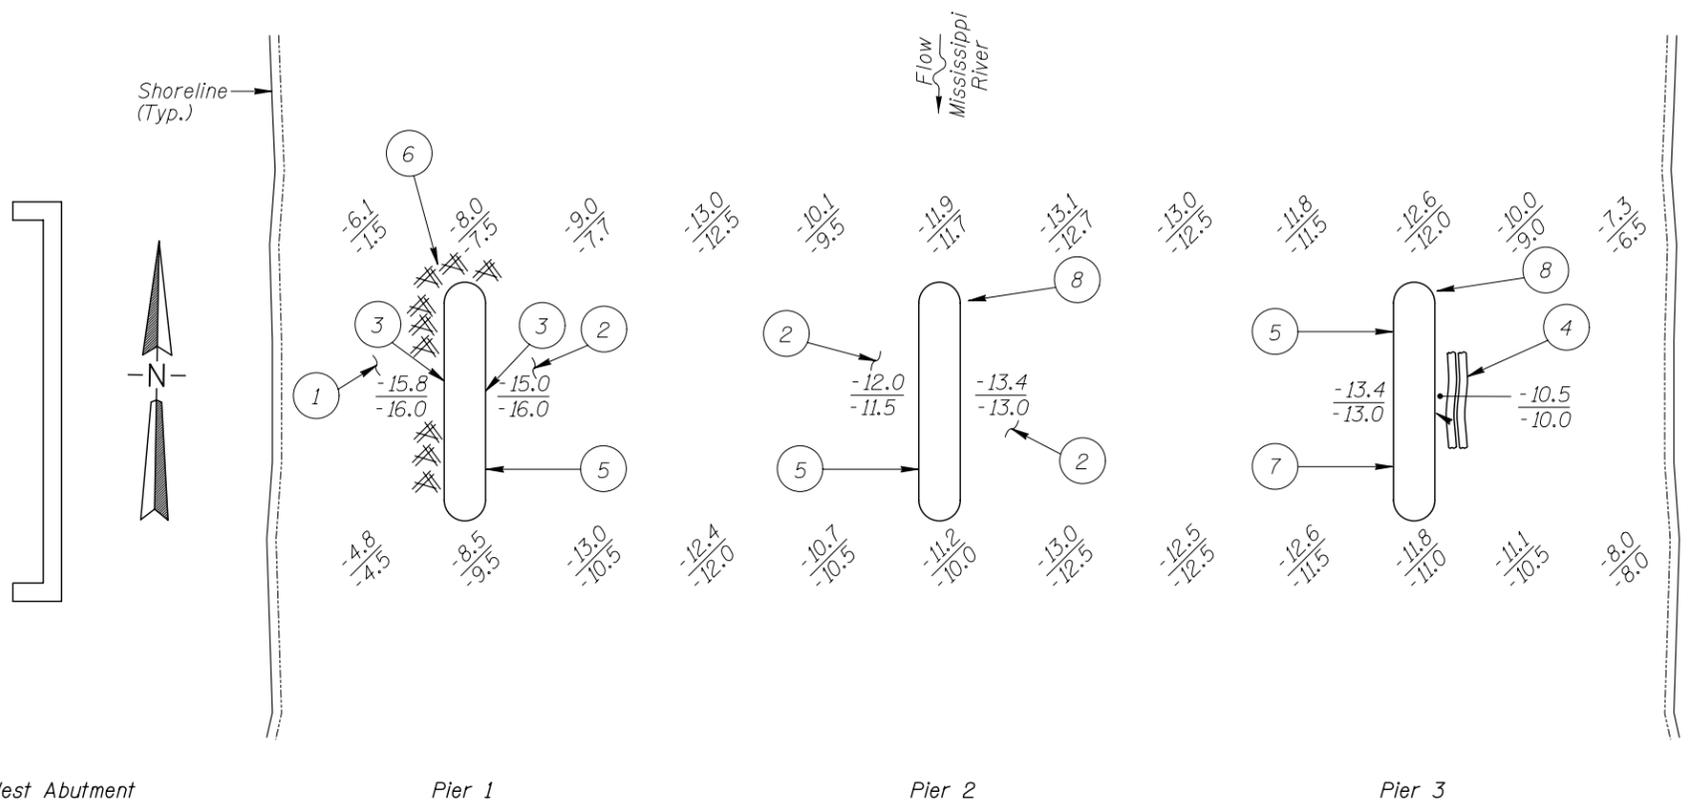
SOUNDING PLAN

- 1 The channel bottom consisted of riprap up to 2 feet in diameter along the west face of Pier 1.
- 2 The channel bottom consisted of silty sand with up to 1 foot of probe rod penetration.

- 3 Vertical crack (1/16 inch wide maximum) extended from the top of the above water step in shaft to the waterline.
- 4 Timber debris consisting of two tree trunks, 2 feet in diameter, was observed along the east face of Pier 3.

- 5 Overall, concrete was smooth and sound.
- 6 Light to moderate accumulation of timber debris located along the upstream nose and to the west side of Pier 1 was observed scattered along the channel bottom extending up 2 feet.

- 7 Vertical cracks (1/16 inch wide maximum) were observed from above water step in shaft to the waterline on west side of Pier 3.
- 8 Rip-rap and concrete rubble was observed at upstream nose of Piers 2 and 3. On Pier 3, it extended along east side as well.
