UNDERWATER BRIDGE INSPECTION REPORT

STRUCTURE NO. 27639

CROW RIVER

MINNESOTA DEPARTMENT OF TRANSPORTATION
UNDERWATER BRIDGE INSPECTION

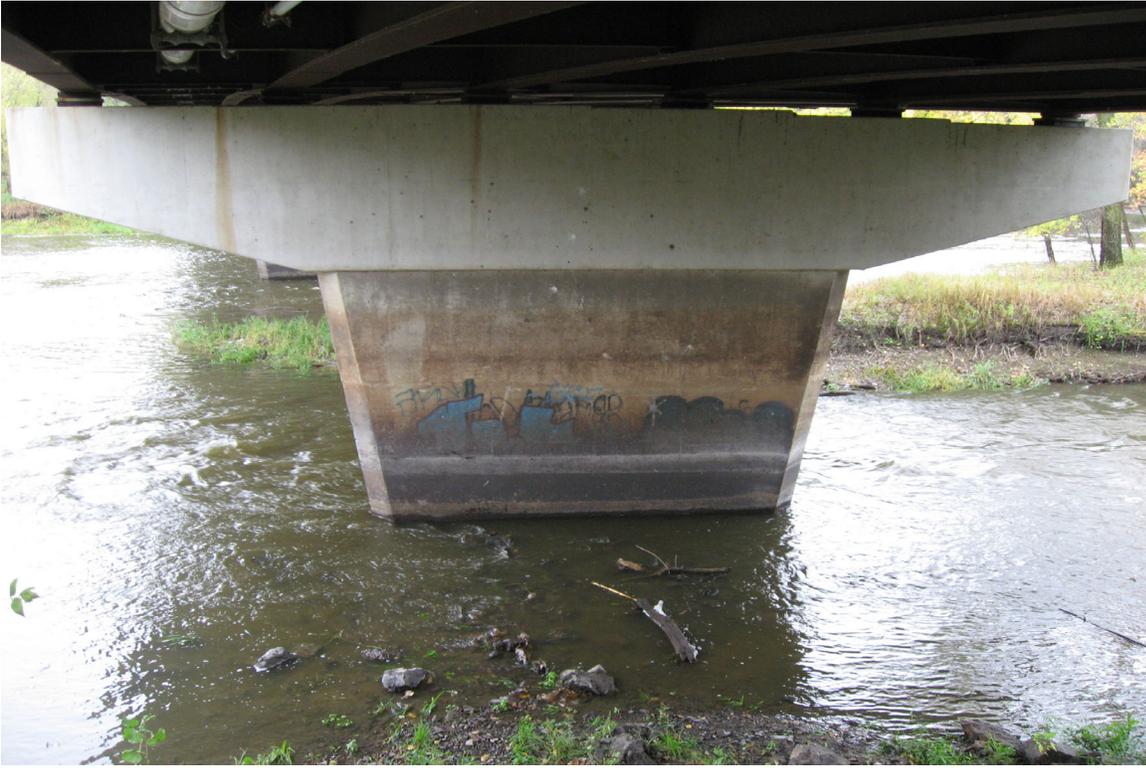
- (A) The concrete of the piers was smooth and sound with no significant deterioration.
- (B) A scour depression 2 feet in radius by 2 foot deep was observed at the upstream end of Pier 2.
- (C) A light accumulation of timber debris consisting of branches 1 inch in diameter and smaller was observed scattered about on the channel bottom around Pier 3.

Photograph 2. View of Pier 1, Looking East.

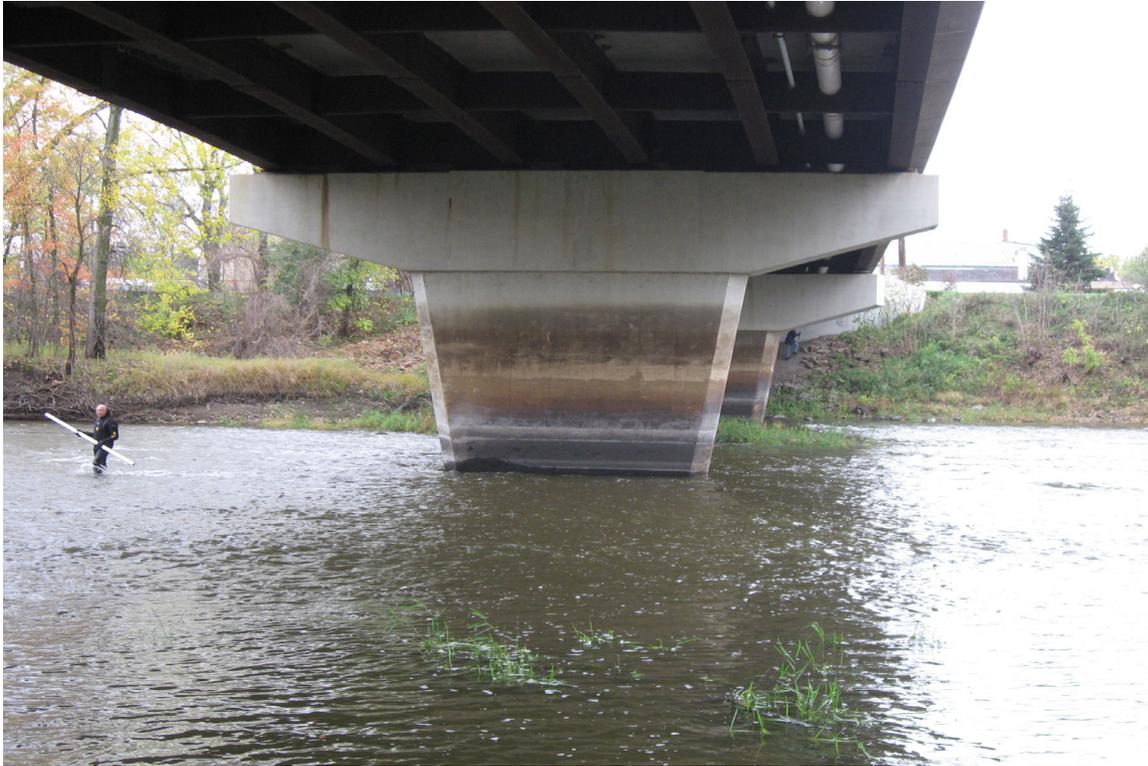
Photograph 3. View of Pier 2, Looking West.

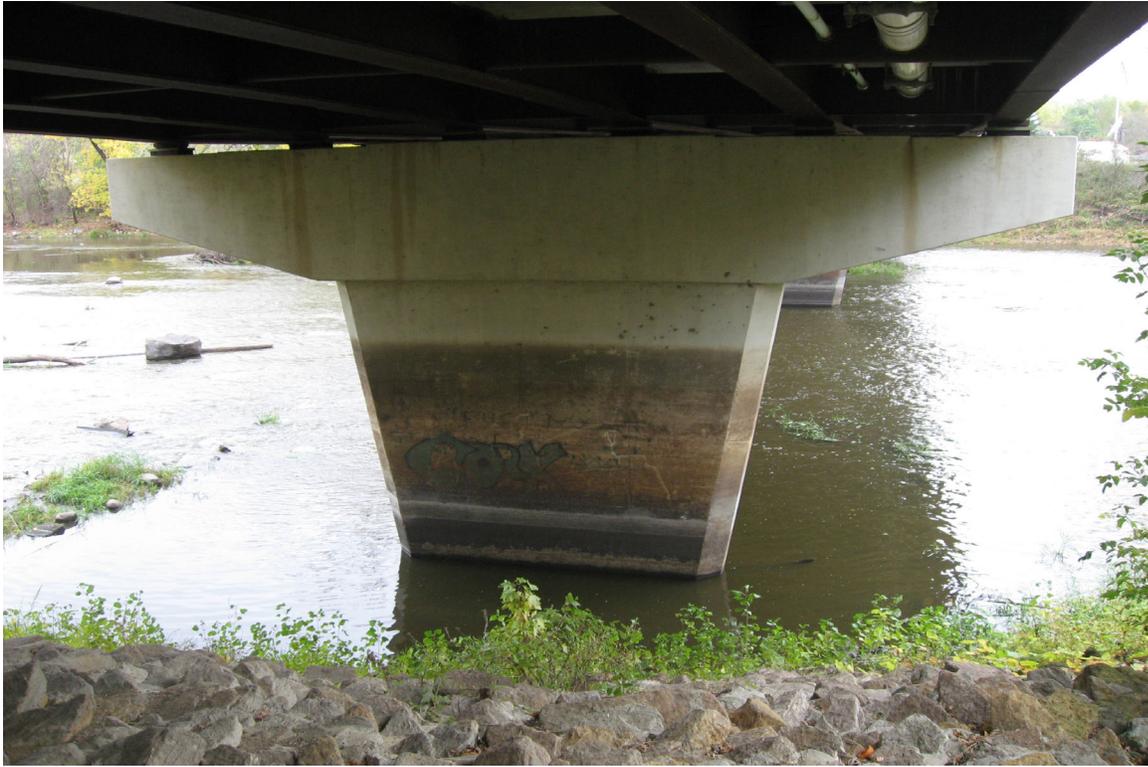
Photograph 4. View of Pier 3, Looking West.

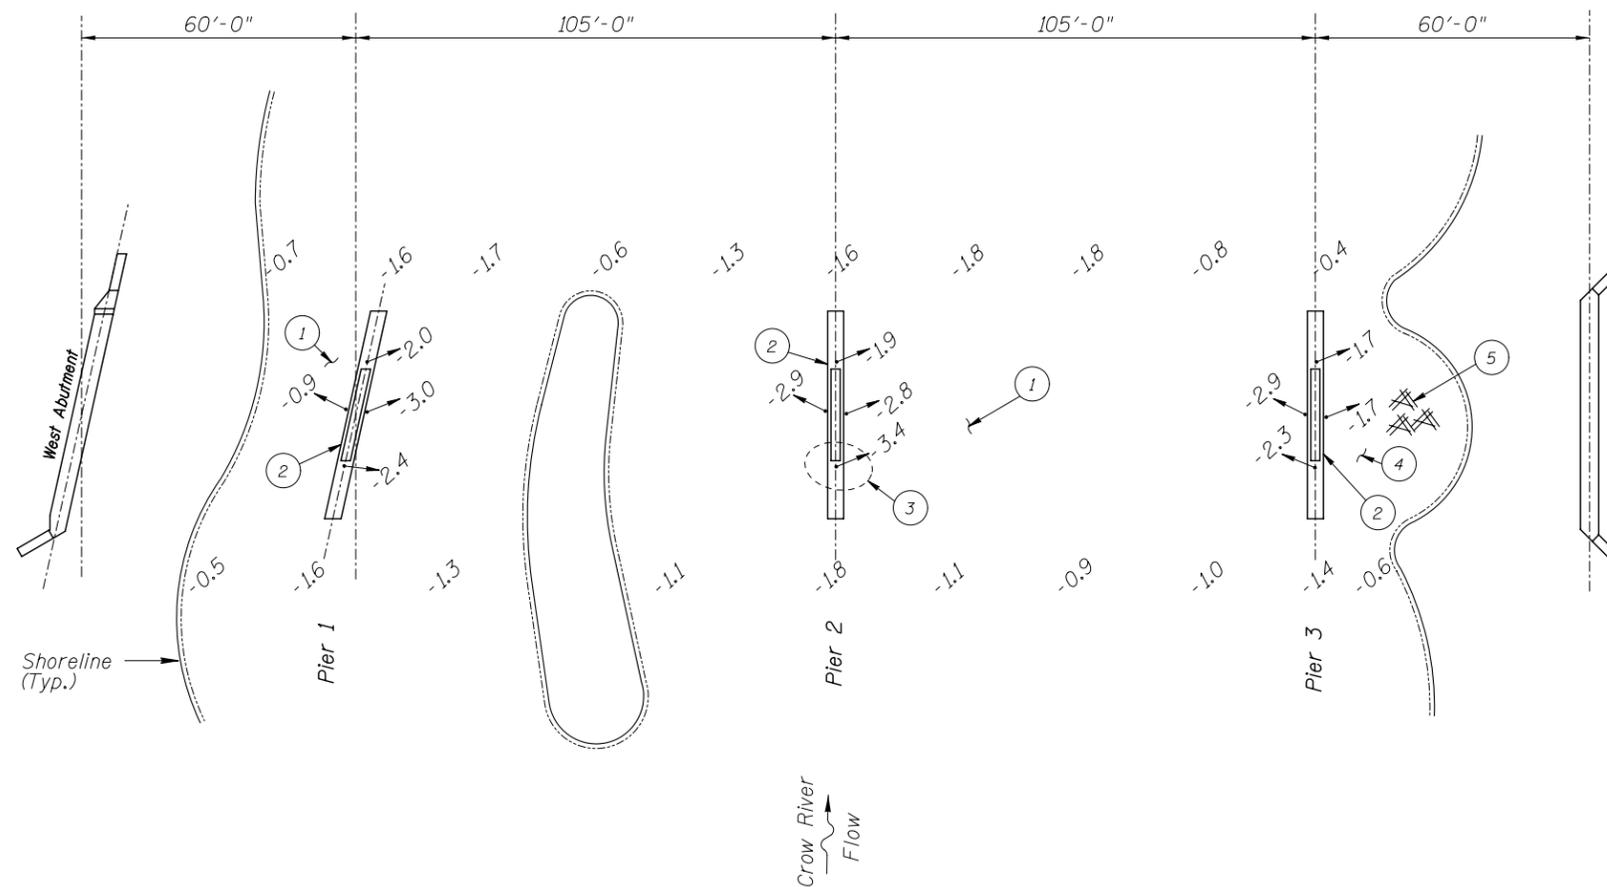
MINNESOTA DEPARTMENT OF TRANSPORTATION UNDERWATER BRIDGE INSPECTION		
STRUCTURE NO. 27639 OVER CROW RIVER DISTRICT 5, HENNEPIN COUNTY		
INSPECTION AND SOUNDING PLAN		
Drawn By: RR	COLLINS ENGINEERS	Date: Nov. 2007
Checked By: MDK		Scale: NTS
Code: 52210037		Figure No.: 1

- ① The channel bottom around Piers 1 and 2 consisted of 2 feet diameter and smaller rocks With no appreciable probe rod penetration possible.
- ② Overall, concrete was smooth and sound without notable deterioration.
- ③ A scour depression 2 feet radius by 1 foot deep was observed at the upstream end of Pier 2.
- ④ The channel bottom around Pier 3 consisted of gravel with 2 inches of silt on top and with up to 3 inches of probe rod penetration.
- ⑤ Light accumulation of timber debris consisting of 1 inch diameter and smaller limbs and branches was observed scattered on the channel bottom around Pier 3.
