UNDERWATER BRIDGE INSPECTION REPORT

STRUCTURE NO. 2796

10TH AVENUE

MISSISSIPPI RIVER

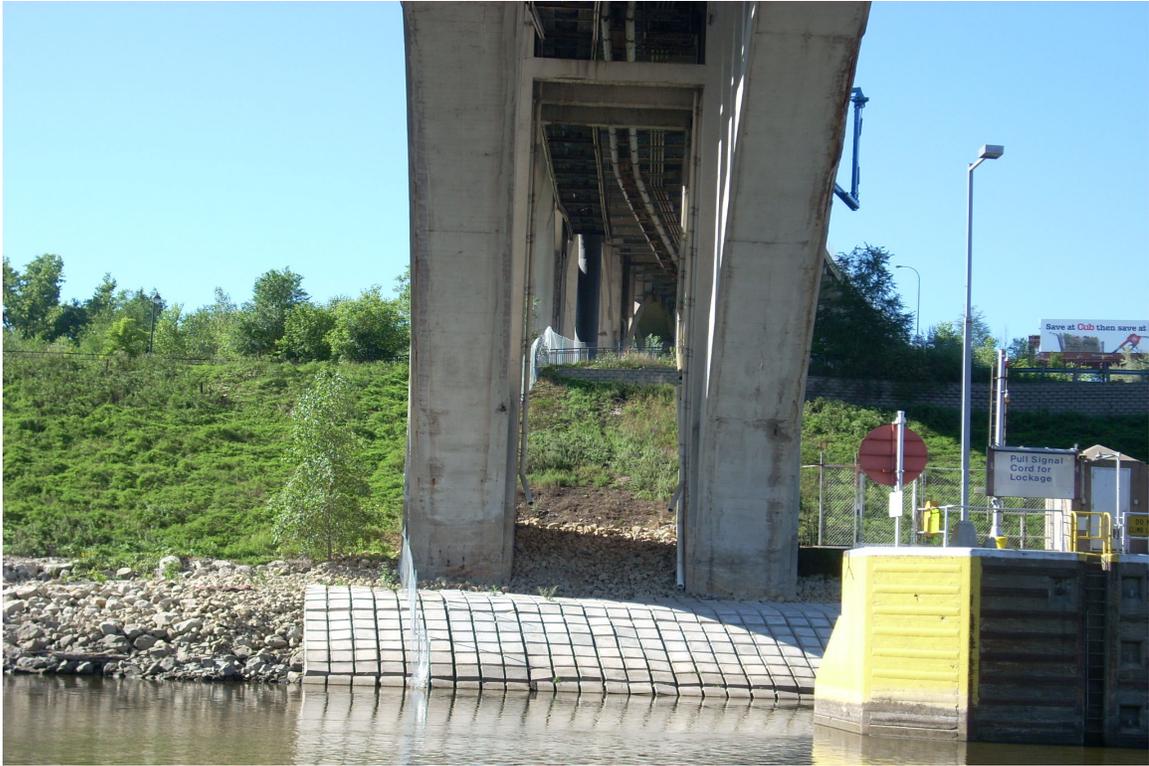
Photograph 1. View of the Southwest Embankment and Pier 11, Looking Southwest.

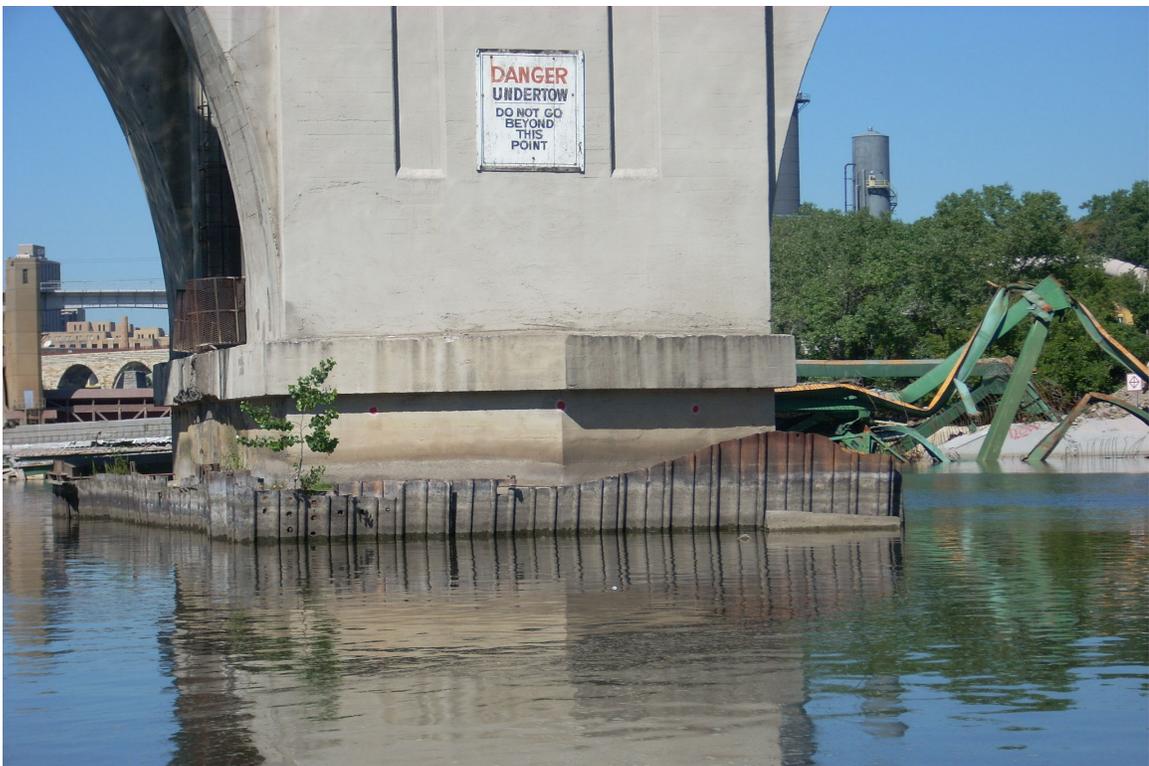
Photograph 2. View of the Downstream Nose of Pier 12, Looking Northwest.

- 6 There was a hole in the steel sheet piling at the downstream end measuring 1 inch in diameter.
- 7 The topside concrete surface within the sheeting was sound, however, gaps/ cracks up to 1' maximum width were observed on both east and west sides of pier 12.

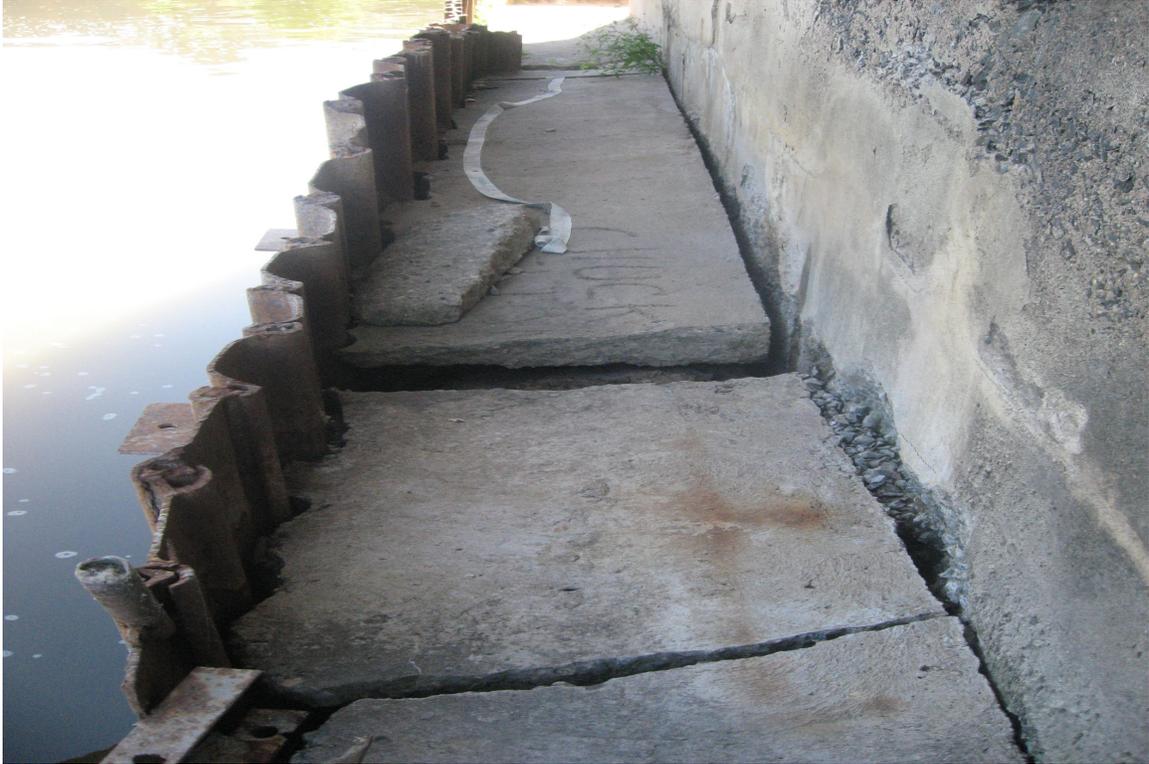
- (A) Gaps were present in the steel sheeting at the east and west upstream quarter points of the pier. The gaps varied in width between the waterline and the channel bottom with a maximum width of 3 feet at the channel bottom on the east side of the pier. The gaps appear to be part of the original sheet pile construction, are unchanged from the last inspection, and do not affect the structural integrity of the pier.

- (C) A void between the horizontal C-channels and the vertical sheeting was observed at the east side upstream quarter point of the pier, 2.5 feet below the waterline. The void had a height of 2.5 feet with 3.5 feet of penetration. There was some settlement, displacement, and cracking of the concrete within the sheeting (see Note E) related to this void.

(E) The topside concrete surface (within the sheeting) was sound, however gaps and/or cracks with up to one foot maximum width were observed on both east and west sides of the pier.

Photograph 3. View of the Concrete and Sheet Piling along East Side of Pier 12, Looking Southeast.

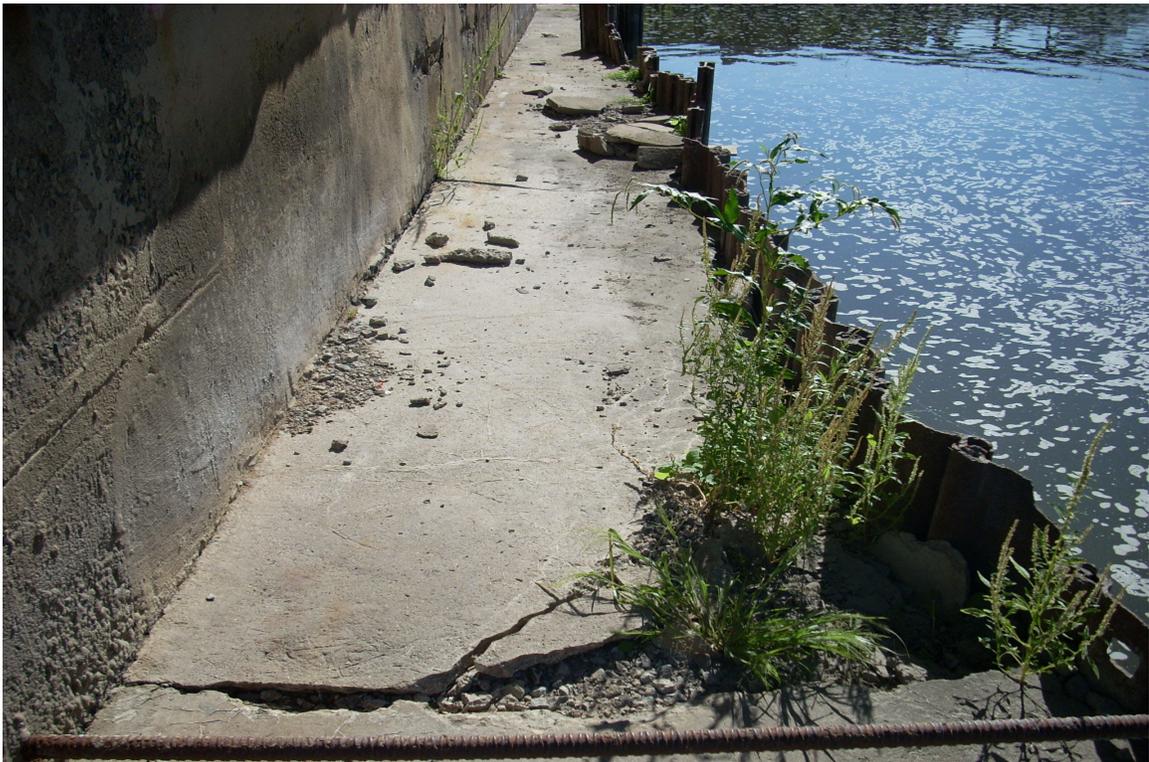
(D) The sheet piling was slightly separated (1 to 2 inch gap) around the base of the pier for a length of 20 feet along both sides of the pier.

Photograph 4. View of the Concrete and Sheet Piling along West Side of Pier 12, Looking Southeast.

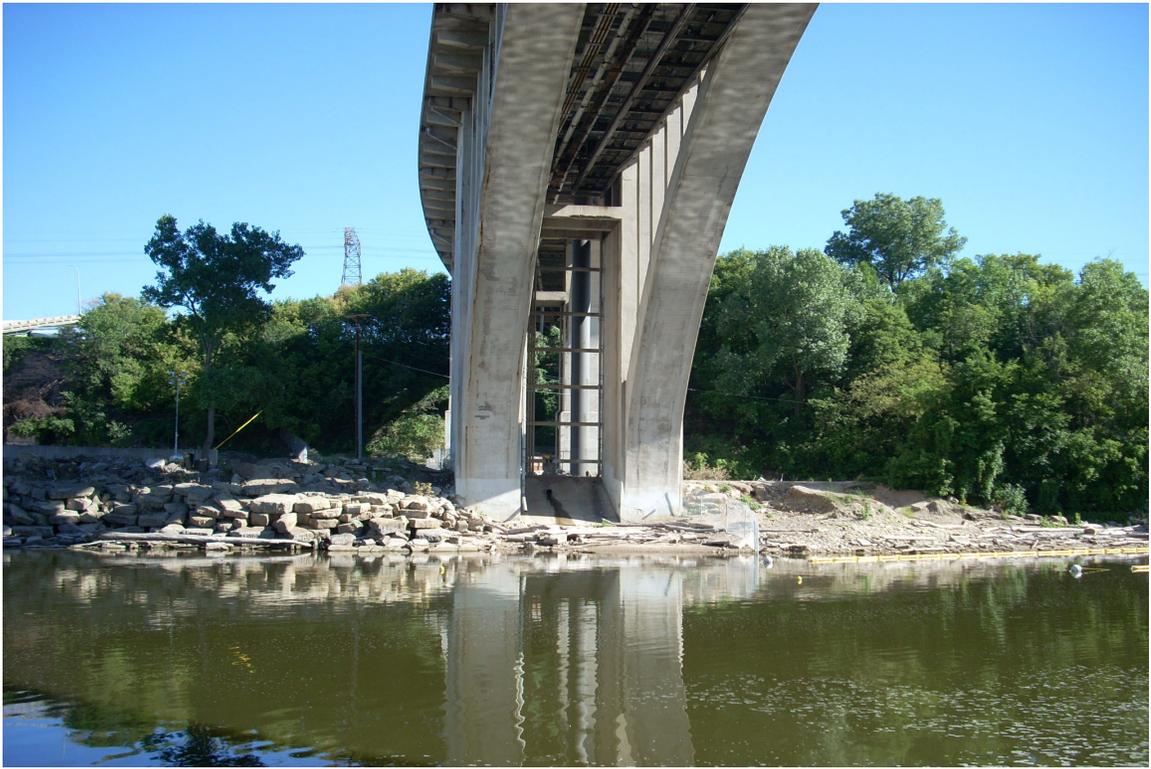
Photograph 5. View of Northeast Embankment and Pier 13, Looking Northeast.

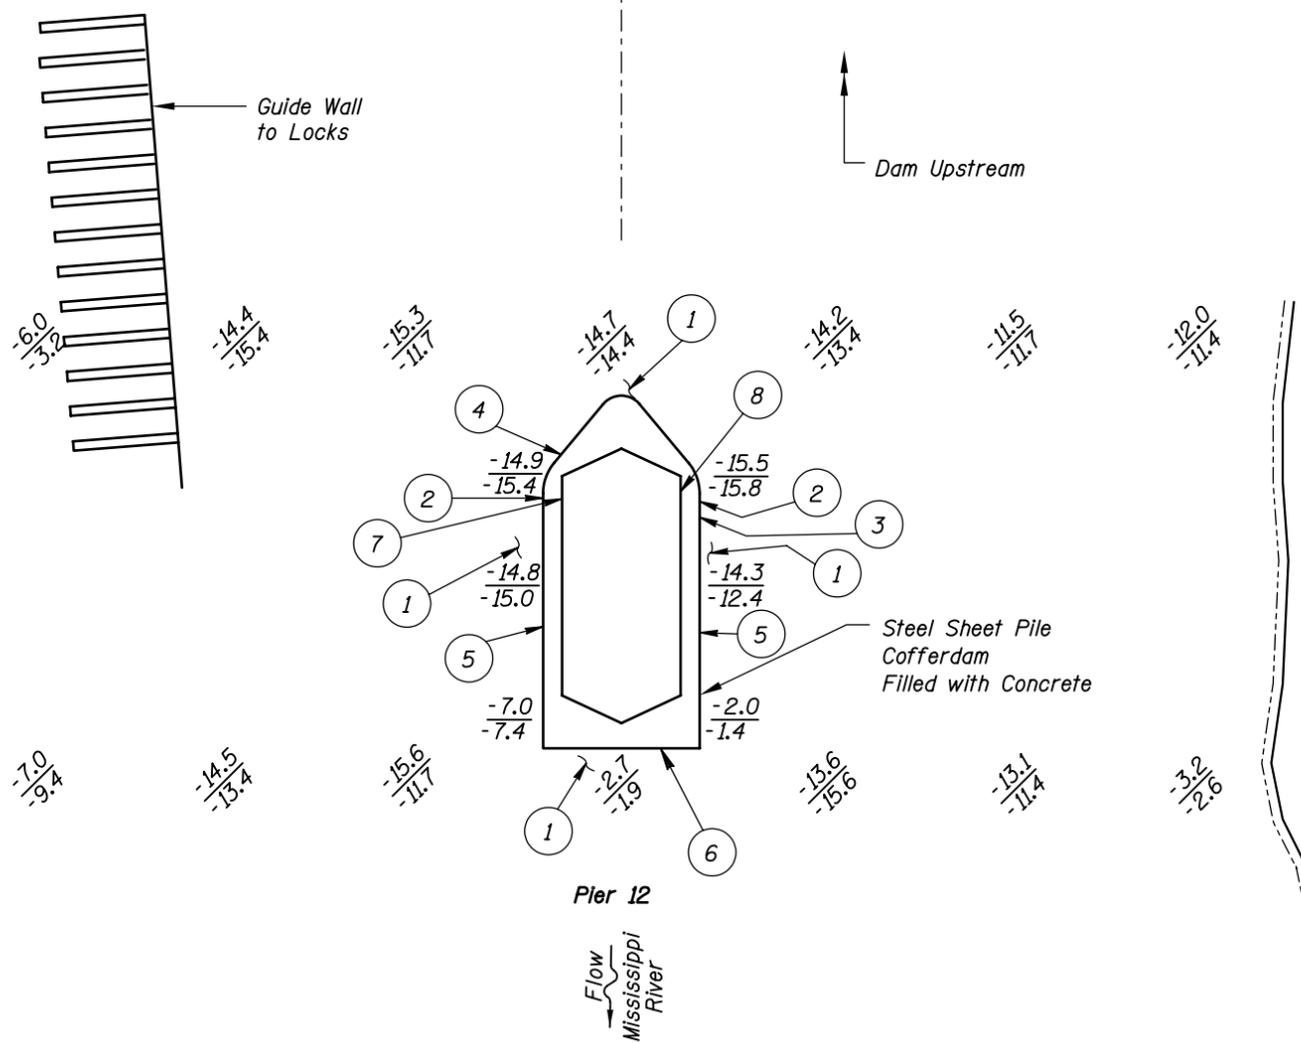
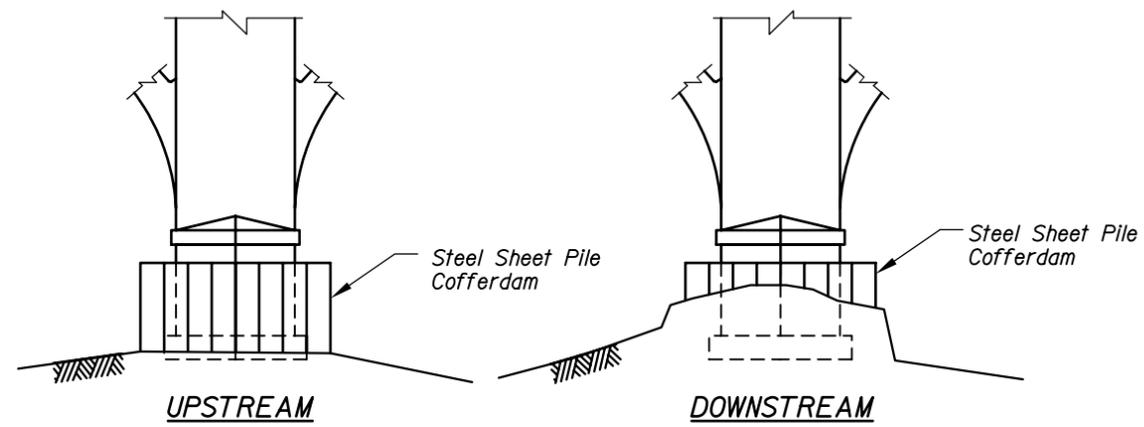
SOUNDING PLAN

- 1 The channel bottom material, within 10 feet of the substructure unit, typically consisted of tightly packed riprap from 1 foot to 3 feet in size. Along the downstream end, the channel sloped up at a steep angle and was located approximately 2.4 feet below the waterline, the downstream channel bottom material consisted of cobbles of less than 6 inches in size and riprap from 1 foot to 4 feet in size.

- 2 Gaps in the lines of construction (not at interlocks), were observed in the steel sheeting at the east and west upstream 1/4 points with maximum widths located at the channel bottom. The west gap measured 15 inches in width and had a maximum penetration of 6 inches. The east side gap measured 36 inches in width and had no penetration.

- 3 A void between the horizontal C-channels and the vertical sheeting was observed at the east side upstream 1/4 point of the pier at 2.5 feet below the waterline with a height of 2.5 feet and 3.5 feet of maximum penetration.

- 4 The steel sheeting was in good condition with a uniform 1/8 inch layer of surface corrosion extending from the top of the sheeting to the channel bottom.

- 5 The steel sheet piling was slightly separated from the concrete around the base of the pier for a length of approximately 20 feet along the east and west sides.
