UNDERWATER BRIDGE INSPECTION REPORT

STRUCTURE NO. 62555

WABASHA STREET

MISSISSIPPI RIVER

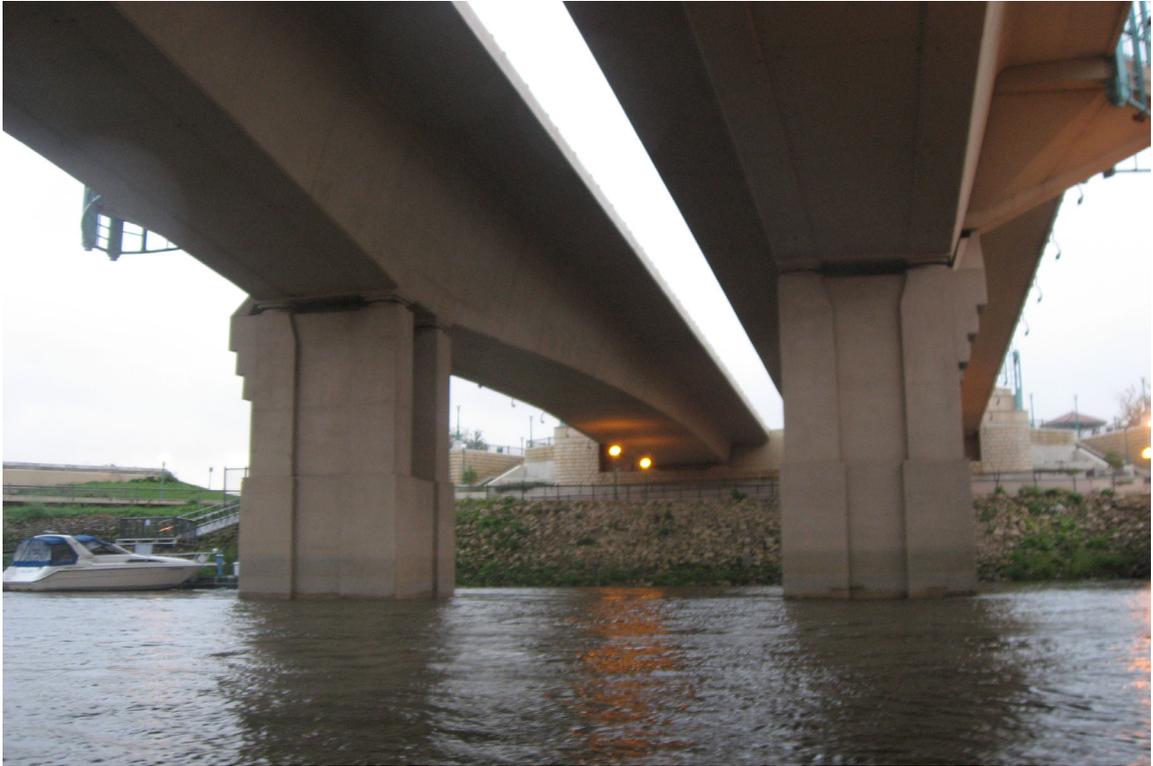
Photograph 1. View of the Pier 3, Looking Southwest

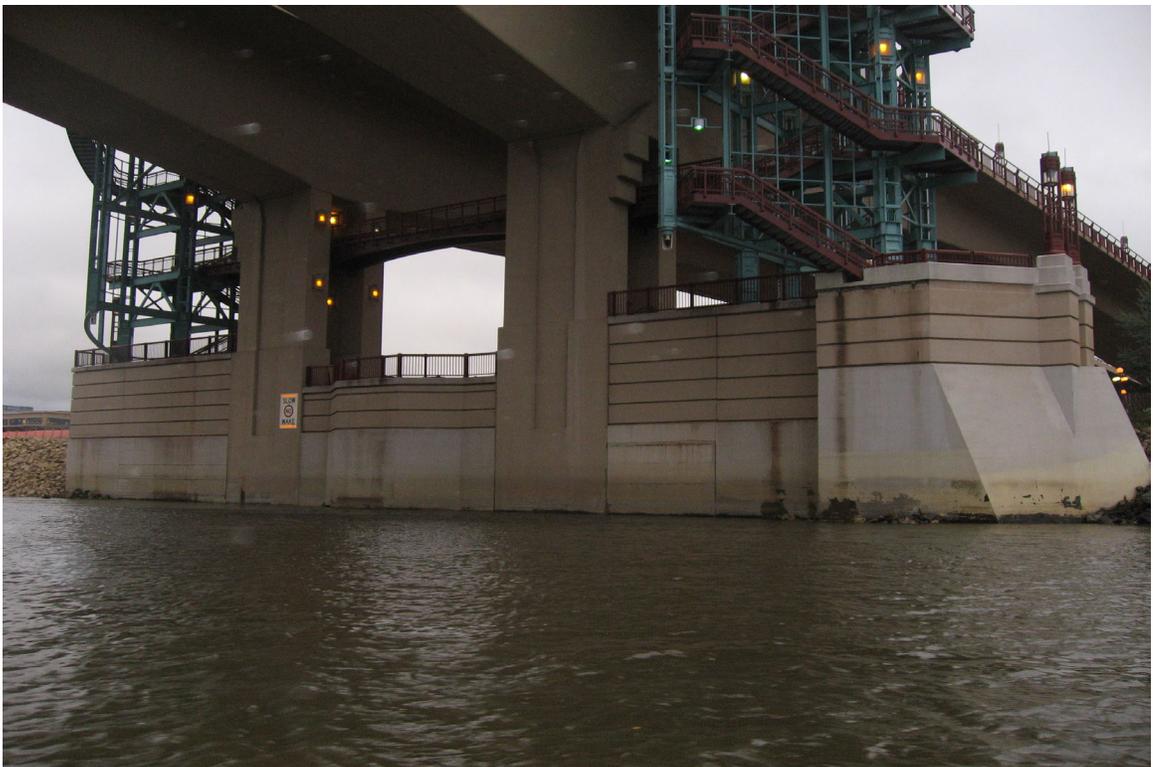
Photograph 2. View of the Pier 2, Looking Southeast. Water depths at pier were 1 foot or less.

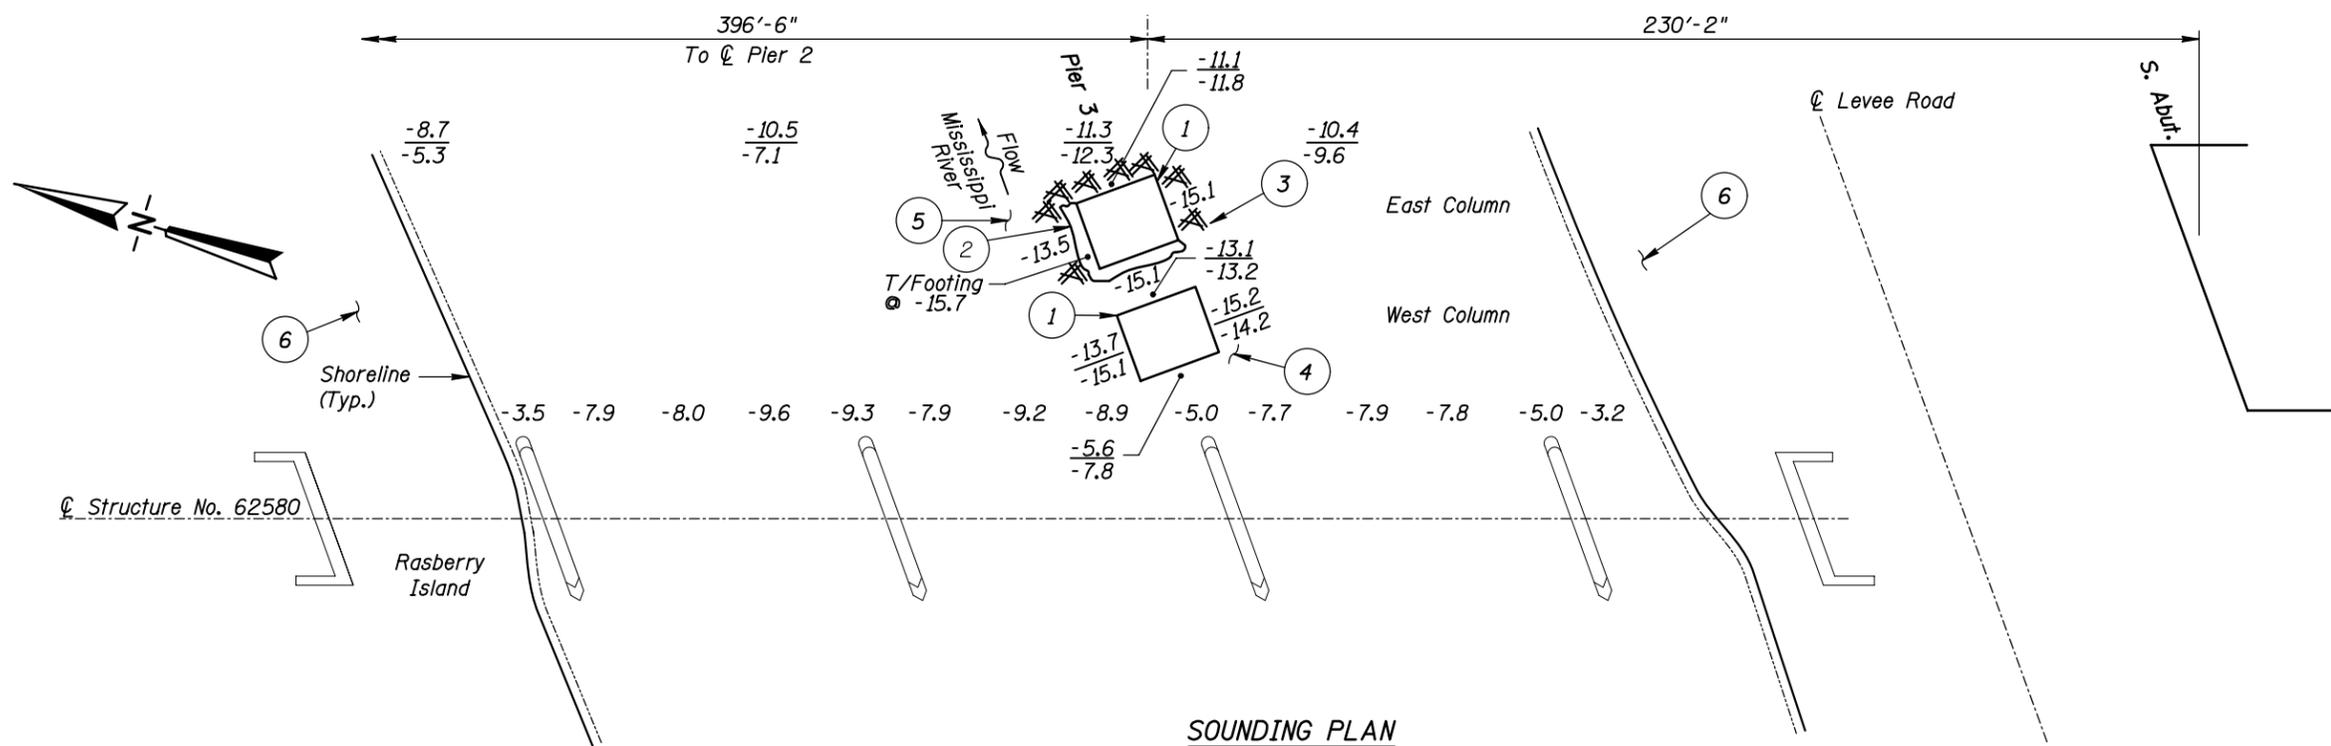
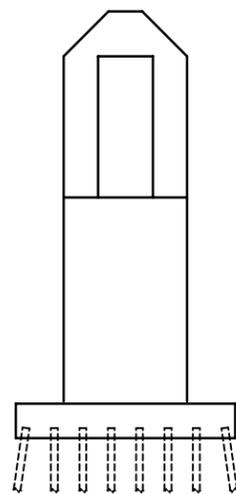
- (A) A 6 foot wide portion of the top of the footing was exposed along the entire upstream and north sides at the East Column. No vertical exposure was detected.
- (B) A minor accumulation of timber debris, consisting of 12 inch diameter logs, was observed on the channel bottom at the downstream end and sides and north face of the East Column.

- 1 The concrete was in good and sound condition with no structurally significant defects observed.
- 2 A 6 foot wide portion of the top of the footing was exposed along the entire upstream side and north face at the East Column.
- 3 A minor accumulation of timber debris, consisting of 12 inch diameter logs, was observed at the downstream end and sides of the East Column extending from the channel bottom up 1 to 3 feet.
- 4 The channel bottom consisted of riprap up to 1 foot in diameter at the upstream nose of the West Column.
- 5 The channel bottom downstream of West Column and all around the East Column consisted of sandy infilling with up to 1 foot of probe rod penetration.
- 6 The embankments were well armored with 1 foot diameter riprap.

- (A) Reinspect the submerged substructure units at the normal maximum recommended (NBIS) interval of five (5) years.
