UNDERWATER BRIDGE INSPECTION REPORT

STRUCTURE NO. 62580
RASPBERRY ISLAND ROAD
OVER THE
MISSISSIPPI RIVER
DISTRICT 9 - RAMSEY COUNTY

PREPARED FOR THE
MINNESOTA DEPARTMENT OF TRANSPORTATION
BY
COLLINS ENGINEERS, INC.

JOB NO. 5221

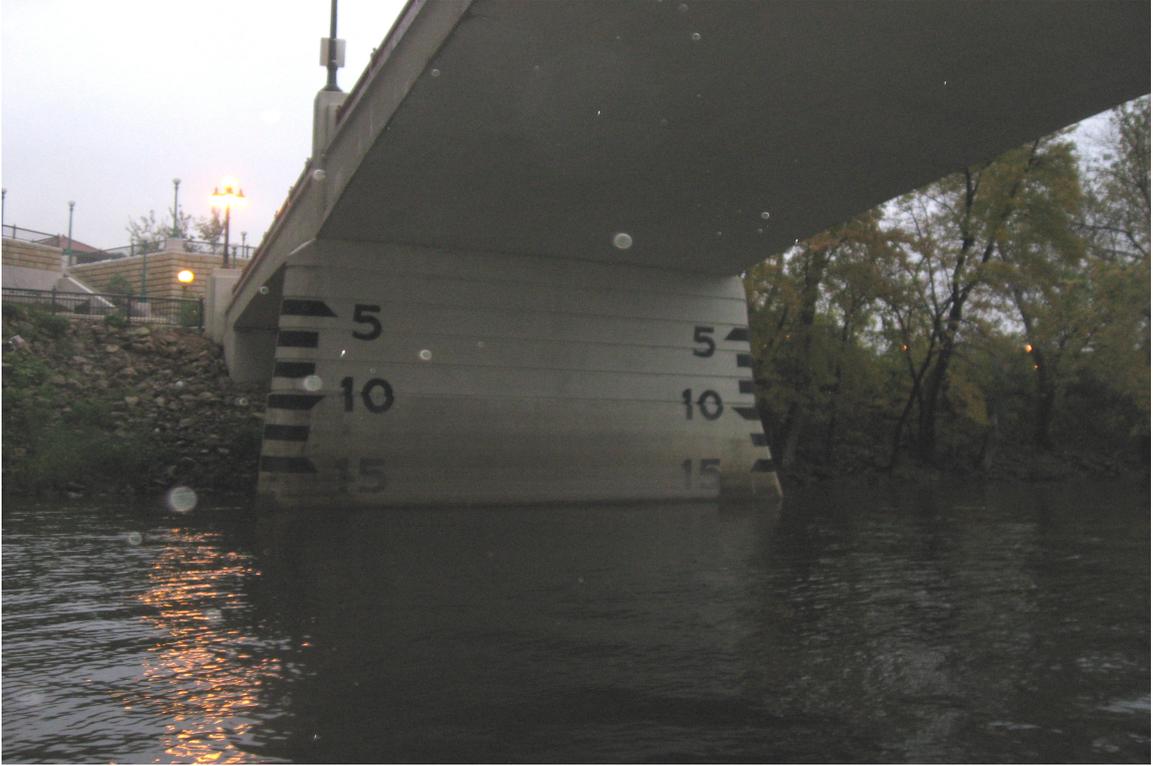
Photograph 1. Overall View of Pier 1, Looking South.

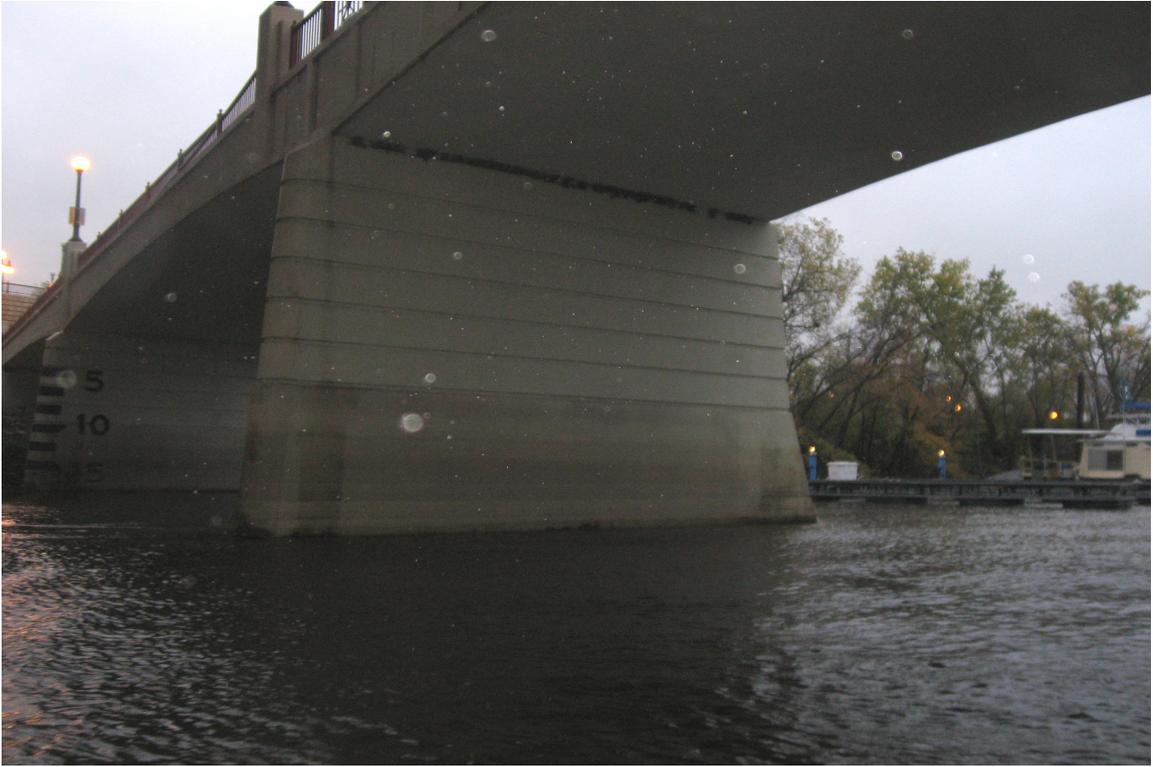
Photograph 2. Overall View of Pier 2, Looking South.

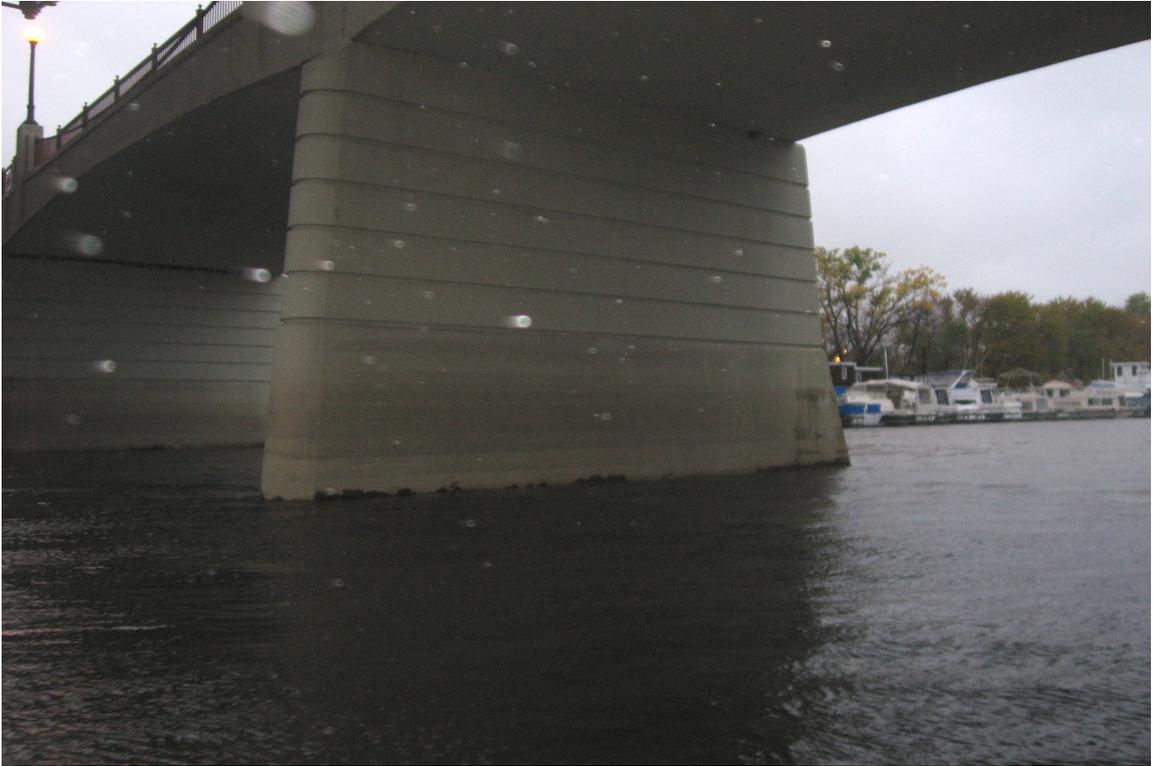
Photograph 3. Overall View of Pier 3, Looking South

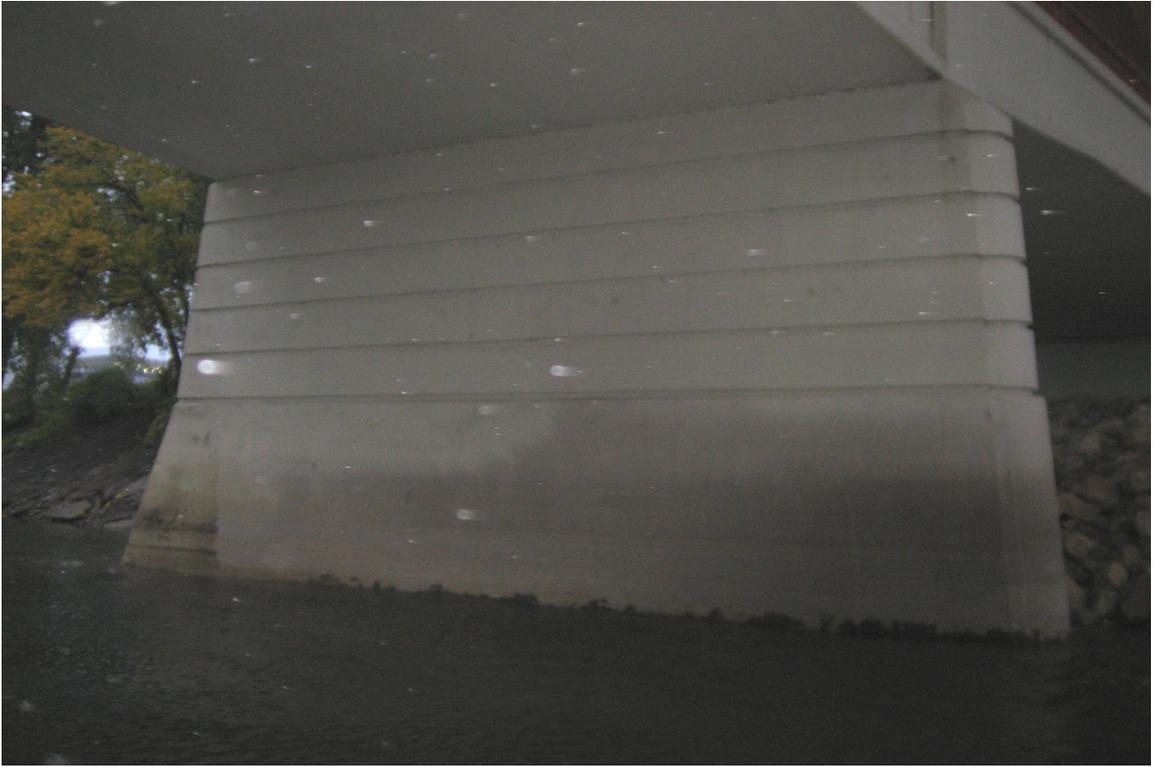
Photograph 4. Overall View of Pier 4, Looking Northwest

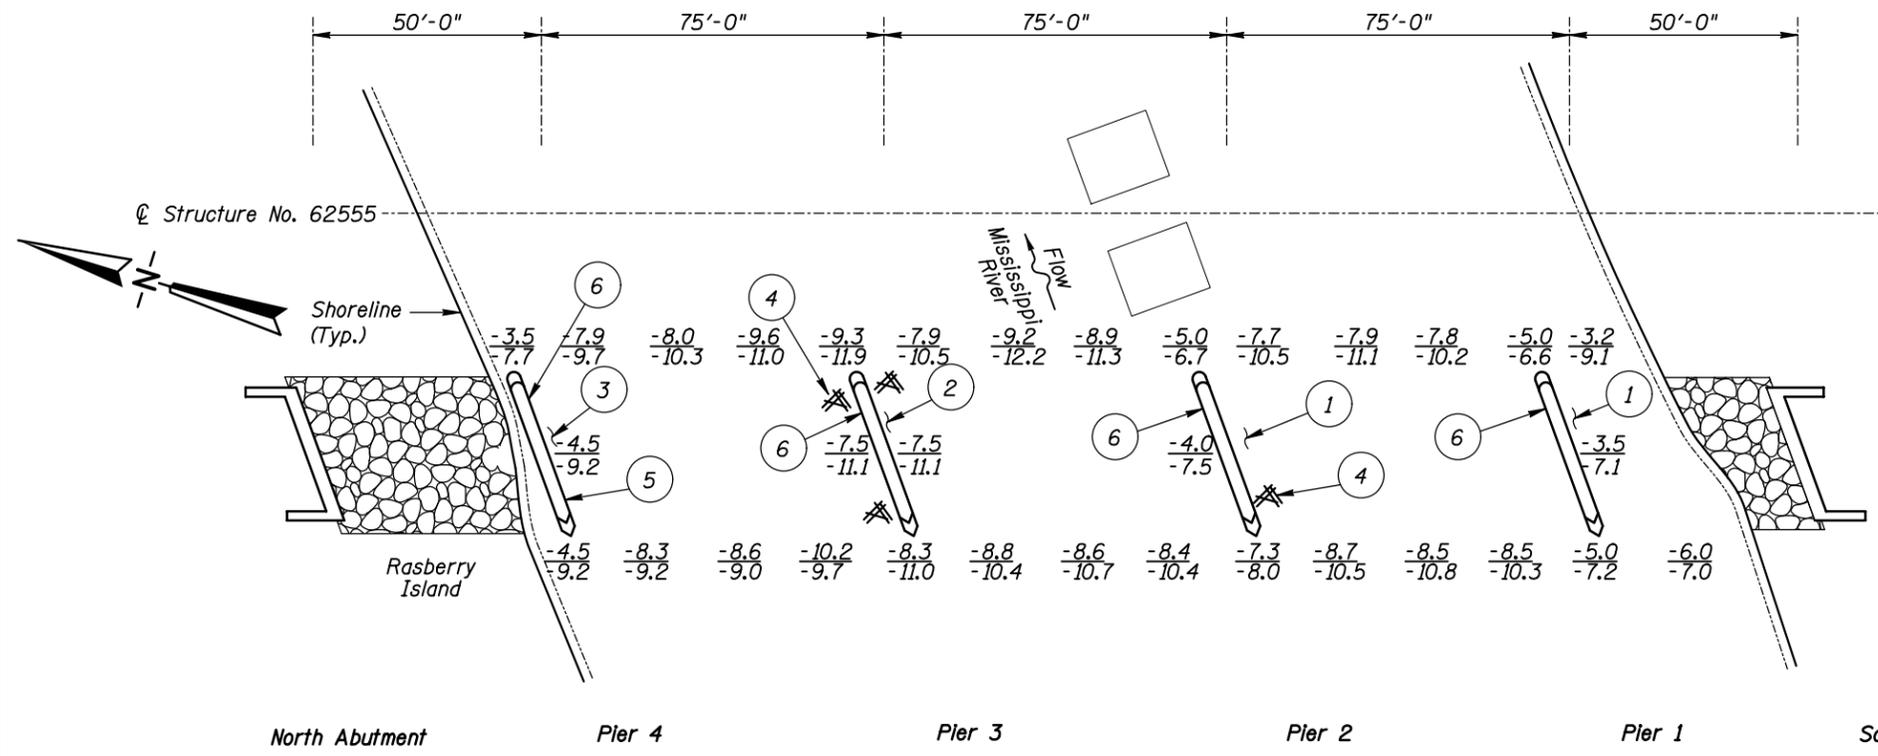
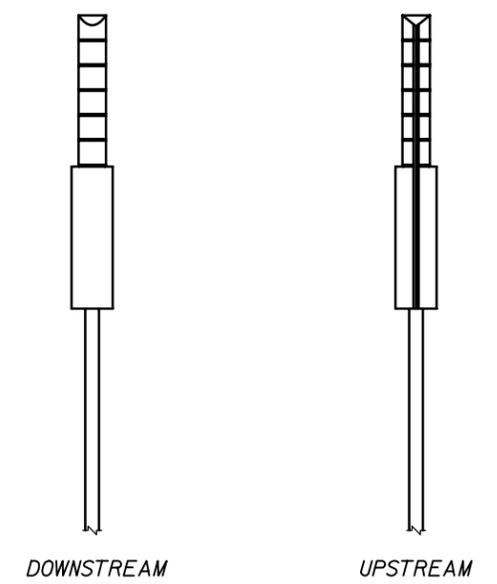
SOUNDING PLAN

- 1 The channel bottom consisted of 2 inch diameter gravel with random riprap at the upstream end and with minimal probe rod penetration..
- 2 The channel bottom consisted of sand with up to 6 inches of probe rod penetration.

- 3 The channel bottom consisted of 6 inch diameter cobbles and gravel.
- 4 A minor accumulation of timber debris, with pieces up to 12 inches in diameter, was observed on the channel bottom randomly scattered throughout the piles of Pier 3 extending from channel bottom up 2 to 3 feet.

- 5 Timber formwork and steel angles were observed at the base of the concrete shaft of Pier 4. The bottom of the shaft was poorly formed with rough edges and reinforcing steel protruding from the base.

- 6 The concrete shaft was in good and sound condition and extended 2 feet below the waterline. The submerged steel piles exhibited light surface corrosion with rust nodules up to 1/4 inch in diameter.
