UNDERWATER BRIDGE INSPECTION REPORT

STRUCTURE NO. 70532  
CSAH NO. 9  
OVER THE  
MINNESOTA RIVER  
DISTRICT M – SCOTT COUNTY

PREPARED FOR THE  
MINNESOTA DEPARTMENT OF TRANSPORTATION  
BY  
COLLINS ENGINEERS, INC.  
JOB NO. 5221

MINNESOTA DEPARTMENT OF TRANSPORTATION  
UNDERWATER BRIDGE INSPECTION

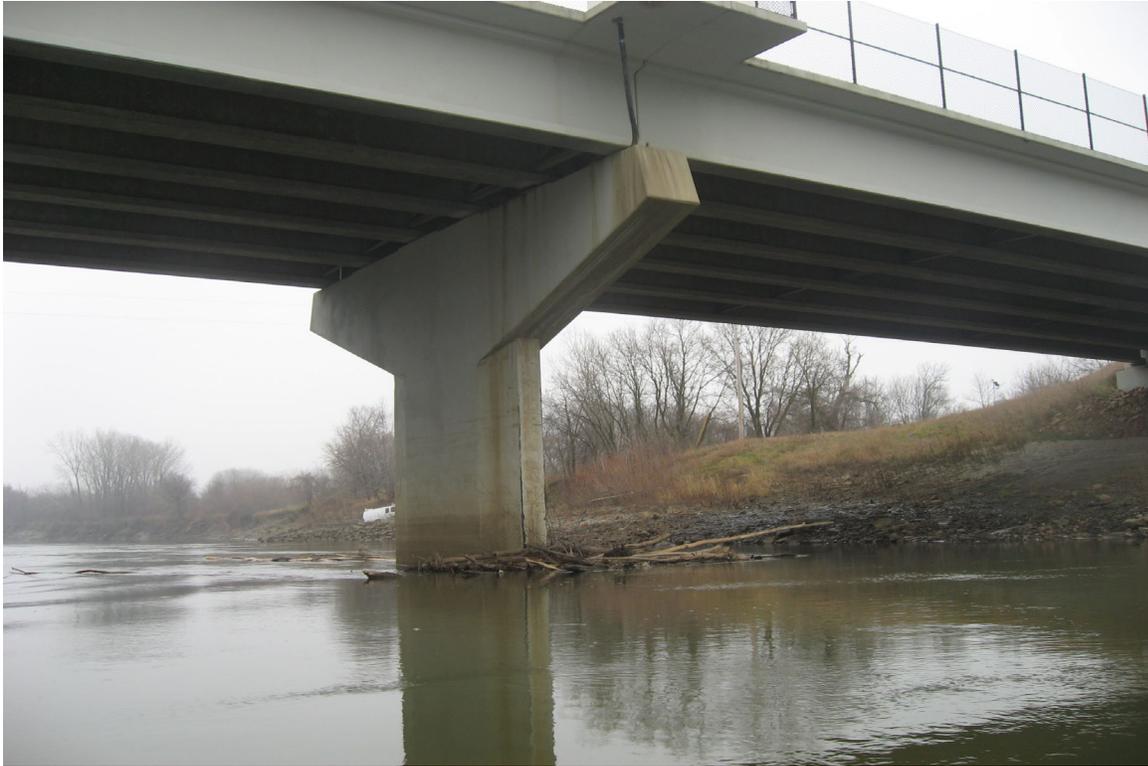
- (A) A heavy accumulation of timber debris consisting of logs and branches 2 feet in diameter and smaller was observed at the upstream end of Pier 1, as well as all along the south face and to the upstream quarter point at the north face. The debris was also observed at the channel bottom on the north face. The accumulation extended 10 feet off the nose and faces and from the channel bottom up to 3 feet above the waterline.
- (B) A heavy accumulation of timber debris consisting of logs and branches 18 inches in diameter and smaller was observed at the upstream end of Pier 2, extending to the midpoint along both sides. The debris extended 10 feet off the upstream nose and from the channel bottom up 2 feet.

Photograph 2. View of Pier 1 and Timber Debris, Looking Southeast.

- 3 A heavy accumulation of timber debris consisting of logs and branches 2 feet in diameter and smaller was observed at the upstream end of Pier 1, all along the south face, and to the upstream 1/4 point at the north face. Debris was also observed at the channel bottom on the north face, extending 10 feet off the nose. Also, logs were sticking out at 10 feet from the downstream end and 40 feet off the north face. Debris extended from the channel bottom up to 3 feet above the waterline.

- (A) Remove the timber debris during future maintenance operations.
- (B) Reinspect the submerged substructure units at the normal maximum recommended (NBIS) interval of five (5) years.

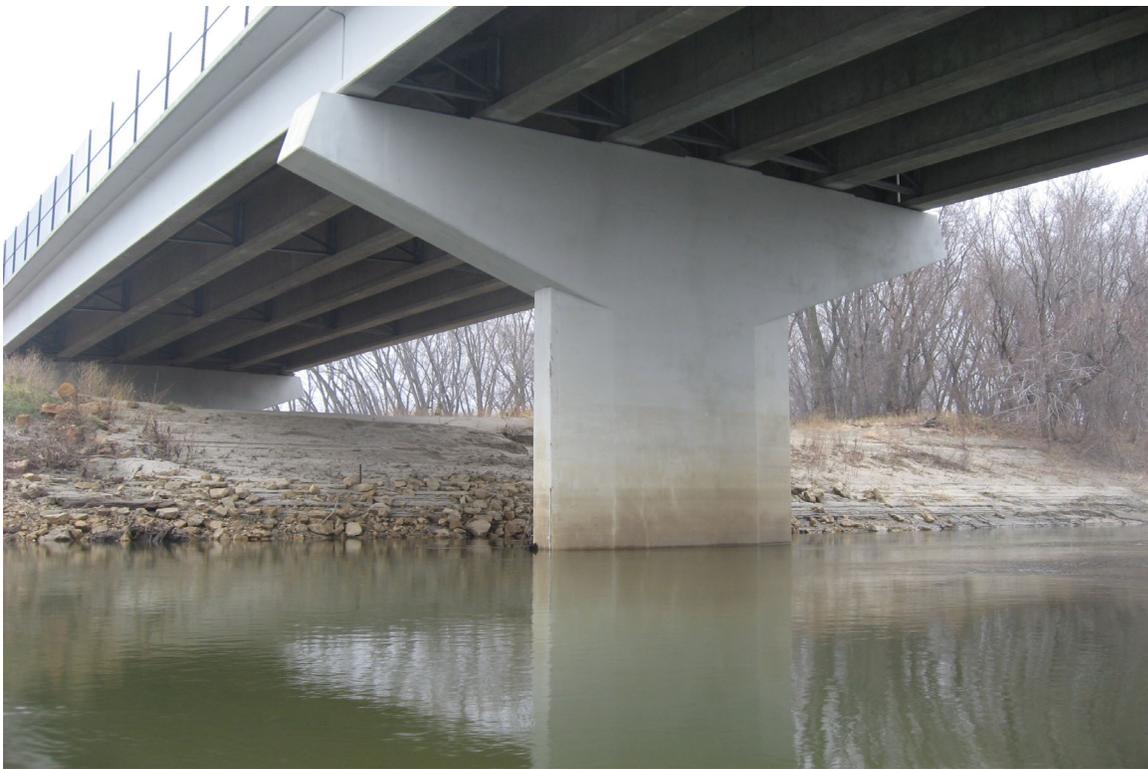
Photograph 3. View of Pier 2, Looking North.

- 2 A heavy accumulation of timber debris consisting of logs and branches 18 inches in diameter and smaller was observed at the upstream end of Pier 2 extending to the midpoint on both sides. The debris extended 10 feet off the upstream nose and from the channel bottom up 2 feet.

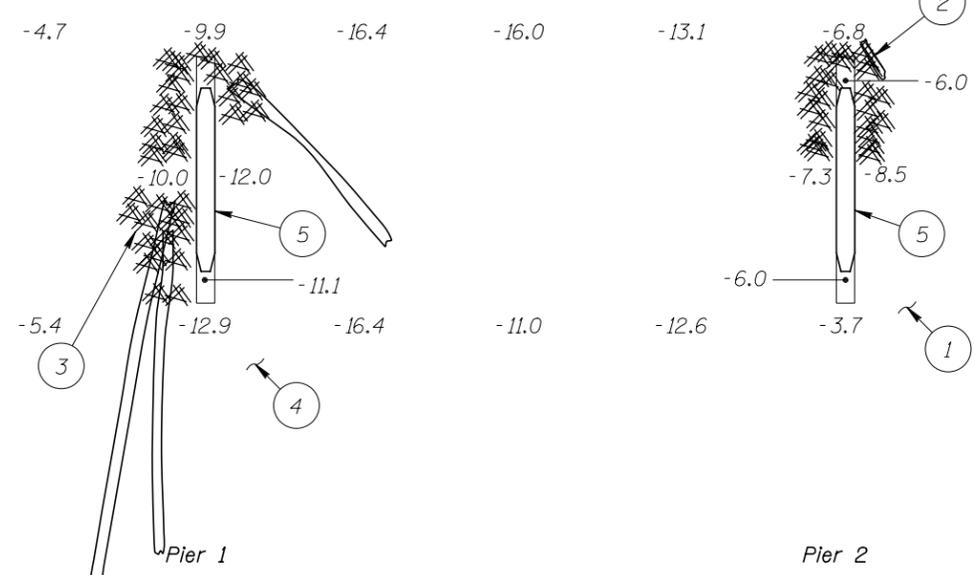
SOUNDING PLAN

- 1 The channel bottom consists of firm silty clay with a maximum probe rod penetration of 3 inches. The channel bottom on the north face was finer. Soft infilling was observed at the downstream end of Pier 2.

- 4 The channel bottom consisted of silty clay with 3 inches of probe rod penetration off the south face and soft infilling at the downstream end. At the north face the channel bottom consisted of firm silty clay and debris was found on the channel bottom.

- 5 The concrete was smooth and sound with no notable defects or deterioration.
