UNDERWATER BRIDGE INSPECTION REPORT

STRUCTURE NO. 70535
CSAH NO. 1
OVER THE
MINNESOTA RIVER
DISTRICT M-7 – SCOTT COUNTY

PREPARED FOR THE
MINNESOTA DEPARTMENT OF TRANSPORTATION
BY
COLLINS ENGINEERS, INC.
JOB NO. 5221

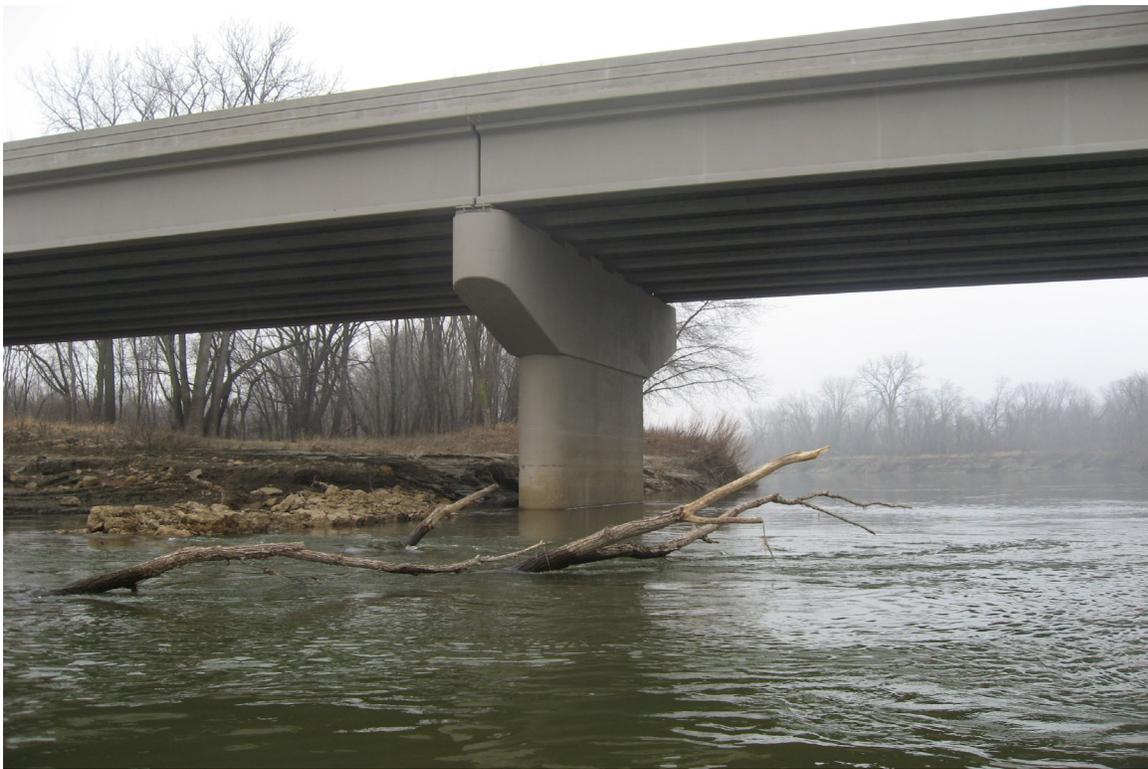
Photograph 2. View of Pier 1 and Timber Debris Upstream of Bridge, Looking Northeast.

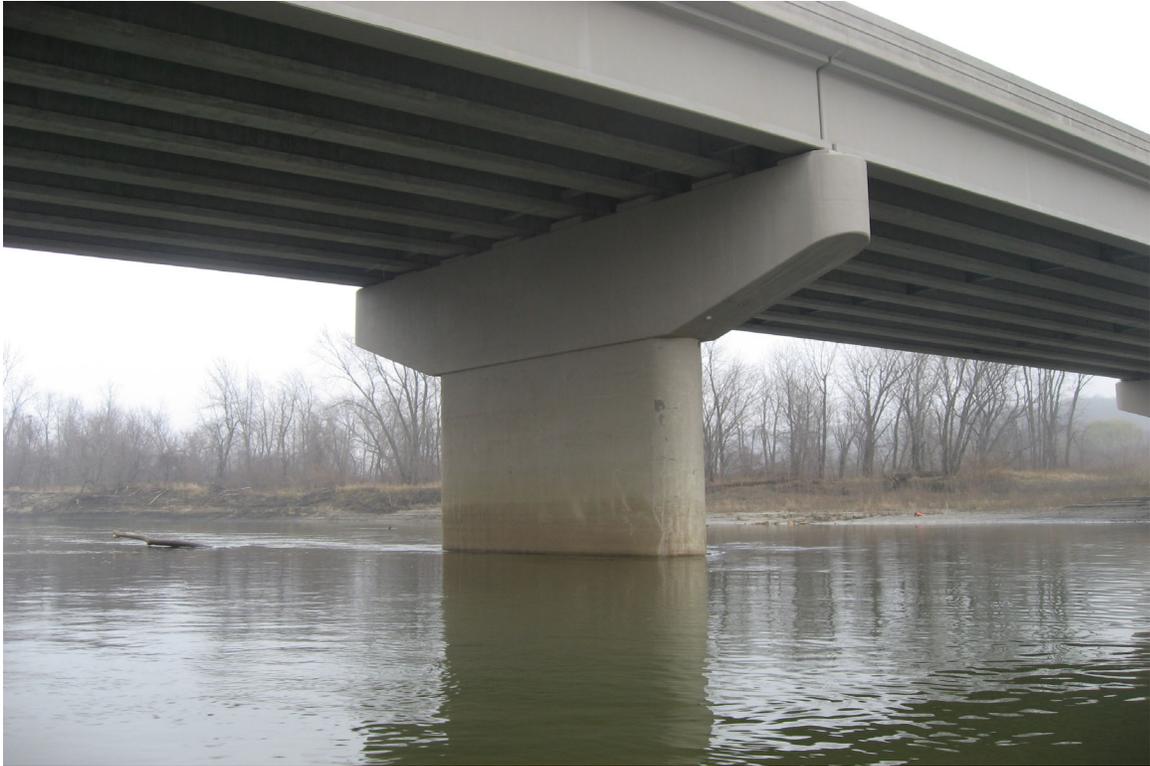
- (A) A moderate accumulation of timber debris consisting of 1 foot diameter and smaller logs and branches was observed at the upstream nose of Pier 2 extending from the channel bottom up 4 feet and along the north face from the upstream end to the shaft midpoint extending from the channel bottom up 2 feet.
- (B) A 10 foot radius scour depression 5 to 6 feet deep was observed all around the upstream nose and along northwest face of Pier 3 (on easterly bank with standing water).

Photograph 3. View of Pier 2, Looking East.

- (A) Monitor the extent of the timber debris accumulation at Pier 2, and if found to be increasing, removal during routine maintenance may become necessary.

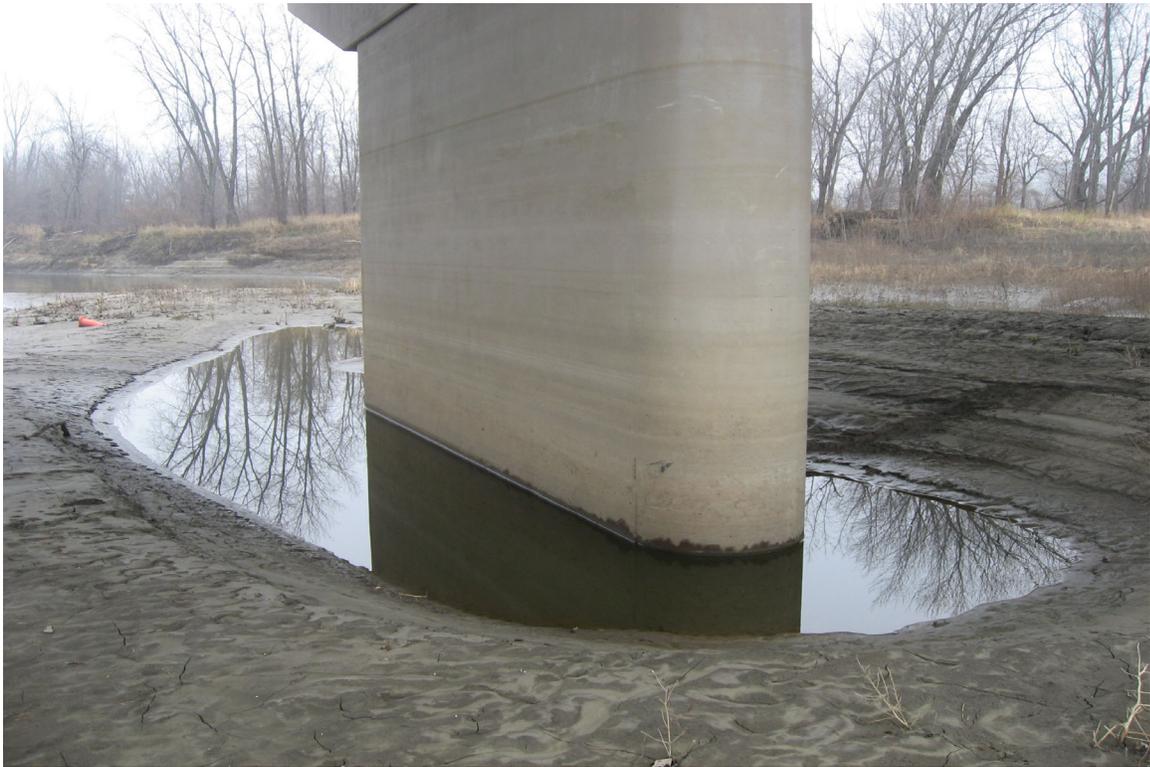
Photograph 4. View of Pier 3, Looking Northeast.

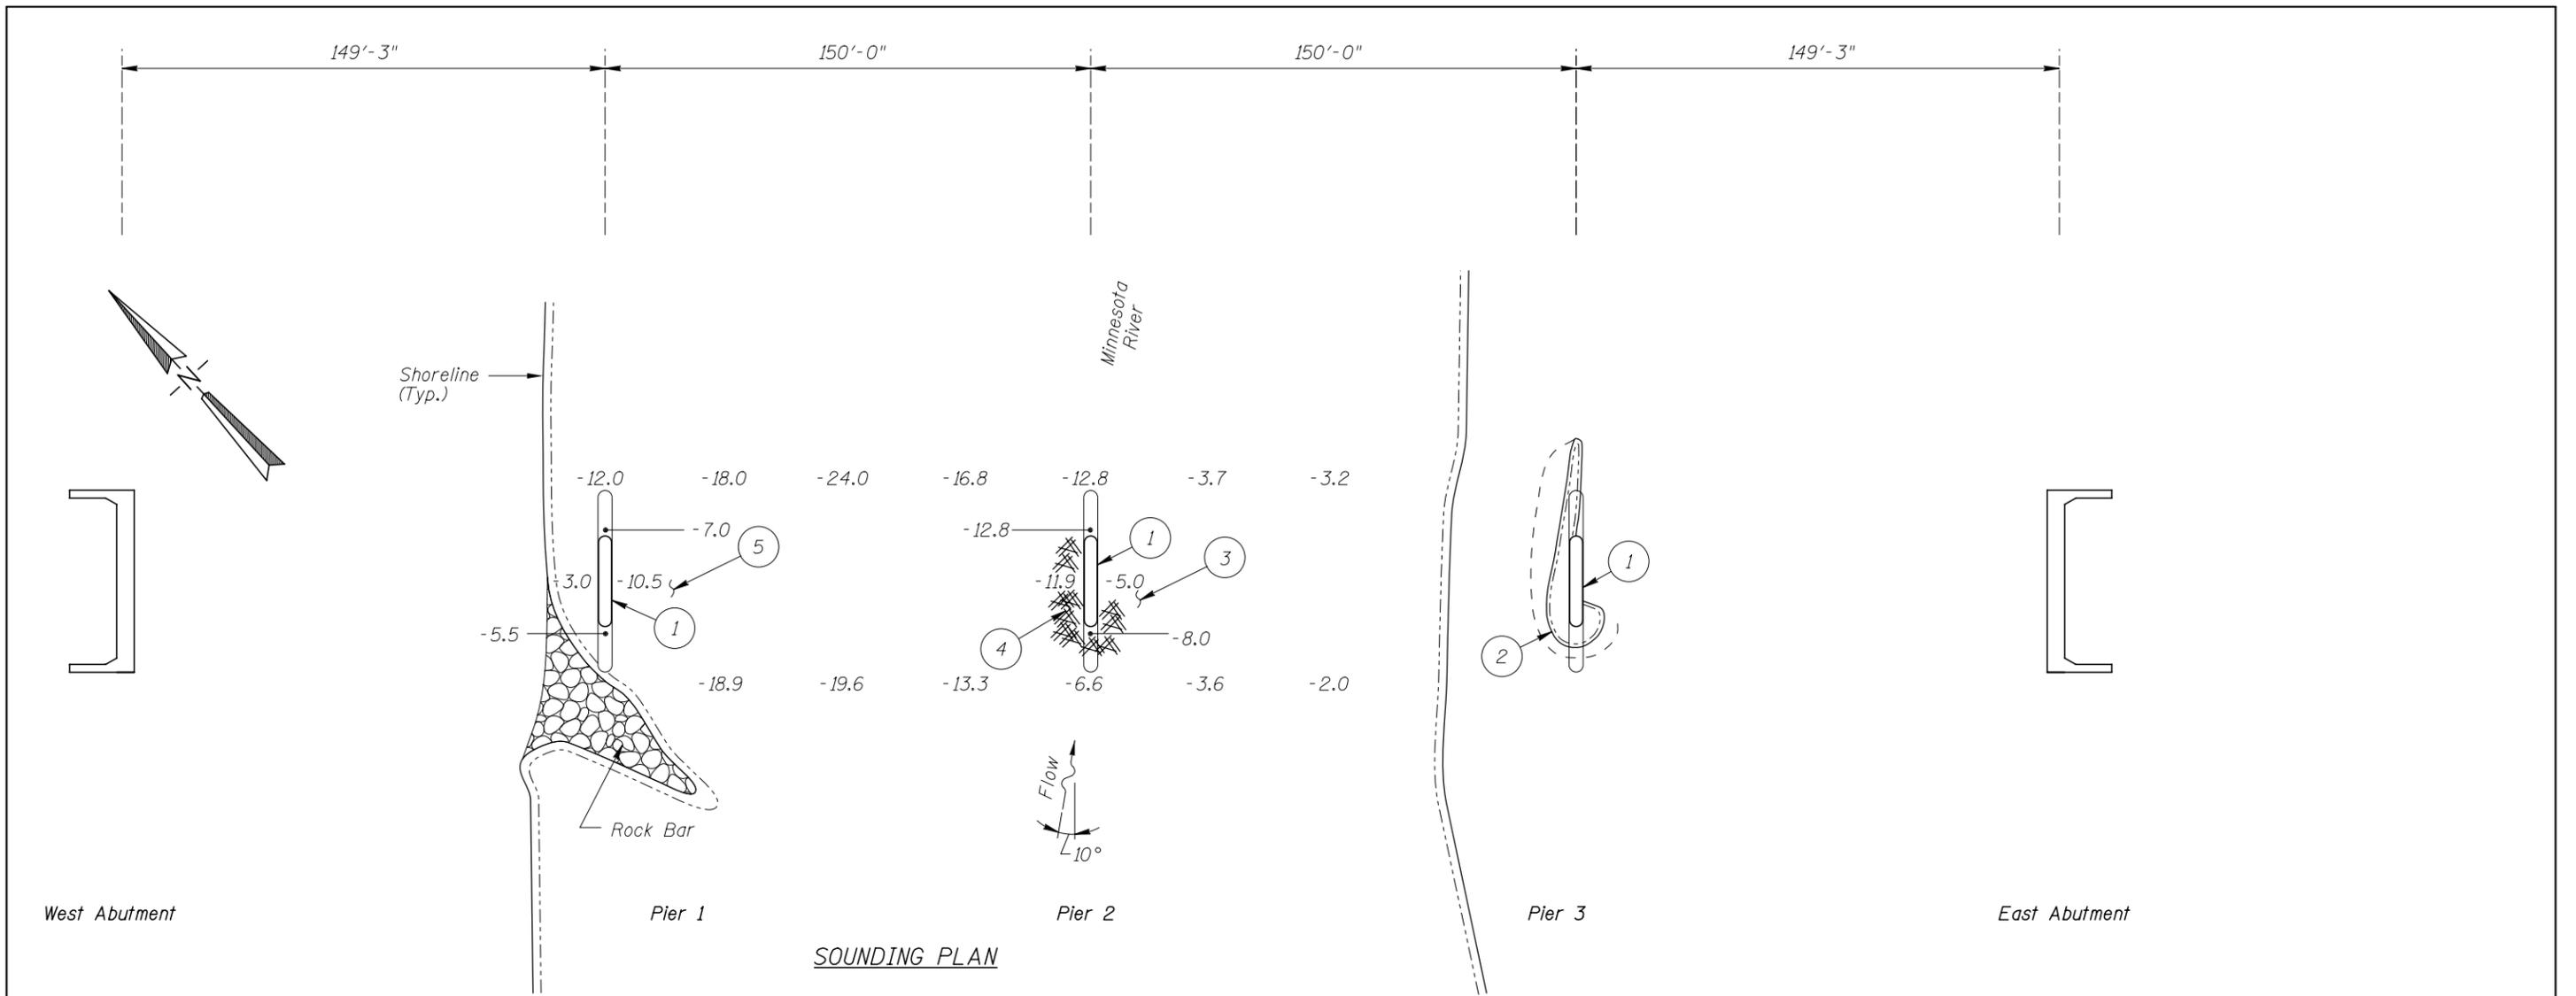
- ① The concrete was smooth and sound with no notable defects.
- ② A 10-foot-radius scour depression 5 to 6 feet deep (2 feet to 3 feet of standing water in scour depression) was observed all around the upstream nose and north-west face of Pier 3.

- ③ The channel bottom consisted of firm silty clay and rocks with 3 inches maximum probe rod penetration.
- ④ A moderate accumulation of timber debris consisting of 1-foot-diameter and smaller logs and branches was observed at the upstream nose of Pier 2 from the channel bottom up 4 feet and along the north face from the upstream end of the midpoint from the channel bottom up 2 feet.

- ⑤ The channel bottom consisted of silty clay with 6 inches maximum probe rod penetration at the north face; at the downstream end it was firmer with 3 inches maximum probe rod penetration; at the upstream end it consisted of rocks 2 feet in diameter and smaller with no probe rod penetration; at the south face it was softer with 6 inches of maximum probe rod penetration.
