UNDERWATER BRIDGE INSPECTION REPORT

STRUCTURE NO. 02501

RUM RIVER

MINNESOTA DEPARTMENT OF TRANSPORTATION

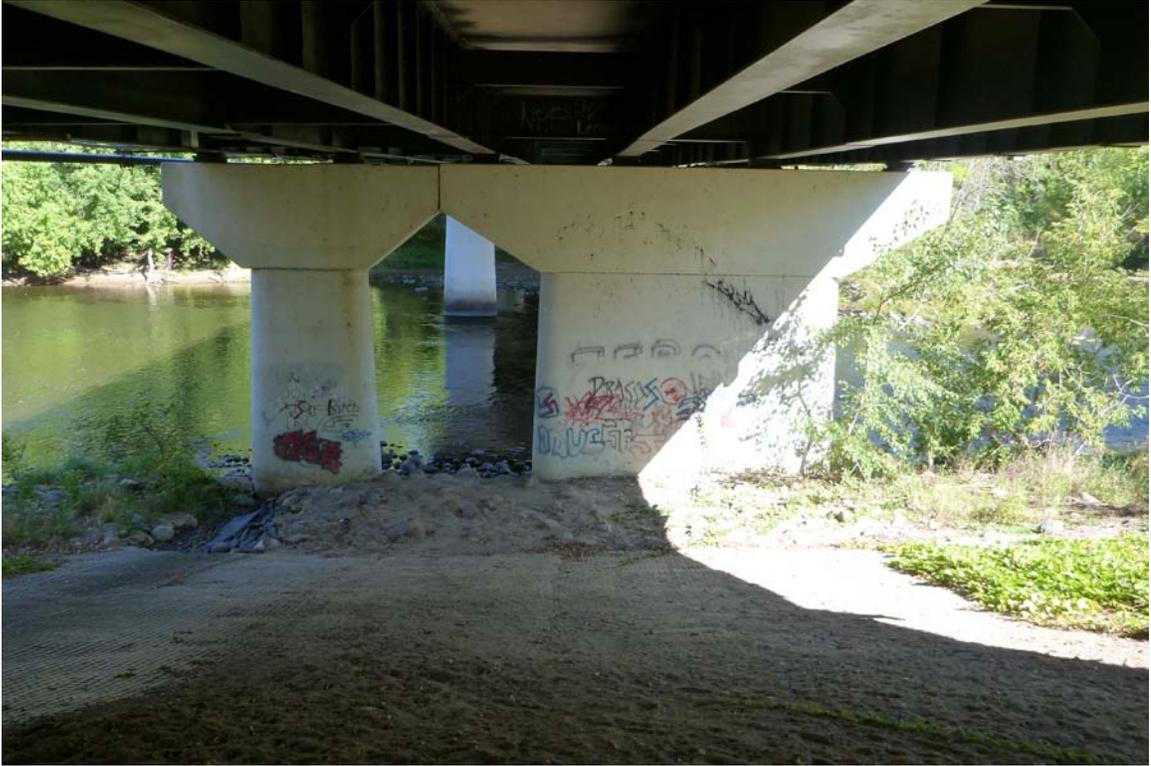
- (A) The top of footing and up to 1 foot of vertical face was exposed along the east side of Pier 1.
- (B) Moderate scaling was observed around the entire perimeter of the downstream shaft of Pier 2 from the channel bottom to 2 feet above the waterline with a maximum penetration of 2 inches. The heaviest scaling was along the west face and the upstream nose.

Photograph 1. View of Pier 1, Looking East.

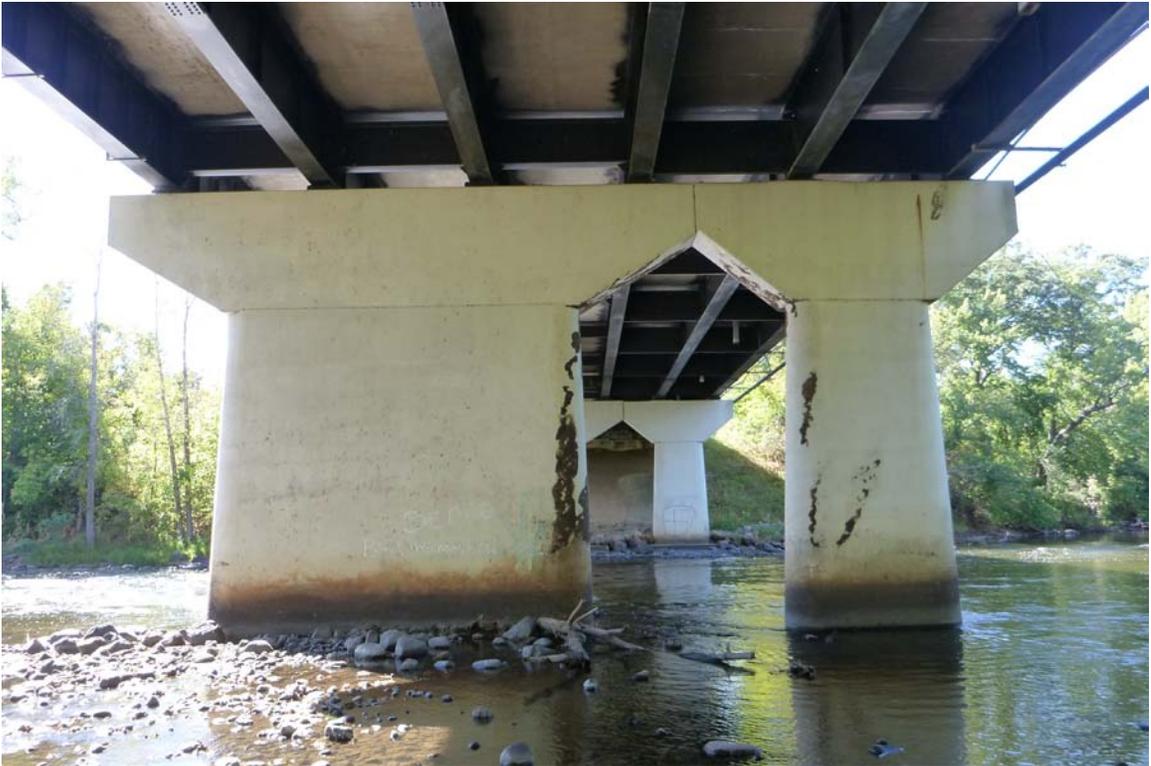
Photograph 2. View of the Pier 2, Looking West.

3. Moderate scaling was observed around the entire perimeter of the downstream shaft of Pier 2 from the channel bottom to 2 feet above the waterline with a maximum penetration of 2 inches. The heaviest scaling was along the west face and the upstream nose.

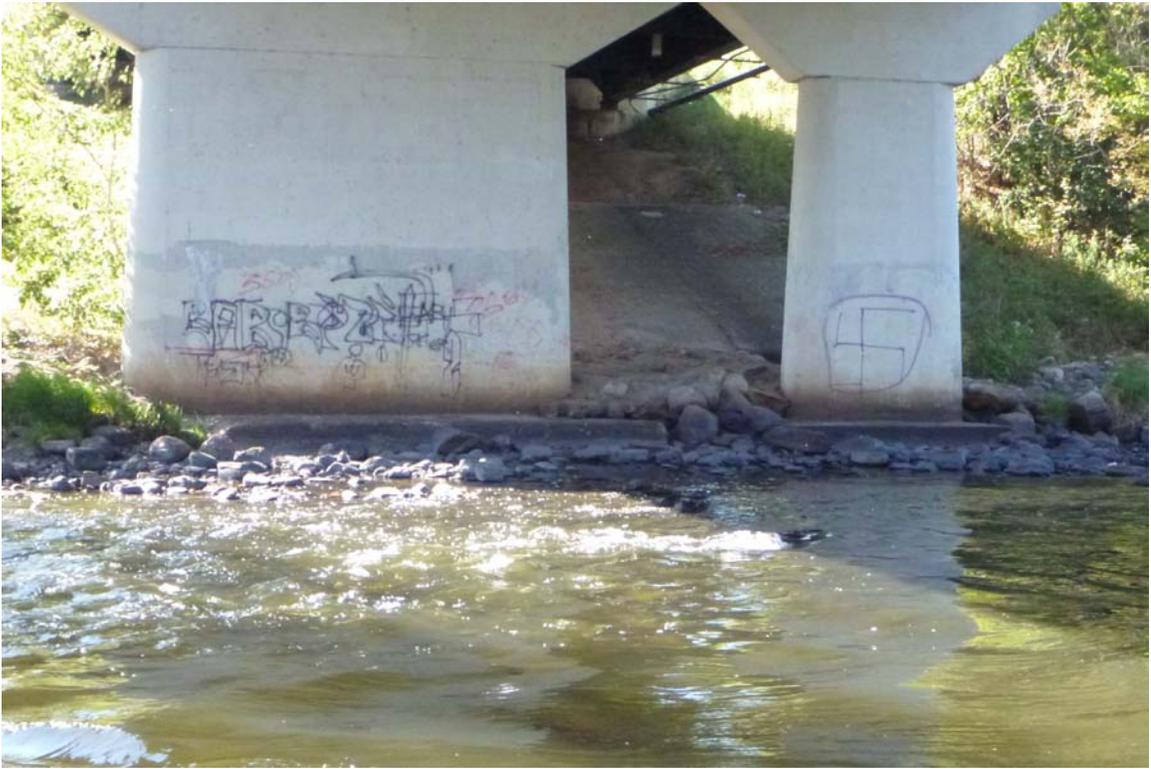
- (C) Heavy scaling, section loss and cracking were observed on the top of the downstream portion of the exposed footing of Pier 1 with penetrations of up to 8 inches. Numerous 1/16 inch to 1/2 inch wide cracks and areas of section loss were observed on the top of the footing between the pier shaft and the edge of the footing. Partially exposed reinforcing steel was present near the downstream end of the exposed Pier 1 footing.

Photograph 3. View of Pier 1 Showing Exposed Footings, Looking West.

1. The channel bottom material consisted of 2-foot-diameter and smaller riprap.
2. The footing was exposed along the east side of Pier 1 with up to 1 foot of the vertical face exposed.

- (A) Monitor the concrete deterioration of the footing at Pier 1. If found to be progressing in the future, consideration could be given to repair by removing the unsound concrete and reforming with a concrete mix designed to promote high durability and low permeability.
- (B) Monitor the extent of the footing exposure at Pier 1.
- (C) Reinspect the submerged substructure units at the normal maximum recommended (NBIS) interval of sixty (60) months.

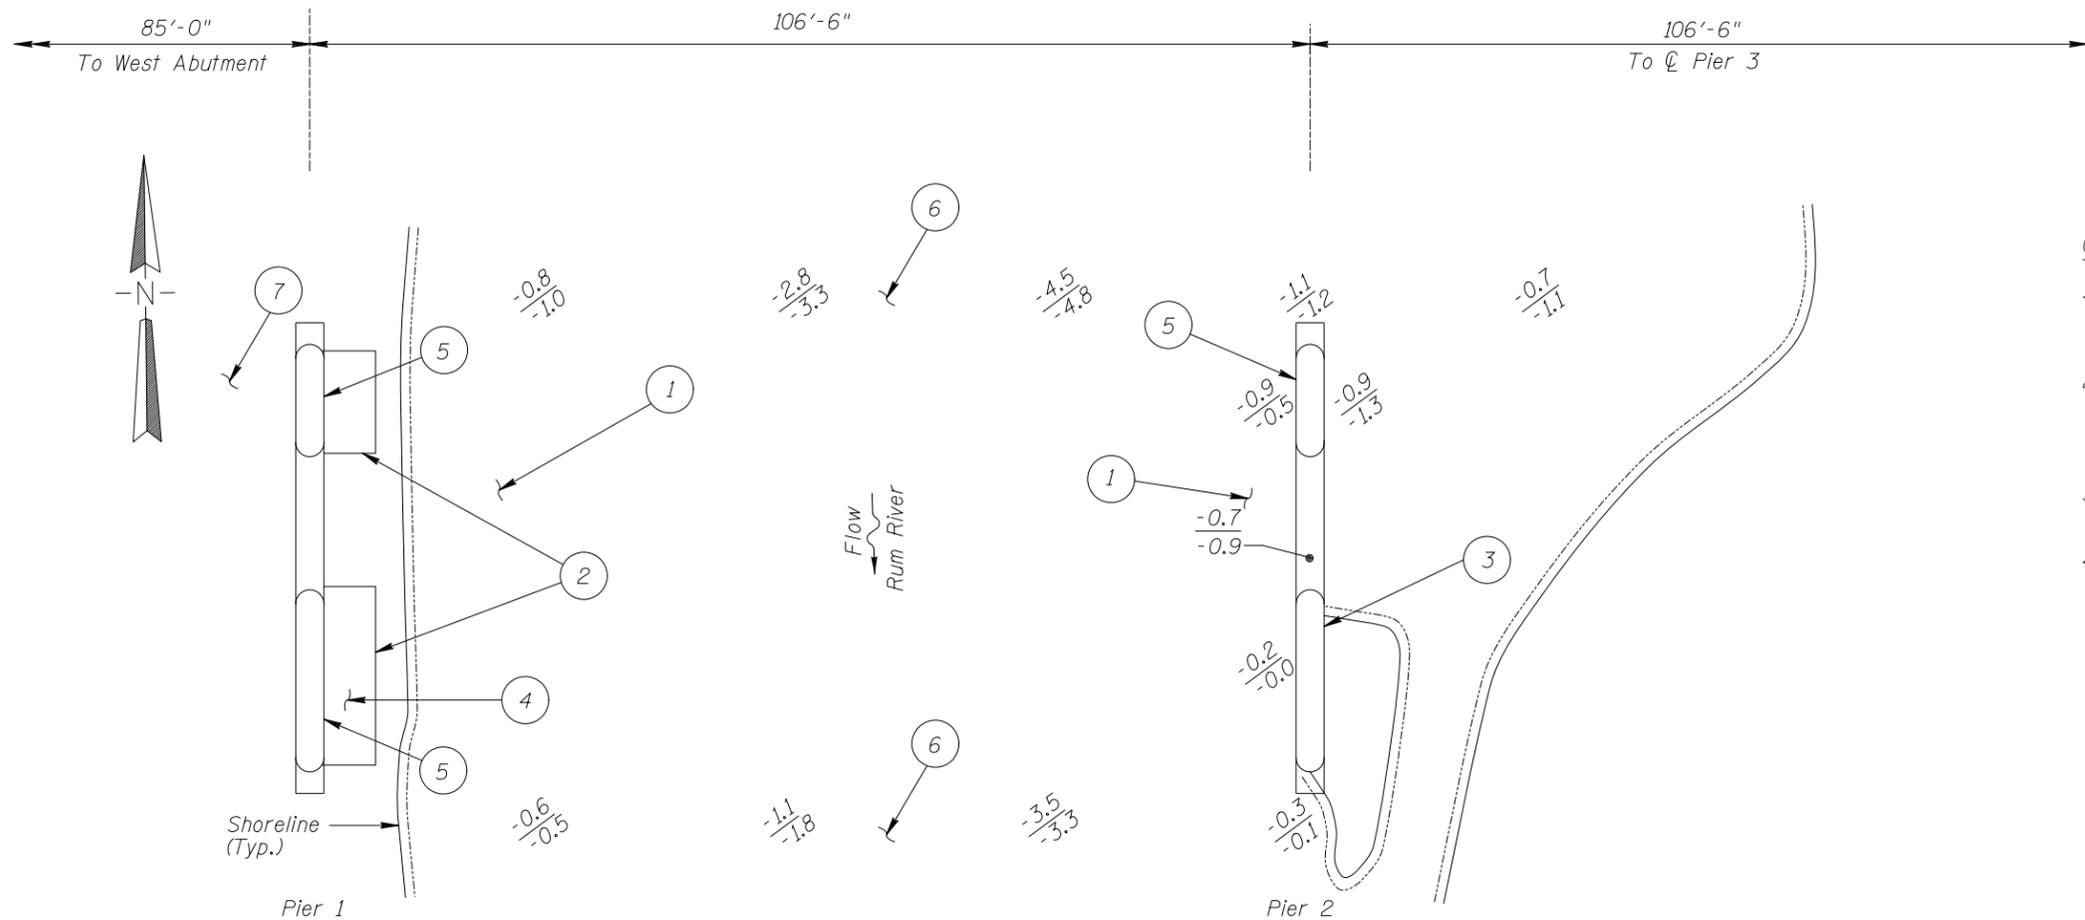
SOUNDING PLAN

4. Heavy scaling and cracking was observed on the top of the footing from the shaft to the footing edge with a maximum penetration of 8 inches. Numerous 1/16 inch to 1/2 inch wide cracks and areas of section loss were also observed on the top of footing from the pier shaft to the edge of the footing with the cracks extending into the channel bottom along the vertical face of the footing. Partially exposed reinforcing steel was present at the downstream end of the exposed footing.

5. The concrete shaft was in smooth and sound condition with no noted deficiencies.
6. The waterline elevation was approximately 6 inches lower along the downstream fascia compared to the upstream fascia.

7. The grouted riprap was deteriorated with missing riprap extending from the west side of the upstream shaft of Pier 1 to the slope protection mat along the western embankment.
