UNDERWATER BRIDGE INSPECTION REPORT

STRUCTURE NO. 02519

CSAH NO. 22

RUM RIVER

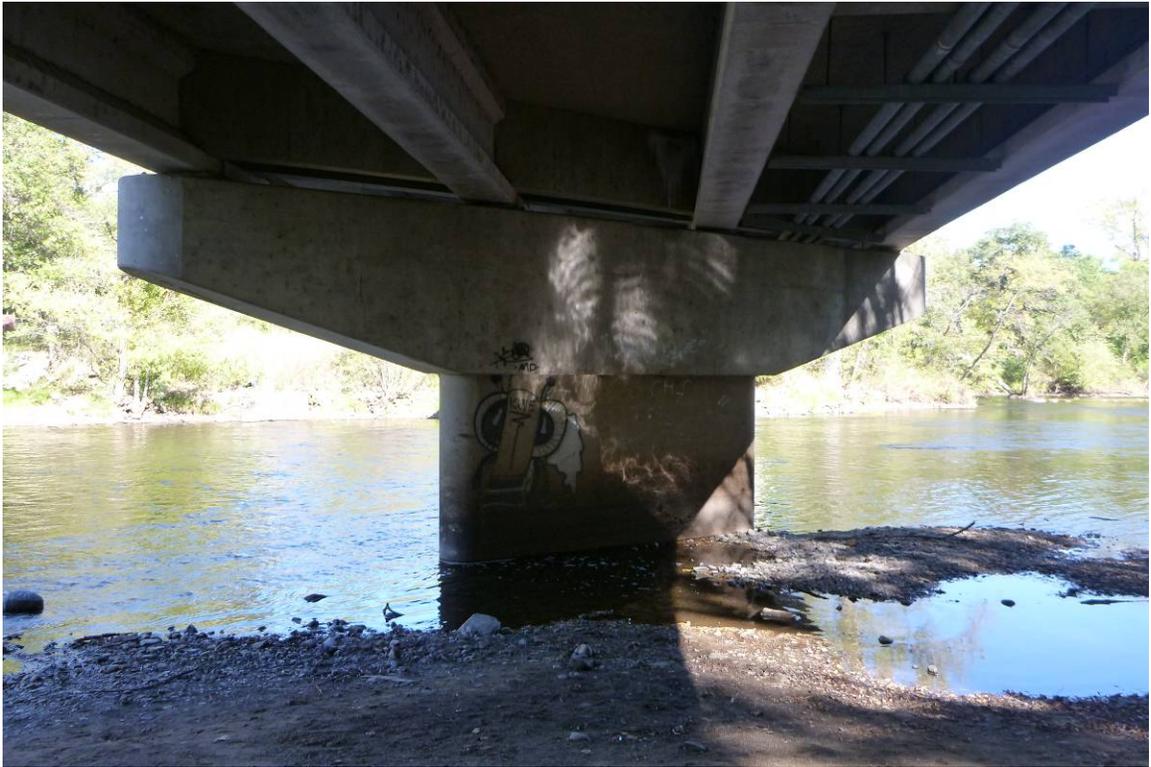
Photograph 1. View of Pier 1, Looking East.

- (A) The top of the footing at each pier was exposed. At Pier 1, the footing was partially exposed along the center of the east face at 2.2 feet below the waterline, with no vertical exposure detected. At Pier 2, the top of footing exposure was encountered at 4.4 feet below the waterline, extending around the upstream nose, and along the east and west faces from the pier nose to the mid point with no vertical face exposure.
- (B) A band of light scaling was observed around both piers from 1 foot above to 6 inches below the waterline, with typical penetrations of 1/16 inch and a maximum penetration of 1/8 inch.
- (C) A 20-foot-long by 2-foot-diameter log was observed along the east face of Pier 2 on the channel bottom.

- (A) Monitor the footing exposures during future inspections.
- (B) Reinspect the submerged substructure units at the normal maximum recommended (NBIS) interval of sixty (60) months.

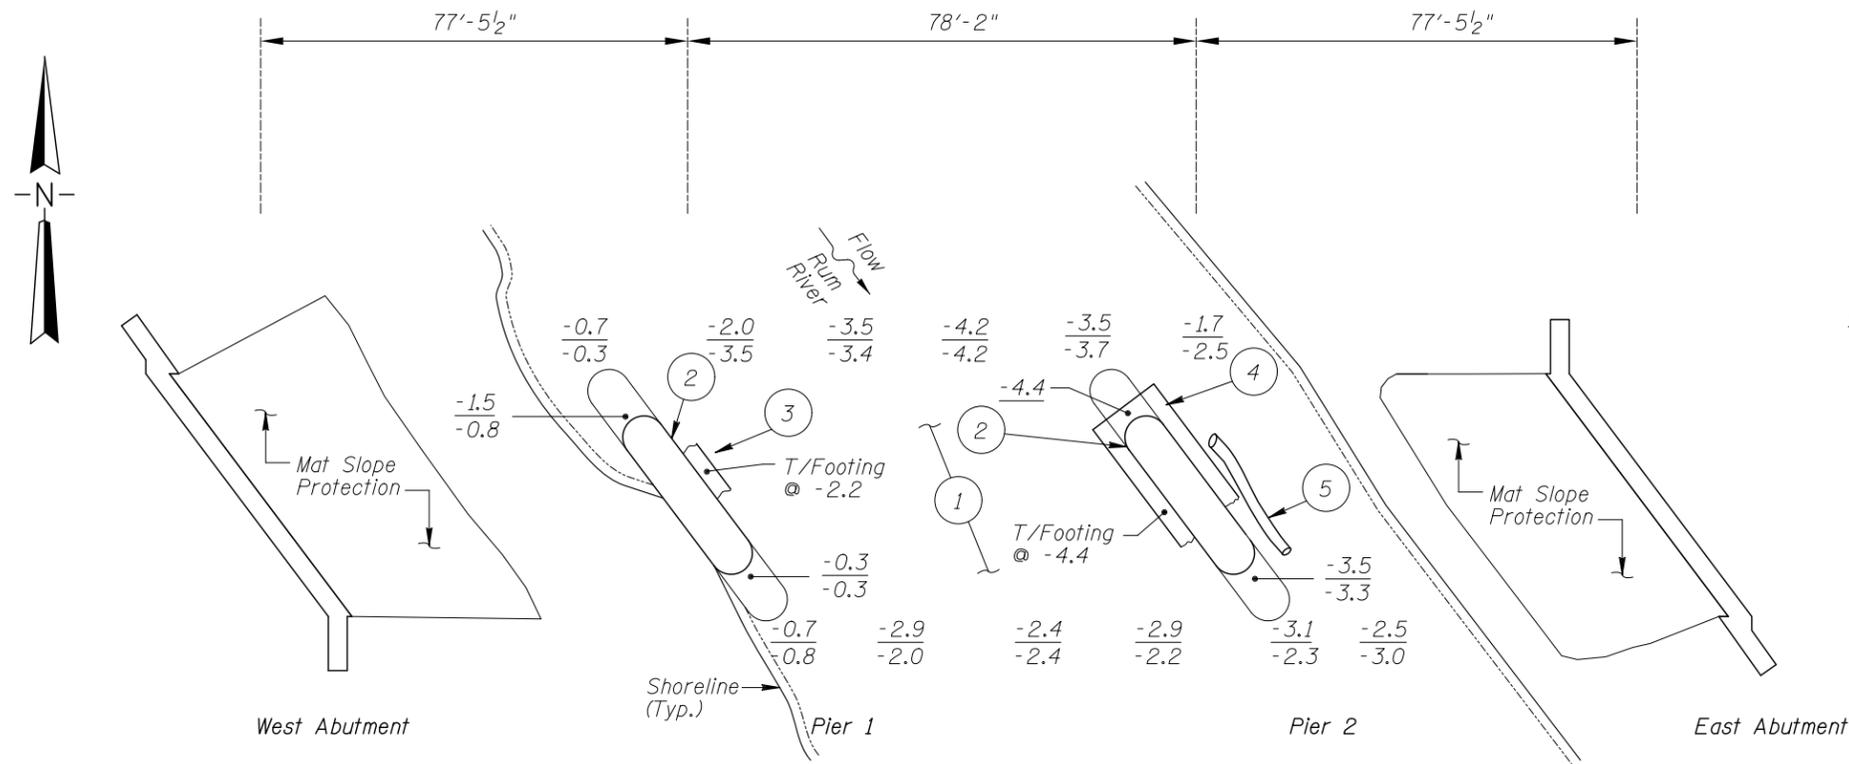
INSPECTION AND SOUNDING PLAN

- 1 The channel bottom material consisted of sand with scattered 2 to 12 inch cobbles.
- 2 A band of light scaling was observed from 1 foot above to 6 inches below the waterline around both piers with typical penetrations of 1/16 inch and maximum penetrations of 1/8 inch. Above and below the band of scaling the concrete was smooth and sound.
- 3 The top of the footing was partially exposed at 2.2 feet below the waterline along the center of the east face of Pier 1 with no vertical exposure observed.
- 4 The top of the footing was exposed at 4.4 feet below the waterline, around the upstream nose, and along the east and west faces from the upstream nose to the mid point, with no vertical face exposure.
- 5 A 20-foot-long by 2-foot-diameter log was observed along the east face of Pier 2 on the channel bottom.
