UNDERWATER BRIDGE INSPECTION REPORT

STRUCTURE NO. 02526

CSAH NO. 7

RUM RIVER

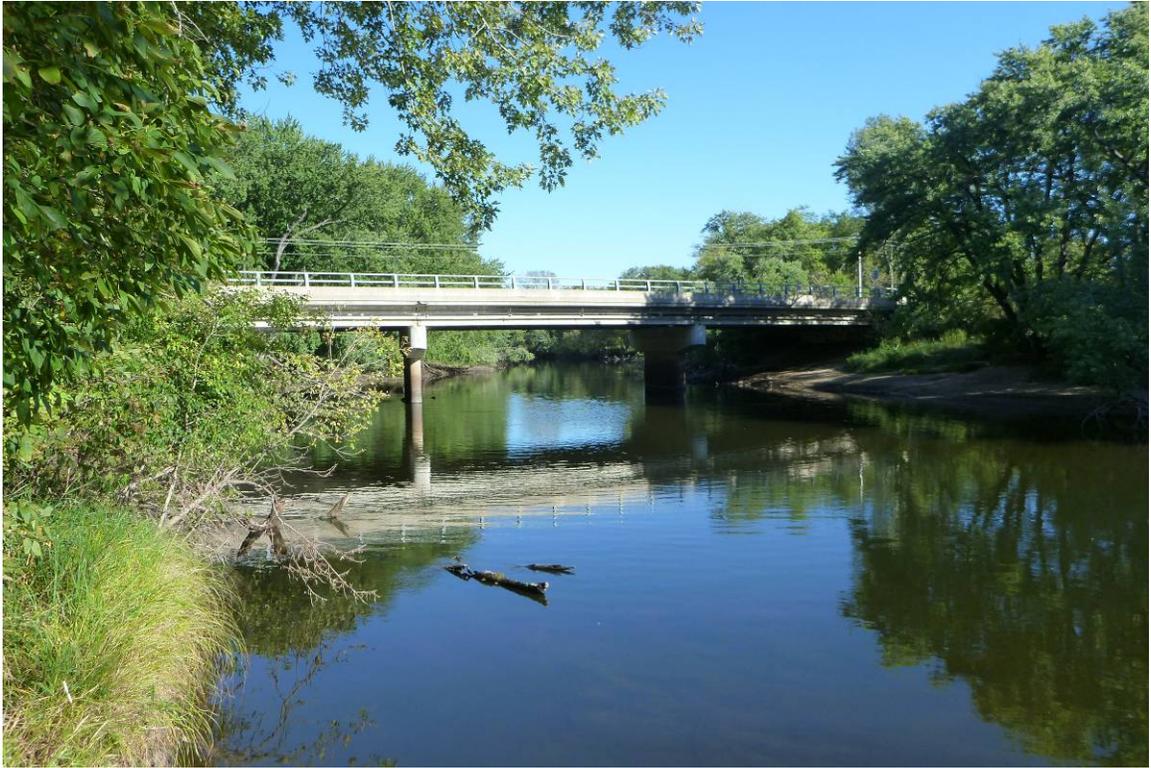
Photograph 1. Overall View of the Structure, Looking East.

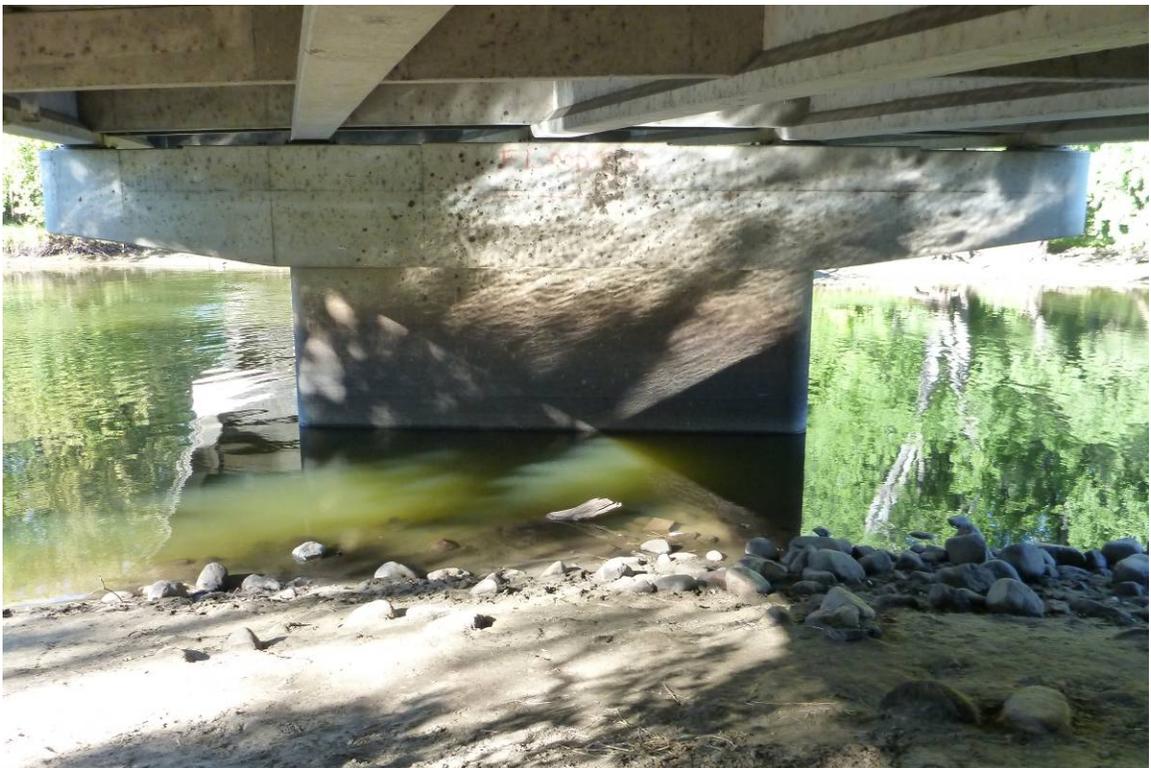
Photograph 2. View of Pier 1, Looking North.

- ① Overall, the concrete of the piers was smooth and sound with no defects of structural significance.
- ② A band of light scaling was observed on Piers 1 and 2 from the waterline up 3 feet with a maximum penetration of 1/8 inch.

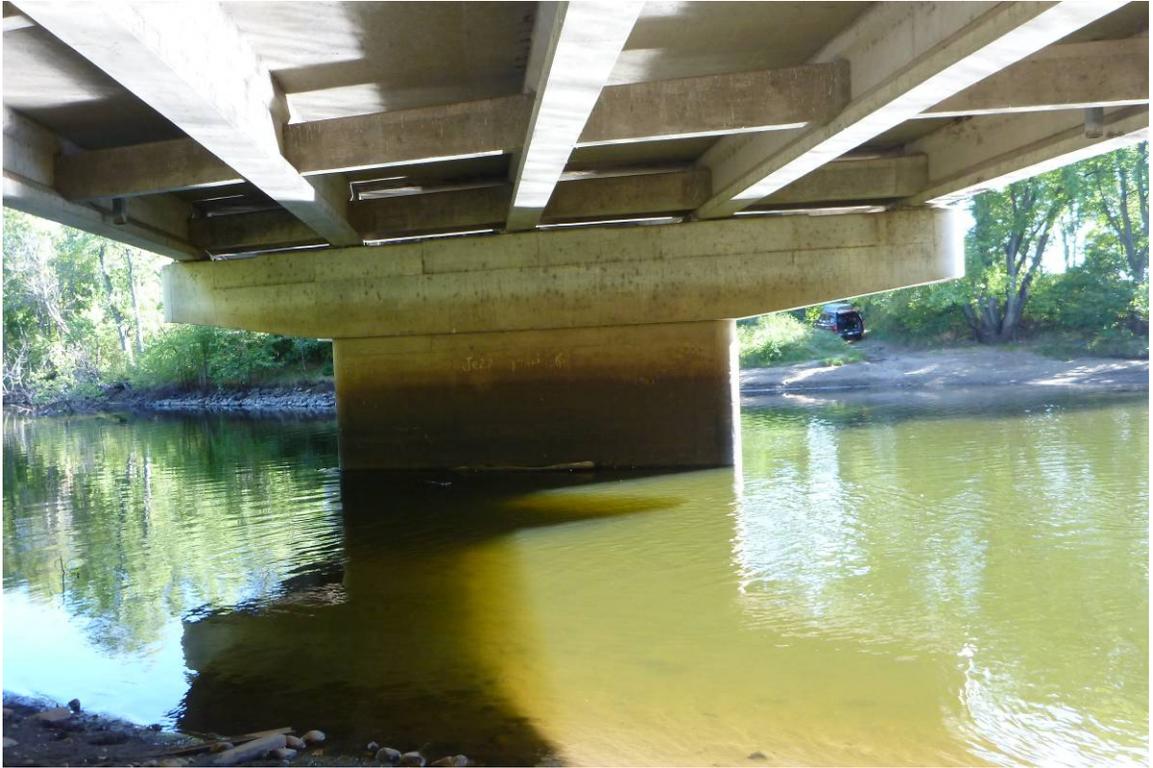
Photograph 3. View of Pier 2, Looking South.

- ④ A light to moderate accumulation of timber debris consisting of logs and branches, 12 inch diameter or smaller, was observed from the downstream 1/4 point of south face, around the upstream nose, to the downstream 1/4 point of the north face. The debris extended from the channel bottom to the waterline and up to 5 feet off the pier faces.

- ⑤ The top of footing was partially exposed along the south face near the downstream 1/4 point of Pier 2 with no vertical face exposure present.

- (A) Footing exposure and timber debris accumulation should be monitored during future inspections.

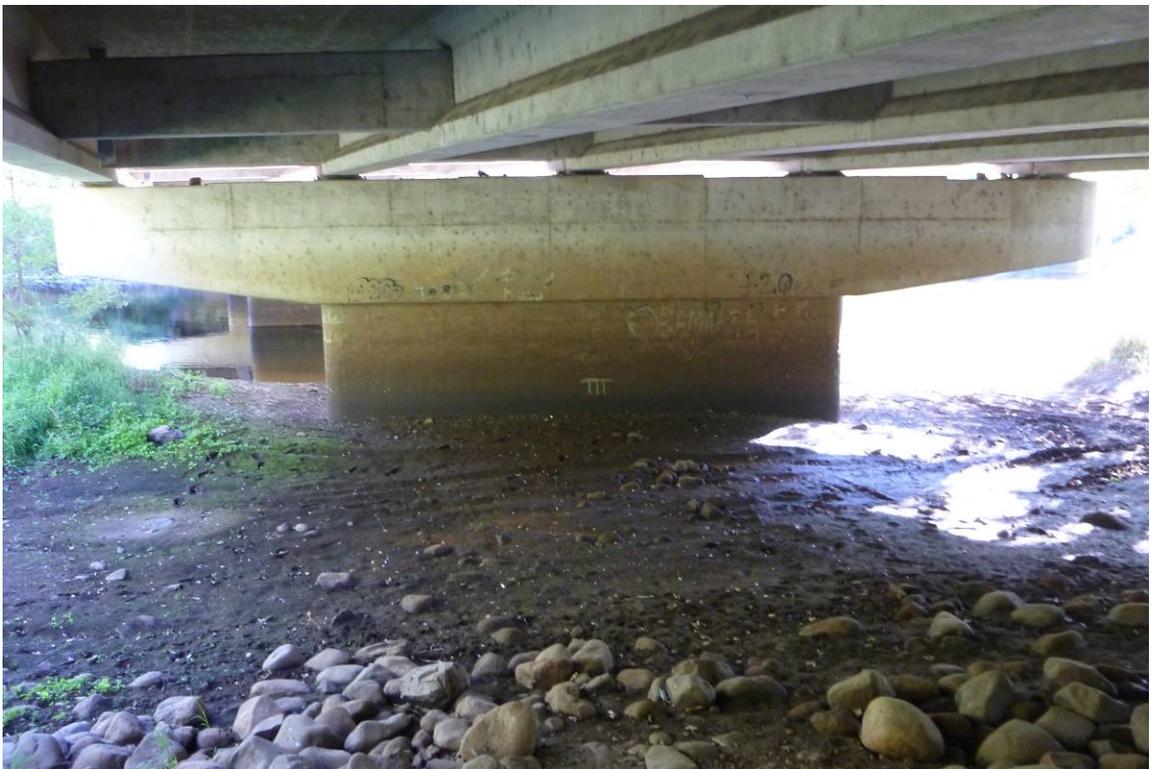
Photograph 4. View of Pier 3, Looking South.

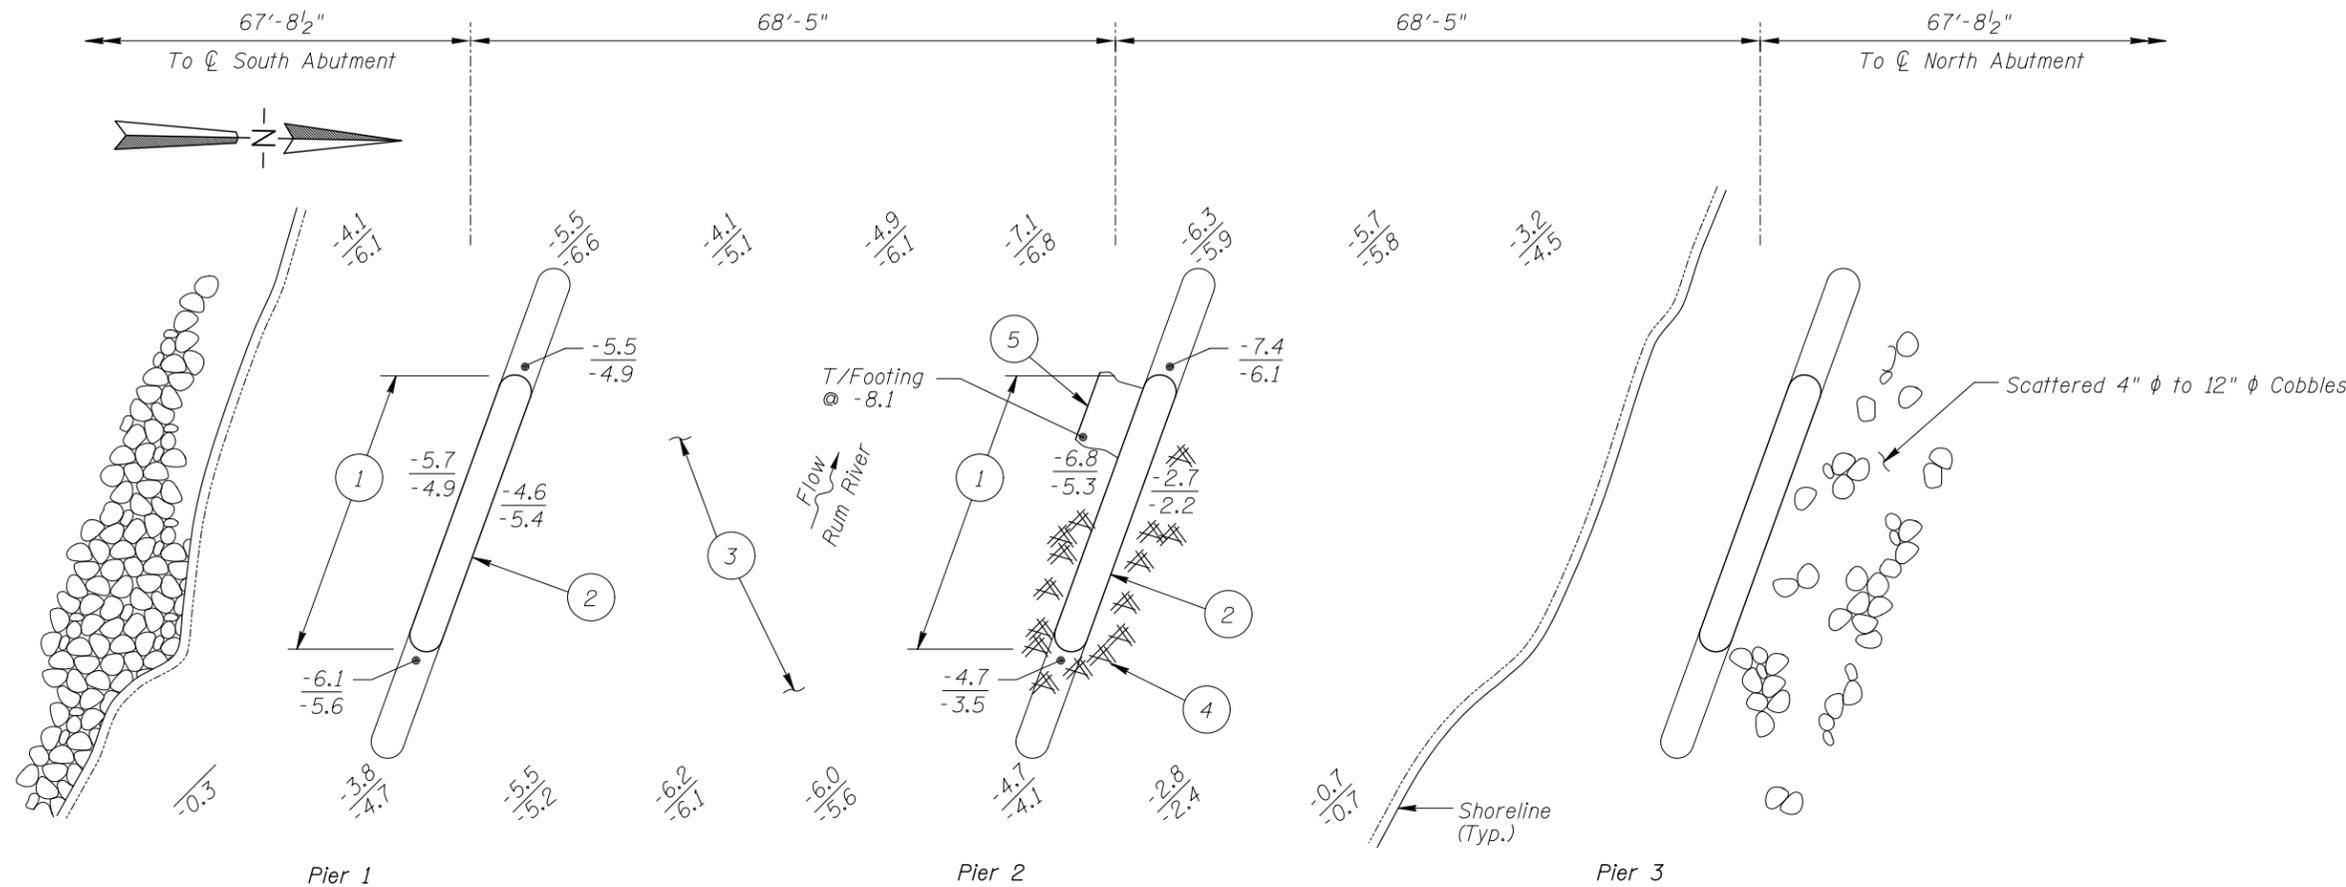
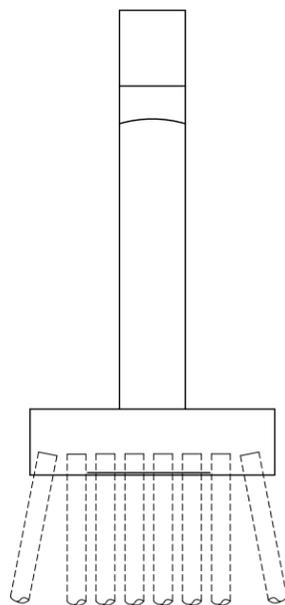
**SOUNDING PLAN**

- ③ The channel bottom consisted of firm sand with 2 to 3 inches of probe rod penetration and 12-inch-diameter riprap located at the upstream noses of Piers 1 and 2 and along the south face of Pier 1.
