UNDERWATER BRIDGE INSPECTION REPORT

STRUCTURE NO. 13503

MAY 19, 2012

COLLINS ENGINEERS, INC.

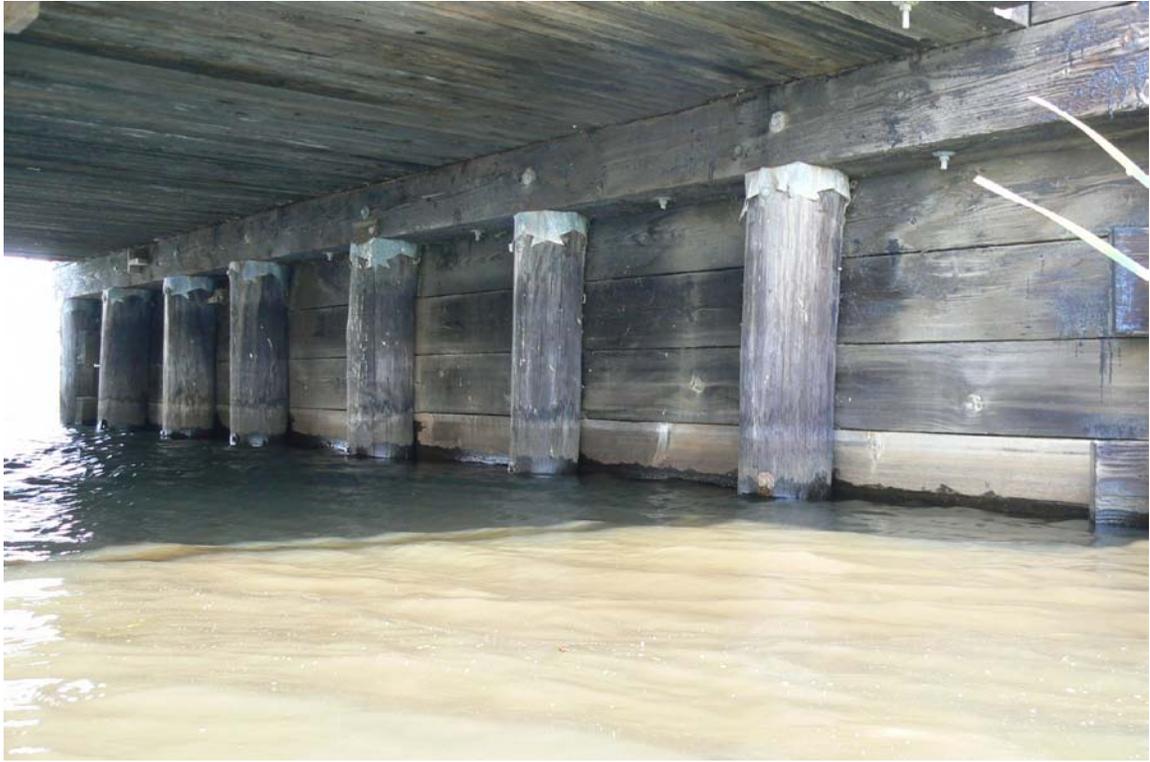
Photograph 1. View of East Abutment, Looking Northeast.

- 4 Pile A on the East Abutment exhibited a 1/2 inch wide split from the top of the pile down 4 feet on the west face.
- 5 Pile D on Pier 2 exhibited a 1/2 inch wide split 3 inches deep from the top of the pile down 2 feet on the north face.

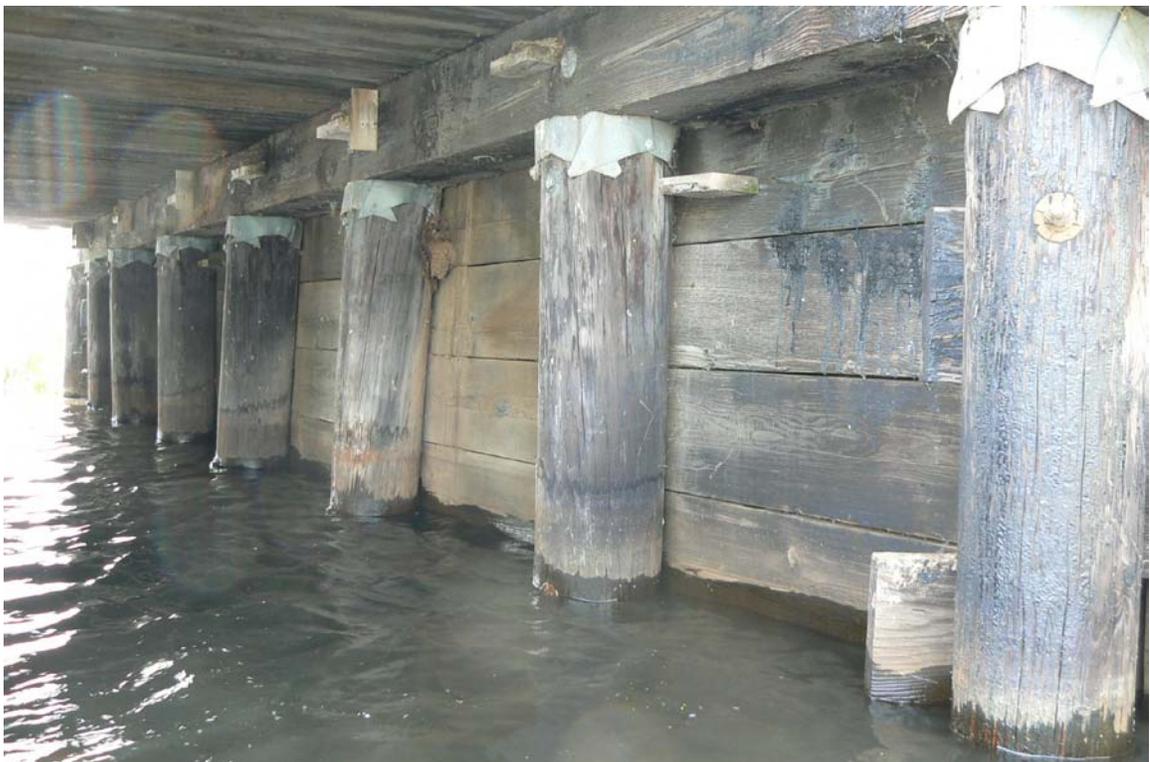
Photograph 2. View of West Abutment, Looking Southwest.

- 7 Pile B of Pier 1 exhibited up to 3 inches of differential settlement.
- 8 Piles A and B on the West Abutment exhibited light deterioration on the north side, from the top of the pier to the waterline, with up to 1 inch of penetration.

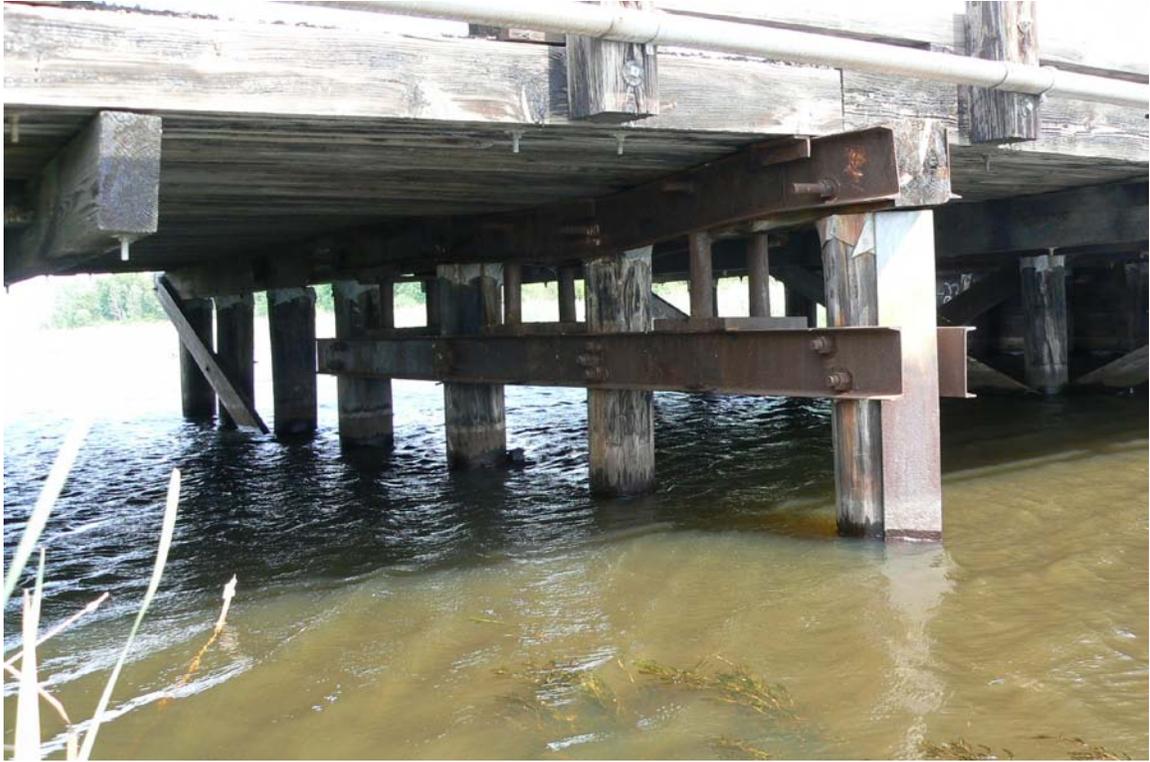
Photograph 3. View of Pier 1, Looking Northeast.

- 6 Steel channel horizontal bracing (repair measures) located on the east and west faces of Pier 1, from Piles A through D, exhibited light corrosion.

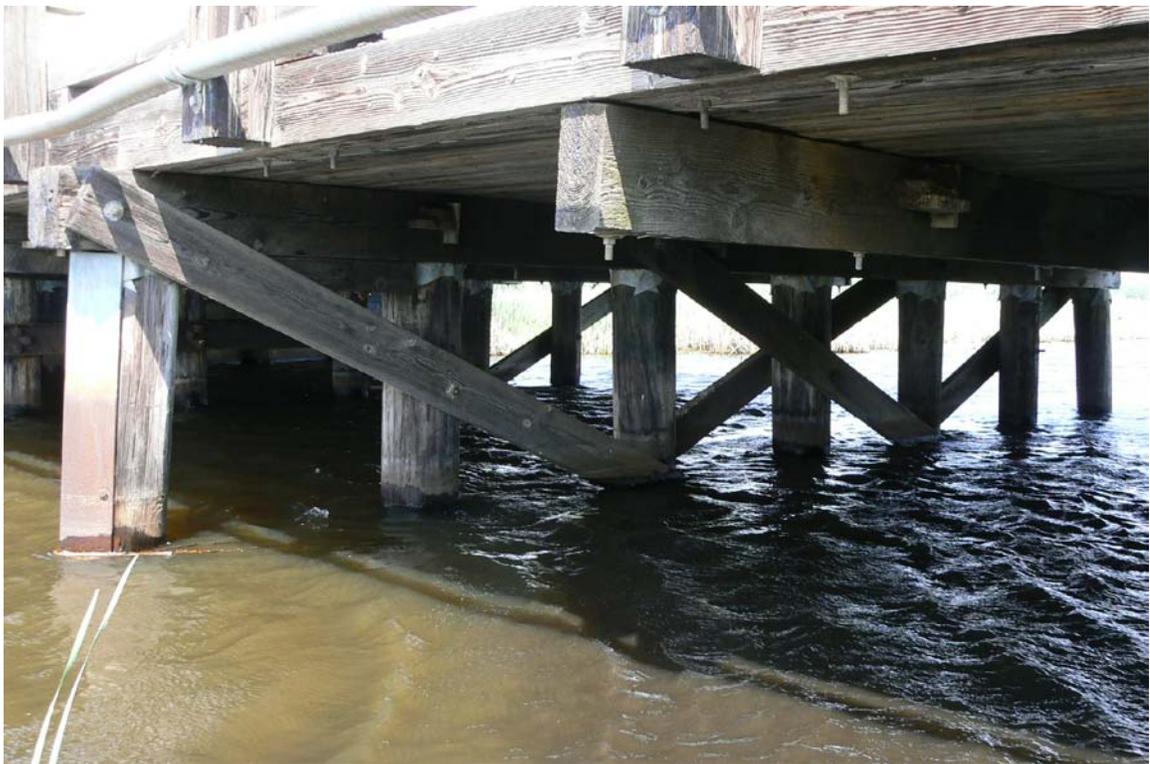
Photograph 4. View of Pier 2, Looking Northwest.

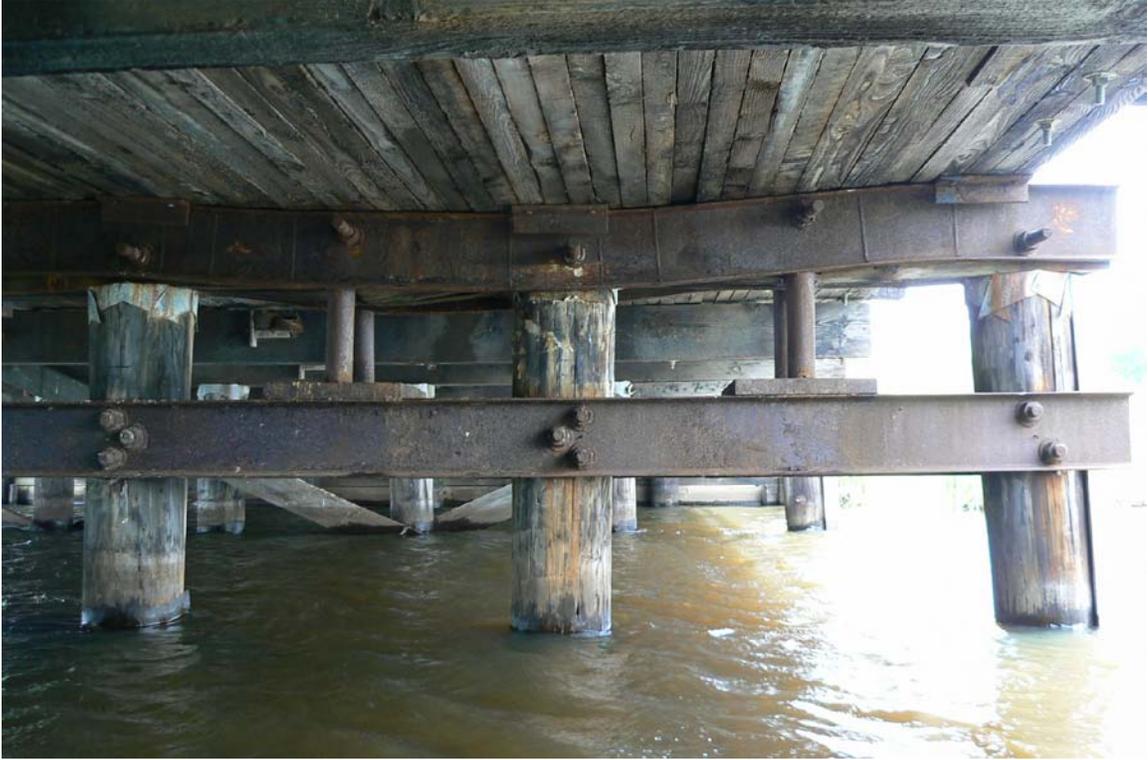
- (F) The steel channel horizontal bracing on the east and west faces of Pier 1 that extended from Piles A to D exhibited light corrosion.
- (G) Up to 3 inches of differential settlement was observed at Pile B of Pier 1. There has been a repair implemented for the pile cap to arrest further settlement. The upper horizontal steel bracing along the Pier 1 cap had a maximum deflection of 3 inches at Pile B. The lower horizontal brace showed no signs of deflection and was used by the repair to provide support to the upper brace/cap. The timber deck boards supporting the roadway were flush with the upper steel brace along the length of the pier cap.
- (H) Piles A and B at the West Abutment exhibited light deterioration on their north face with up to 1 inch of penetration extending from the top of the piles to the waterline.

Photograph 5. View of settlement and repair at Pile B of Pier 1, Looking East.

- 9 Upper horizontal steel bracing repair along the Pier 1 cap exhibited a maximum deflection of 3 inches at Pile B. Lower horizontal steel bracing showed no signs of deflection.

- (A) Monitor the settlement at Pile B of Pier 1.

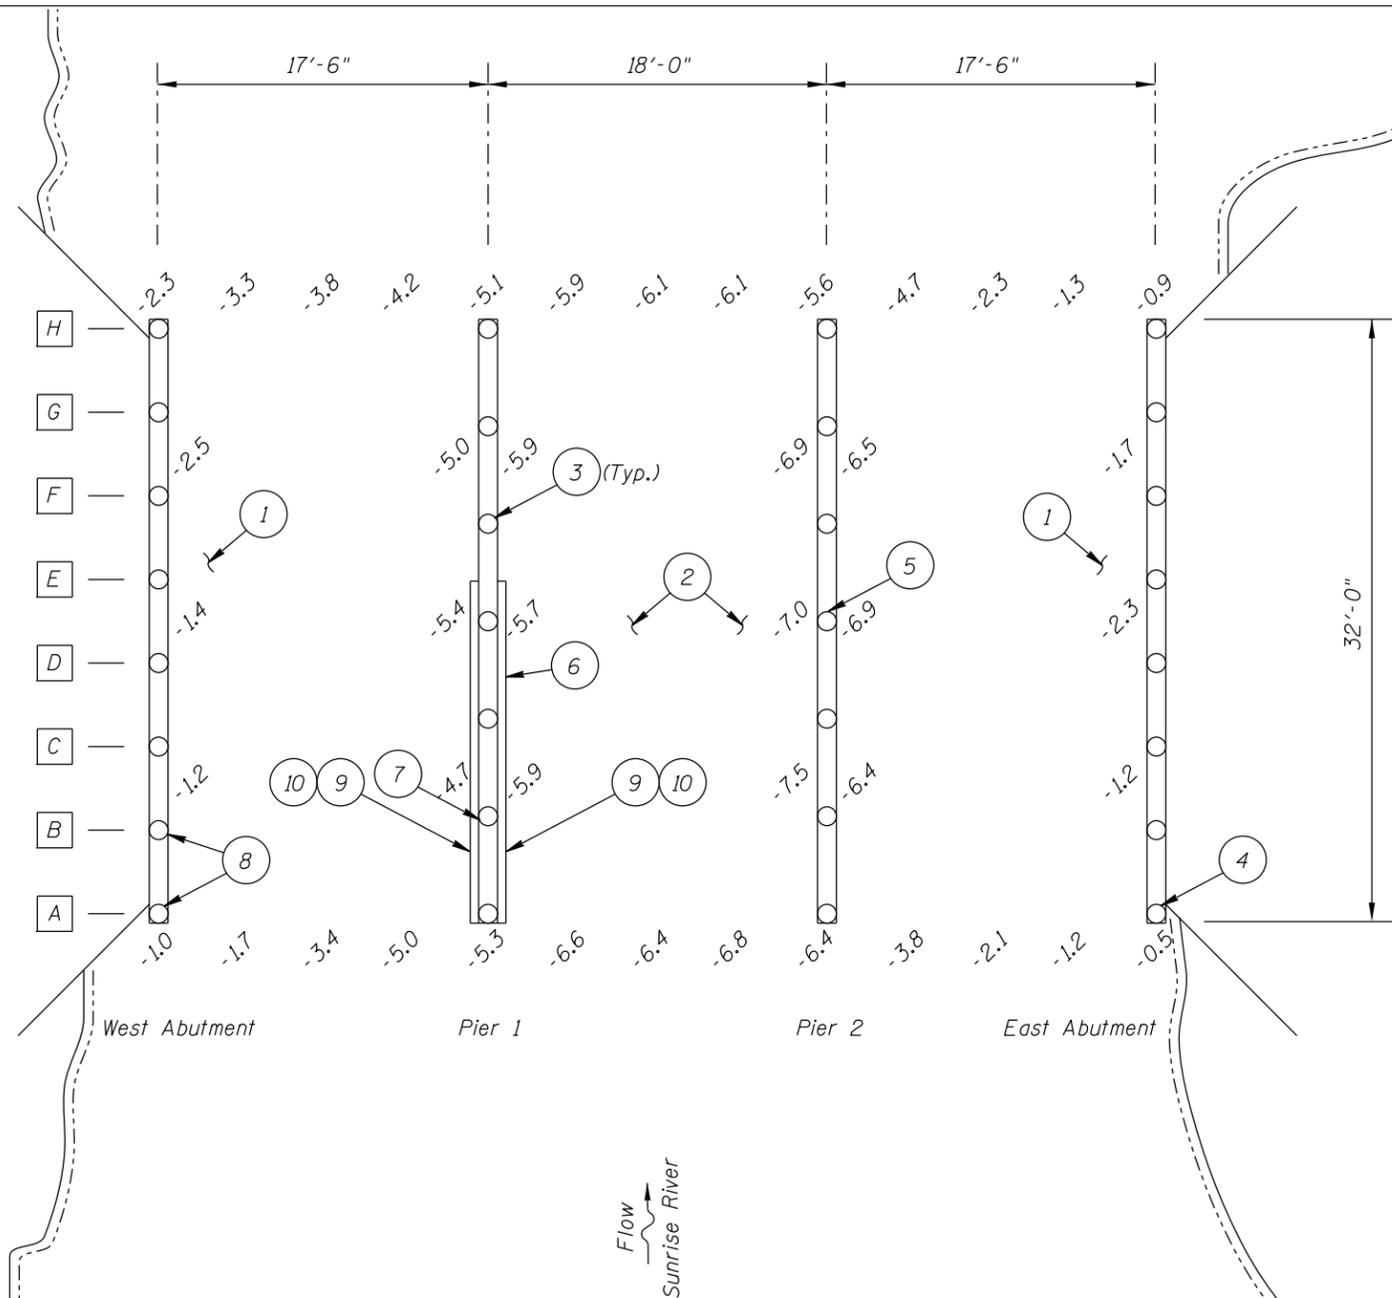
SOUNDING PLAN

- 1 Channel bottom material at the East and West abutments consisted of cobbles up to 4 inches in diameter and silty sand with 6 inches of probe rod penetration.

- 2 Channel bottom material at Piers 1 and 2 consisted of silty clay with up to 2 feet of probe rod penetration.
- 3 Timber piles were generally sound with checking up to 1/4 inch wide and up to 1/8 inch of awl penetration.

- 10 Timber deck boards were flush with the upper horizontal steel bracing along the length of the brace.
