UNDERWATER BRIDGE INSPECTION REPORT

STRUCTURE NO. 19529

CSAH 68

VERMILLION RIVER

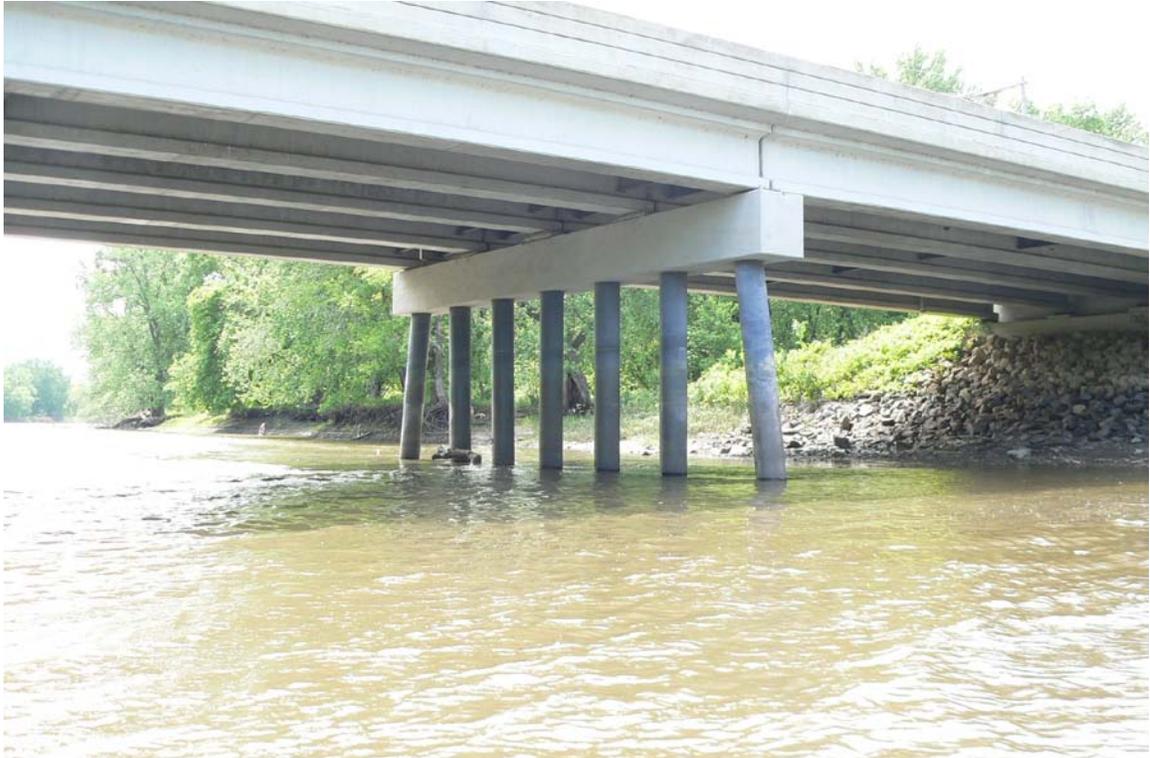
- (A) The steel pipe piles were sound with the coating intact above and below waterline.
- (B) Timber debris accumulation, consisting of up to 1 foot diameter logs, was observed extending from the midpoint of the east face of Bent 1 to the downstream nose.
- (C) The channel bottom material between the West Abutment and Bent 1 consisted of cobbles and riprap with no probe rod penetration.
- (D) The channel bottom material east of Bent 1 consisted of sandy silt allowing probe rod penetration of up to 6 inches.

Photograph 1. View of Bent 1, Looking Southwest.

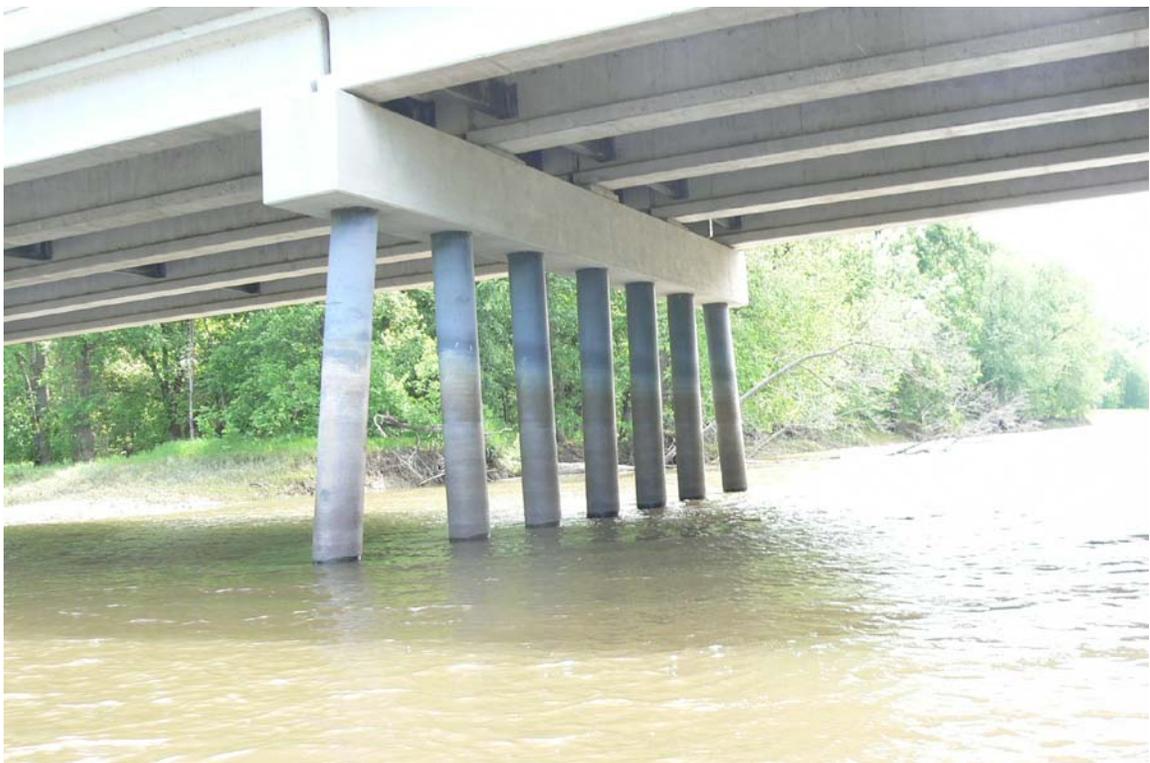
Photograph 2. View of Bent 2, Looking Southeast.

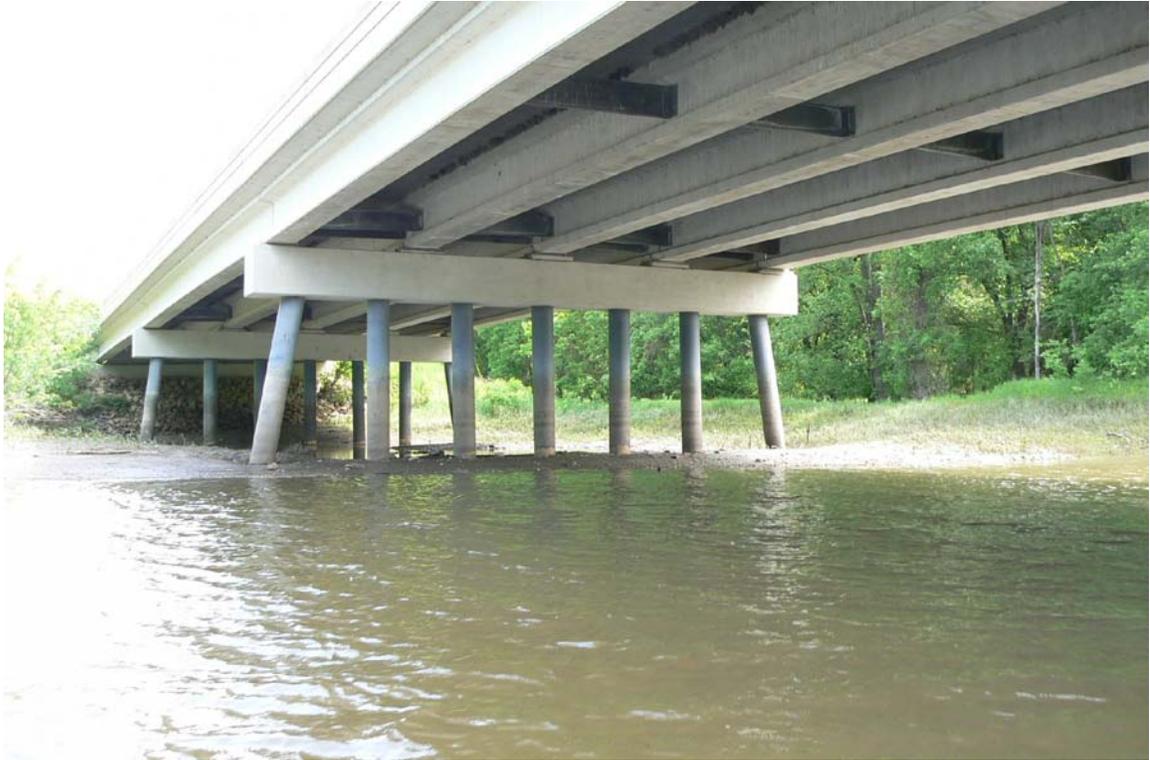
Photograph 3. View of Bent 3, Looking Southeast.

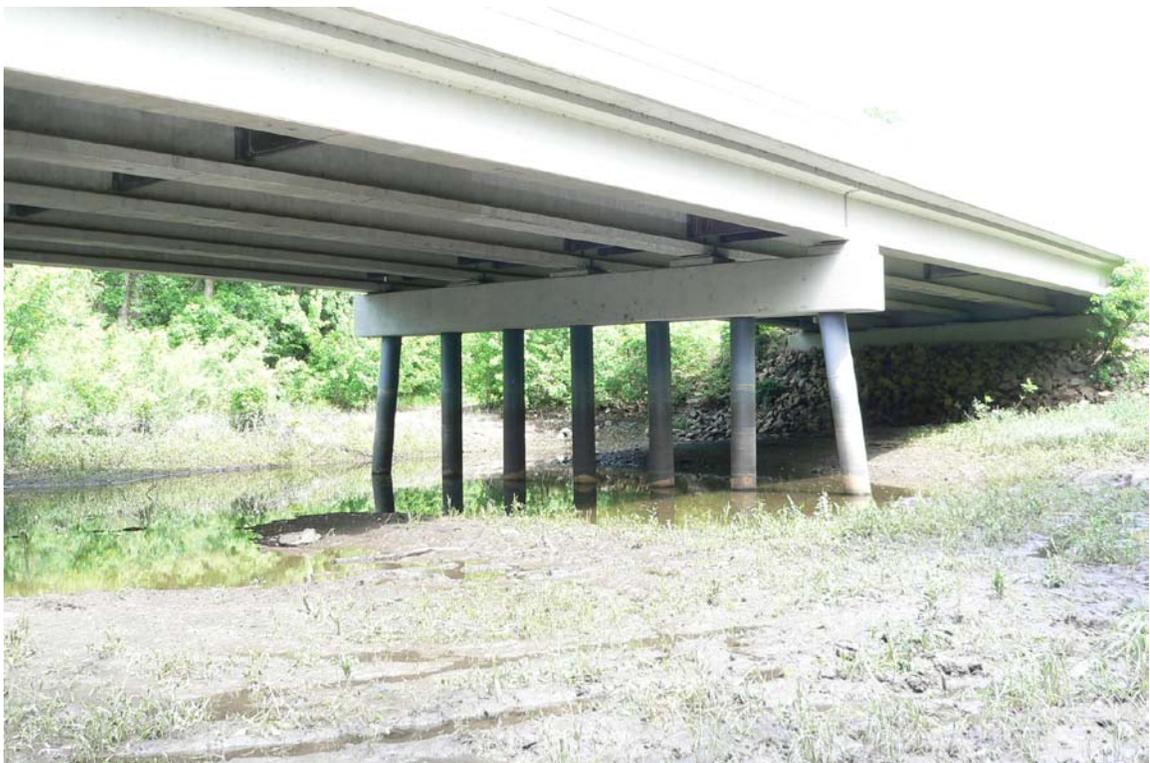
Photograph 4. View of Bent 4, Looking Northeast

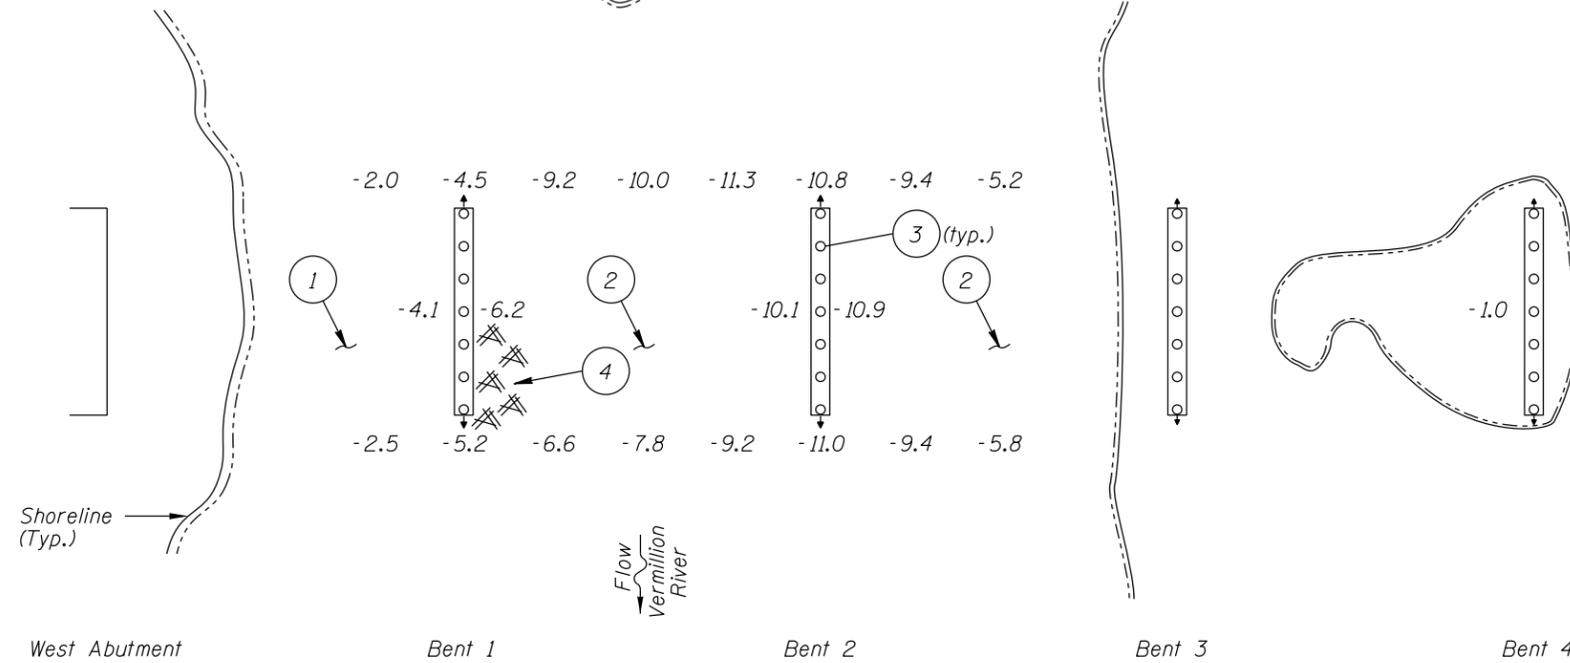
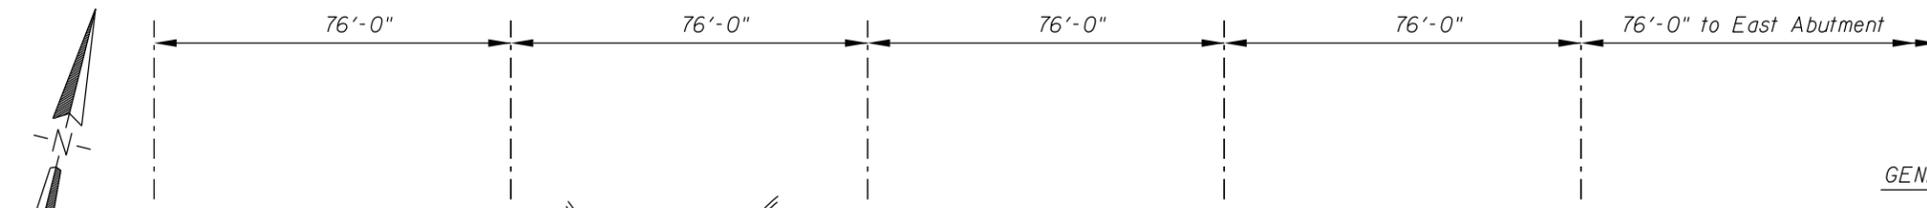
- 1 The channel bottom material consisted of cobbles and riprap up to 1 foot diameter.
- 2 The channel bottom material consisted of sandy silt with up to 6 inches of probe rod penetration.
- 3 The steel piles were structurally sound with the coating intact above and below waterline.
- 4 Accumulation of timber debris was observed along the east face on the downstream half of Bent 1. Logs and branches were up to 1 foot in diameter.
