UNDERWATER BRIDGE INSPECTION REPORT

STRUCTURE NO. 19563

CANADA AVENUE

CANNON RIVER

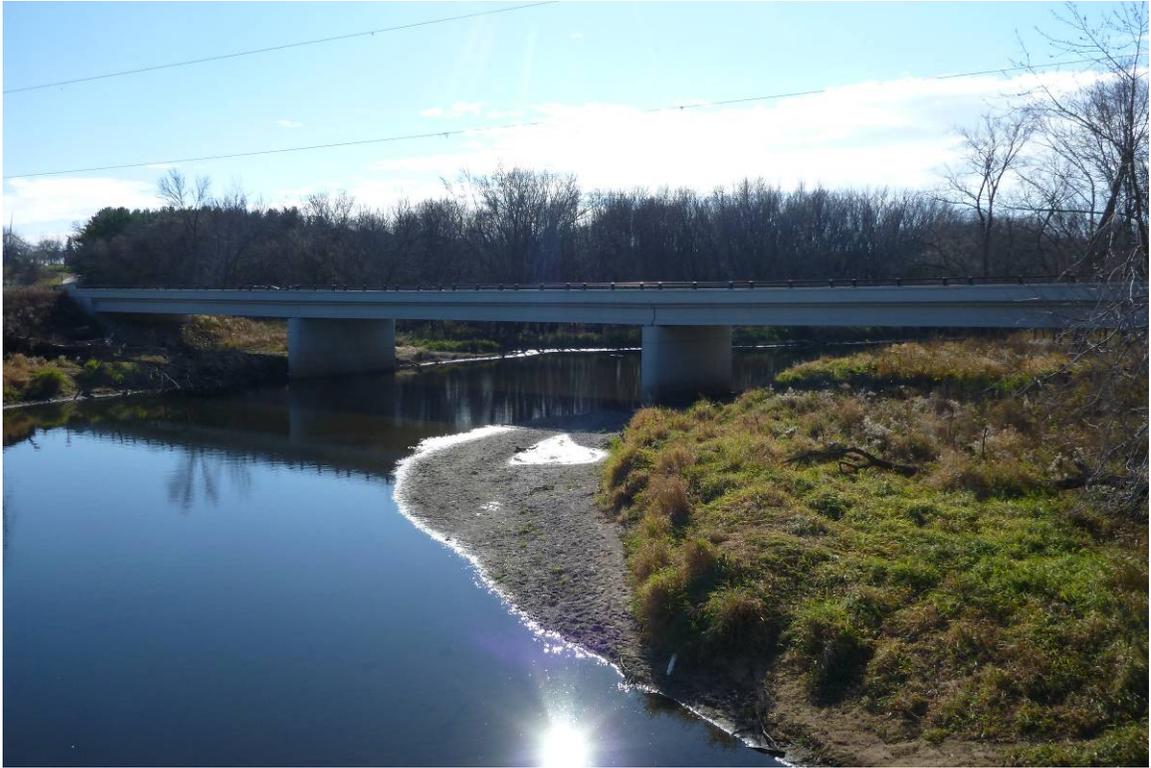
Photograph 1. Overall View of the Structure, Looking West.

The substructure units inspected at Bridge No. 19563, Piers 1 and 2, were found to be in very good condition with no defects of structural significance. The concrete of all substructure units was smooth and sound. A scour pocket was observed at the upstream nose of Pier 2, otherwise, the channel bottom appeared to be stable and well established.

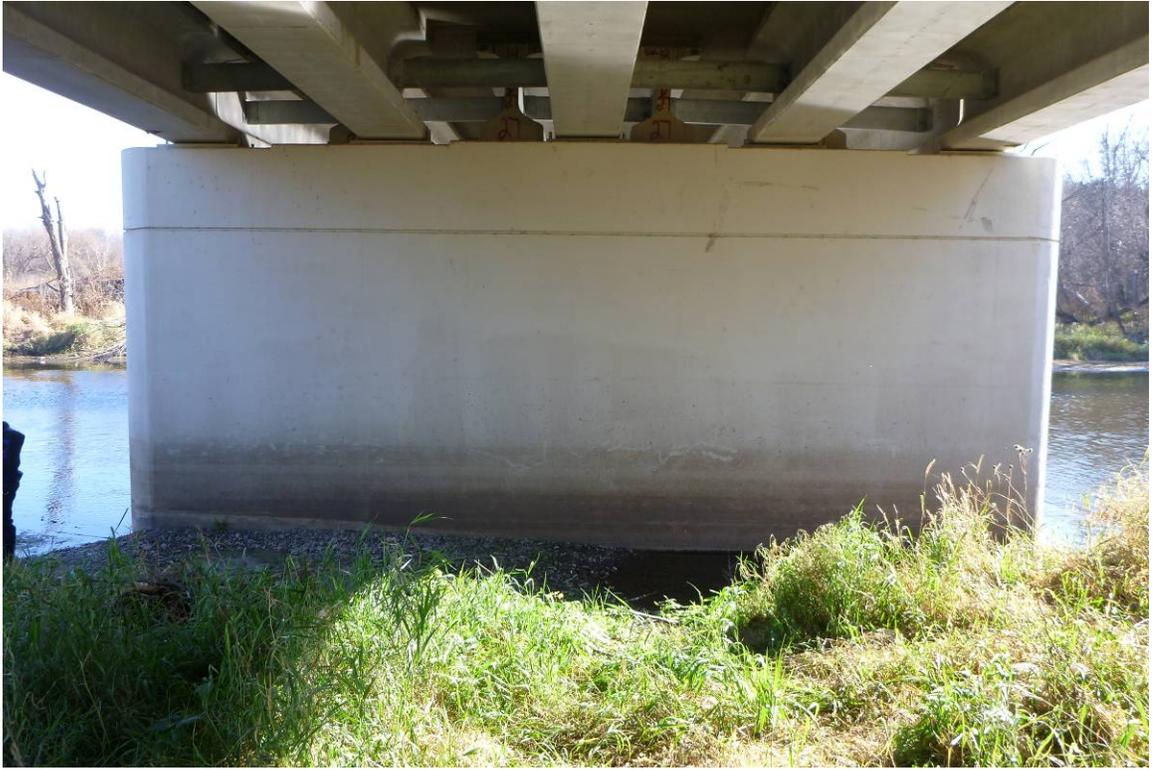
Photograph 3. View of Pier 2, Looking South.

- (A) The concrete surfaces above and below water were typically smooth and sound.
- (B) The channel bottom material along the channel side of both piers consisted of sandy silt and scattered cobbles allowing up to 4 inches of probe rod penetration.
- (C) The channel bottom material along the south side of Pier 1 consisted of soft organic silt allowing up to 1 foot of probe rod penetration.
- (D) A 6 foot diameter and 3 foot deep scour pocket was observed at the upstream nose of Pier 2.

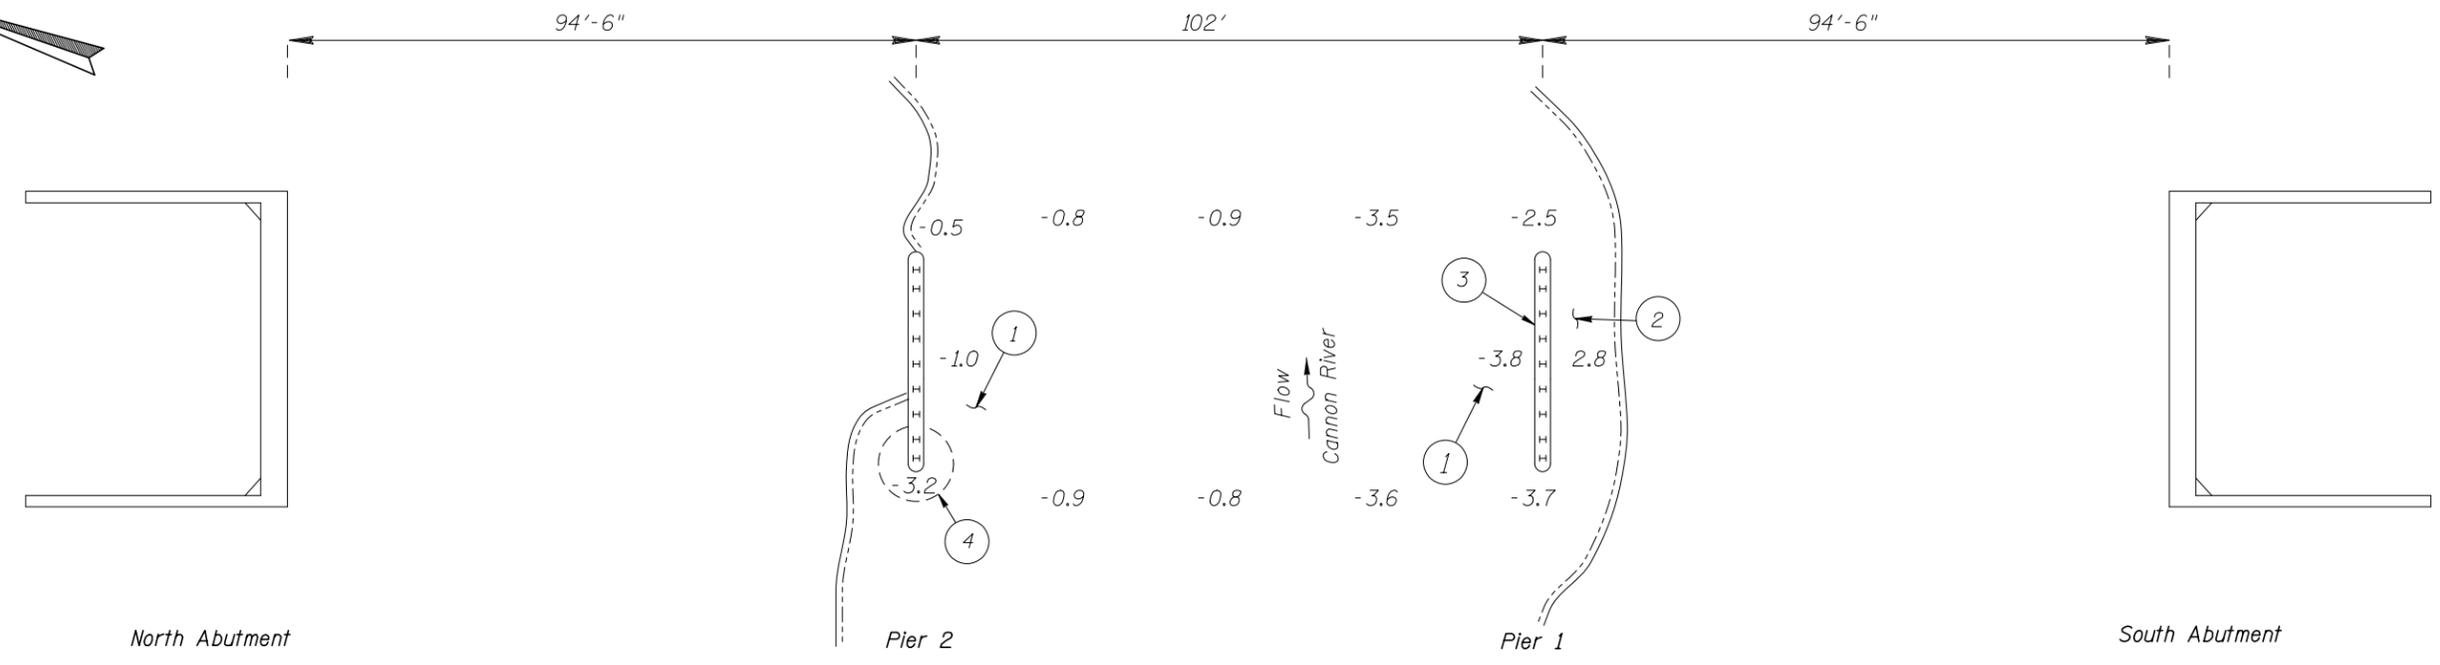
SOUNDING PLAN

1. The channel bottom material on the channel side of each pier consisted of sandy silt with randomly scattered cobbles allowing up to 4 inches of probe rod penetration.
2. The channel bottom material along the south face of Pier 1 consisted of soft organic silt allowing up to 1 foot of probe rod penetration.
3. The concrete surfaces of both piers were smooth and sound.
4. A scour depression, measuring approximately 6 feet diameter and 3 feet deep, was observed at the upstream nose of Pier 2.
