UNDERWATER BRIDGE INSPECTION REPORT

STRUCTURE NO. 2441  
CSAH NO. 5 (FRANKLIN AVENUE)  
OVER THE  
MISSISSIPPI RIVER  
HENNEPIN COUNTY

OCTOBER 29, 2012

BY  
COLLINS ENGINEERS, INC.

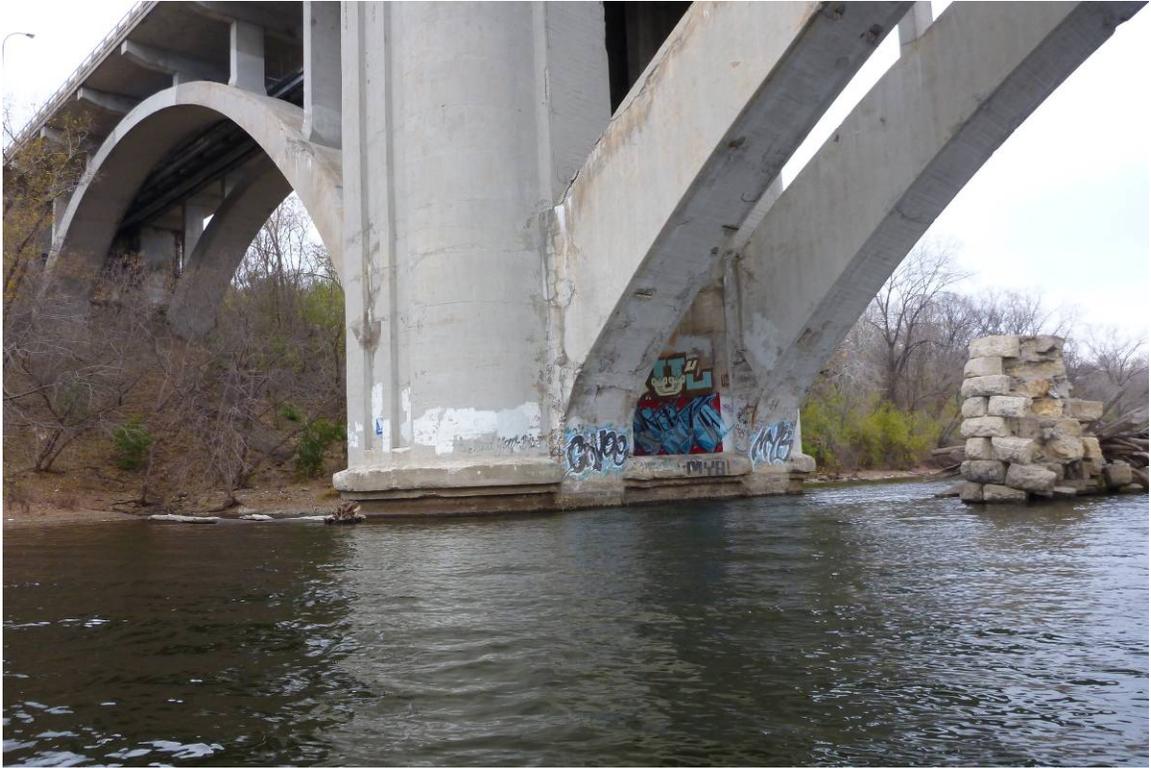
Photograph 1. View of Pier 2, Looking Northwest.

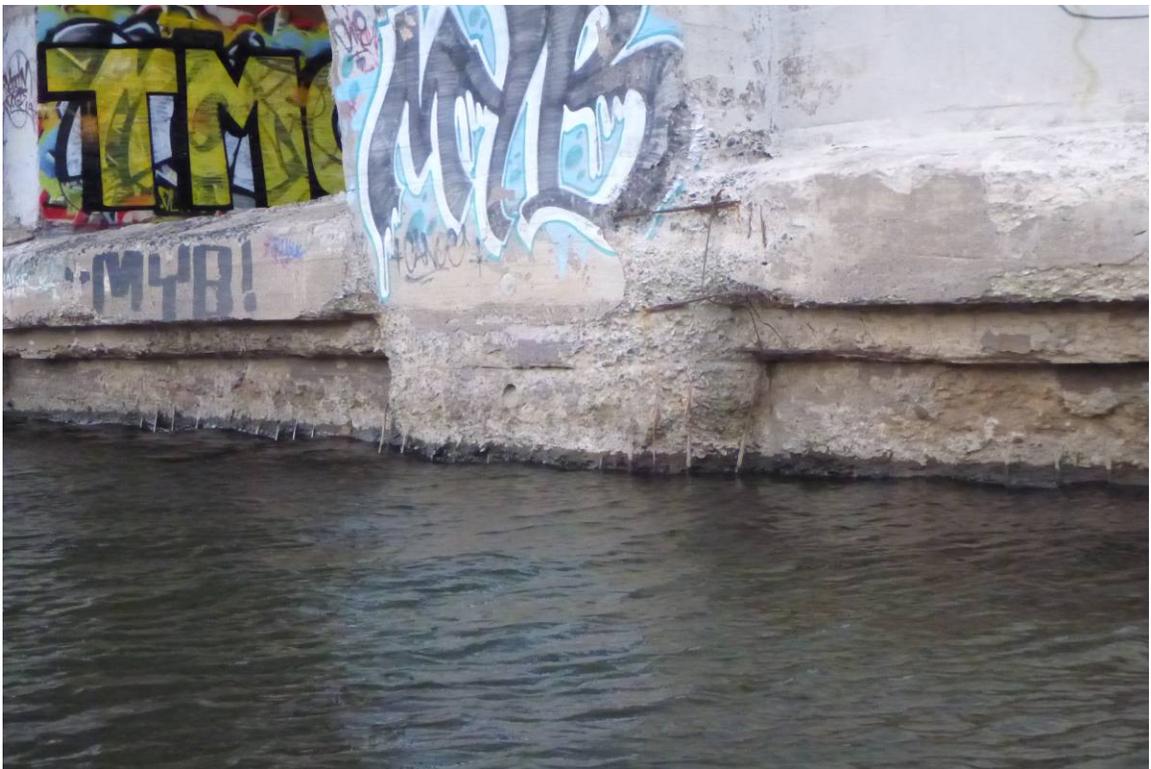
Photograph 2. View of Upstream End of Pier 2, Looking Southwest.

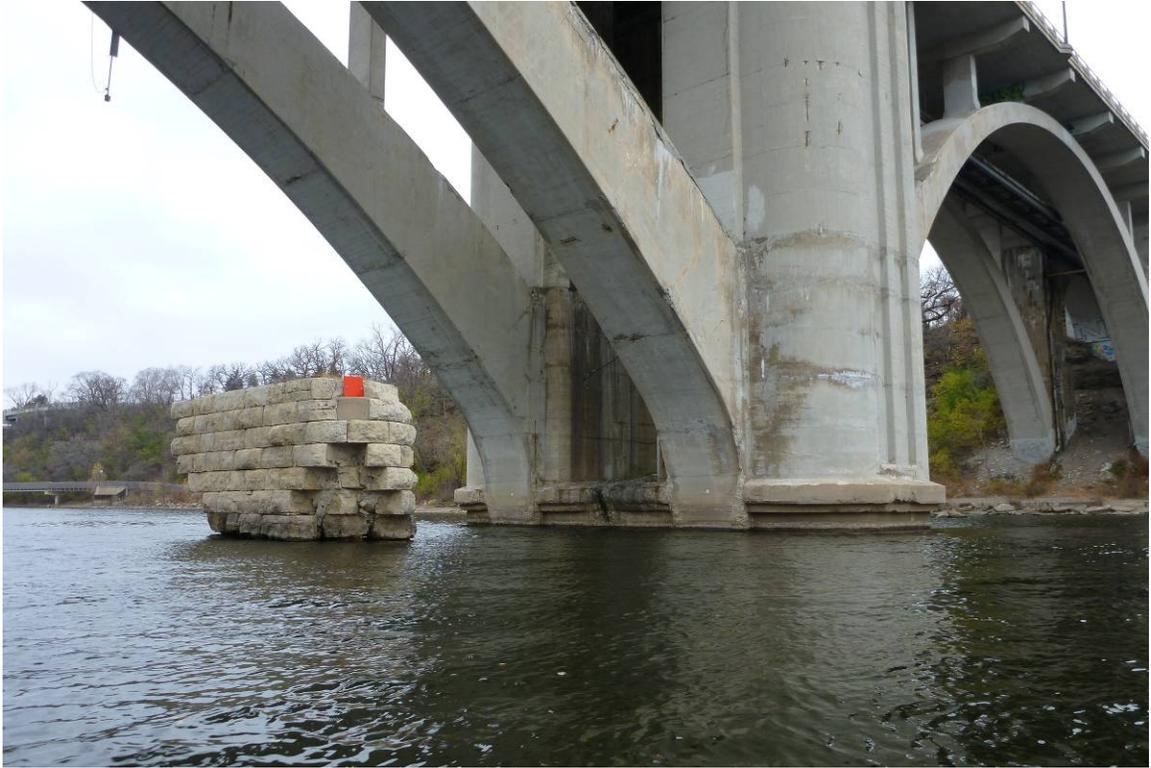
Photograph 3. View of Pier 3, Looking Northeast.

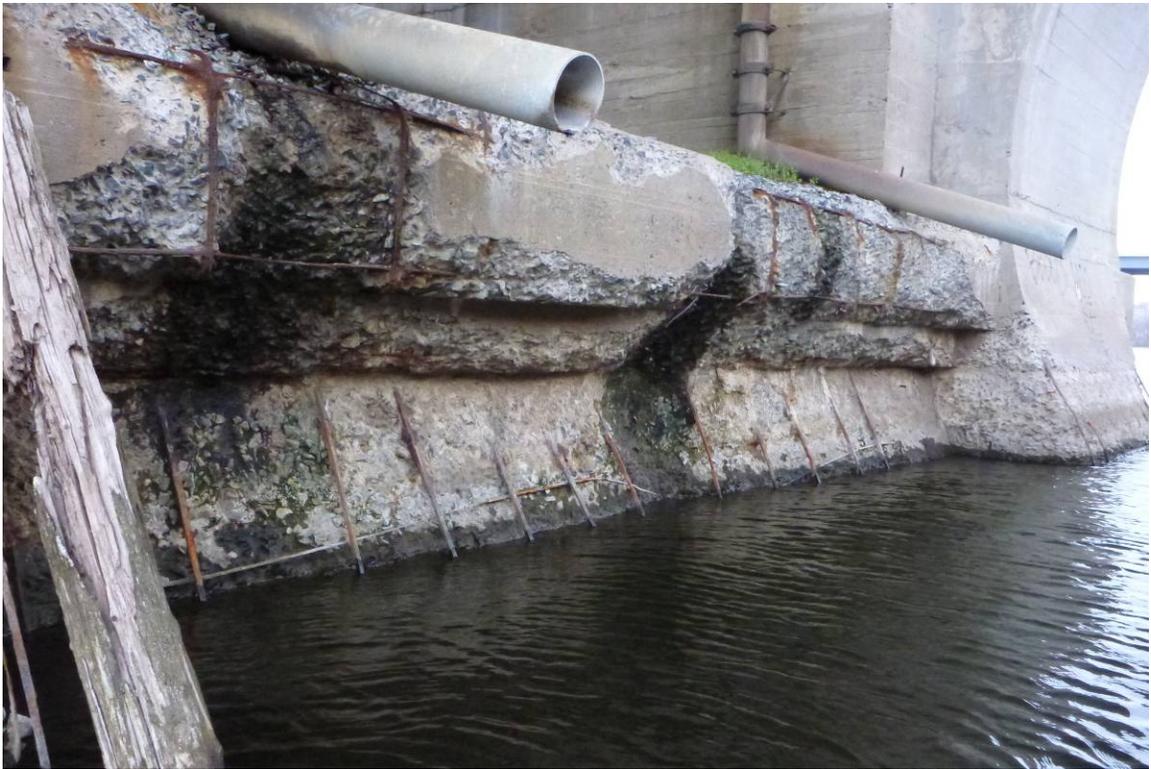
the waterline along the middle portion of Pier 3 along both faces with exposed reinforcing steel and up to 1 foot of penetration.

Photograph 4. View of Heavy Deterioration and Section Loss along the East Side of Pier 3, Looking West.

At a minimum, the exposed reinforcing steel should be cleaned and covered with an epoxy grout. Due to the substantial loss of section, however, a more desirable repair would be to remove all loose and unsound concrete, clean the exposed reinforcing steel, and reform the concrete to the original dimensions and lines.

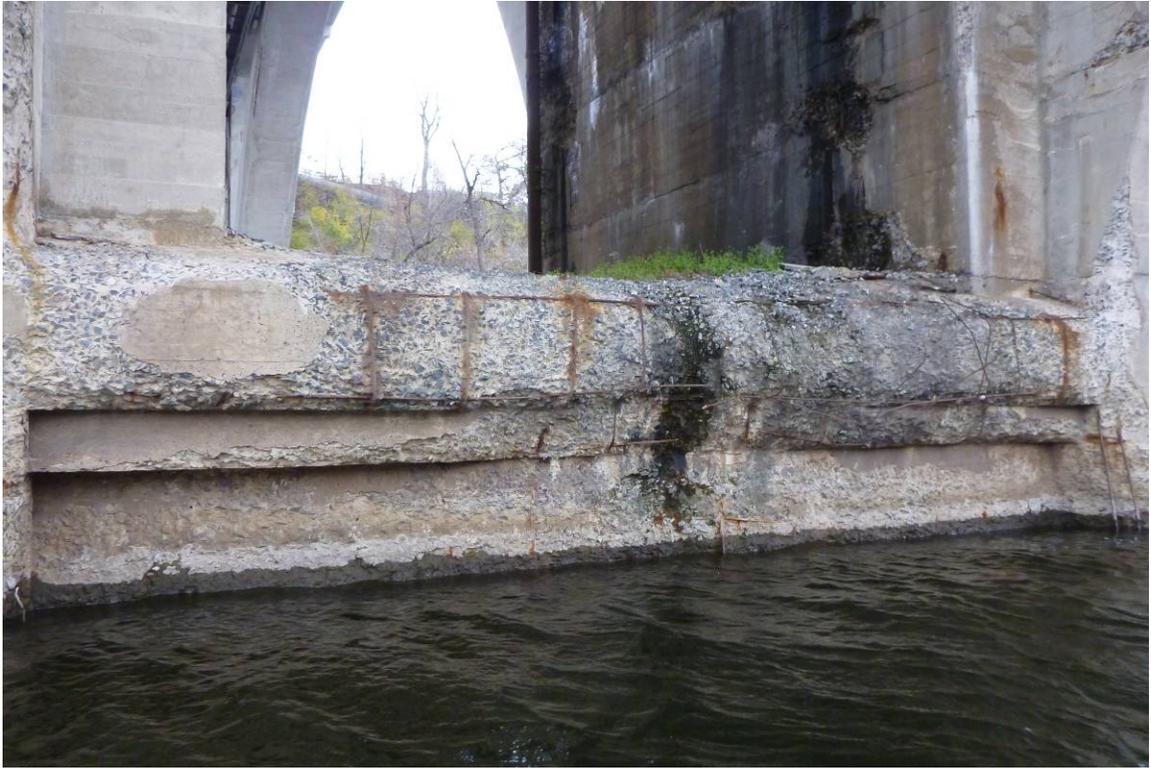
Photograph 5. View of Deterioration and Section Loss along the West Side of Pier 3, Looking East.

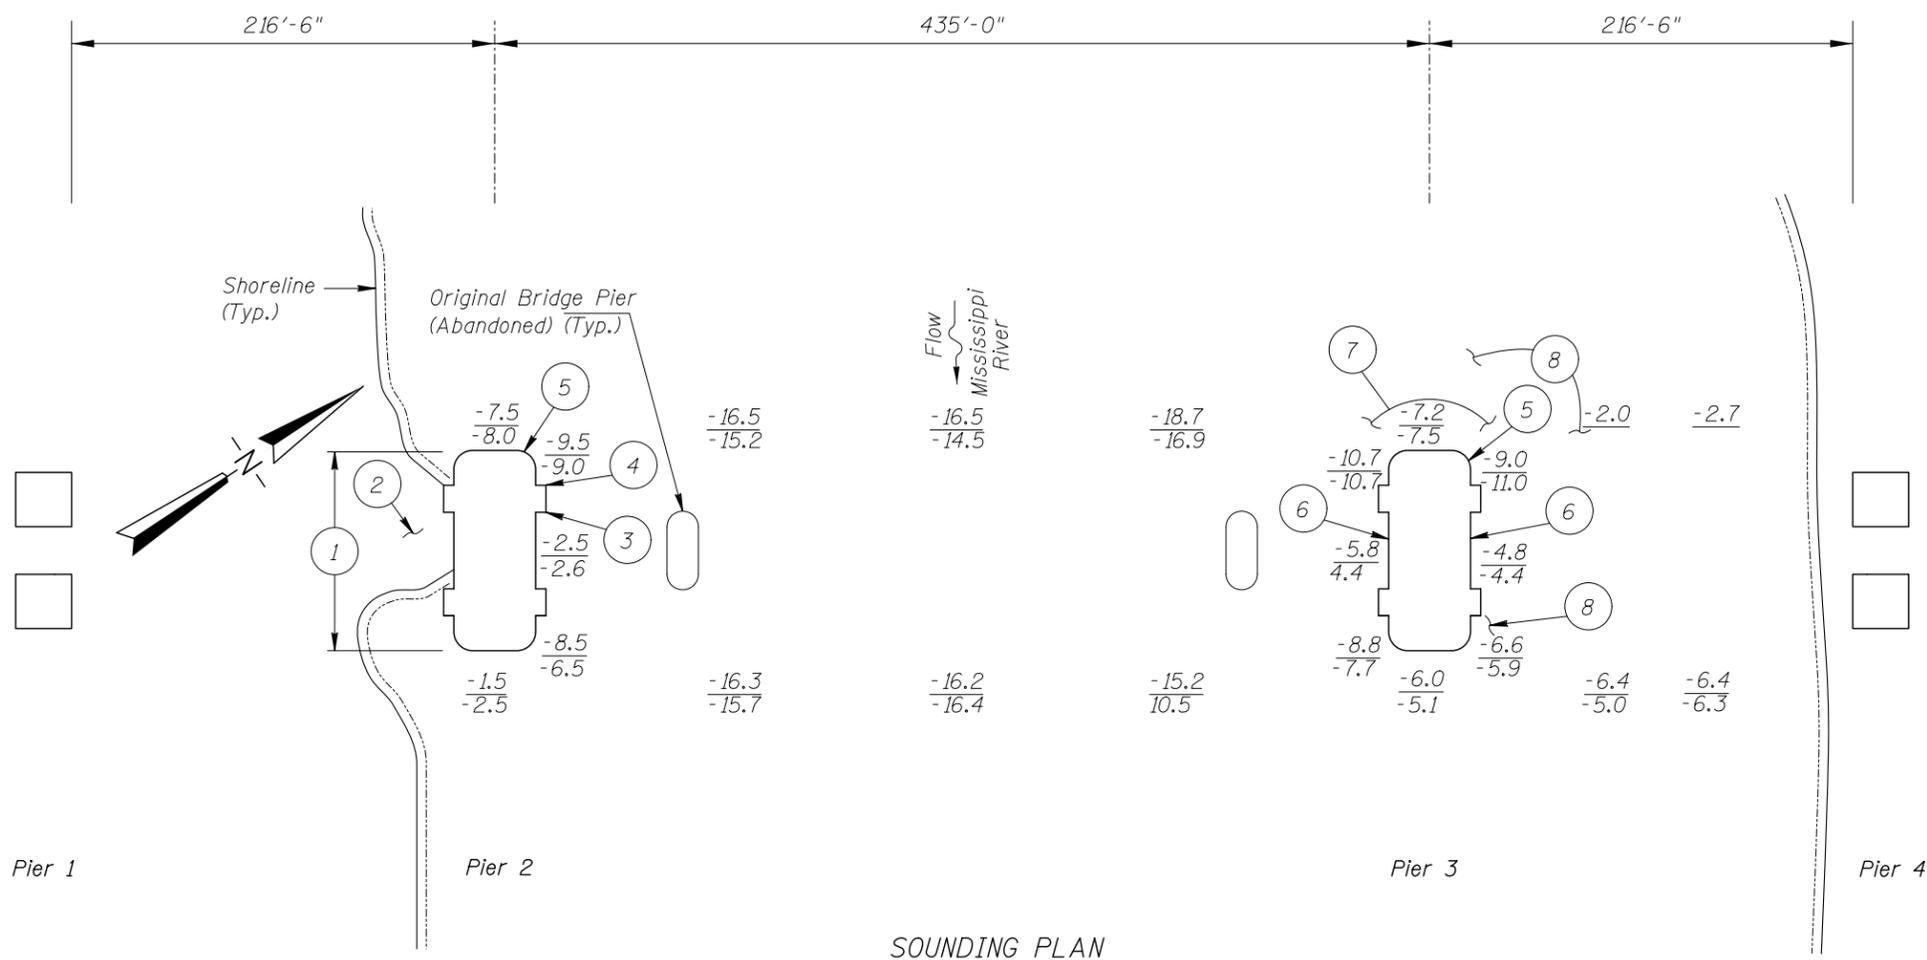
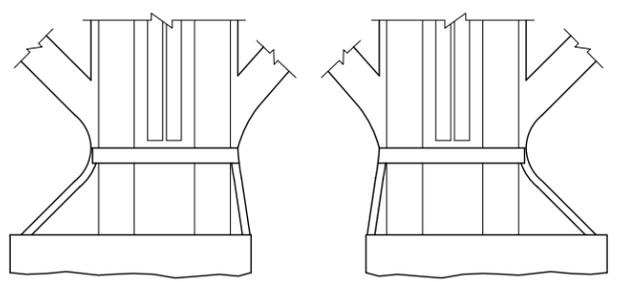
SOUNDING PLAN

- ① The concrete along the west face of Pier 2 was in fair to poor condition with extensive scaling and areas of section loss observed from approximately 4 feet above the waterline to the channel bottom. Typically, the areas of section loss exhibited up to 14 inches of penetration with exposed heavily corroded reinforcing steel.

- ② Accumulation of concrete rubble and steel debris was observed around Pier 2 and extended approximately 1 foot above the waterline along the west face of the pier.

- ③ An area of section loss with exposed reinforcing steel was observed from 4 feet above the waterline to approximately 4 feet below the waterline with up to 10 inches of penetration.

- ④ An area of section loss with exposed reinforcing steel was observed from 4 feet above the waterline to approximately 5 feet below the waterline with up to 12 inches of penetration.

- ⑤ Typically, Piers 2 and 3 exhibited heavy scaling from 2 feet above the waterline to 3 feet below waterline with areas of exposed reinforcing steel and up to 8 inches of penetration.

- ⑥ Heavy section loss was observed from 6 feet above the waterline to 3 feet below the waterline along the middle portion of the pier along both faces with exposed reinforcing steel and up to 1 foot of penetration.

- ⑦ Large diameter riprap was stacked up in front of the upstream nose of Pier 3.
- ⑧ Rocks and boulders were observed on the channel bottom along the east side of Pier 3.
