UNDERWATER BRIDGE INSPECTION REPORT

STRUCTURE NO. 27510

ARCOLA CHANNEL

MAY 21, 2012

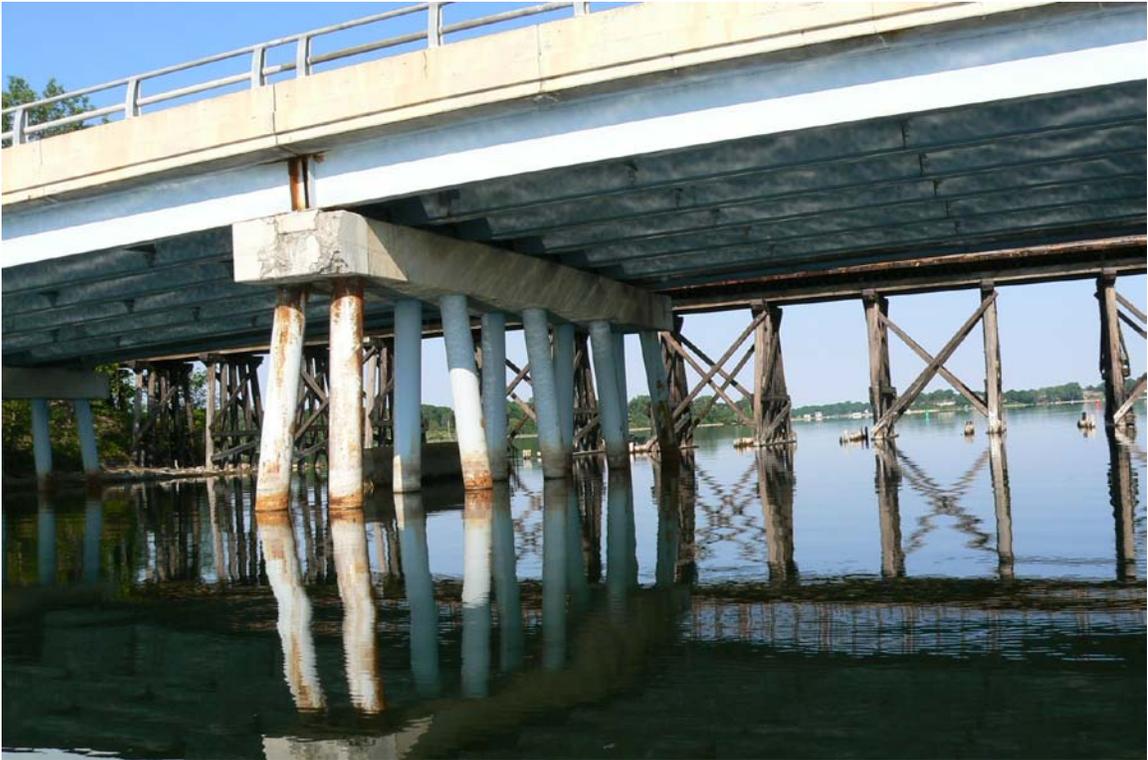
Photograph 2. View of Pier 2, Looking Southwest.

- 3 The channel bottom material around Piers 3, 5, 6 and 7 consisted of silty sand and scattered rocks up to 2 feet in diameter.
- 4 The northwest pile of Pier 2 exhibited a dent that was 4 inches in diameter and 2 inches deep located 5 feet below the waterline.

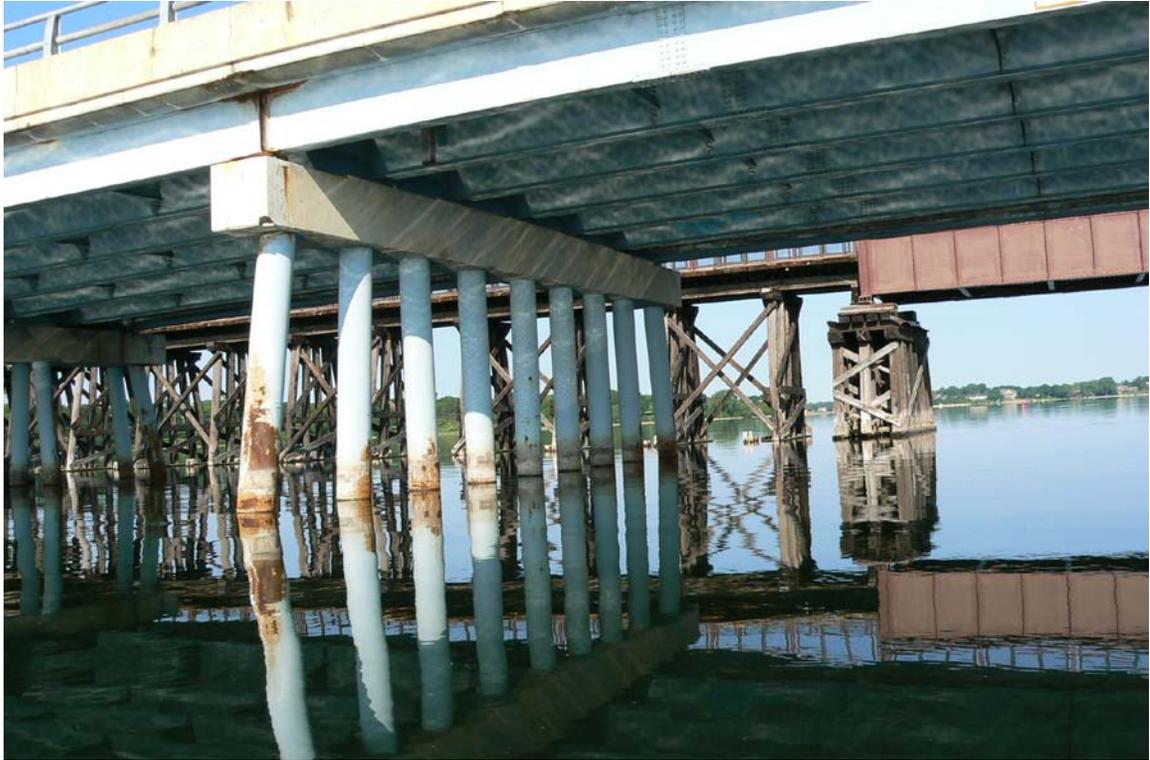
Photograph 3. View of Pier 3, Looking Southwest.

- 5 Five steel pipe piles at the west end of Pier 3 exhibited dents that were 12 inches long with 1 inch deep indentation and were located 5 to 7 feet below the waterline.

- 10 The concrete repair to the pile cap at the east end of Pier 3 exhibited map cracking and spalling with up to 4 inches of penetration and exposed reinforcing steel, extending from the top to the bottom of the pile cap on the south face.

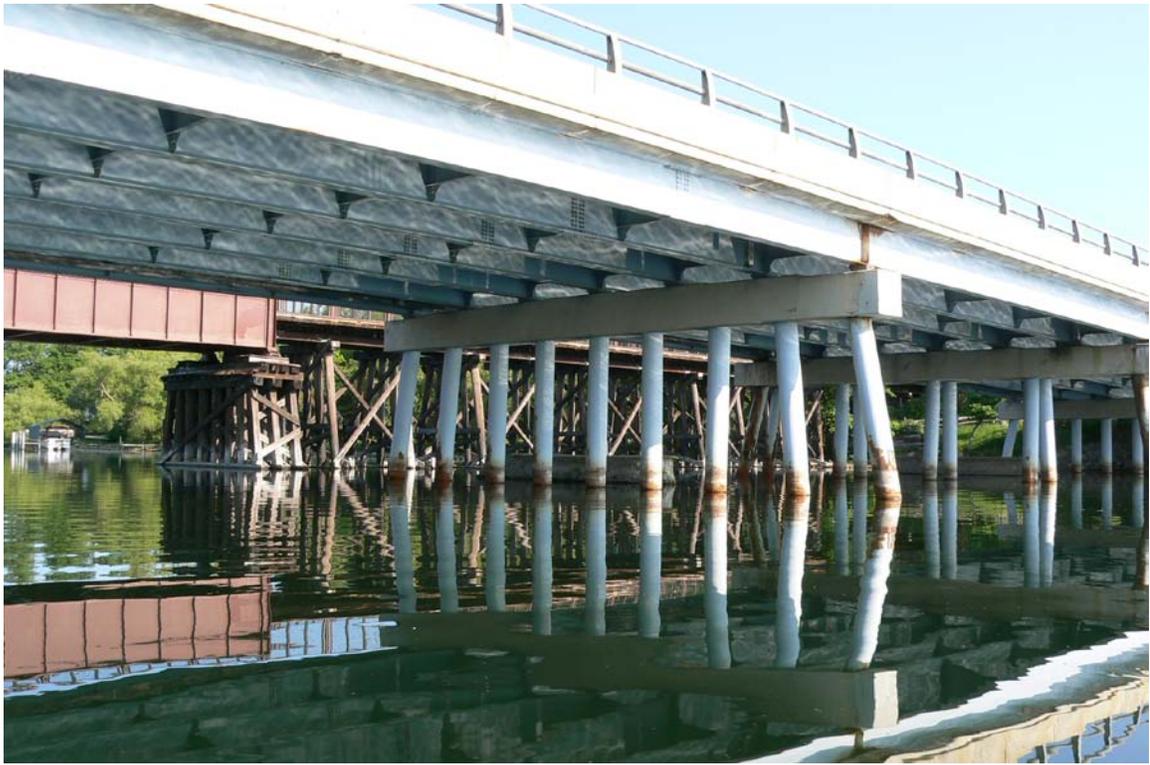
- (E) The pile cap at Pier 5 had a spall 1 foot long by 6 inches high with up to 1 inch of penetration and partially exposed reinforcing steel at the east end on the south side of the pier.
- (F) The pile cap at Pier 2 exhibited map cracking and a spall on the entire east end with up to 6 inches of penetration and exposed reinforcing steel with up to 15 percent loss of section.

Photograph 5. View of Pier 5, Looking Northwest.

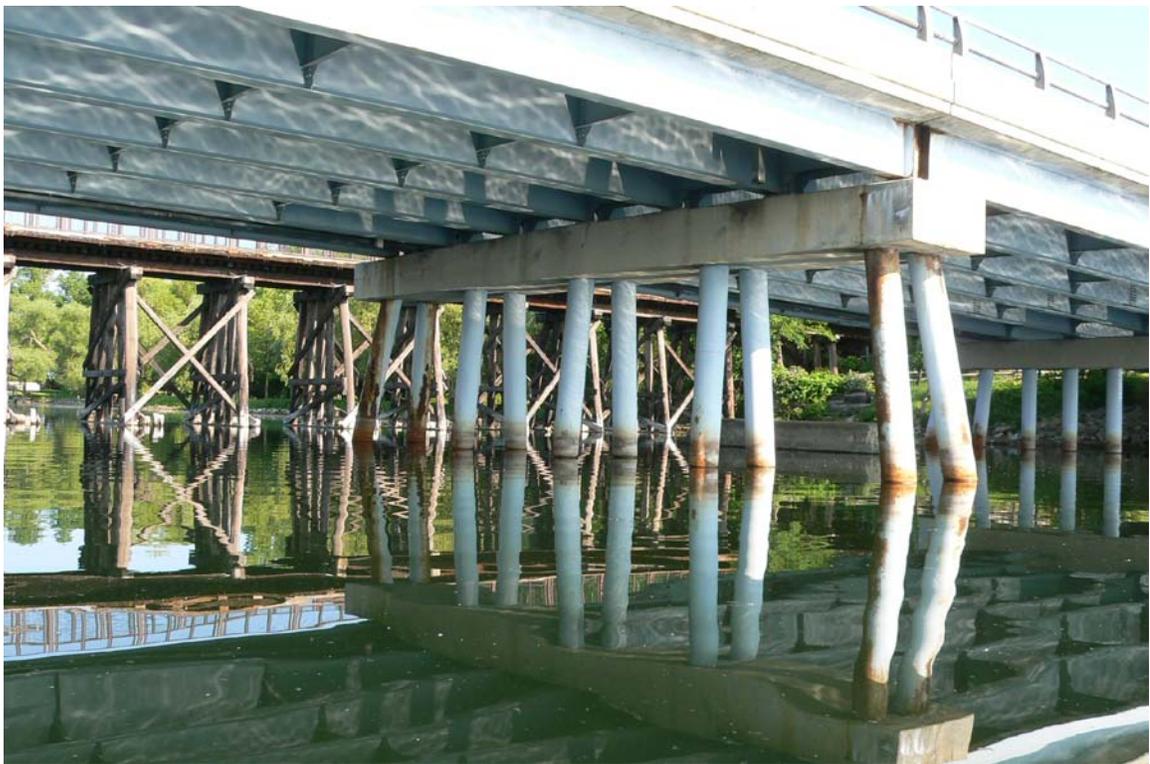
- (D) Minor cracking was observed at the west end and heavy cracking at the east end of Pier 6 and Pier 2 pile caps. In addition Pier 6 had a spall 3 feet by 2.5 feet with up to 2.5 inches of penetration and exposed reinforcing steel with up to 25 percent loss of section.

Photograph 6. View of Pier 6, Looking Northwest.

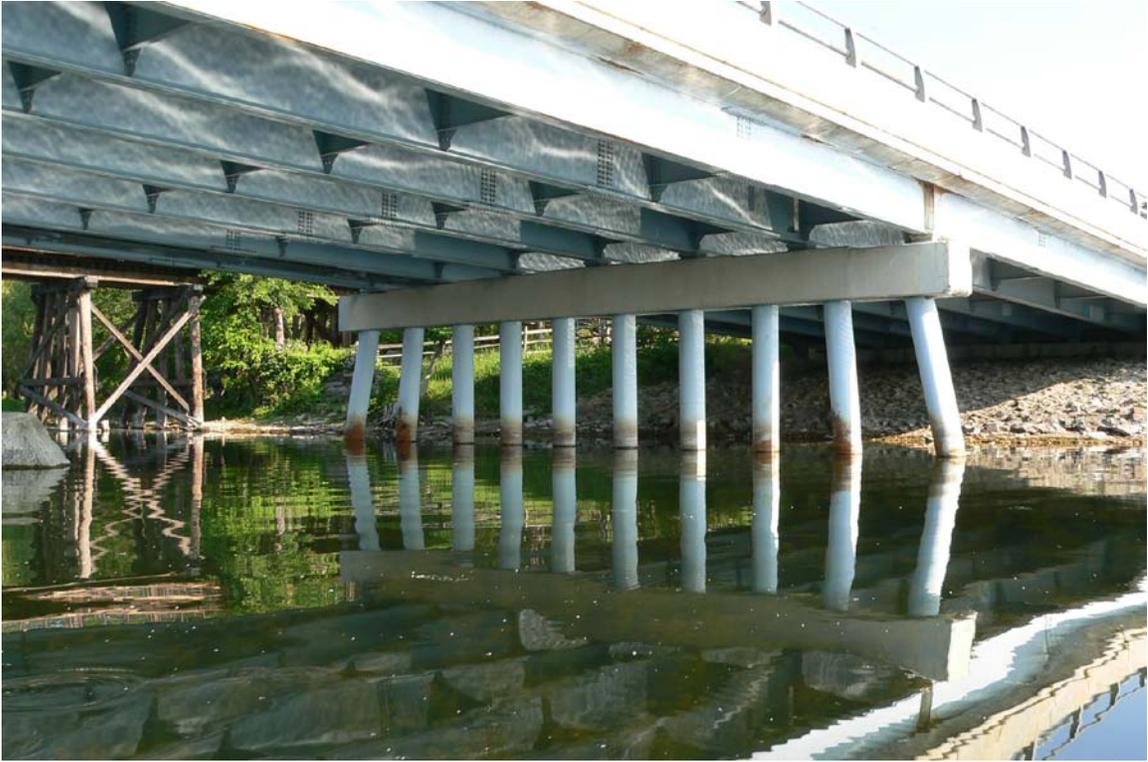
- (C) The concrete pile cap of Pier 7 exhibited areas of section loss approximately 1.5 feet long and 6 inches high on the west end with exposed reinforcing steel on the top and bottom edges where there was up to 3 inches of penetration.

Photograph 7. View of Pier 7, Looking Northwest.

- 9 The concrete pile cap at Pier 7 exhibited areas of section loss approximately 1.5 feet long and 6 inches high on the west end with exposed reinforcing steel on the top and bottom faces where there was 2 to 3 inches of penetration and wide spread cracking with rust staining.

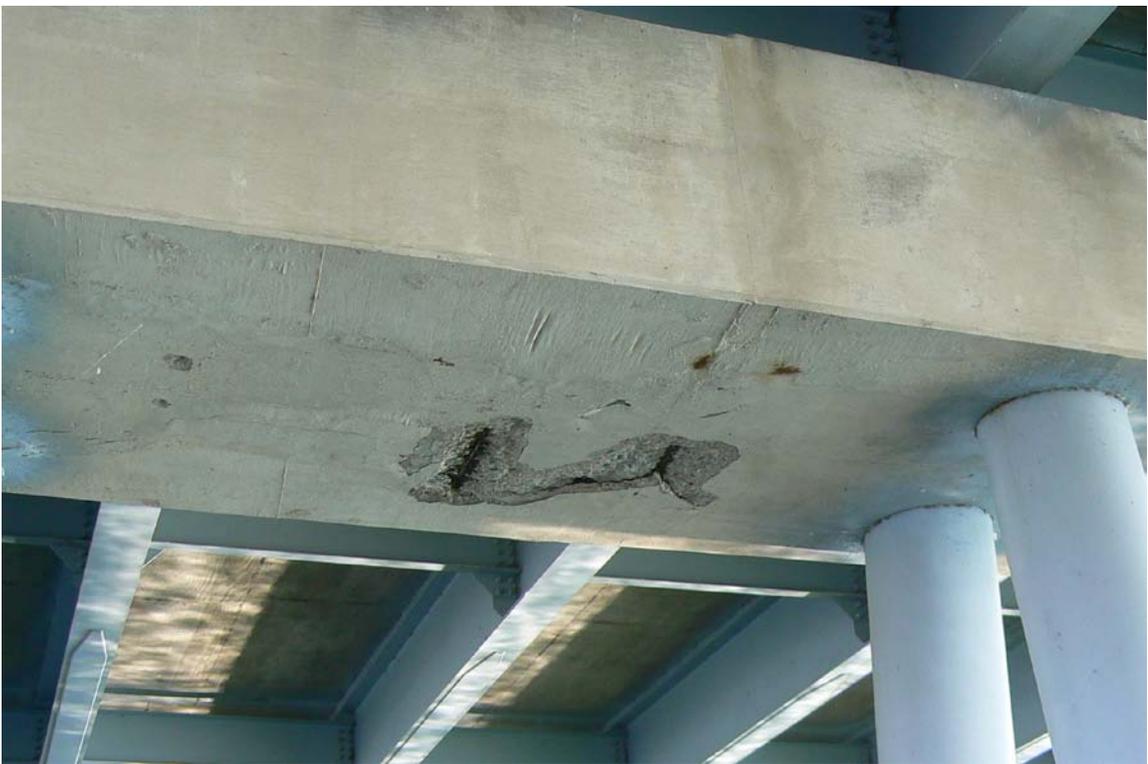
Photograph 8. View of Spall with Exposed Reinforcing Steel on the Underside of Pier 6 Pile Cap, Looking North

- (A) The spalled areas on the pier caps with exposed reinforcing steel should be properly repaired to prevent further deterioration. Repairs should include removal of all unsound concrete to a minimum of one inch behind the reinforcing steel, cleaning and replacing the reinforcing steel as necessary, and placing concrete designed for high durability and low permeability.
- (B) Reinspect the submerged substructure units at the normal maximum recommended (NBIS) interval of sixty (60) months.

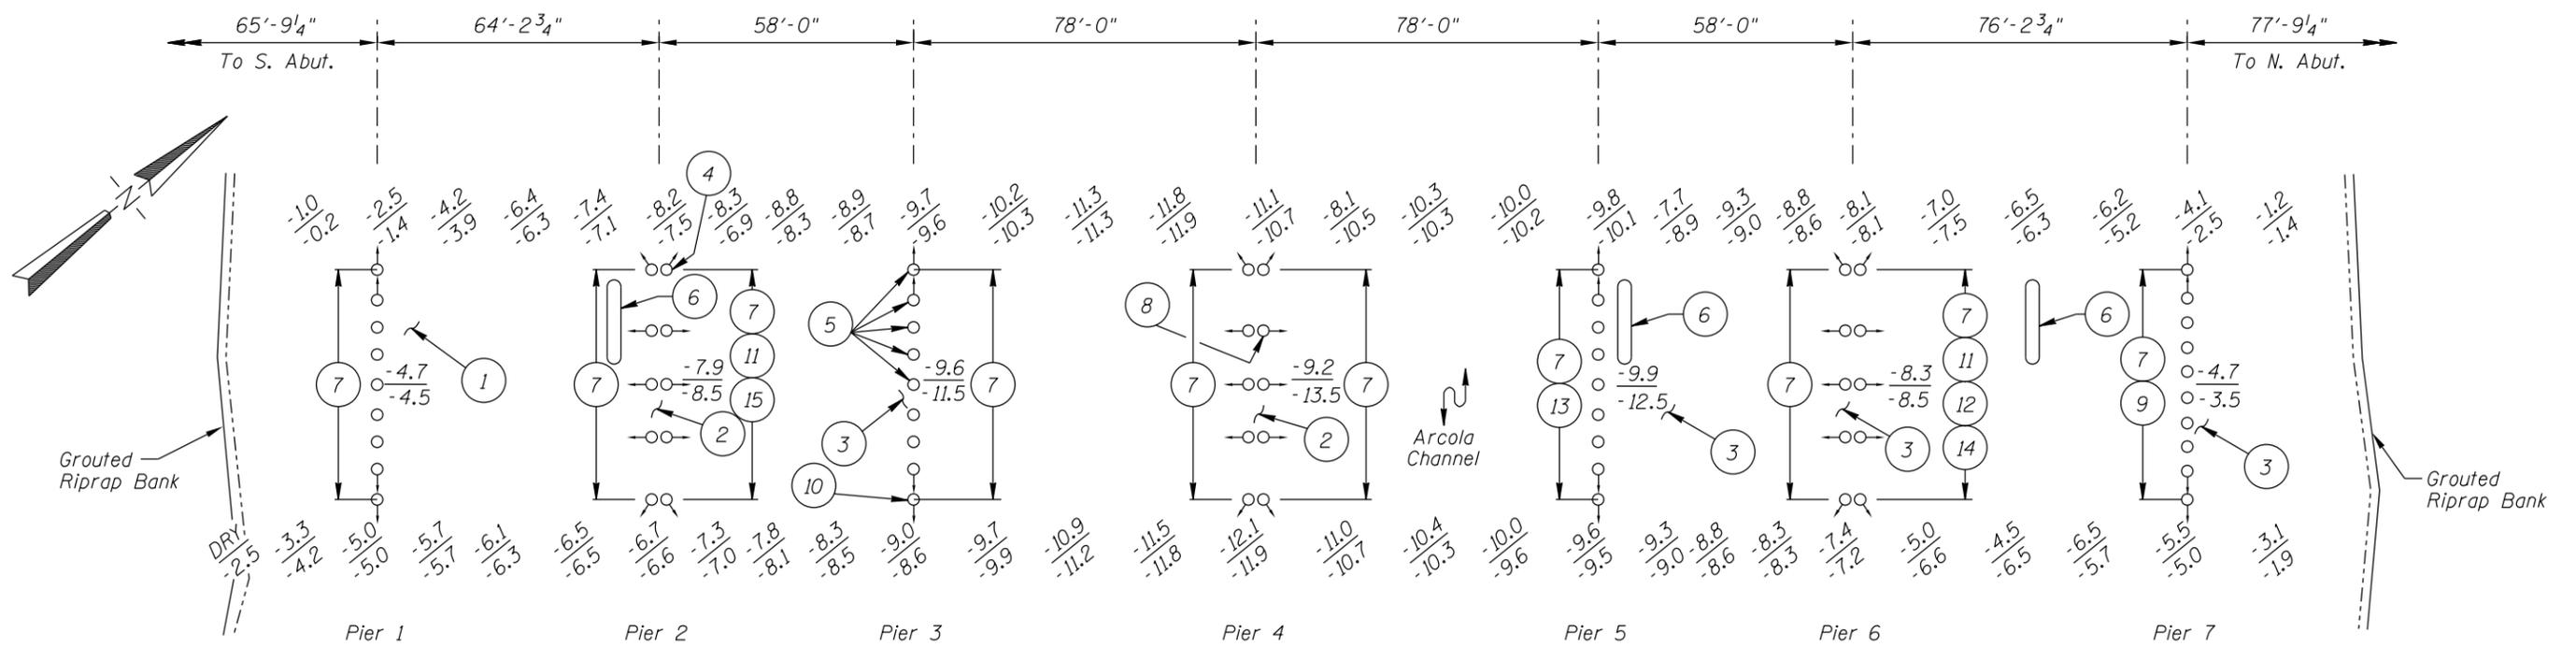
SOUNDING PLAN

- 1 The channel bottom material around Pier 1 consisted of sand and gravel with 3 inches of maximum probe rod penetration.
- 2 The channel bottom material around Piers 2 and 4 consisted of gravel, concrete rubble, and abandoned timber piles.

- 6 Abandoned concrete piers were encountered between Piers 1 and 2, 5 and 6, and 6 and 7, and extended approximately 2 feet above the waterline.
- 7 The steel pipe pile typically exhibited light surface corrosion with minor pitting and rust scale delaminations up to 1/8 inch thick from 2 feet above to 1 foot below the waterline.

- 8 The steel pipe piles exhibited a dent 4 feet above the waterline that was 8 inches in diameter with 1/2 inch of penetration. A second 12 inch diameter dent was observed from 1 foot above to 2 feet below the waterline, with a 5 inch deep indentation.

- 11 Minor cracking at west end and heavy cracking at east end of pier cap at Piers 6 and 2.

- 12 The piles exhibited lighter corrosion and/or coating loss from channel bottom to 6 feet above waterline.
- 13 The pier cap at Pier 5 had a spall measuring 1 foot long by 6 inches high with 1 inch of penetration with partially exposed reinforcing steel at the east end on the south face.
- 14 The pier cap at Pier 6 had a spall measuring 3 feet by 2.5 feet with 2-1/2 inches of penetration and exposed reinforcing steel that had approximately 25 percent loss of section.
- 15 The pier cap at Pier 2 exhibited map cracking and spalling on the entire east end with up to 6 inches of penetration and up to 15 percent section loss on the exposed reinforcing steel.
