UNDERWATER BRIDGE INSPECTION REPORT

STRUCTURE NO. 27532

CROW RIVER

JULY 23, 2012

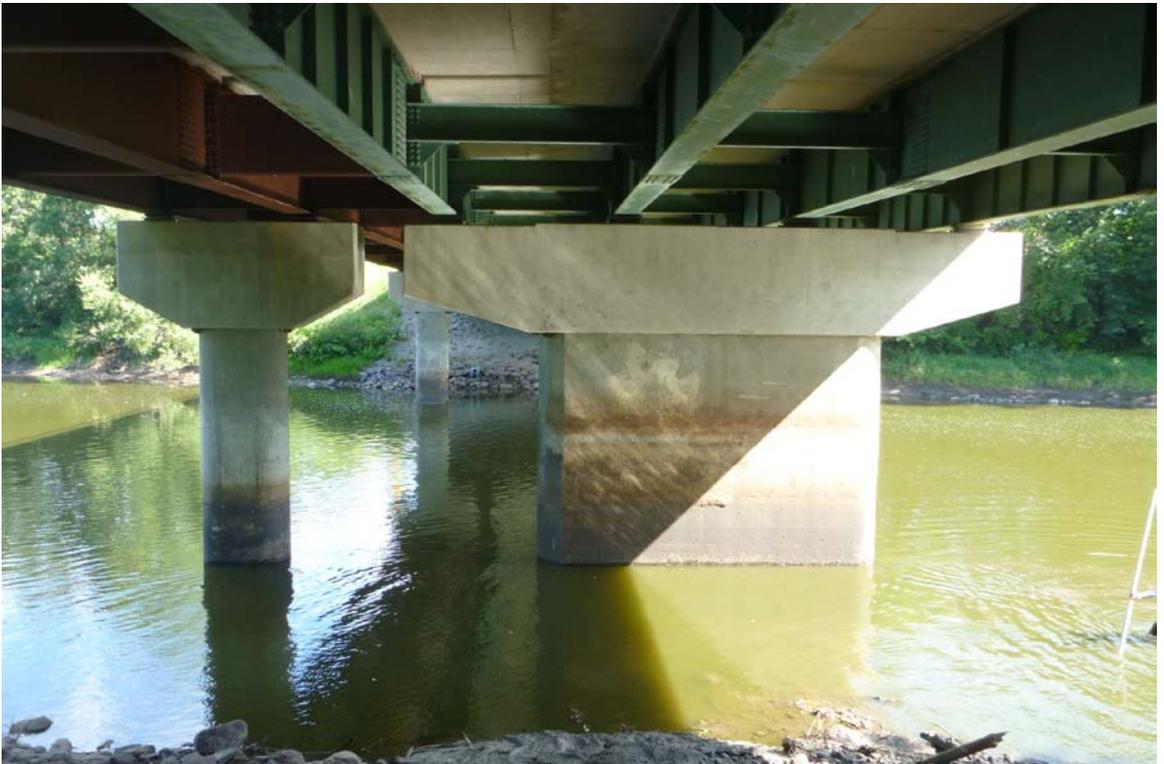
- (A) The footing was exposed along the north face from downstream nose to the upstream nose of Pier 1 (downstream shaft) with up to 1 foot of vertical exposure.
- (B) The downstream shaft of both piers exhibited small areas of concrete repair patches located approximately 3 feet above the waterline.

Photograph 2. View of Pier 1, Looking North.

- (A) Monitor footing exposure at Pier 1 during future underwater inspections.

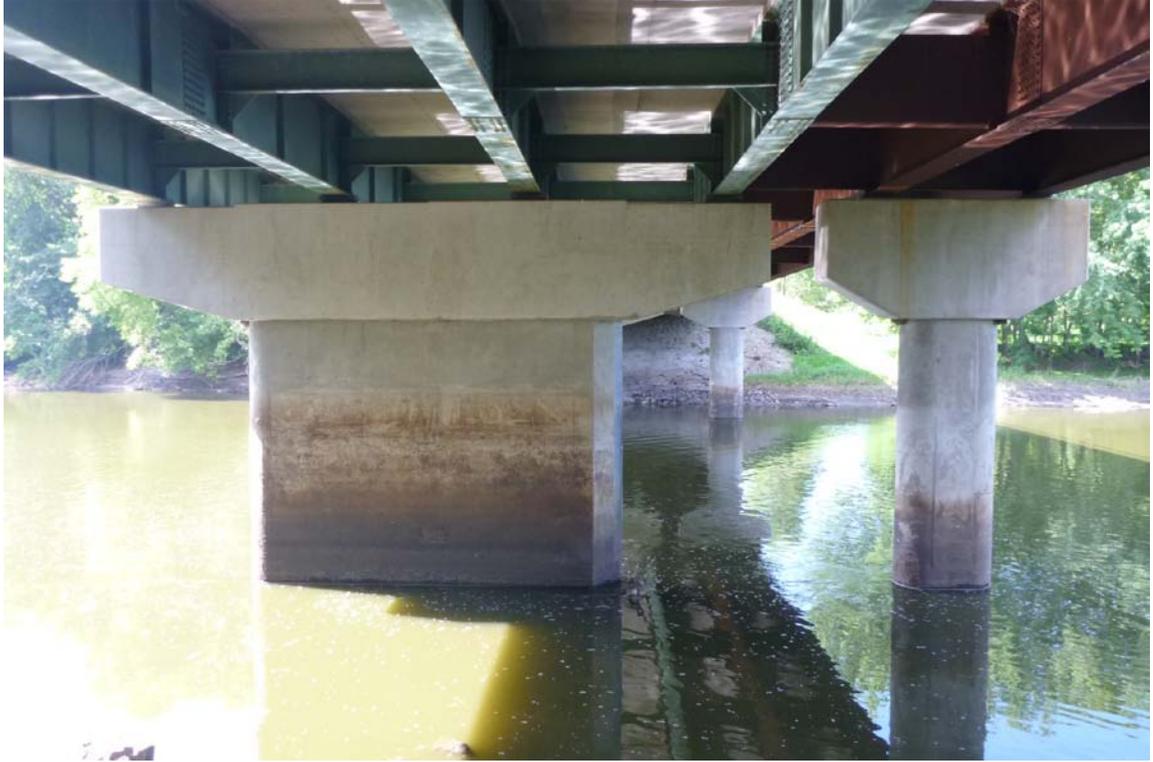
Photograph 3. View of Pier 2, Looking South.

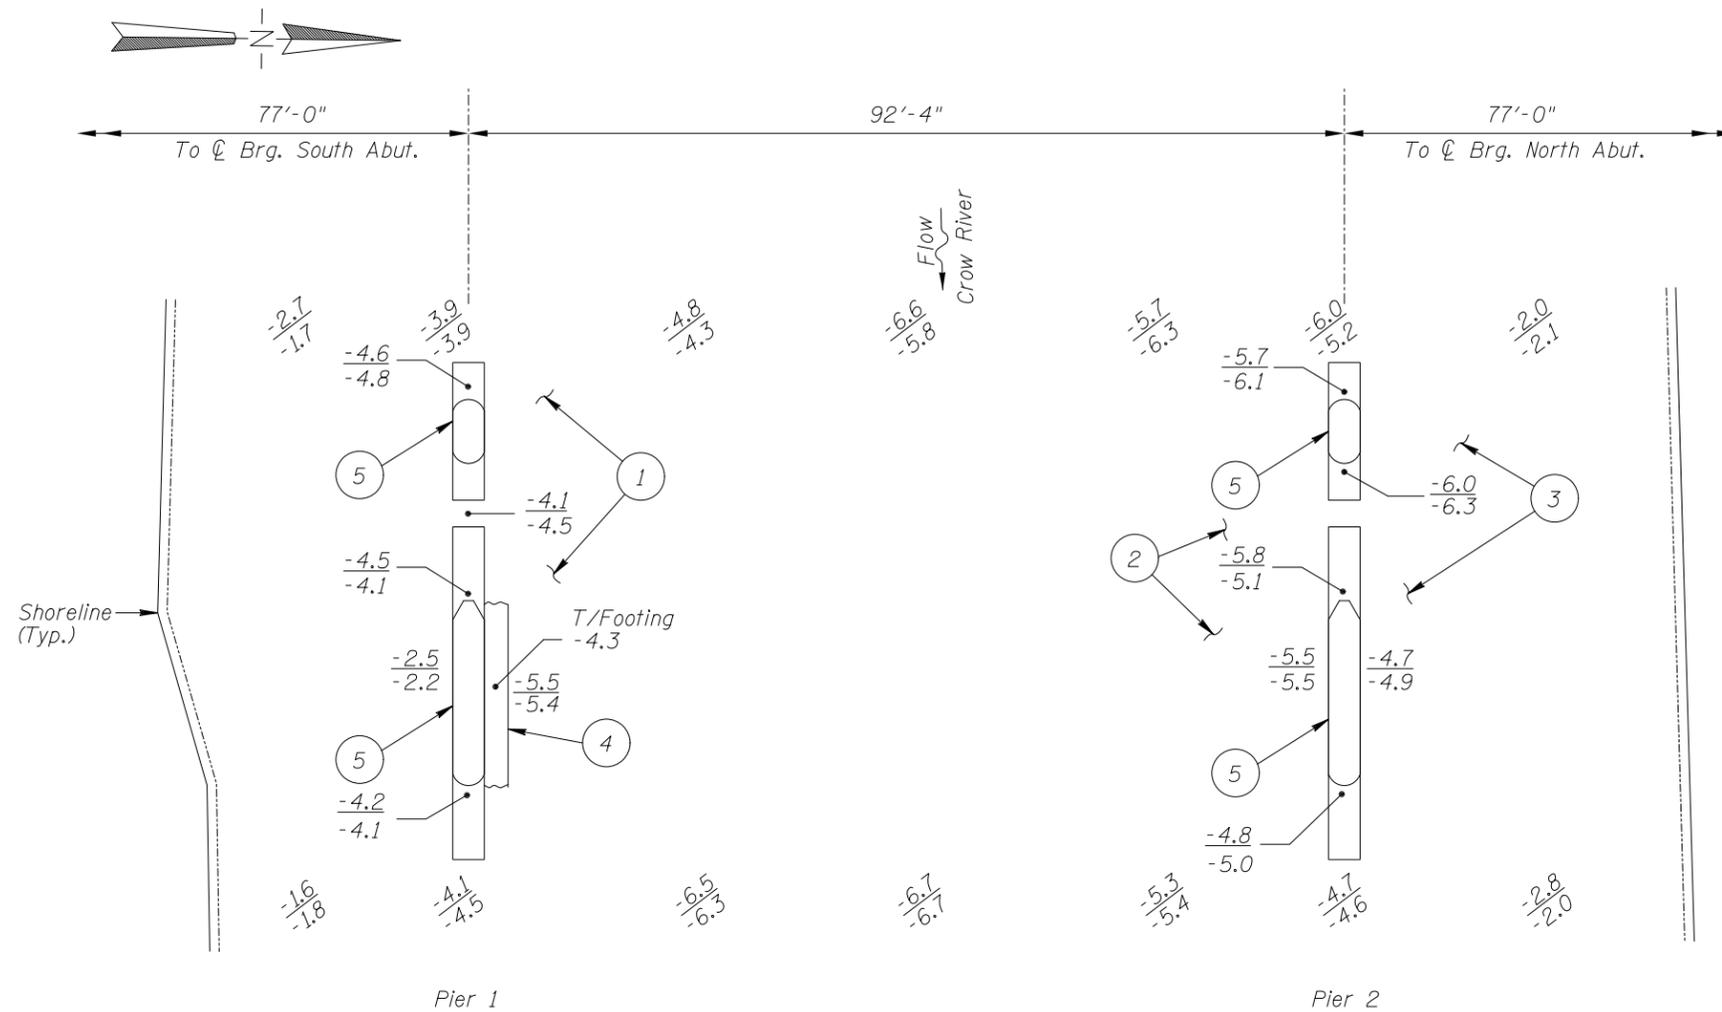
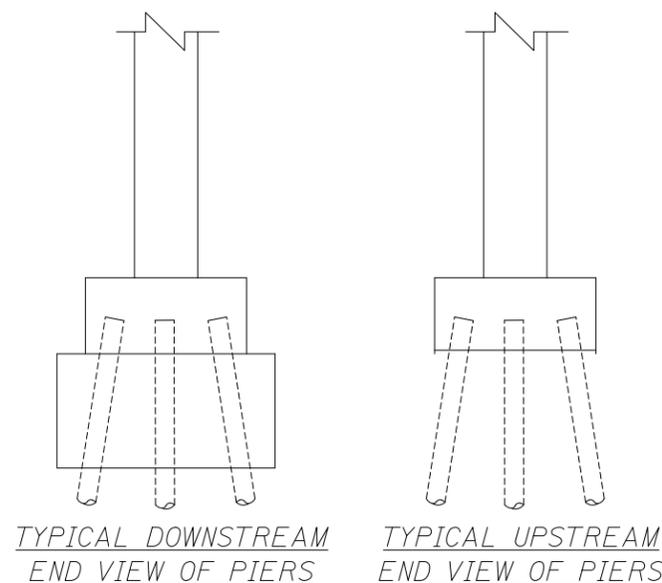
SOUNDING PLAN

- 1 The channel bottom consisted of sandy gravel and 8-inch-diameter riprap with up to 4 inches of probe rod penetration.
- 2 The channel bottom consisted of sandy gravel with up to 4 inches of probe rod penetration.
- 3 The channel bottom consisted of riprap up to 2 feet in diameter with silty sand infilling with up to 3 inches of probe rod penetration.
- 4 The footing was exposed along the north face of the downstream section of Pier 1 with up to 1 foot of vertical face exposure.
- 5 Overall, the concrete was smooth and sound with random minor areas of poor consolidation with penetrations of up to 1/8 inch.
