UNDERWATER BRIDGE INSPECTION REPORT

STRUCTURE NO. 27537
CSAH NO. 52, 1ST AVENUE
OVER THE
EAST CHANNEL OF THE MISSISSIPPI RIVER
HENNEPIN COUNTY

OCTOBER 28, 2012

BY
COLLINS ENGINEERS, INC.

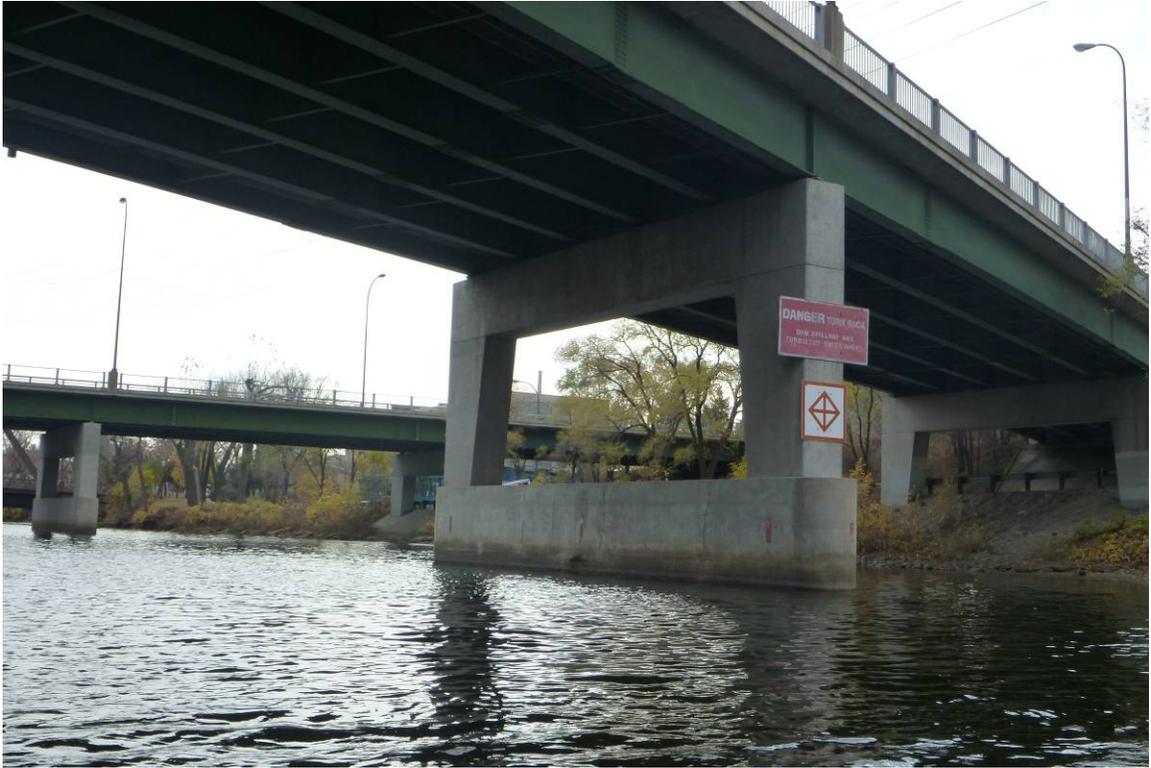
- (H) Vertical cracks (1/16 inch maximum width) were observed along east face (5 cracks) and west face (3 cracks) of Pier 2, extending from channel bottom to top of pier shaft.

Photograph 1. View of Pier 2, Looking Southwest.

- (A) Monitor vertical cracking in pier concrete during future underwater inspections.
- (B) Reinspect the submerged substructure units at the normal maximum recommended (NBIS) interval of sixty (60) months.

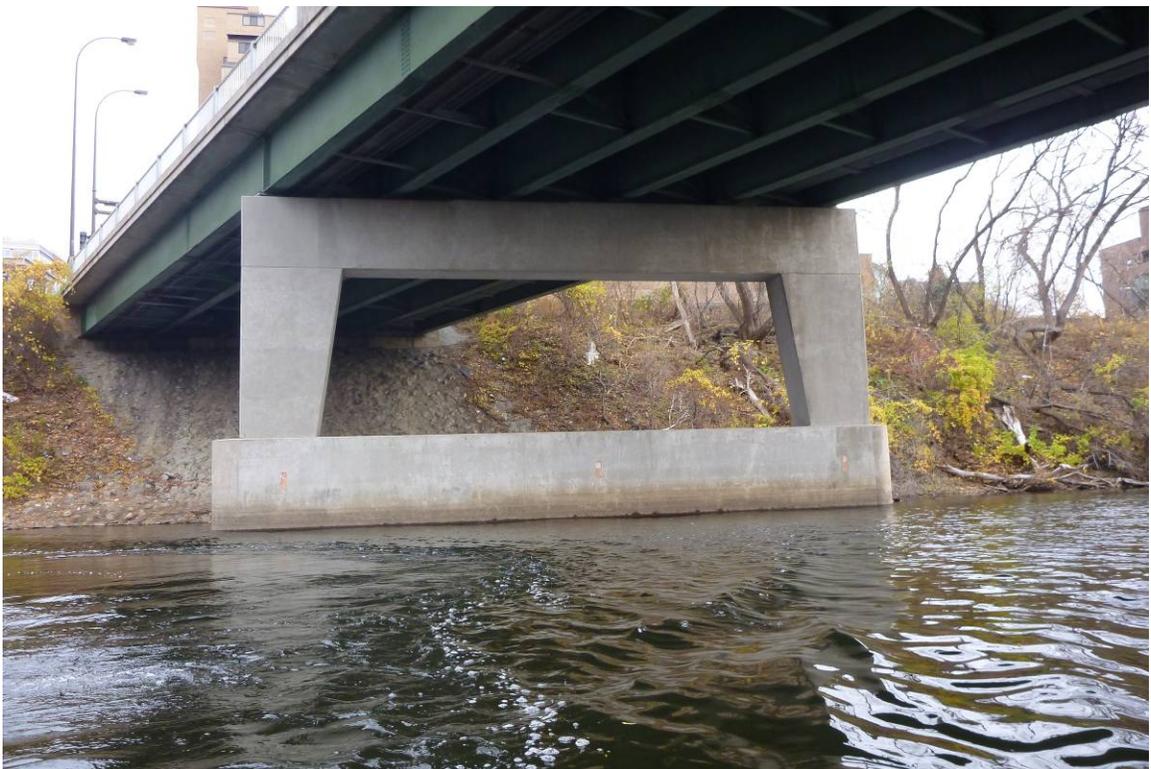
Photograph 2. View of Pier 3, Looking Southeast.

- 5 Vertical cracks 1/16 inch wide were observed along the west face of Pier 3, extending from channel bottom to top of pier shaft.
- 6 Footing exposure (top at 6.3 feet below waterline) was observed along the west face of Pier 3. The footing's surface was rough with some irregularities. Steel sheet piling was observed along footing from the midpoint to the downstream nose with a maximum vertical exposure of 1.5 feet (footing and sheeting).

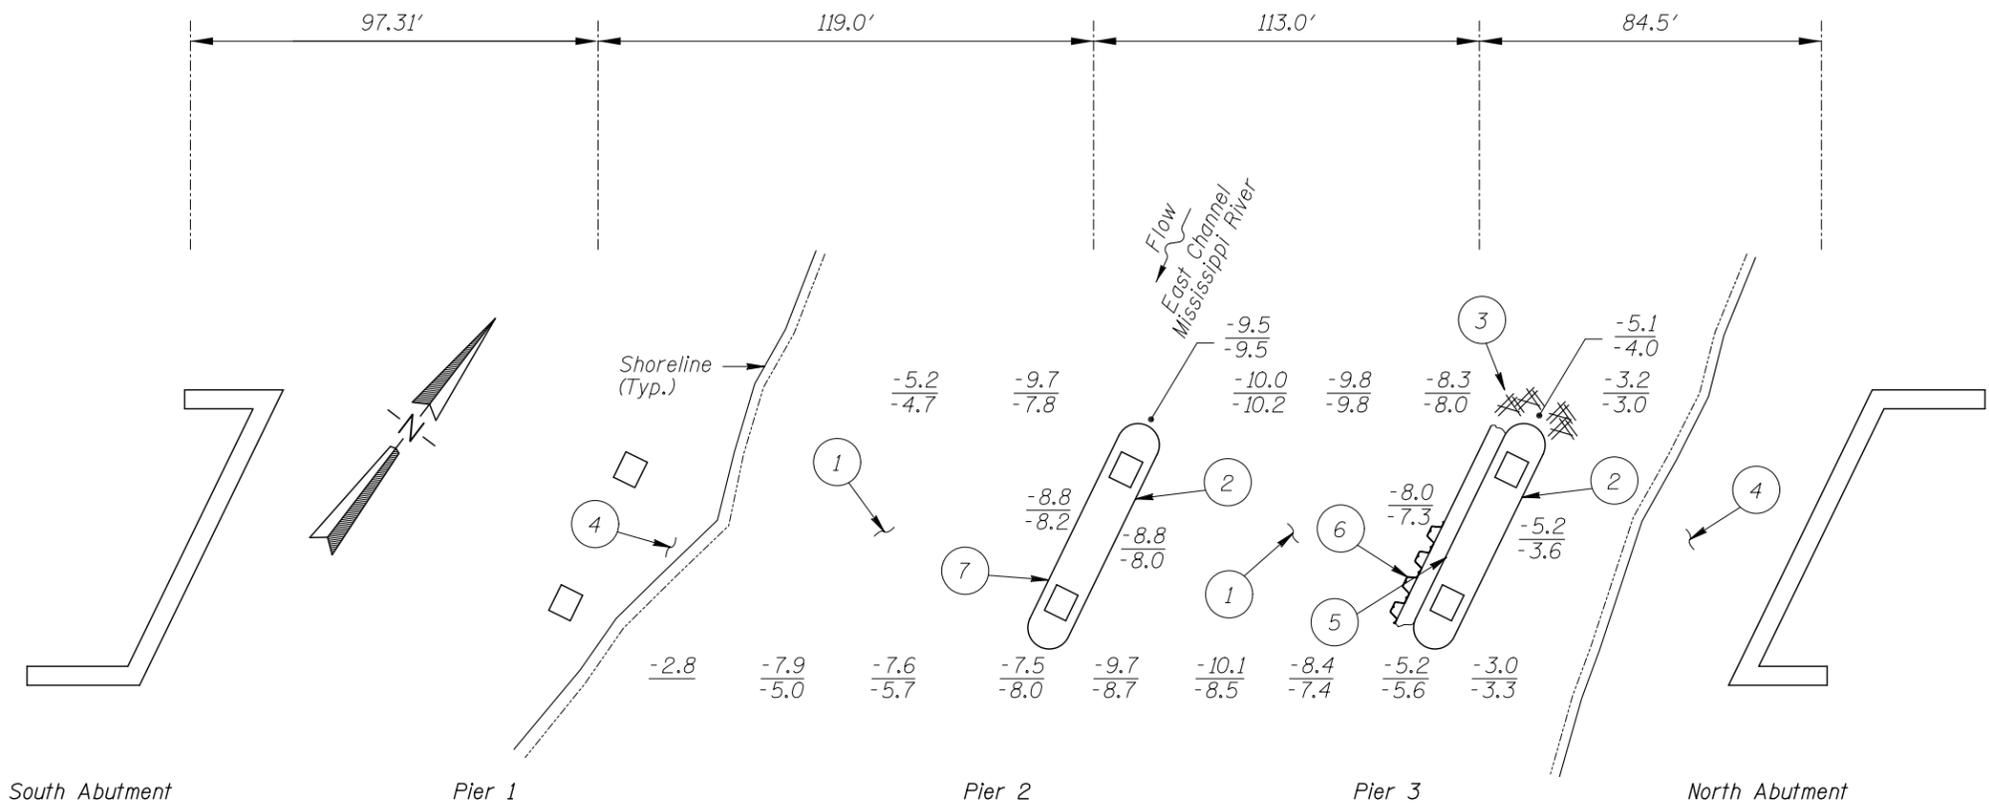
SOUNDING PLAN

- 1 The channel bottom consisted of silty sand and scattered cobbles with up to 1 foot of probe rod penetration.
- 2 The concrete piers exhibited light scaling from 1.5 foot above to 1 foot below the waterline.

- 3 A light accumulation of timber debris, consisting of 1 foot-diameter logs and branches, was observed at the upstream end of Pier 3.
- 4 Both embankments were well armored with grouted riprap.

- 7 Vertical cracks (1/16 inch maximum width) were observed along east face (5 cracks) and west face (3 cracks) of Pier 2, extending from channel bottom to top of pier shaft.
