UNDERWATER BRIDGE INSPECTION REPORT

STRUCTURE NO. 27549

42ND AVENUE

MINNESOTA DEPARTMENT OF TRANSPORTATION
UNDERWATER BRIDGE INSPECTION

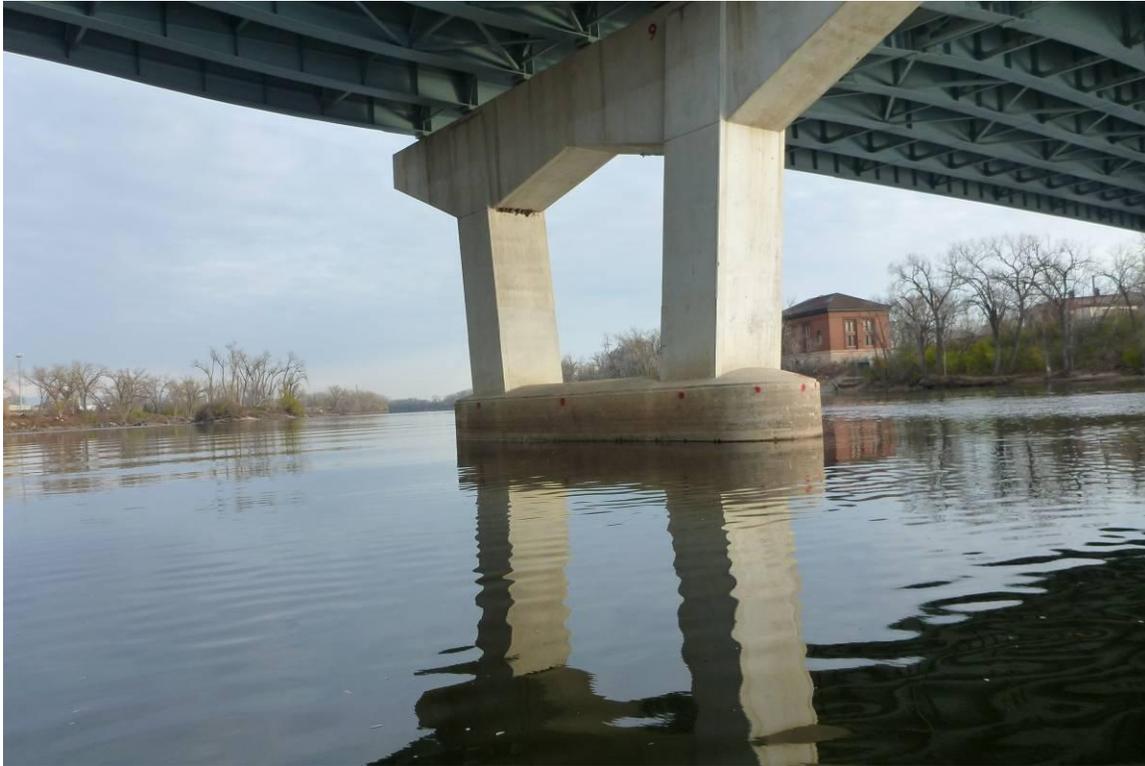
- (B) The top of the footing around the entire perimeter of Pier 9 was exposed with vertical face exposure between 1 foot at the upstream west corner, 2 to 4 inches along the downstream face, and a maximum of 2.5 feet along the west face.

- (C) An 18 inch diameter log was observed on the channel bottom at the upstream end of Pier 9.
- (D) A log that was 18 inches in diameter and 30 feet long was observed on the channel bottom along the east face of Pier 9.

to the waterline on the west face of Pier 9.

Photograph 2. View of Pier 9, Looking Northeast.

- (A) Monitor the timber debris at Pier 9 and 10, and if found to be increasing in the future, removal operations may become warranted.
- (B) Monitor the footing exposure at Pier 9 during future underwater inspections. The scour evaluation indicates that the pier foundations are stable for the calculated scour conditions.
- (C) Reinspect the submerged substructure units at the normal maximum recommended (NBIS) interval of sixty (60) months.

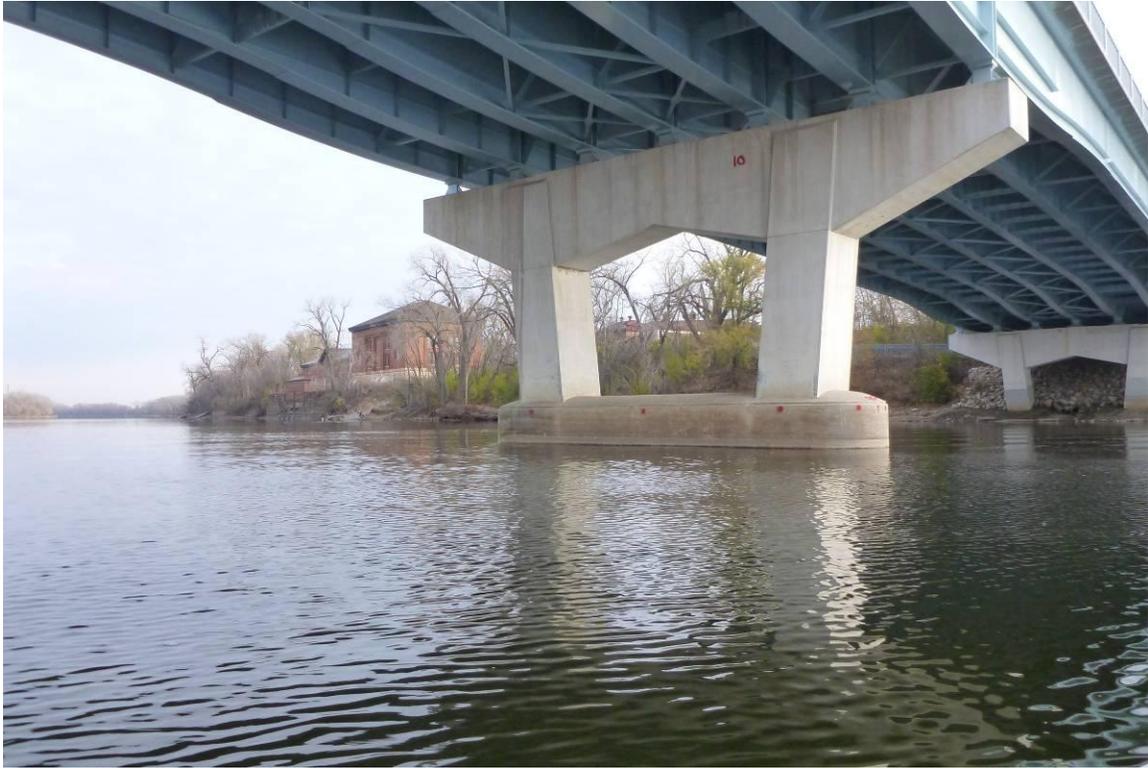
- (E) Numerous vertical hairline cracks were observed extending from the top of the webwall to the waterline on both faces of Piers 9 and 10.
- (F) The channel bottom material around of Pier 10 consisted of 1 to 3 foot diameter riprap with sand infilling that allowed up to 8 inches of probe rod penetration.

Photograph 3. View of Pier 10, Looking Northeast.

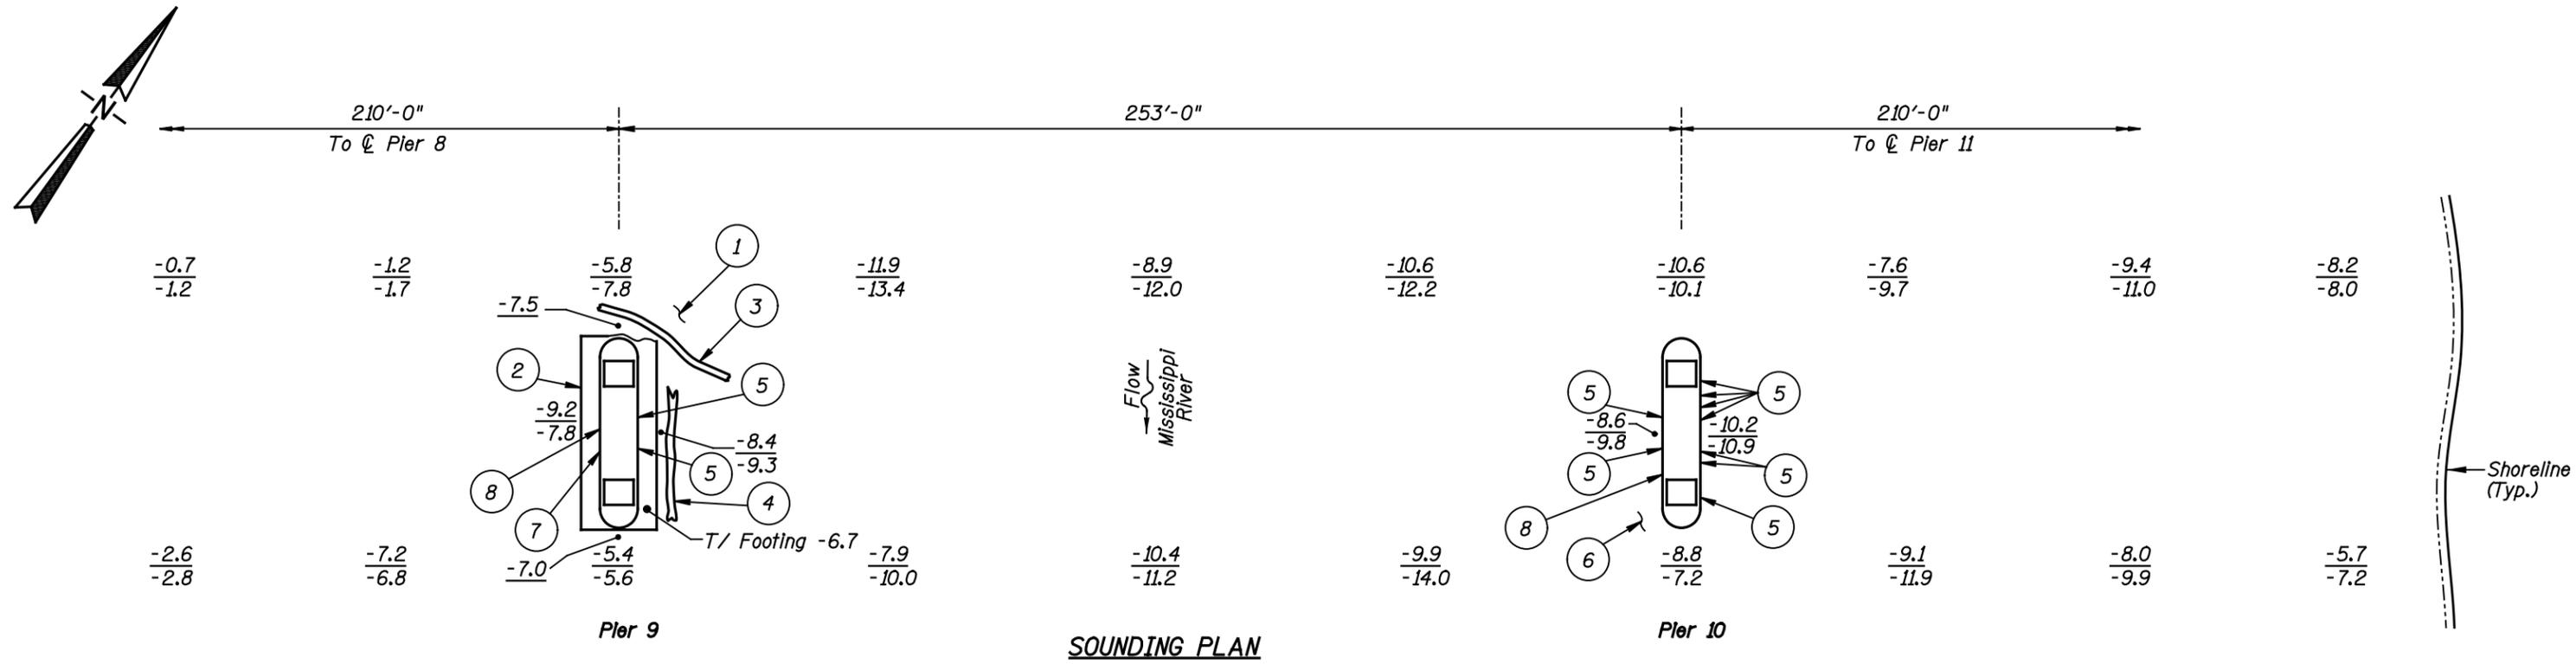
SOUNDING PLAN

- 1 The channel bottom material around Pler 9 consisted of riprap up to 1 foot in diameter at the upstream nose and sand infilling around the rest of the pier that allowed up to 1.5 foot of probe rod penetration.

- 2 The top of the footing around the entire perimeter of Pler 9 was exposed with vertical face exposure between 1 foot at the upstream west corner, 2 to 4 inches along the downstream face, and a maximum of 2.5 feet along the west face.

- 3 An 18 inch diameter log was observed on the channel bottom at the upstream end of Pler 9.
- 4 A log that was 18 inches in diameter and 30 feet long was observed on the channel bottom along the east face of Pler 9.

- 5 Numerous vertical hairline cracks were observed extending from the top of the webwall to the waterline on both faces of Piers 9 and 10.
- 6 The channel bottom material around of Pler 10 consisted of 1 to 3 foot diameter riprap with sand infilling that allowed up to 8 inches of probe rod penetration.

- 7 A vertical 1/8 inch wide crack was observed extending from the top of the webwall to the waterline on the west face of Pler 9.
- 8 Overall, the concrete of Piers 9 and 10 was smooth and sound with some random minor areas of poor consolidation with 1/4 inch maximum penetration.
