UNDERWATER BRIDGE INSPECTION REPORT

STRUCTURE NO. 27554

CROW RIVER

DISTRICT 5 – HENNEPIN COUNTY

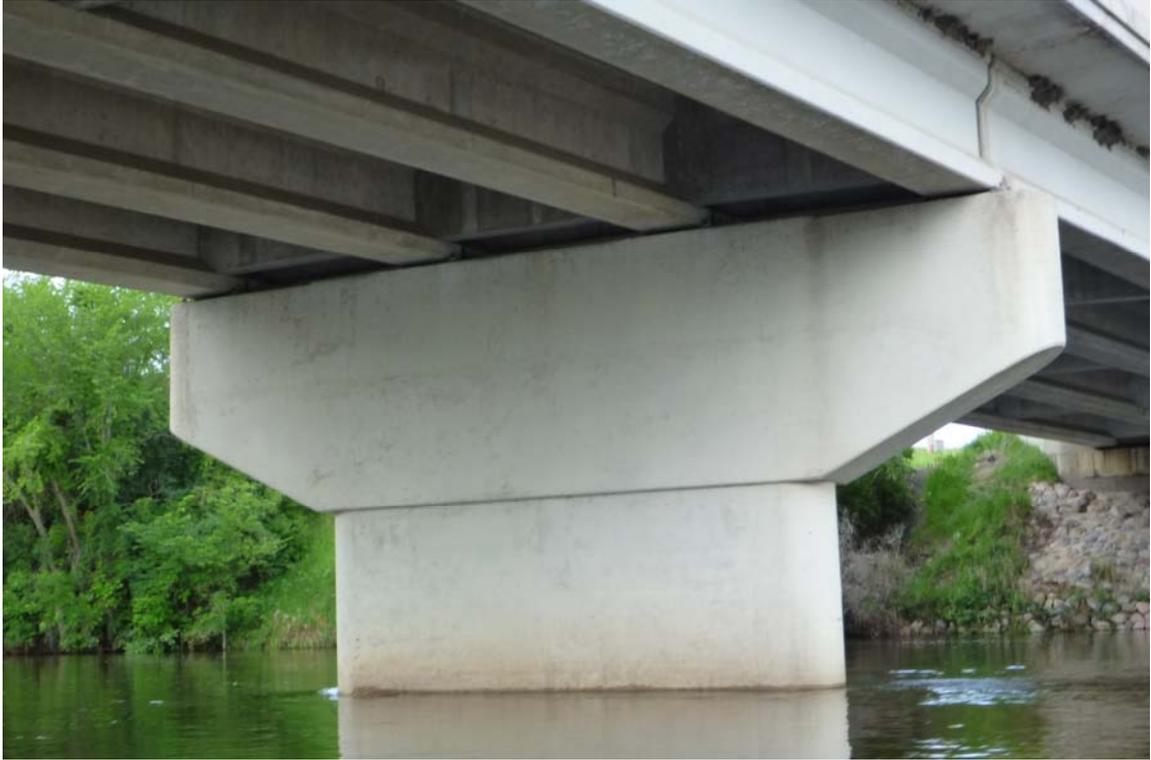
The substructure units inspected at Bridge No. 27554, Piers 1 and 2, were found to be in good condition with no significant structural defects observed. A heavy accumulation of timber debris was observed upstream of Pier 2. The top of footing of Pier 1 was exposed with up to 8 inches of vertical exposure. Heavy erosion of the grouted rip-rap protection was observed along the East Abutment.

Photograph 3. View of Pier 1, Looking Southwest.

- (A) Remove the timber drift that has accumulated around the piers including the large logs on the channel bottom at Pier 2, which could contribute to scour and footing exposure.
- (B) Monitor footing exposure at Pier 1 during future underwater inspections.
- (C) Repair and/or replace the grouted rip-rap erosion protection at the East Abutment.
- (D) Reinspect the submerged substructure at the normal maximum recommended (NBIS) interval of sixty (60) months.

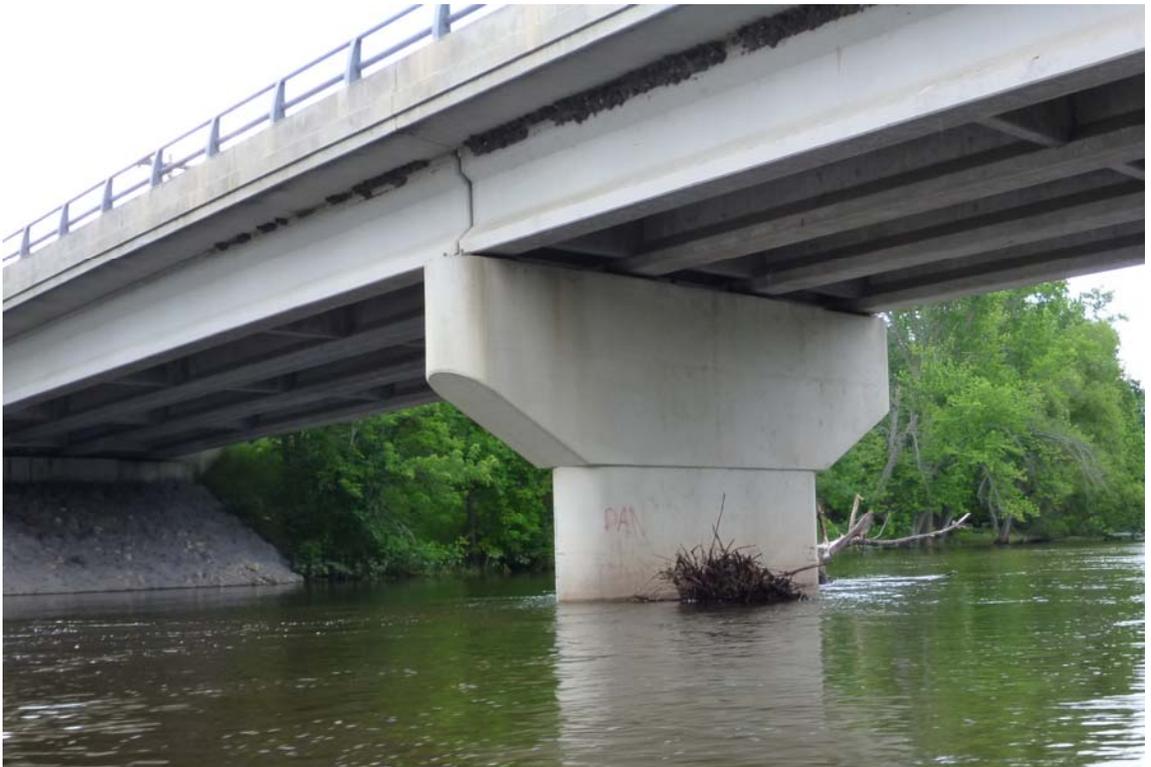
Photograph 4. View of Pier 2, Looking Southeast.

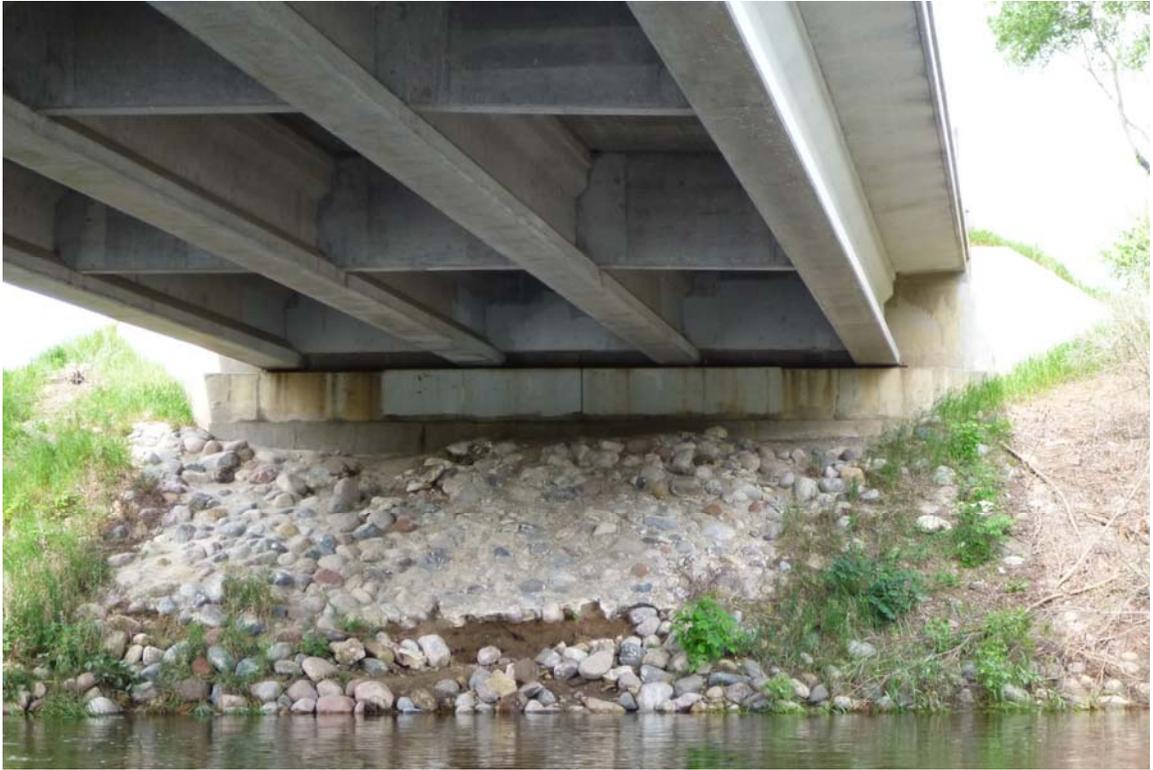
Photograph 5. View of West Abutment, Looking West. Note Erosion of the Grouted Rip-Rap.

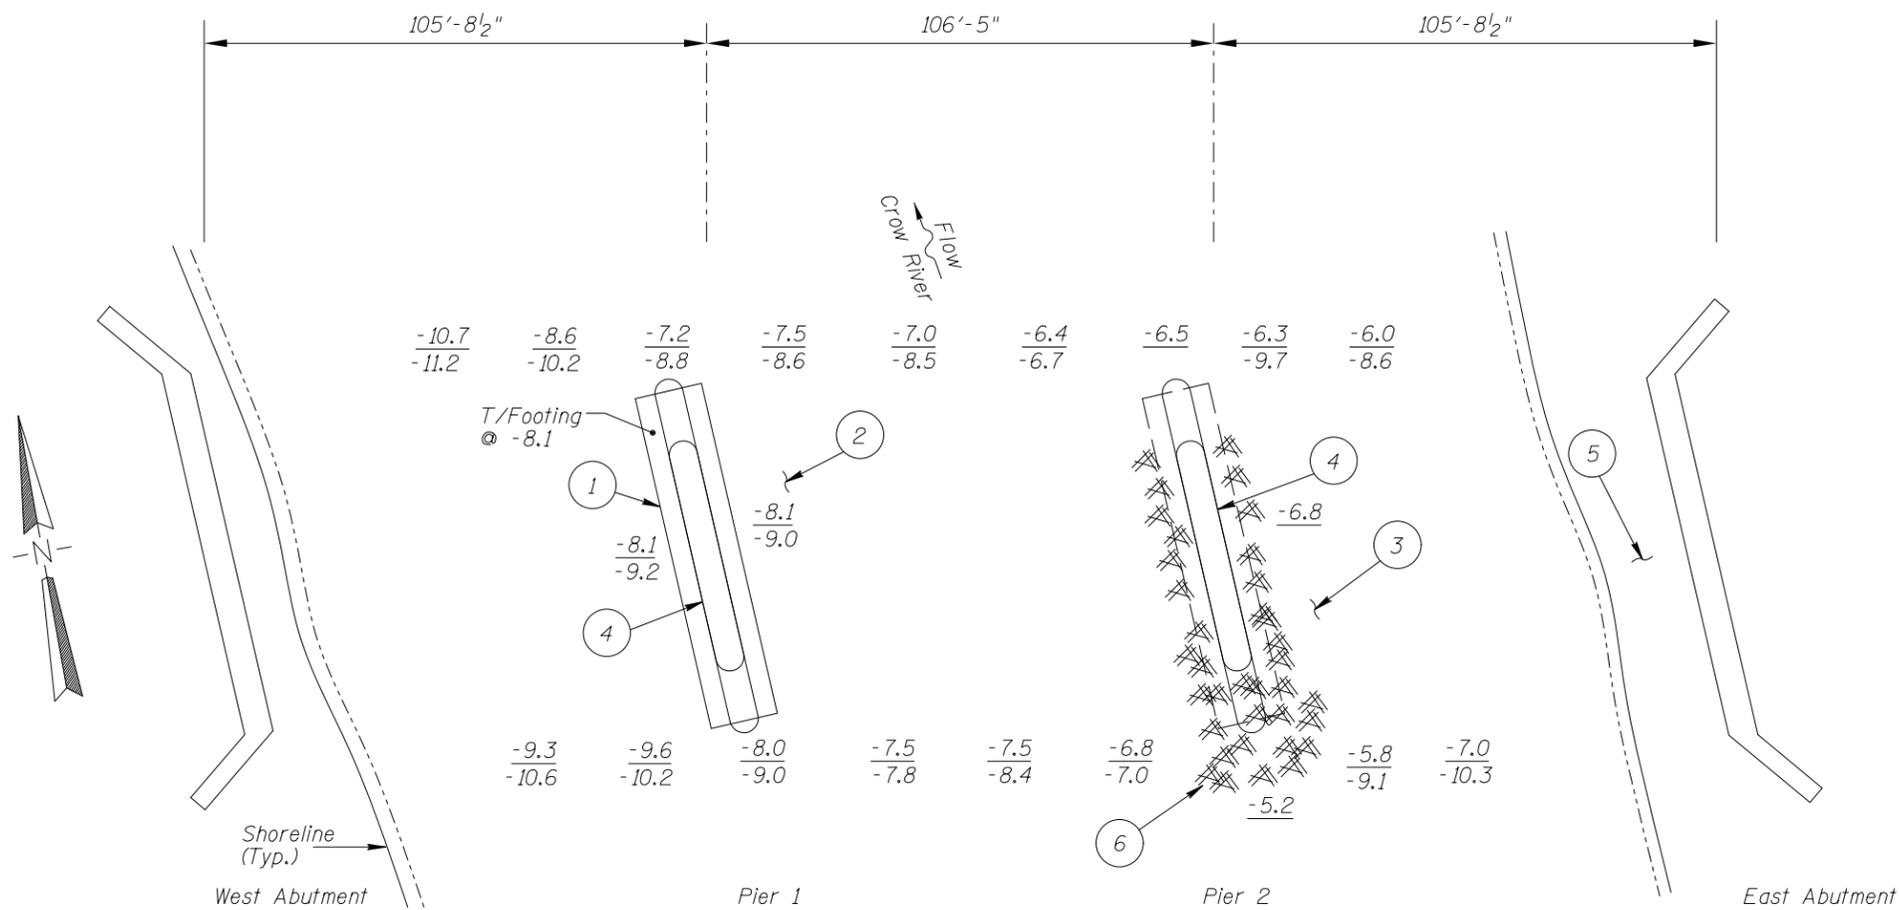
INSPECTION AND SOUNDING PLAN

- 1 The top of footing was exposed at 8.1 feet below the waterline around Pier 1 with up to 8 inches of vertical exposure at the southeast corner.
- 2 The channel bottom at Pier 1 consisted of sand with up to 6 inches of probe rod penetration.
- 3 The channel bottom at Pier 2 consisted of silt with up to 2 feet of probe rod penetration.
- 4 Concrete of Piers 1 and 2 was smooth and sound.
- 5 The grouted rip-rap, up to 18 inches in diameter, that protected the East Abutment exhibited heavy erosion with up to 75 percent loss of cobbles.
- 6 A heavy accumulation of timber debris, consisting of 24-inch-diameter and smaller logs and branches, was observed at the upstream nose and along both faces of Pier 2. The debris extended from the channel bottom to 3 feet above the waterline, 10 feet off of the pier faces and up to 30 feet off of the upstream nose.
