UNDERWATER BRIDGE INSPECTION REPORT

STRUCTURE NO. 27595

ELM CREEK

MINNESOTA DEPARTMENT OF TRANSPORTATION
UNDERWATER BRIDGE INSPECTION

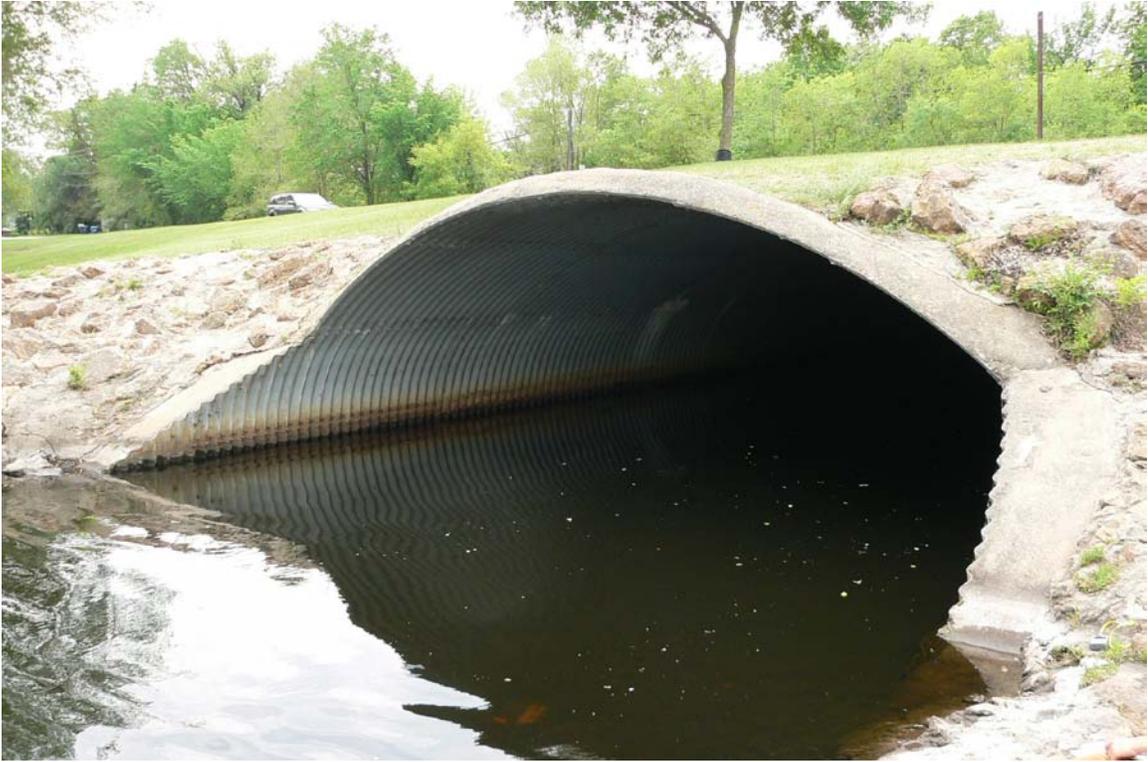
Photograph 1. View of Downstream Opening, Looking Southwest.

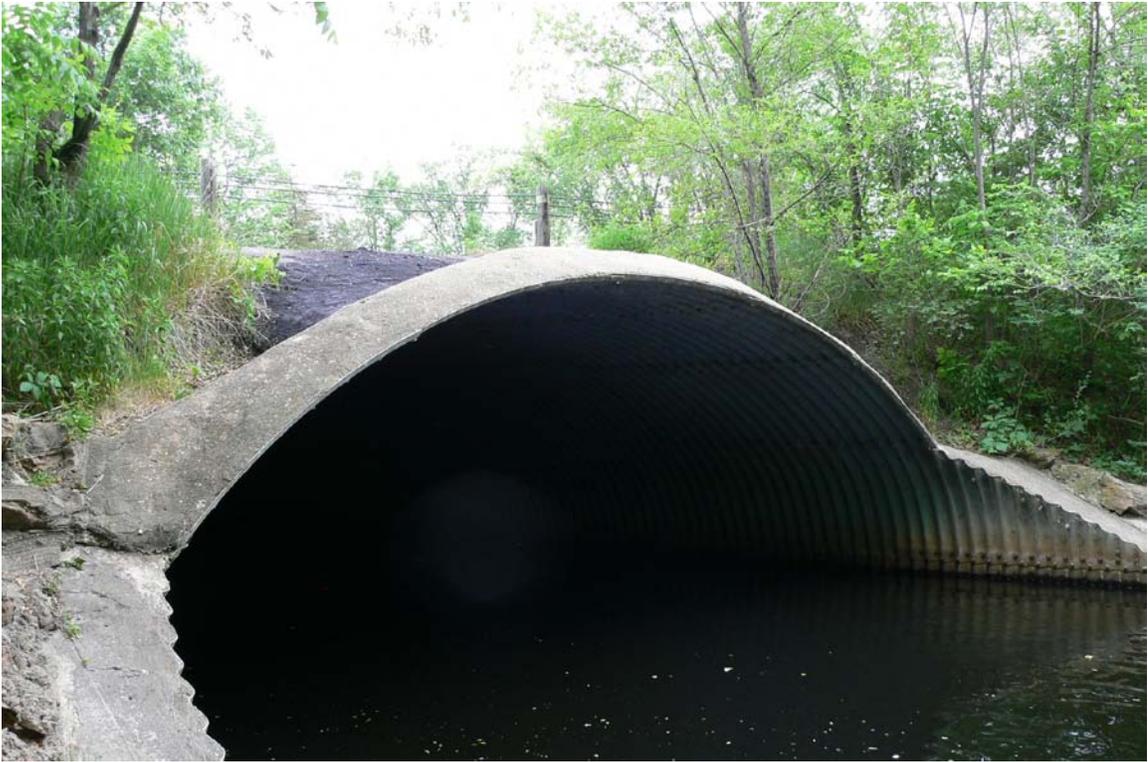
Photograph 2. View of Upstream Opening, Looking Southeast.

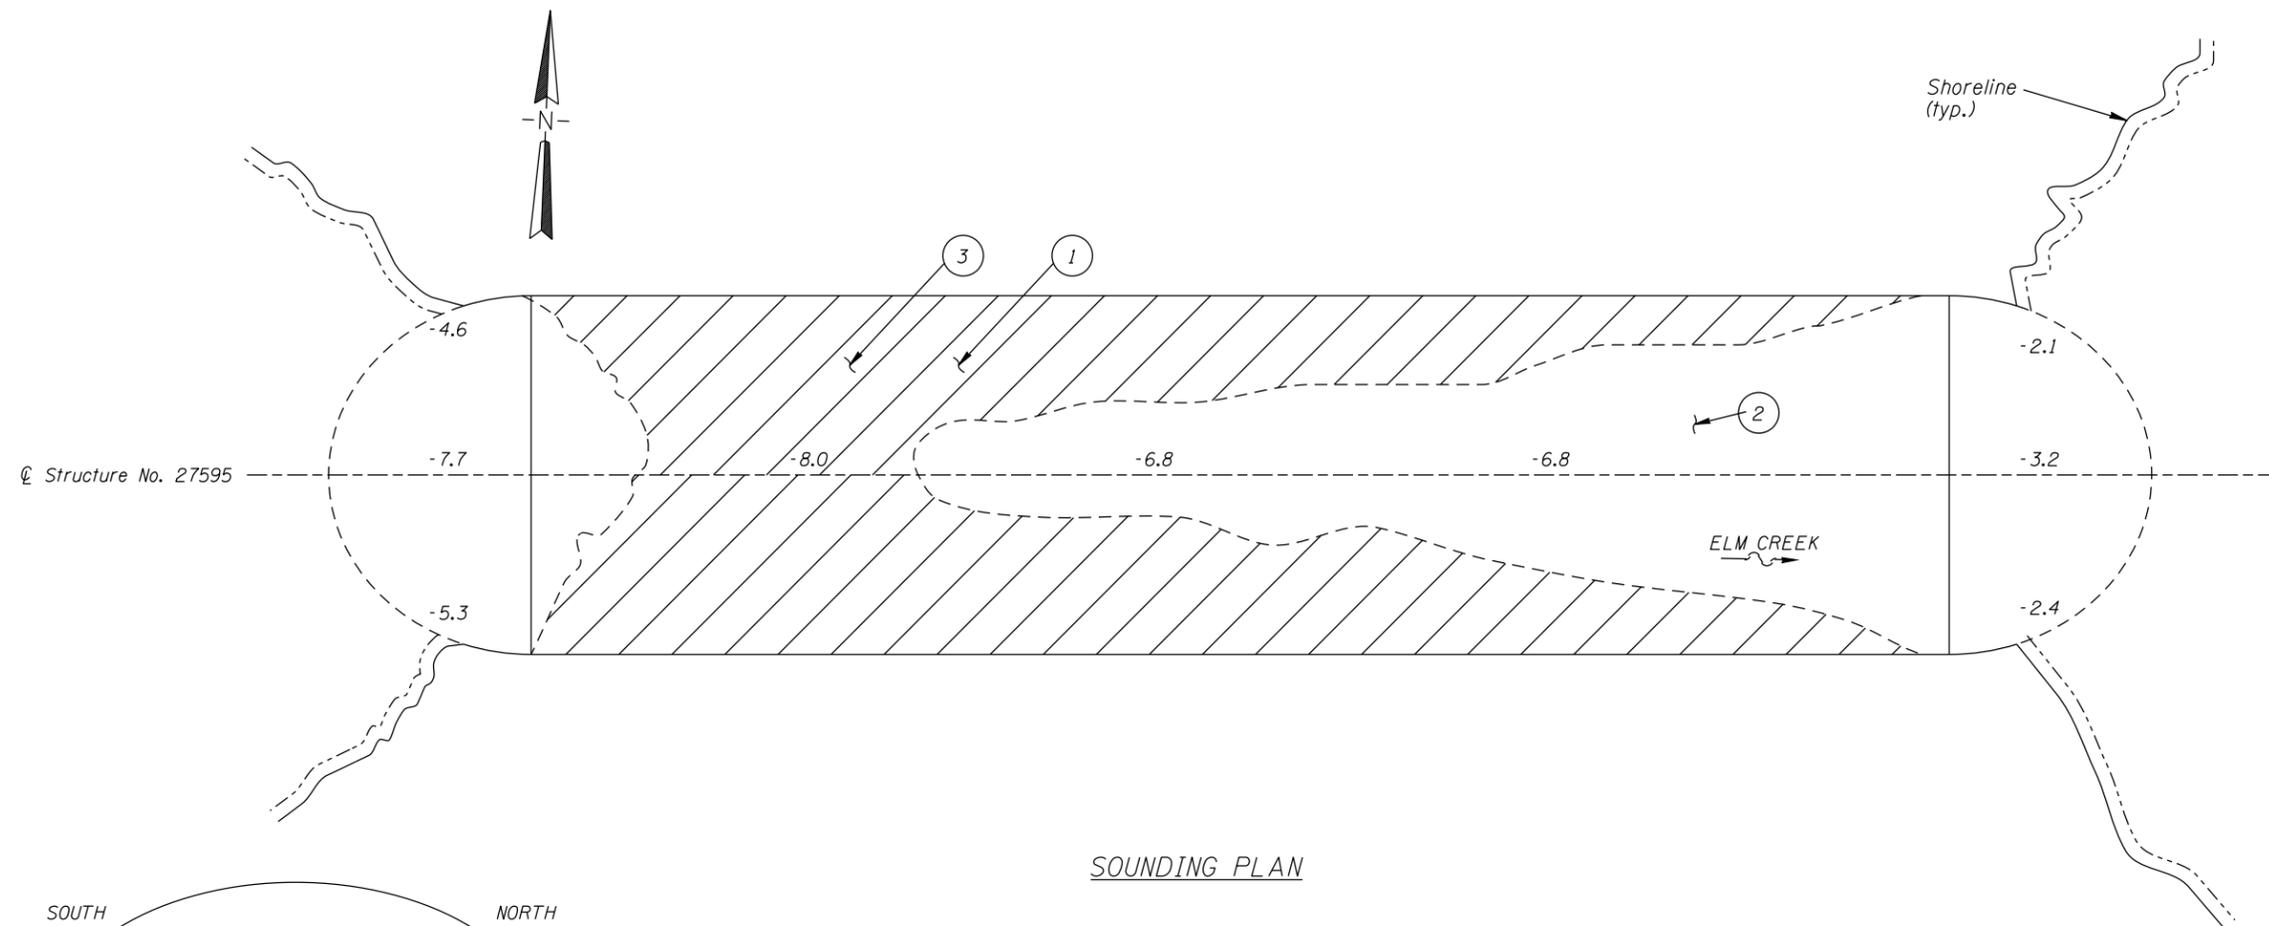
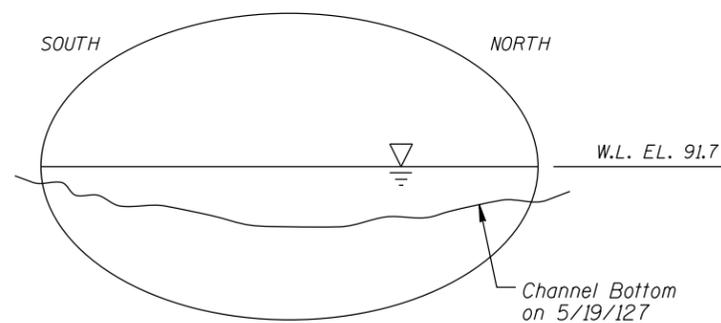
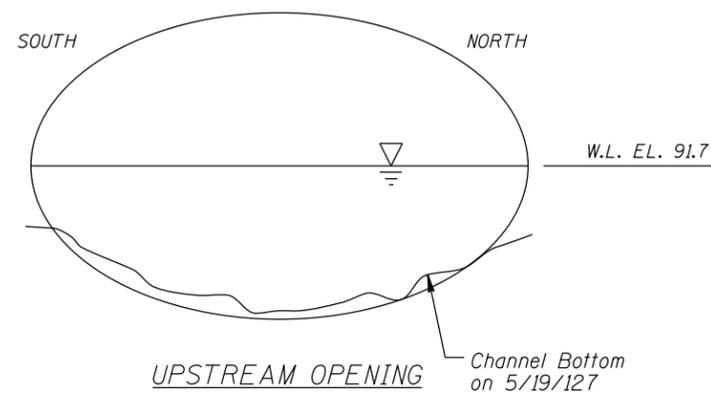
SOUNDING PLAN

- ① Corrugated steel pipe exhibited light corrosion from the waterline to the bottom of the pipe.
- ② The culvert floor was covered by a layer of silty sand, stones, and riprap up to 16 inches in diameter.
- ③ The corrugated steel pipe floor was clean of any debris and/or infill.
