UNDERWATER BRIDGE INSPECTION REPORT

STRUCTURE NO. 27608
BROADWAY AVENUE
OVER
THE MISSISSIPPI RIVER
HENNEPIN COUNTY

OCTOBER 28, 2012
PREPARED FOR THE
MINNESOTA DEPARTMENT OF TRANSPORTATION
BY
COLLINS ENGINEERS, INC.
JOB NO. 7423

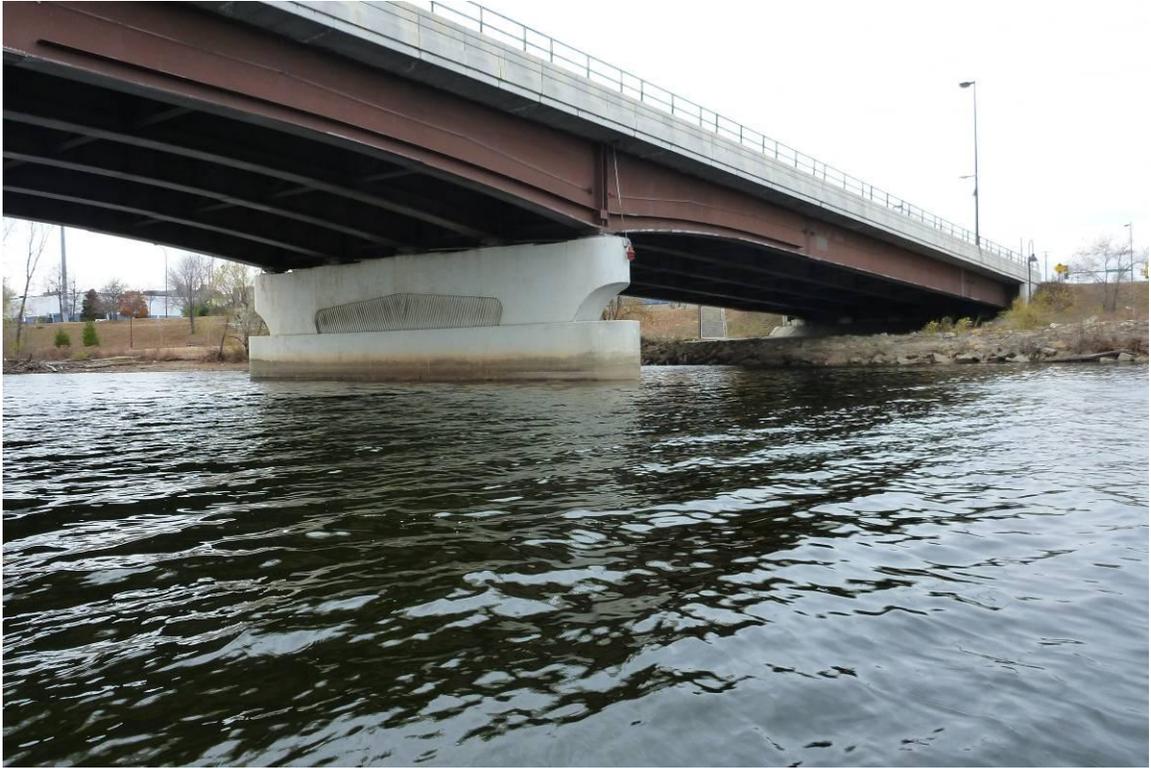
- (B) Vertical crack (1/16 inch wide maximum) extended from the top of the above water step in shaft to the waterline on both sides of Pier 1.
- (C) Timber debris consisting of two tree trunks, 2 feet in diameter, was observed along the east face of Pier 3.

Photograph 1. View of Pier 1, Looking Southwest.

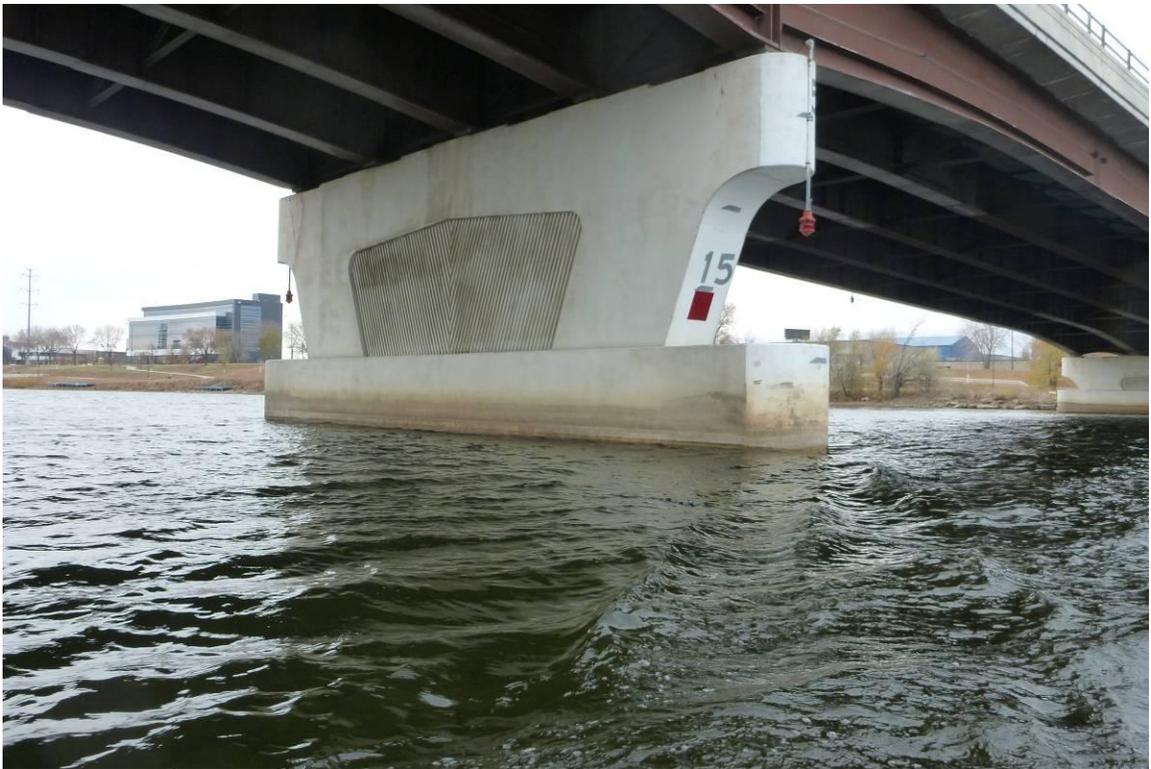
Photograph 2. View of Pier 2, Looking Southwest

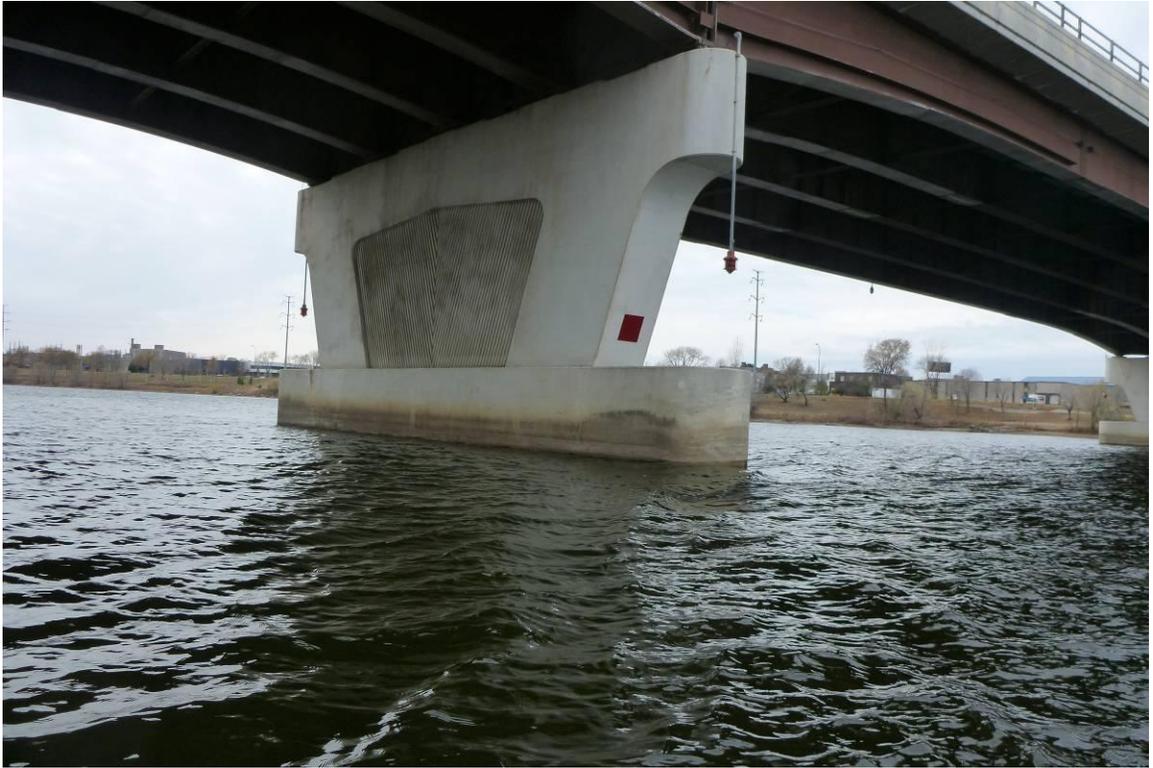
- (F) Vertical cracks (1/16 inch wide maximum) were observed from above water step in shaft to the waterline on the west face of Pier 3.
- (G) Riprap and concrete rubble was observed at the upstream nose of Piers 2 and 3. At

Photograph 3. View of Pier 3, Looking Southwest.

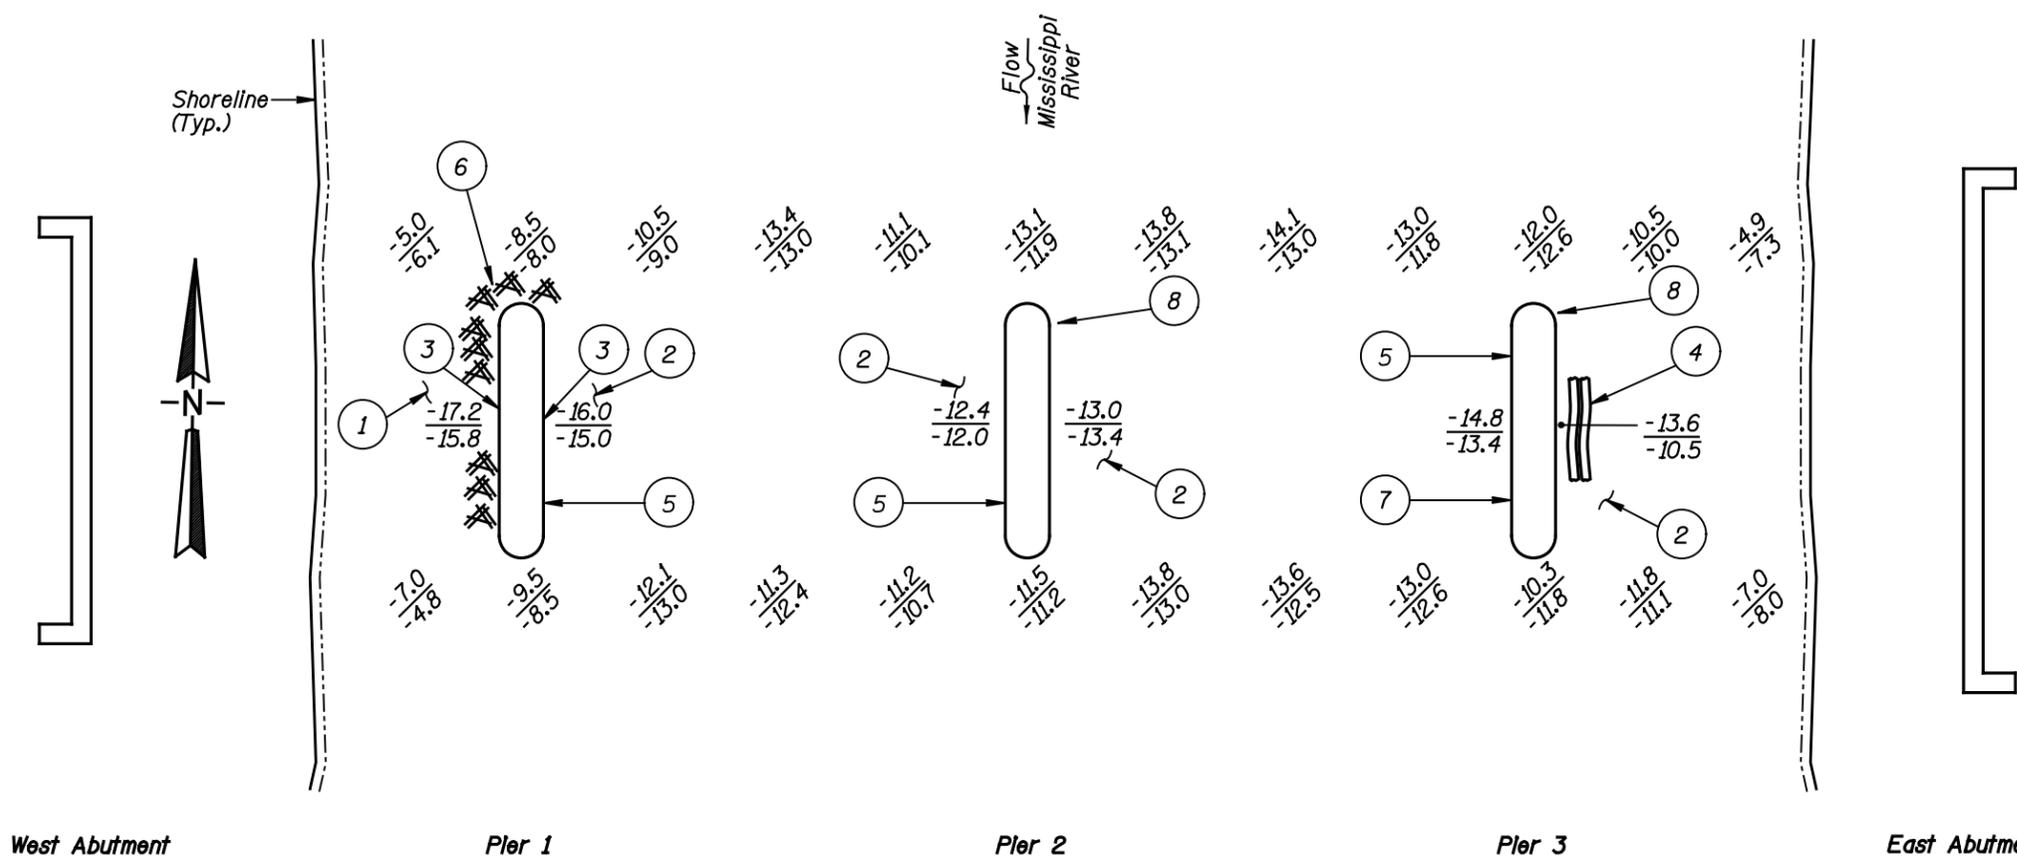
- ① The channel bottom consisted of riprap up to 2 feet in diameter along the west face of Pier 1.
- ② The channel bottom consisted of silty sand with up to 1 foot of probe rod penetration.
- ③ Vertical crack (1/16 inch wide maximum) extended from the pier shaft step to the waterline.
- ④ Timber debris consisting of two tree trunks, 2 feet in diameter, was observed along the east face of Pier 3.
- ⑤ Overall, the concrete was smooth and sound.
- ⑥ Light to moderate accumulation of timber debris located along the upstream nose and the west side of Pier 1 was observed scattered along the channel bottom extending up 4 feet.
- ⑦ Vertical cracks (1/16 inch wide maximum) were observed from the top of the pier shaft step the waterline on the west face of Pier 3.
- ⑧ Riprap and concrete rubble was observed at upstream nose of Piers 2 and 3. At Pier 3, it extended along east side as well.

- (A) Monitor the timber debris accumulations at the piers, and if found to be increasing in the future, removal operations may become warranted.
- (B) Reinspect the submerged substructure units at the normal maximum recommended (NBIS) interval of sixty (60) months.
