UNDERWATER BRIDGE INSPECTION REPORT

STRUCTURE NO. 27639

BRIDGE STREET

CROW RIVER

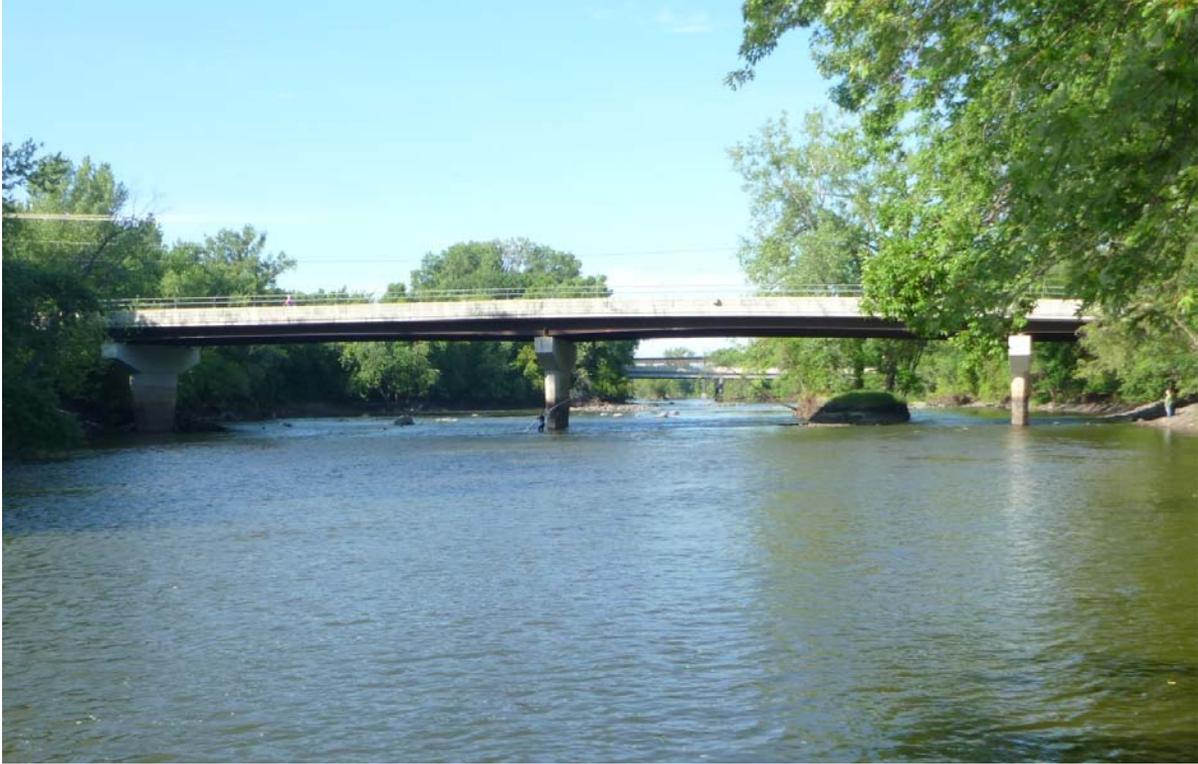
Photograph 1. Overall View of the Structure, Looking South.

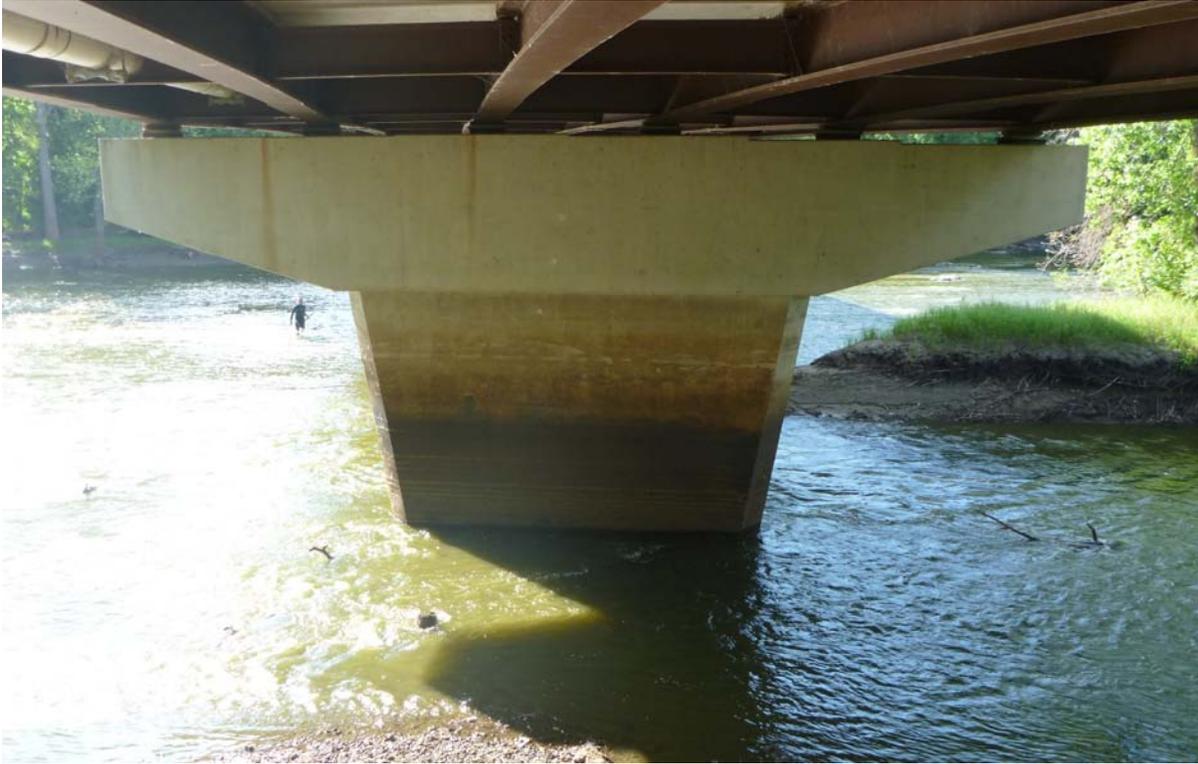
Photograph 2. View of Pier 1, Looking East.

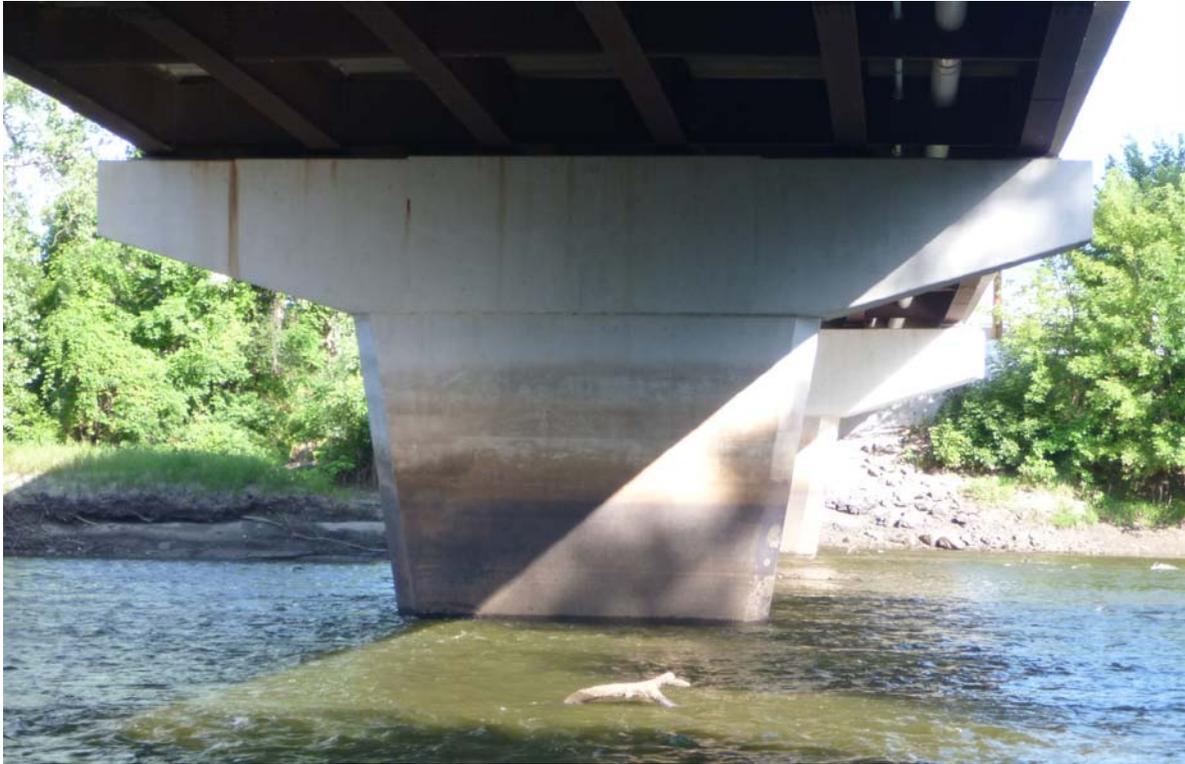
- (A) The concrete of the piers was smooth and sound with no significant deterioration.
- (B) A scour depression 2 feet in radius by 1.5 feet deep was observed at the upstream end of Pier 2.
- (C) Heavy accumulation of timber debris consisting of logs and branches up to 14 inches in diameter was observed at the upstream nose of Pier 3. The debris extended to the midpoint on the east face of the pier, 10 feet upstream of the upstream nose, and from the channel bottom to 4 above the waterline.

Photograph 3. View of Pier 2, Looking West.

- (A) Monitor the scour depression at Pier 2 during future inspections.
- (B) Monitor the timber debris accumulation at Pier 3 during future inspections, and if found to be increasing to a more detrimental extent, removal operations may become warranted at that time.
- (C) Reinspect the submerged substructure units at the normal maximum recommended (NBIS) interval of sixty (60) months.

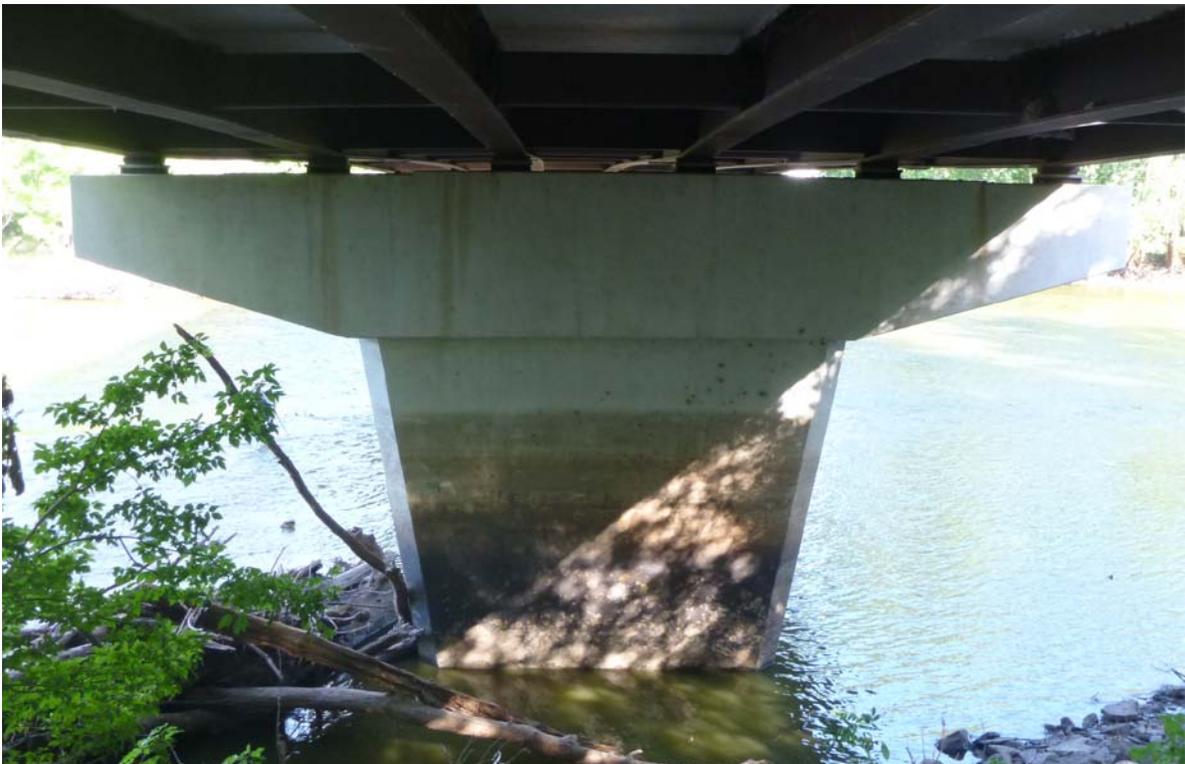
Photograph 4. View of Pier 3, Looking West. Note Timber Debris Accumulation at the Upstream Nose.

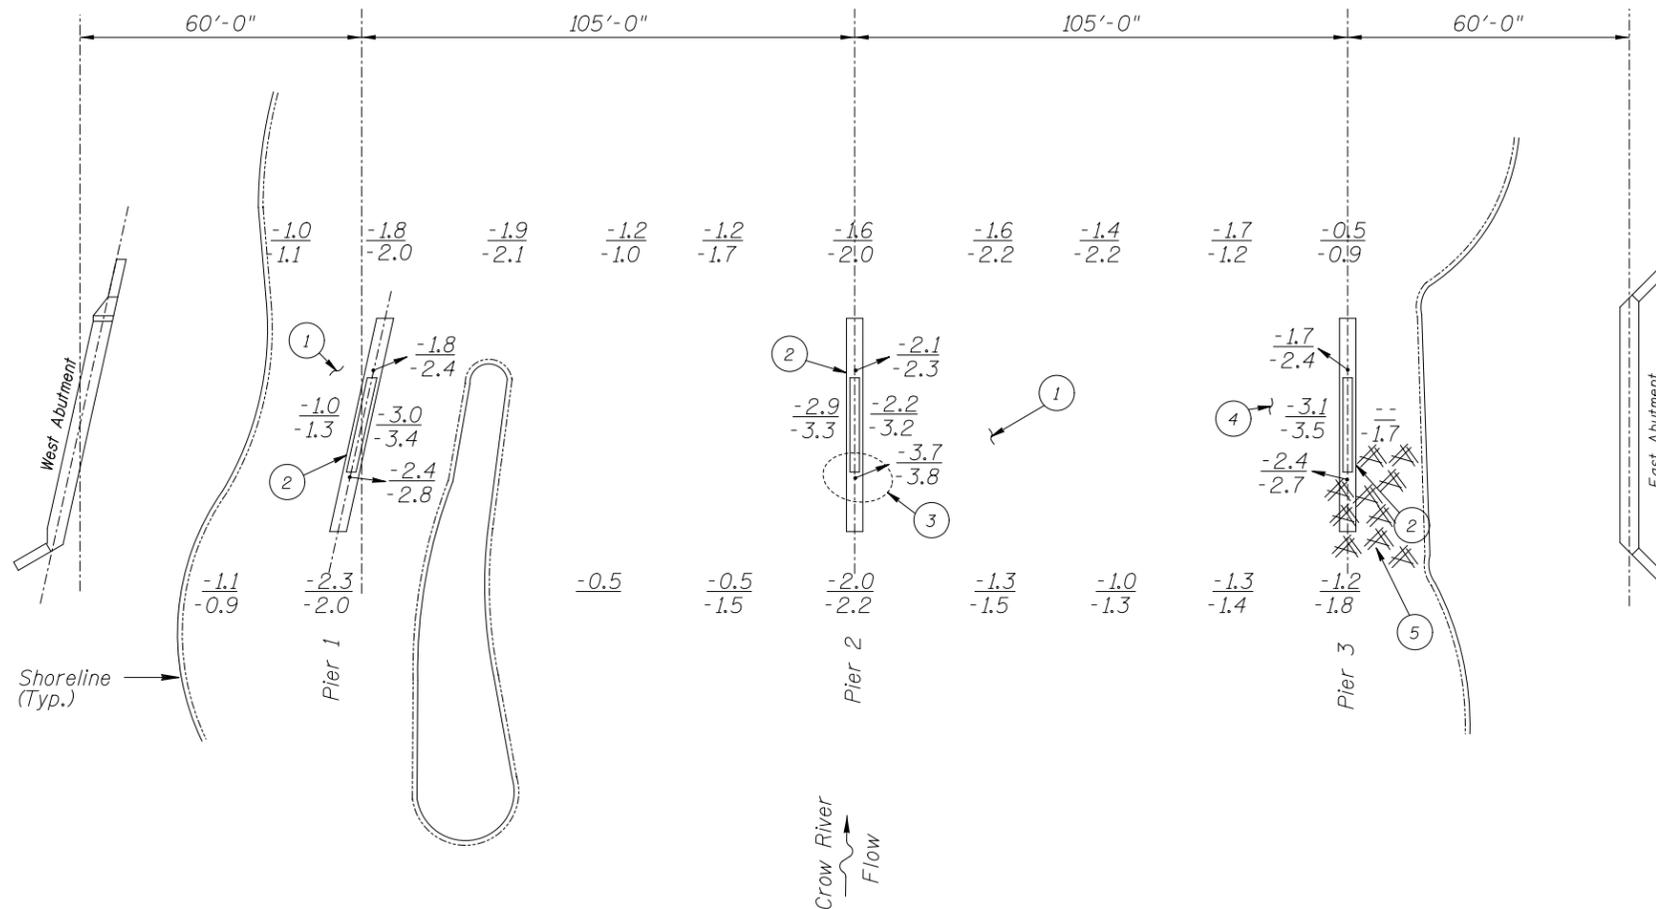
INSPECTION AND SOUNDING PLAN

- 1 The channel bottom around Piers 1 and 2 consisted of 2 feet diameter and smaller rocks with no appreciable probe rod penetration possible.
- 2 Overall, concrete was smooth and sound without notable deterioration.
- 3 A scour depression 2 feet radius by 1.5 feet deep was observed at the upstream end of Pier 2.
- 4 The channel bottom around Pier 3 consisted of gravel with overlaying 2 inches of silt and with up to 3 inches of probe rod penetration.
- 5 Heavy accumulation of timber debris consisting of logs and branches up to 14" in diameter was observed at the upstream nose of Pier 3. The debris extended to the midpoint on the east face to the pier, 10 feet upstream of the upstream nose, and from channel bottom to 4 feet above the water line.
