UNDERWATER BRIDGE INSPECTION REPORT

STRUCTURE NO. 2796

10<sup>TH</sup> AVENUE

OCTOBER 29, 2012

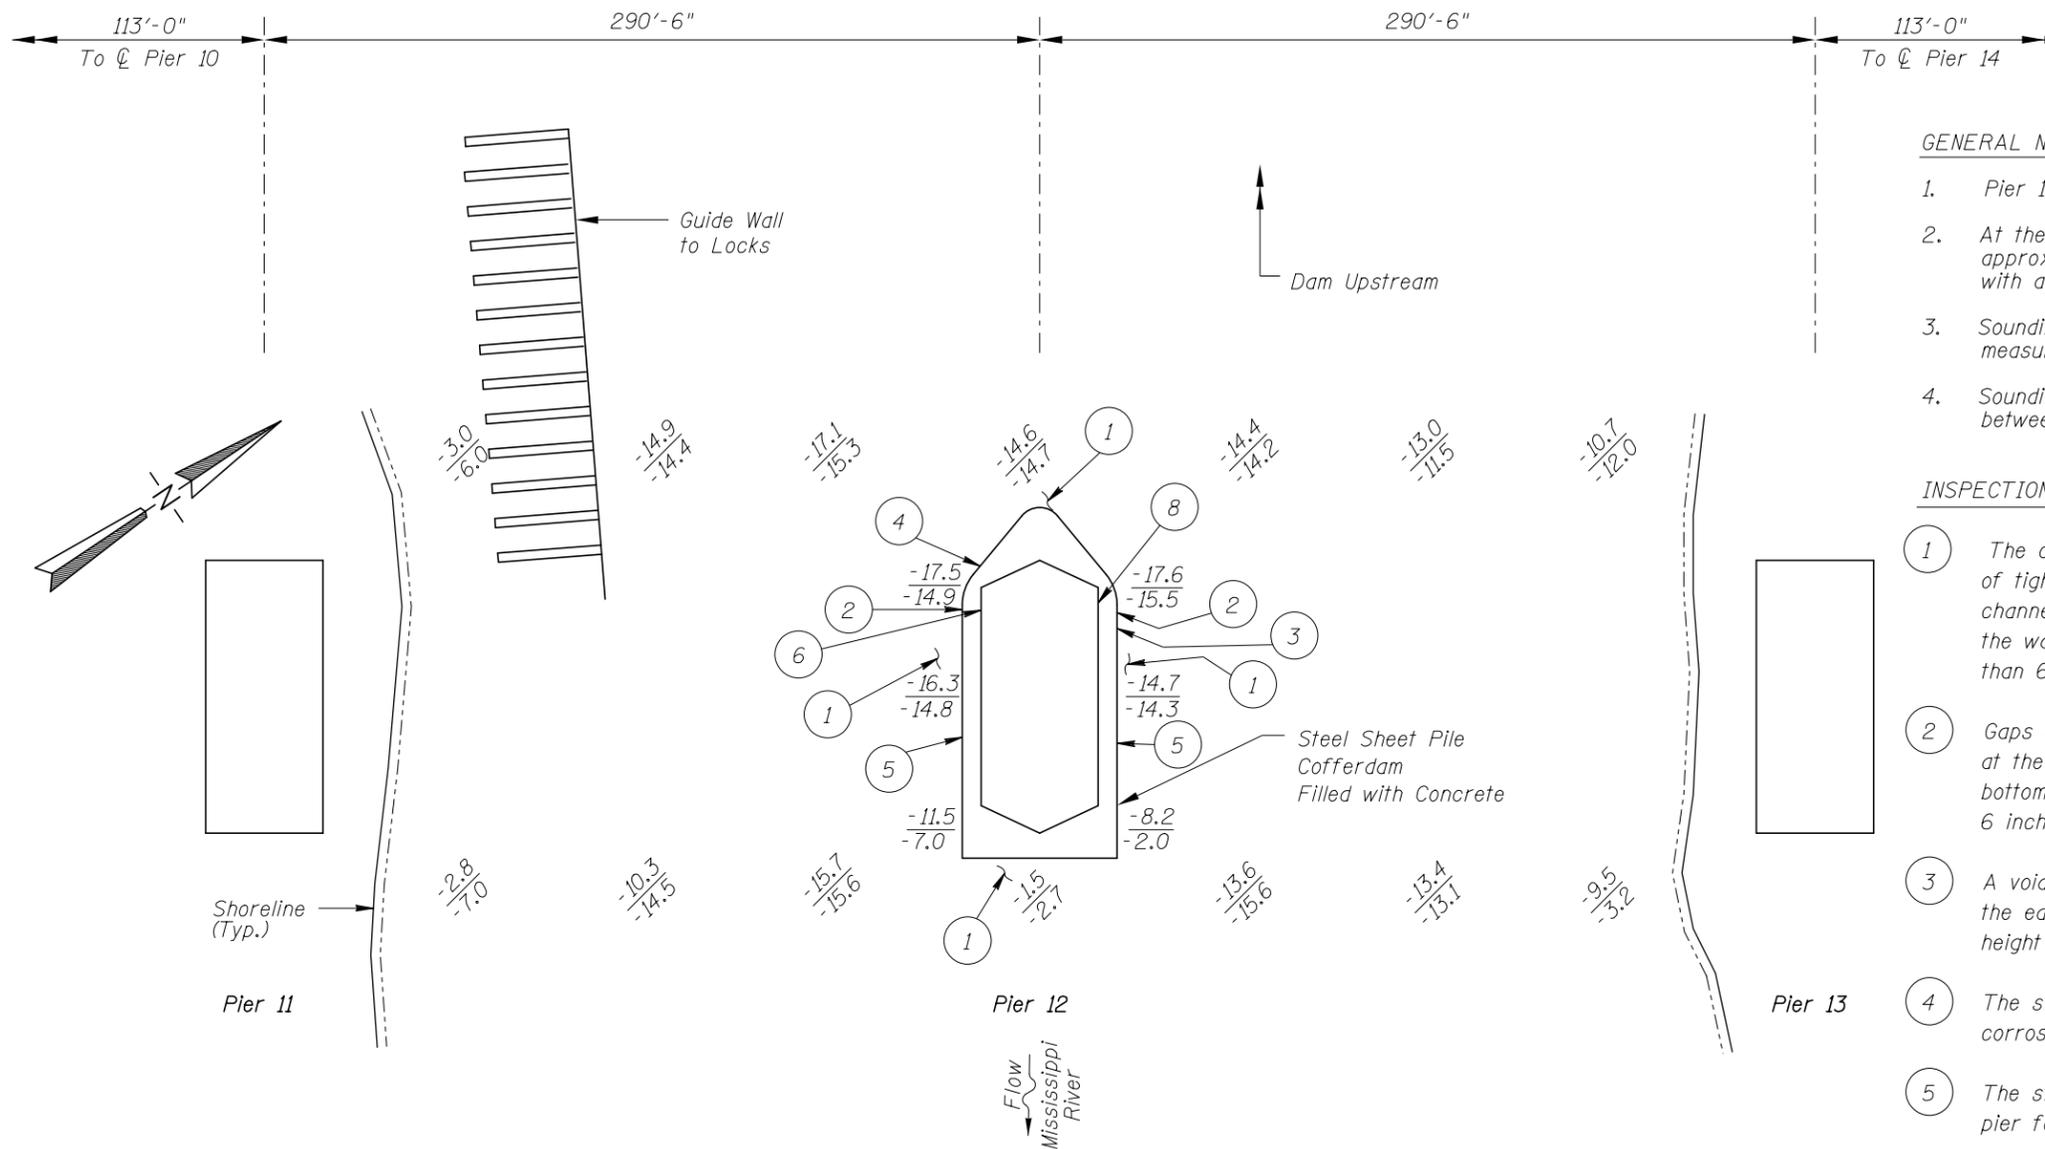
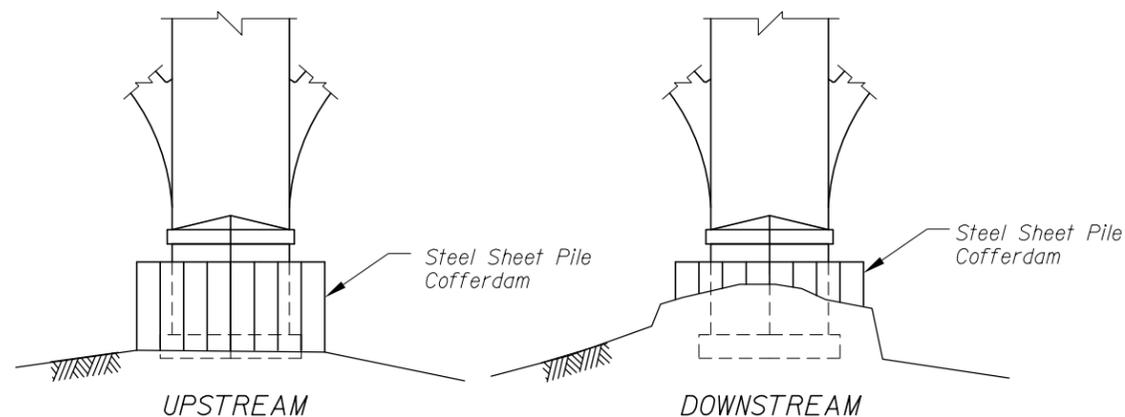
**SOUNDING PLAN**

- ① The channel bottom material, within 10 feet of the substructure unit, typically consisted of tightly packed riprap from 1 foot to 3 feet in size. Along the downstream end, the channel sloped up at a steep angle and was located approximately 2 feet below the waterline, the downstream channel bottom material consisted of cobbles of less than 6 inches in size and riprap from 1 foot to 4 feet in size.

- ② Gaps in the lines of construction (not at interlocks), were observed in the steel sheeting at the east and west upstream 1/4 points with maximum widths located at the channel bottom. The west gap measured 15 inches in width and had a maximum penetration of 6 inches. The east side gap measured 36 inches in width and had no penetration.

- ③ A void between the horizontal C-channels and the vertical sheeting was observed at the east side upstream 1/4 point of the pier at 2.5 feet below the waterline with a height of 2.5 feet and 3.5 feet of maximum penetration.

- ④ The steel sheeting was in good condition with a uniform 1/8 inch layer of surface corrosion extending from the top of the sheeting to the channel bottom.

- ⑤ The steel sheet piling was slightly separated from the concrete around the base of the pier for a length of approximately 20 feet along the east and west sides.

- ⑥ The topside concrete surface within the sheeting was sound, however, gaps/ cracks up to 1 foot maximum width were observed on both east and west sides of Pier 12.

- (A) Reinspect the submerged substructure unit at the normal maximum recommended (NBIS) interval of sixty (60) months.
