UNDERWATER BRIDGE INSPECTION REPORT

STRUCTURE NO. 27A34

MUN. 81 (ENCHANTED LANE)

CHANNEL OF LAKE MINNETONKA

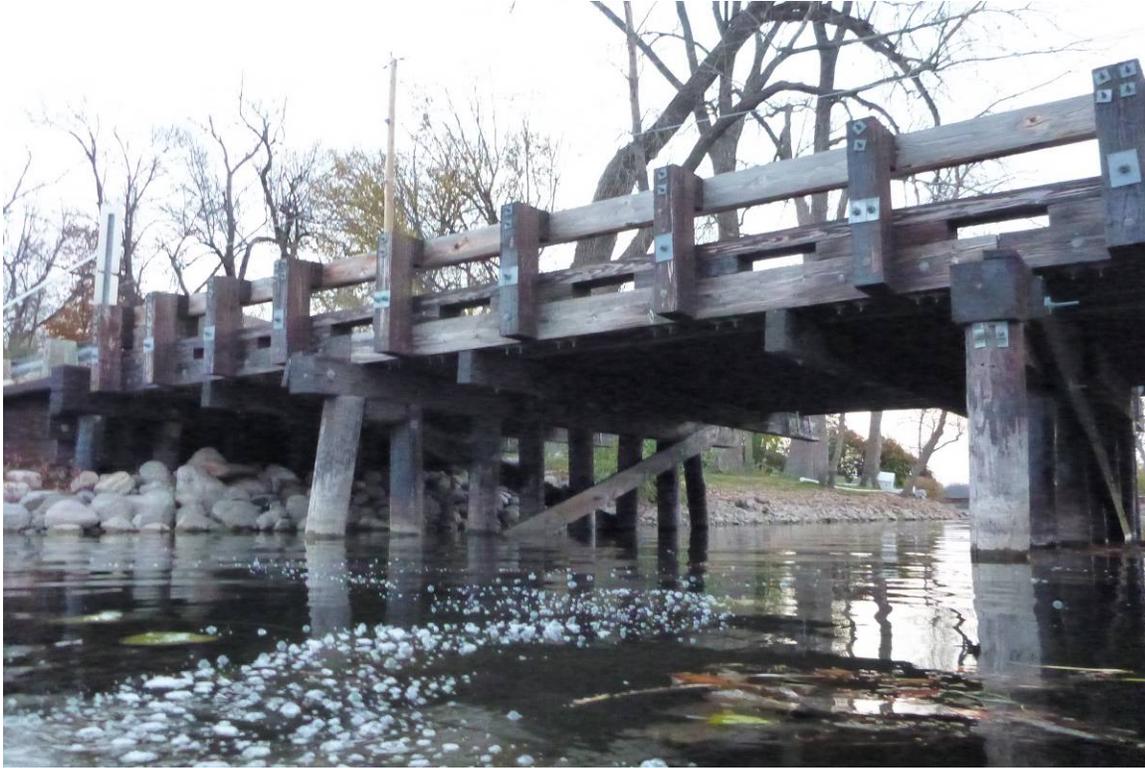
Photograph 1. Overall View of the Structure, Looking Southeast.

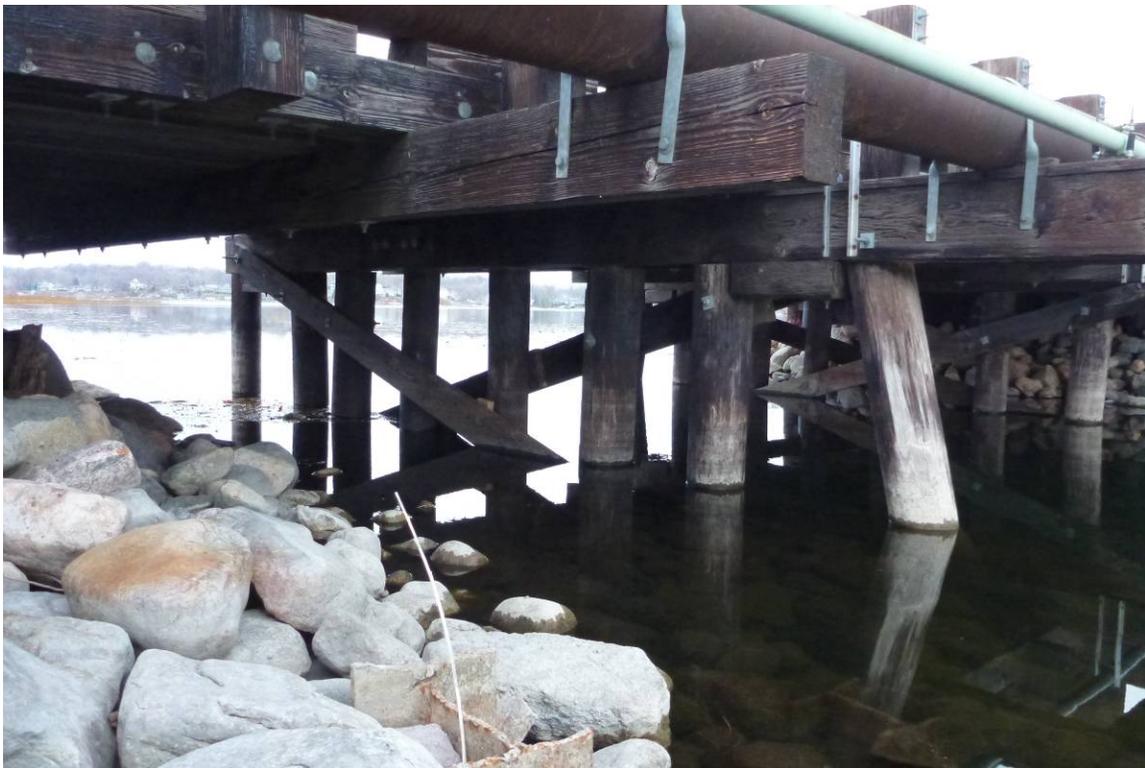
- (A) The channel bottom material consisted of 1 to 2.5 feet diameter riprap.
- (B) Timber piles were generally sound and in good condition with negligible deterioration.

Photograph 2. View of Pier 1, Looking Northeast.

- (A) Reinspect the submerged substructure units at the normal maximum recommended (NBIS) interval of sixty (60) months.

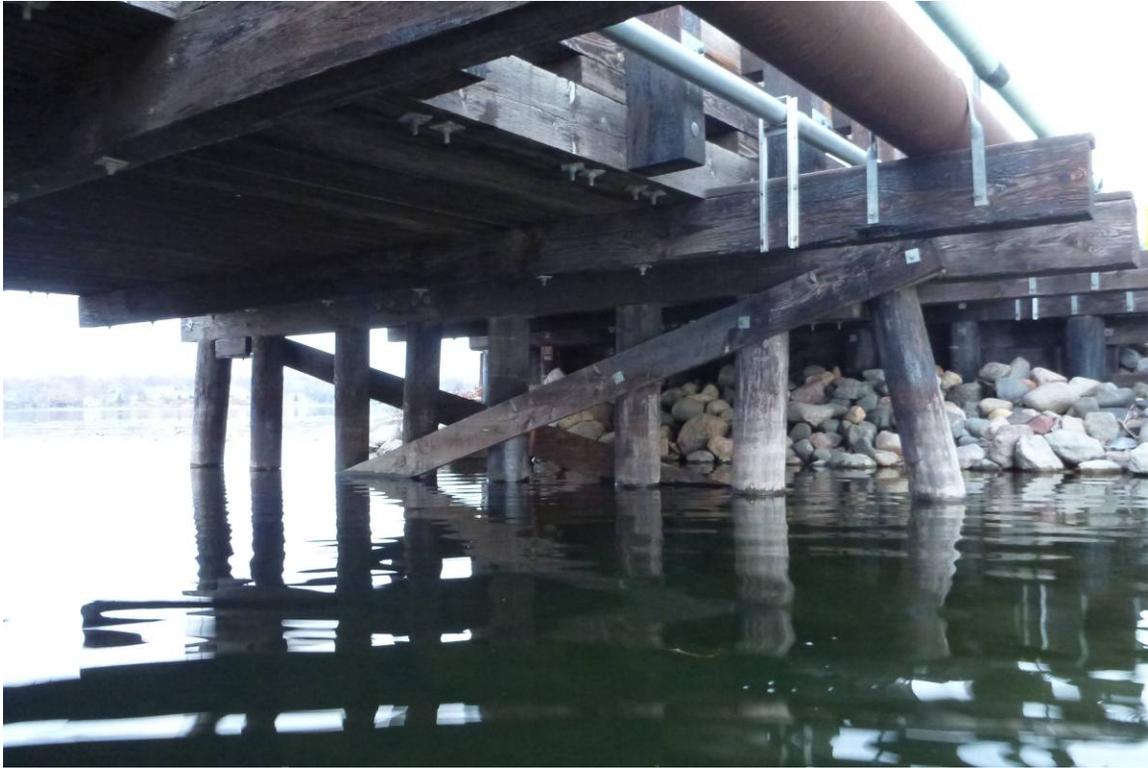
Photograph 3. View of Pier 2, Looking Northeast.

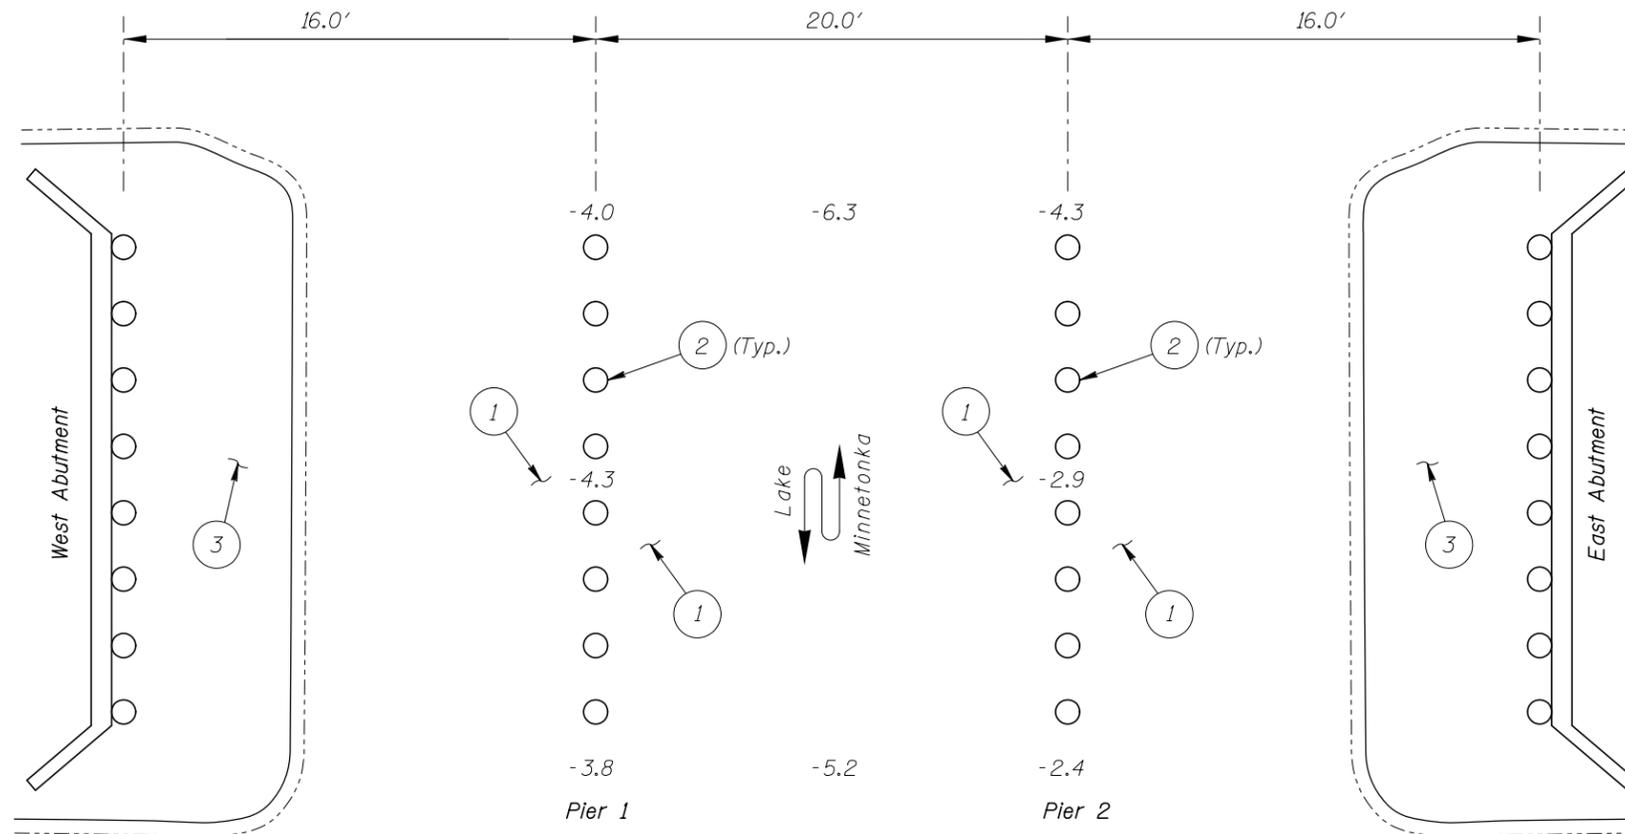
SOUNDING PLAN

- ① The channel bottom material consisted of 1 to 2.5 foot diameter riprap.
- ② The timber piles were generally sound and in good condition with negligible deterioration.
- ③ Large riprap protected both banks in the vicinity of the structure.
