UNDERWATER BRIDGE INSPECTION REPORT

STRUCTURE NO. 3072

PEDESTRIAN BRIDGE

ELM CREEK

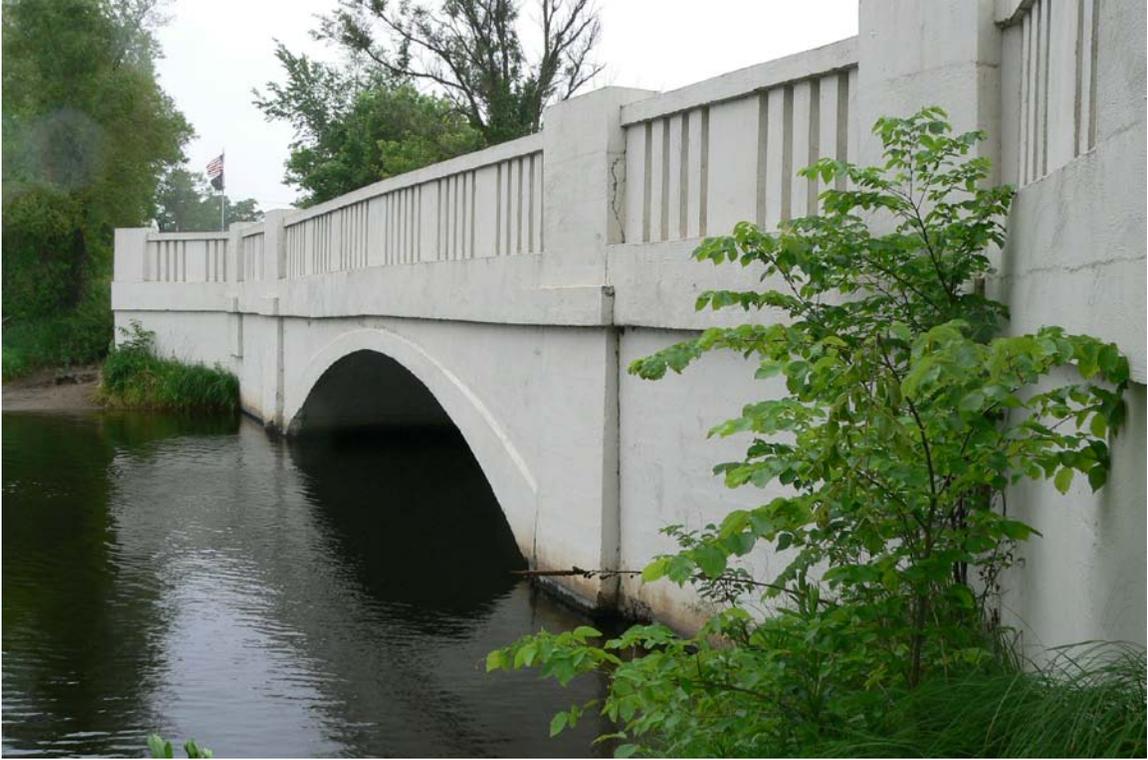
Photograph 1. View of Downstream Fascia, Looking Southwest.

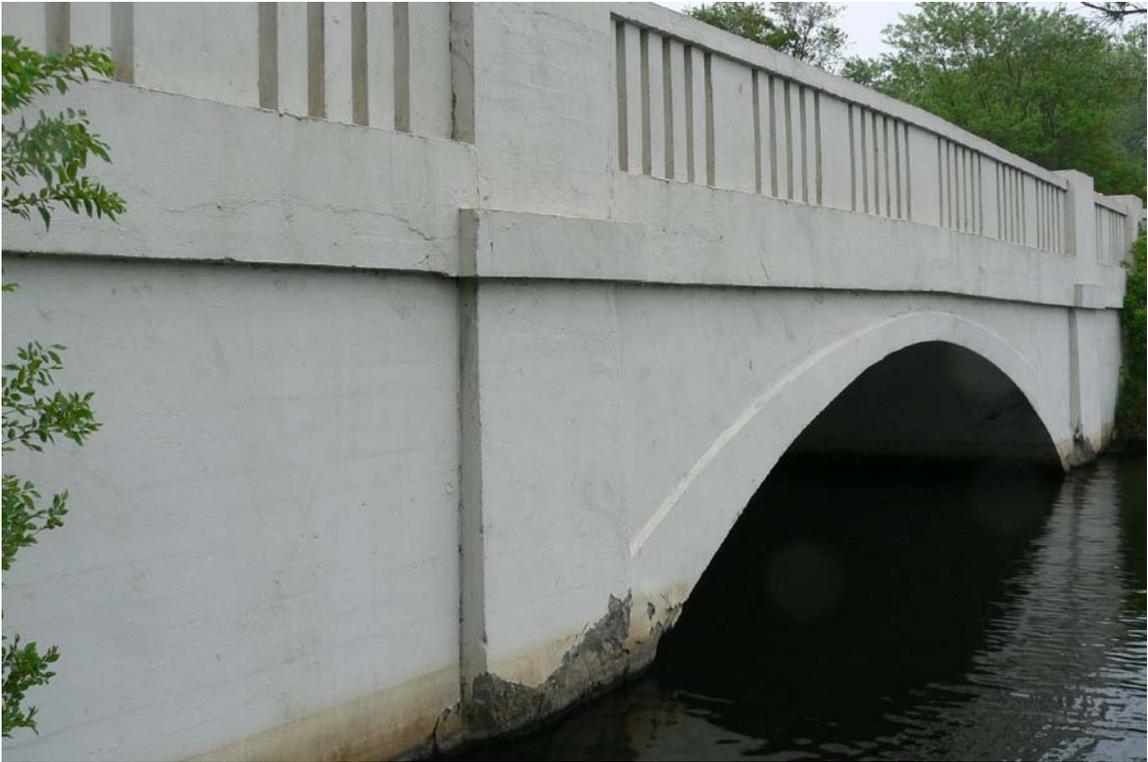
Photograph 2. View of Upstream Fascia, Looking Southeast.

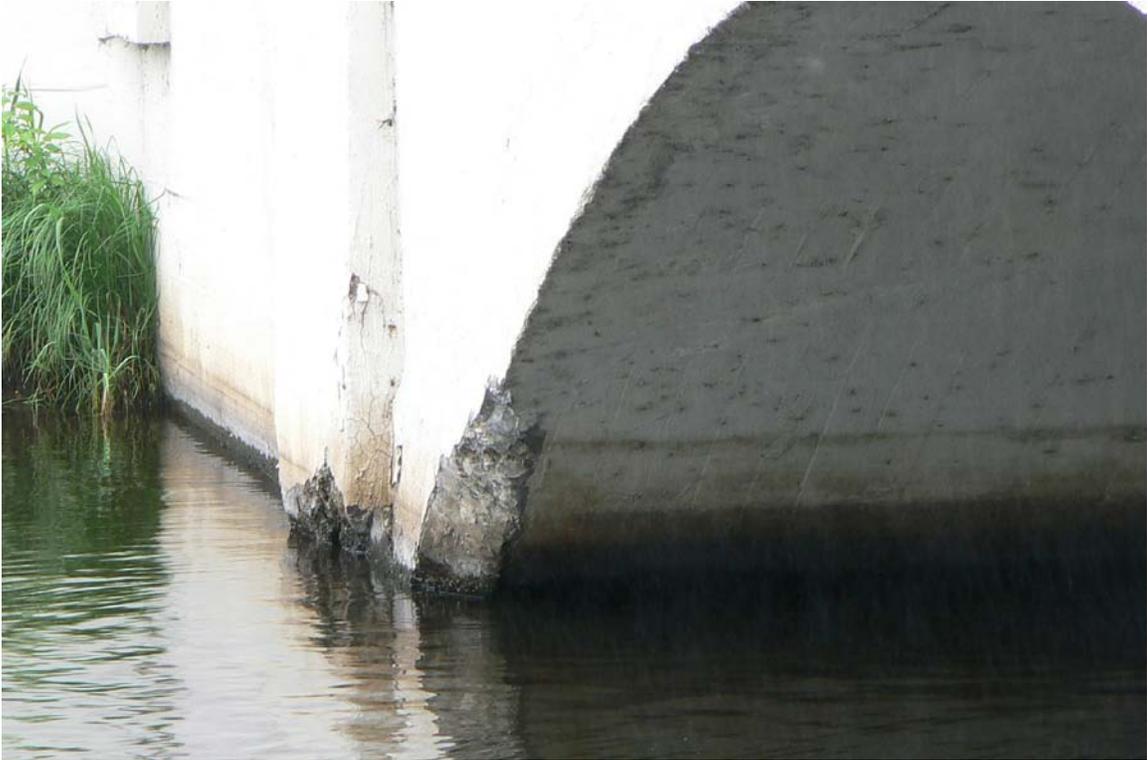
- (C) A 5 foot wide spall extending from 1 foot above the waterline to the channel bottom with typical penetration of 6 inches and a maximum penetration of 1 foot was observed at the upstream and downstream corners of the North Abutment and the downstream corner of the South Abutment. Reinforcing steel was completely exposed at the upstream and downstream corners of the North Abutment with up to 20 percent loss of section and reinforcing steel was partially exposed at the downstream corner of the South Abutment with up to 20 percent loss of section.

Photograph 3. View of Spall at East Corner of the South Abutment, Looking Southwest.

Repair areas of spalled concrete where reinforcing steel is exposed by removing unsound concrete to a minimum of one inch behind reinforcing steel, cleaning and replacing reinforcing steel as required, and placing concrete designed to provide high durability with low permeability.

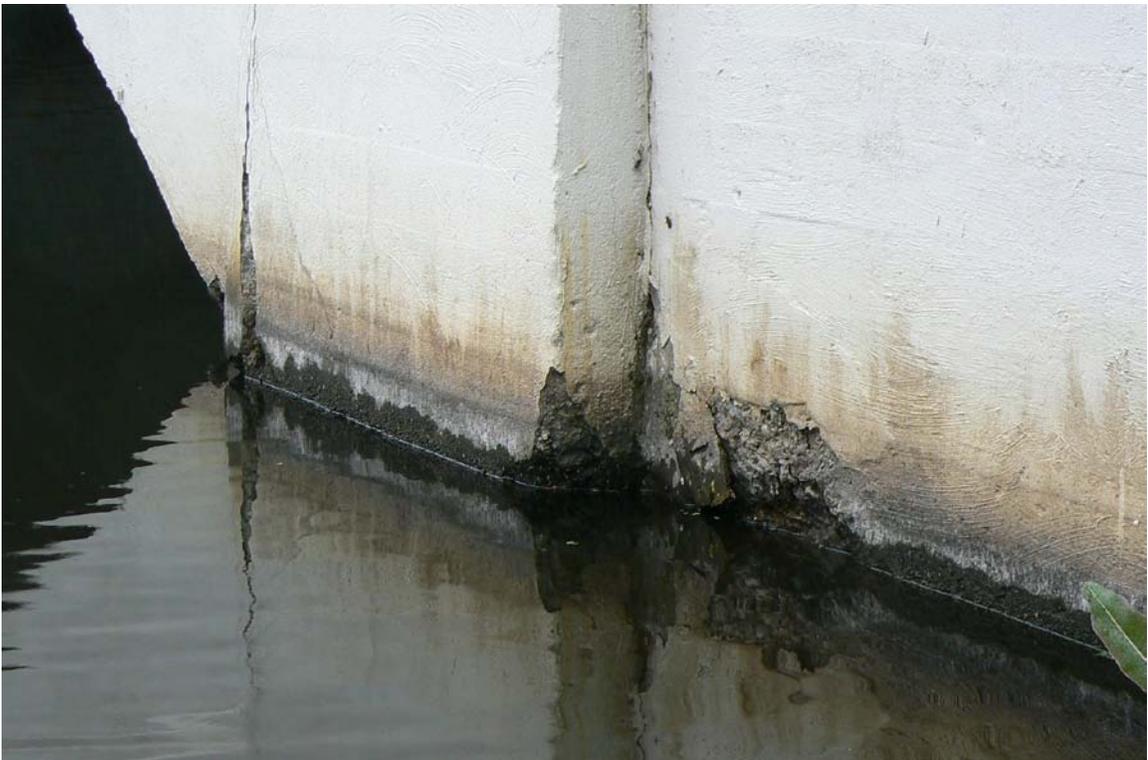
Photograph 4. View of Spall at East Corner of the North Abutment, Looking Southwest.

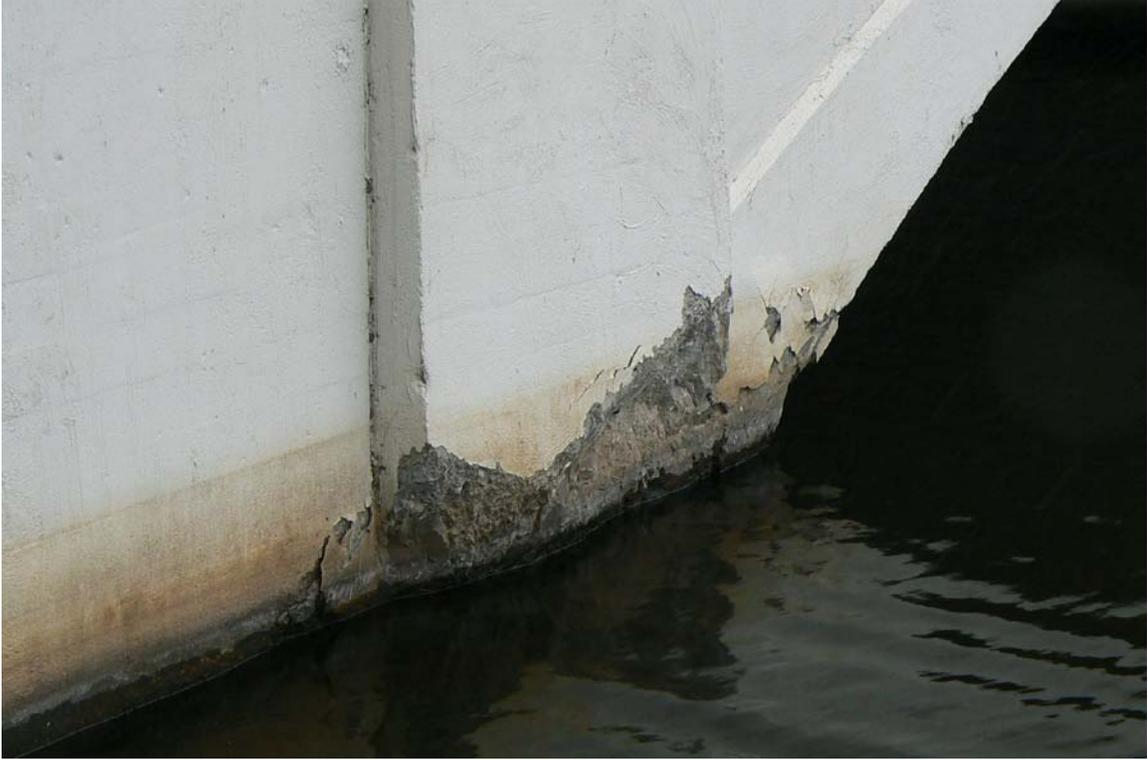
Photograph 5. View of Spall at West Corner of the North Abutment, Looking Southeast.

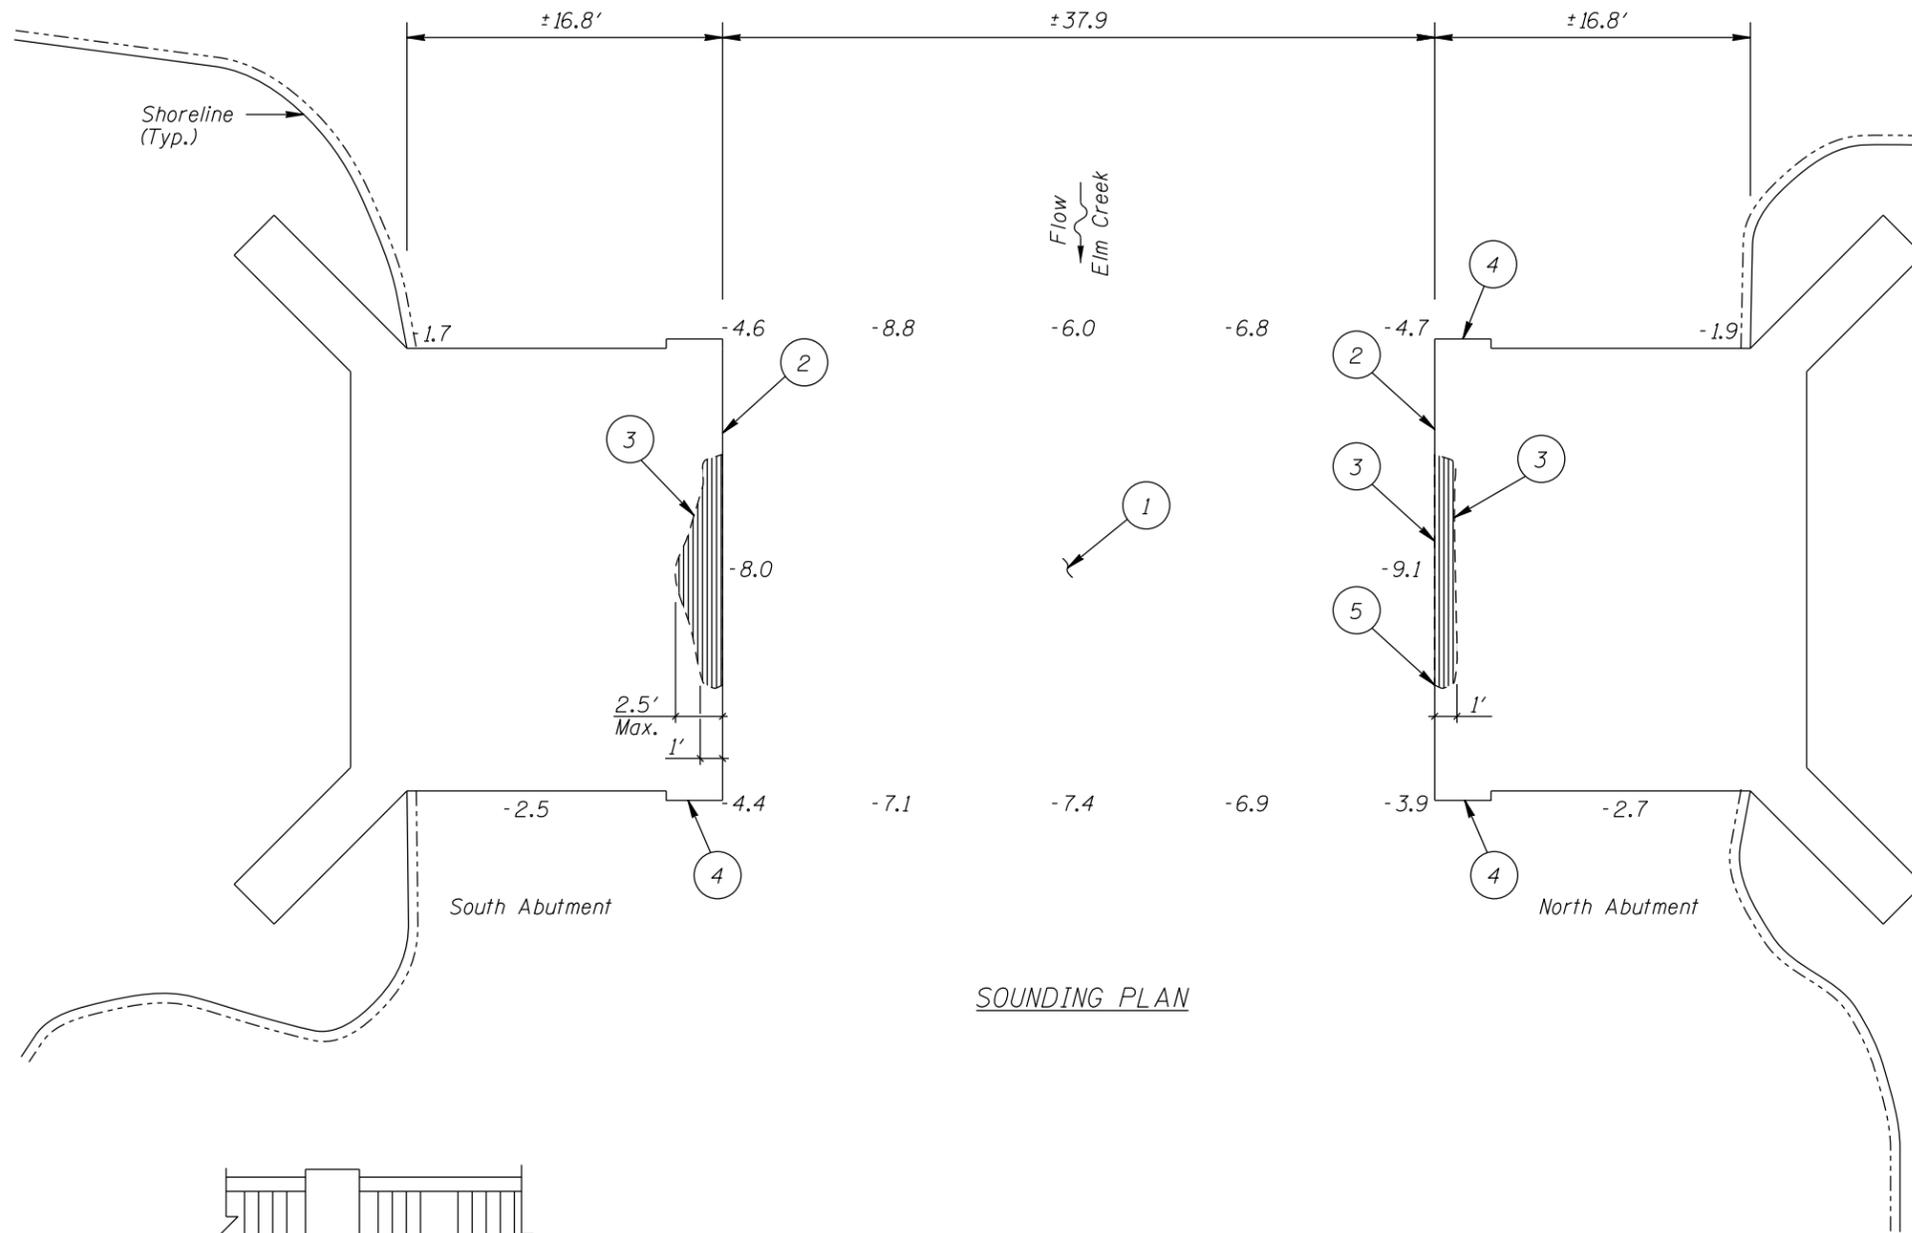
SOUNDING PLAN

- 1 Channel bottom material consisted of sand and cobbles up to 4 inches in diameter allowing 4 inches of probe rod penetration.
- 2 Areas of concrete section loss along the perimeter of the East and West Abutments extended from the channel bottom to 1 foot above the waterline with typical 2 inches and maximum 8 inches of penetration.

- 3 Undermining along the faces of both abutments from the upstream quarter point to the downstream quarter point with a undermining cavity 6 inches high and 1 foot of horizontal penetration and maximum 2.5 feet of penetration at the midpoint of the South Abutment.

- 4 Spalls located on the upstream and downstream fascias of the North Abutment and the downstream fascia of the South Abutment, measuring 5 feet wide, extended from the channel bottom to 1 foot above the waterline with typical 6 inches and maximum 1 foot of penetration. Fully exposed reinforcing steel was observed, with up to 20 percent loss of section.

- 5 Spall, measuring 6 inches in diameter, located 1 foot below the waterline at the downstream quarter point on the North Abutment with typical 6 inches and maximum 8 inches of penetration. Exposed reinforcing steel with up to 20 percent loss of section was observed.

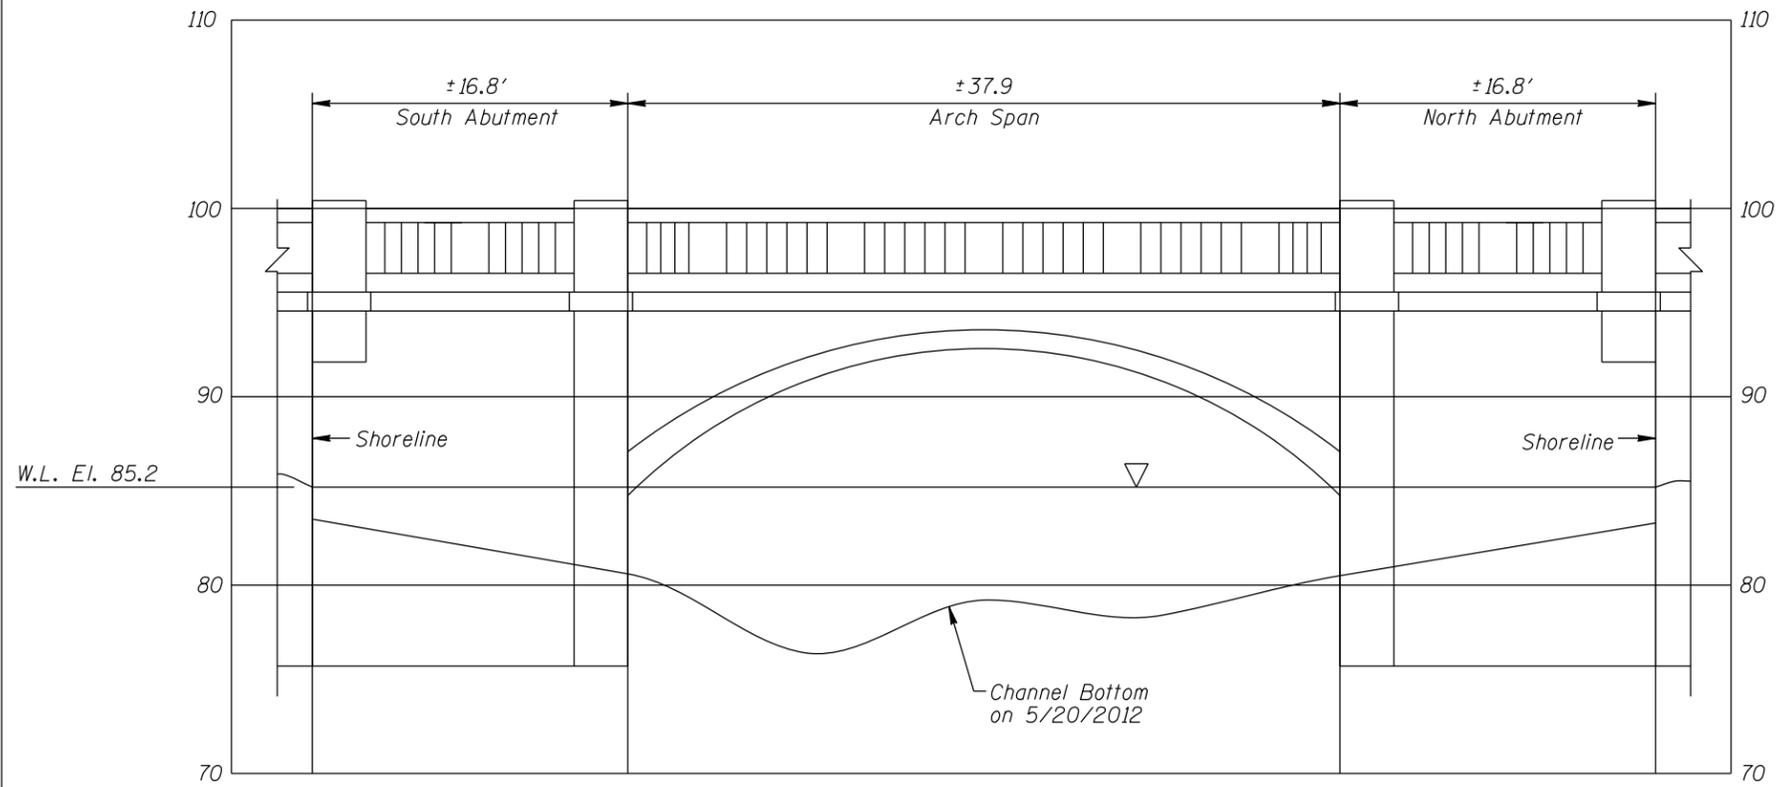
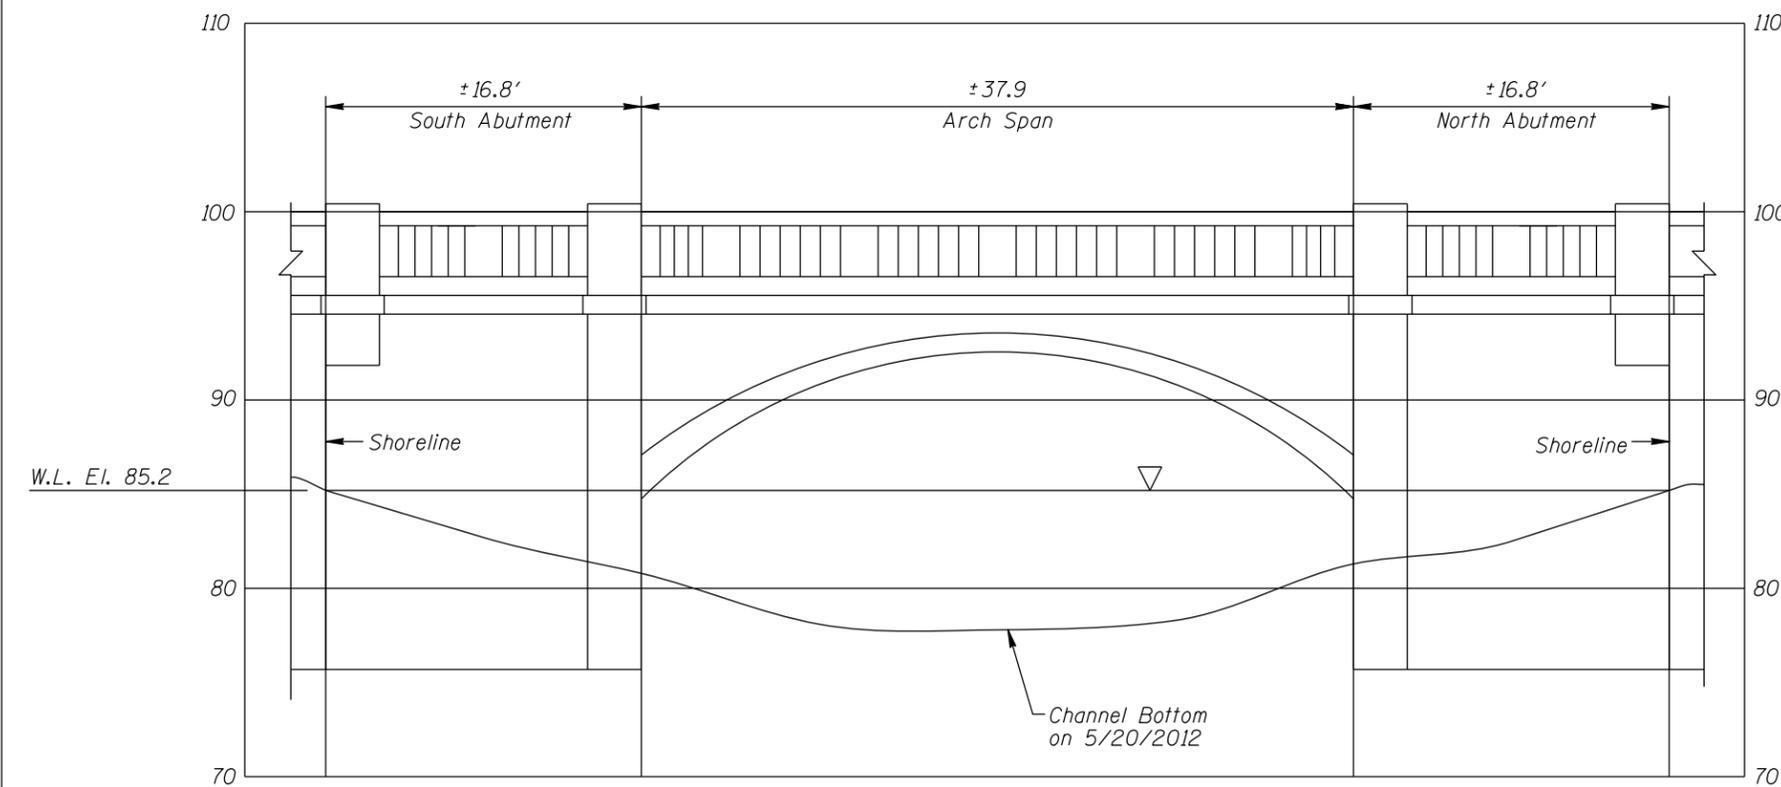
UPSTREAM FASCIA PROFILE

DOWNSTREAM FASCIA PROFILE
