UNDERWATER BRIDGE INSPECTION REPORT

STRUCTURE NO. 3575

FORD PARKWAY

MINNESOTA DEPARTMENT OF TRANSPORTATION
UNDERWATER BRIDGE INSPECTION

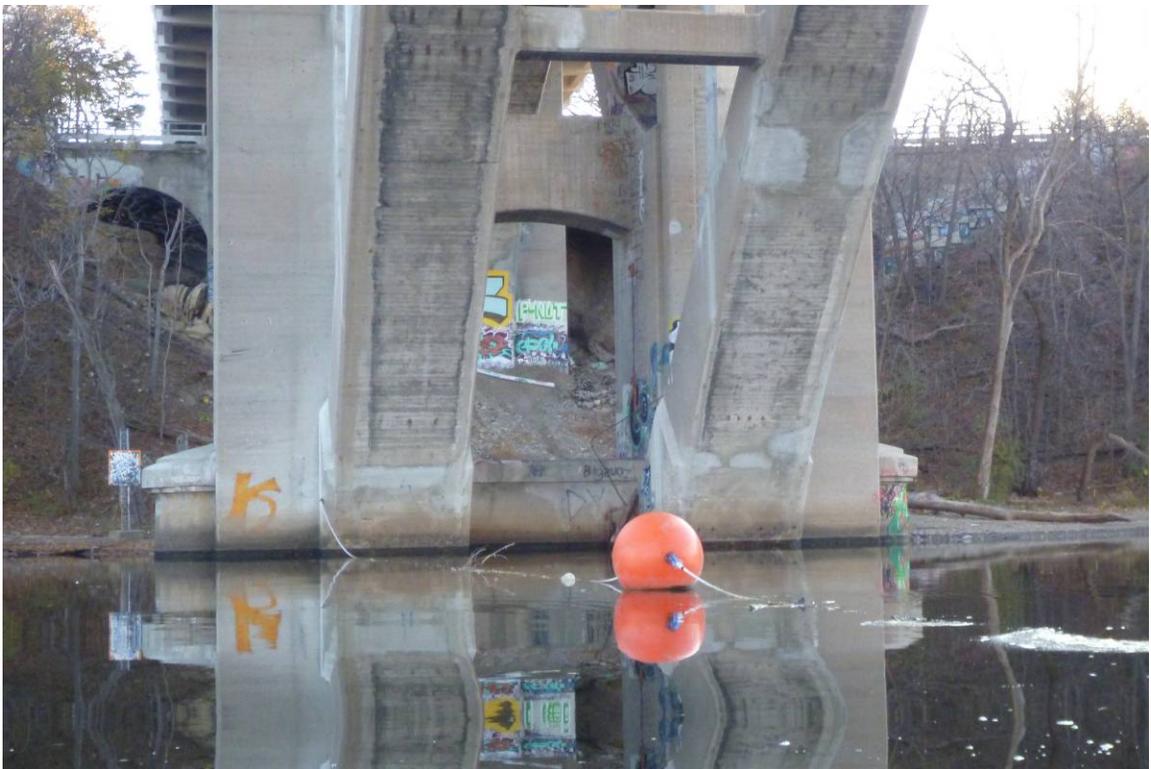
Photograph 2. View of Pier 7, Looking East.

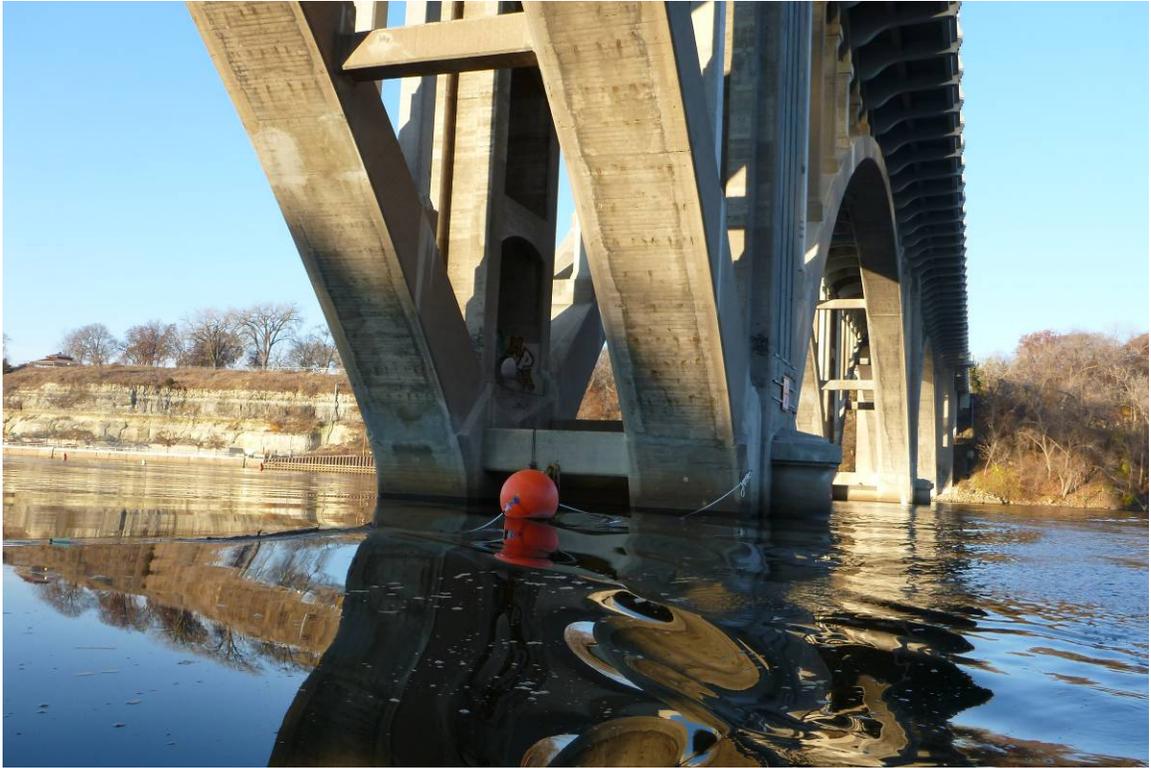
Photograph 3. View of Pier 8, Looking West.

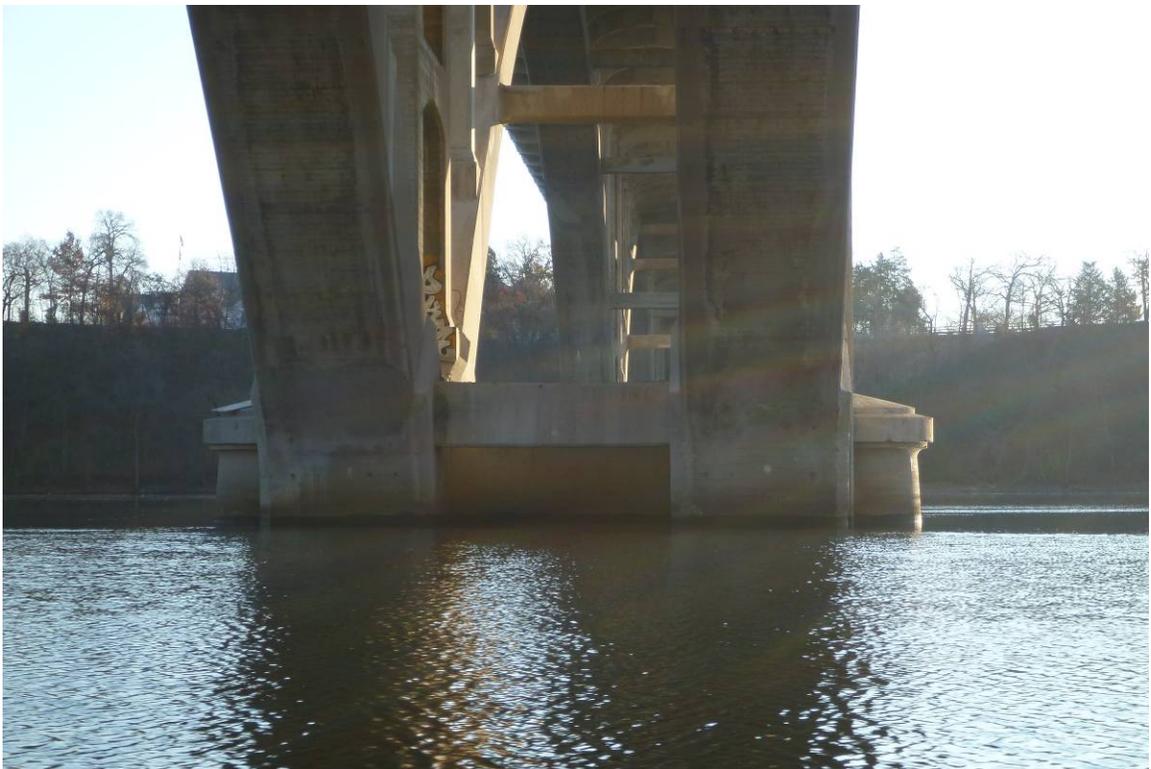
Photograph 4. View of Pier 9, Looking East.

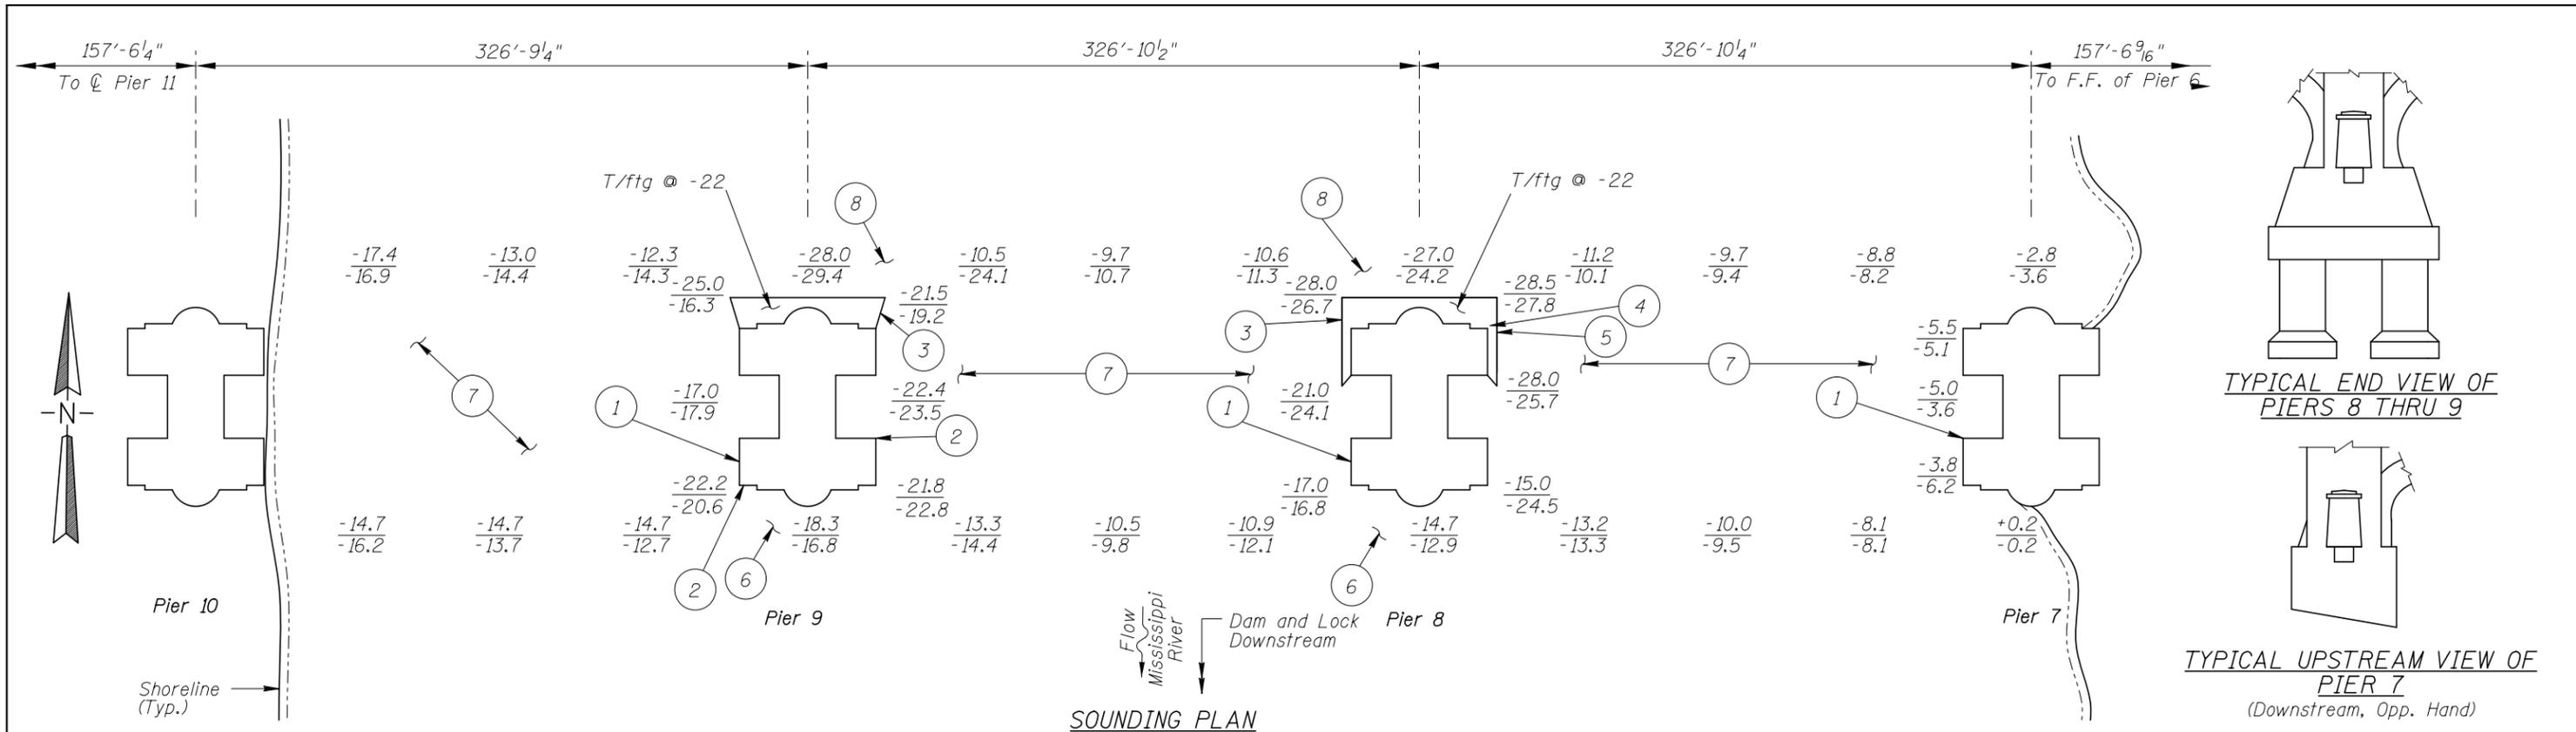
INSPECTION AND SOUNDING PLAN

- Overall, the concrete was in good to satisfactory condition with light to moderate scaling around the perimeter of the piers, with random areas of section loss (1 to 3 inches of penetration typical), from 2 feet above to 2 feet below the waterline.

- An area of concrete was spalled, 2 feet by 2 feet with 2 inches of penetration, at 3 feet below the waterline.
- The footing was exposed around the upstream third of Pier 8 and along the upstream face of Pier 9. Timber formwork was encountered along the footings of Piers 8 and 9. The exposed portion of the footings exhibited widespread heavy scaling with 1 to 2 feet of penetration and a maximum vertical face exposure of 6 feet (full height) at Pier 8. No vertical face exposure at Pier 9.

- The footing at the northeast corner of Pier 8 was undermined, with a cavity measuring 3 feet long by 1 foot high with up to 1 foot of horizontal penetration.

- A void was found in the side of the footing, measuring 2 feet in diameter with 3 feet of penetration, located at the northeast corner of Pier 8.
- Areas of silty sand deposition (infilling) were located at the downstream ends of Piers 8 and 9 covering the footings.

- The channel bottom consisted of gravel and sand with scattered concrete rubble, reinforcing steel and riprap around the substructure units. The concrete rubble had protruding reinforcing steel and appeared to have been placed / dropped as part of bridge rehabilitation.
- Localized scour depressions were observed around the upstream end of Piers 8 and 9 with typical depths of 5 to 10 feet, and concrete rubble with protruding reinforcing steel was found on the base of the scour depression.

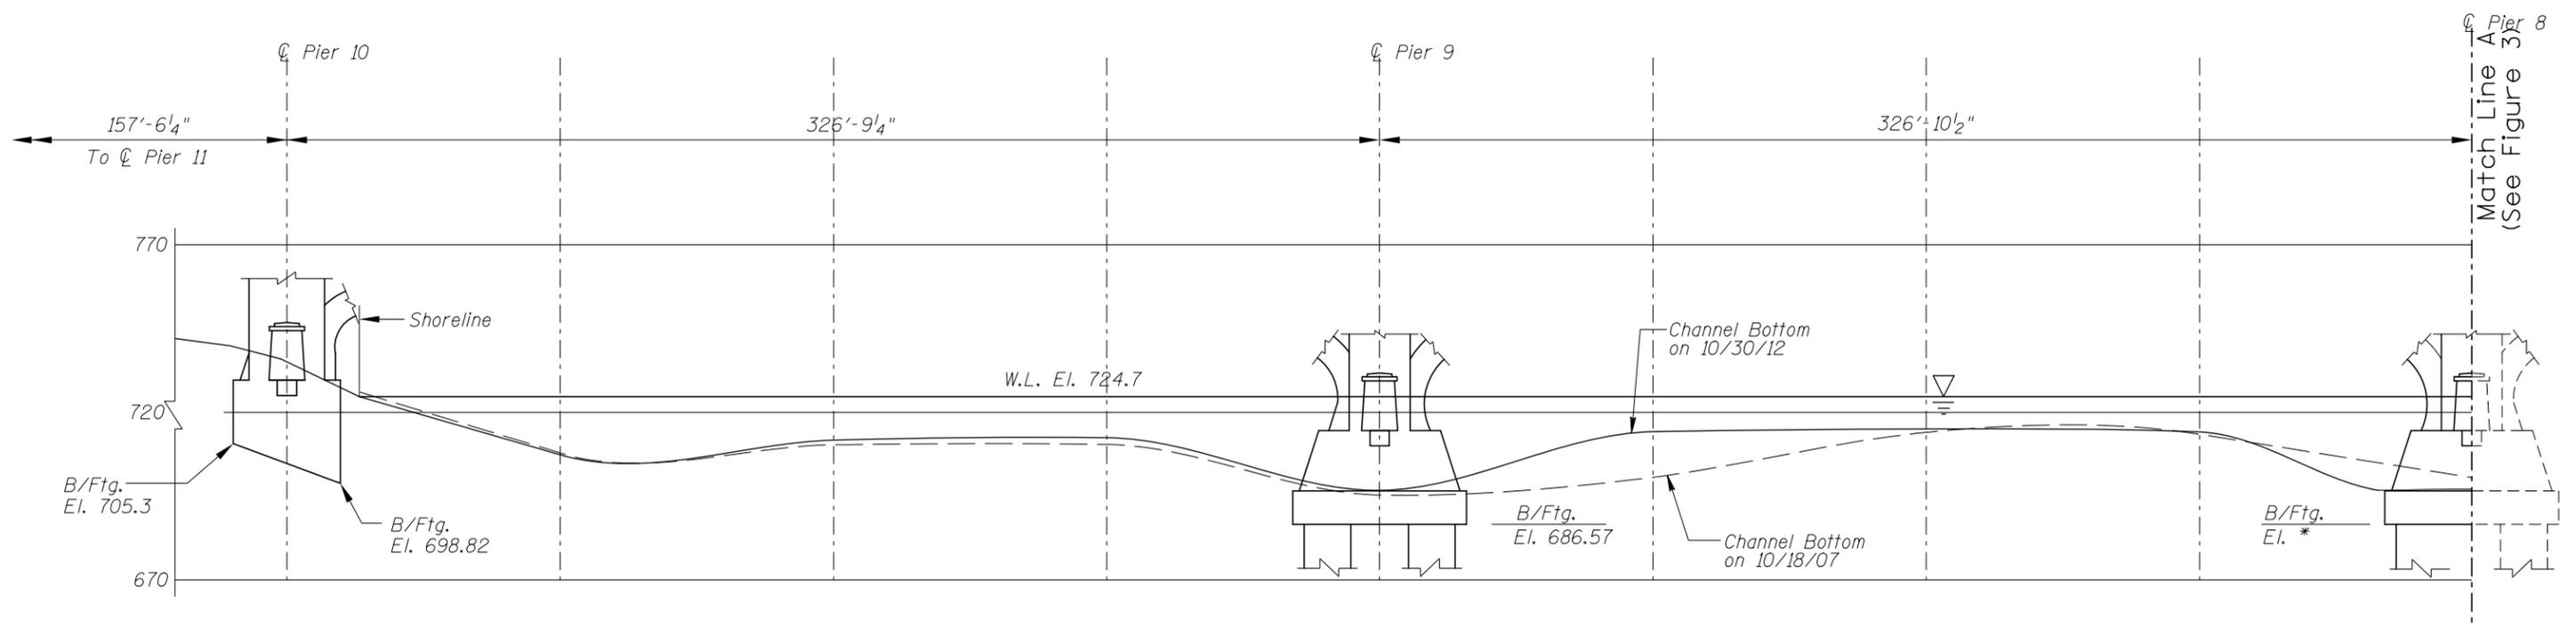
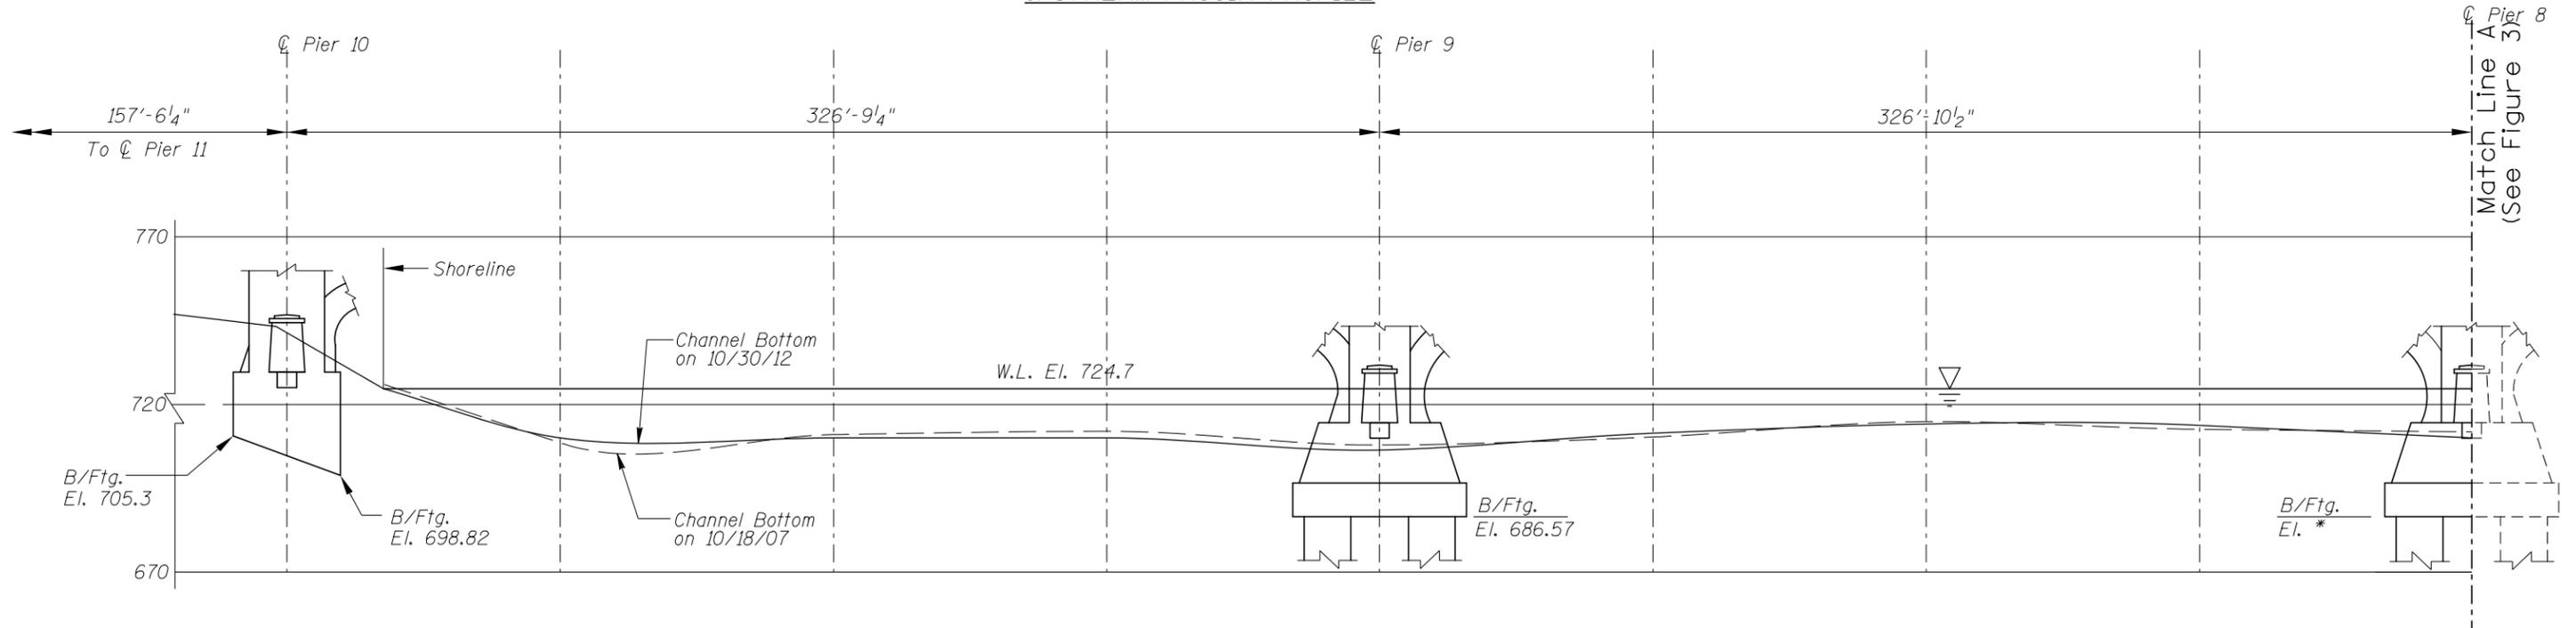
* The bottom of footing elevation noted on the Design Plans does not correspond to the soundings and/or undermining detected at the time of the underwater inspection.

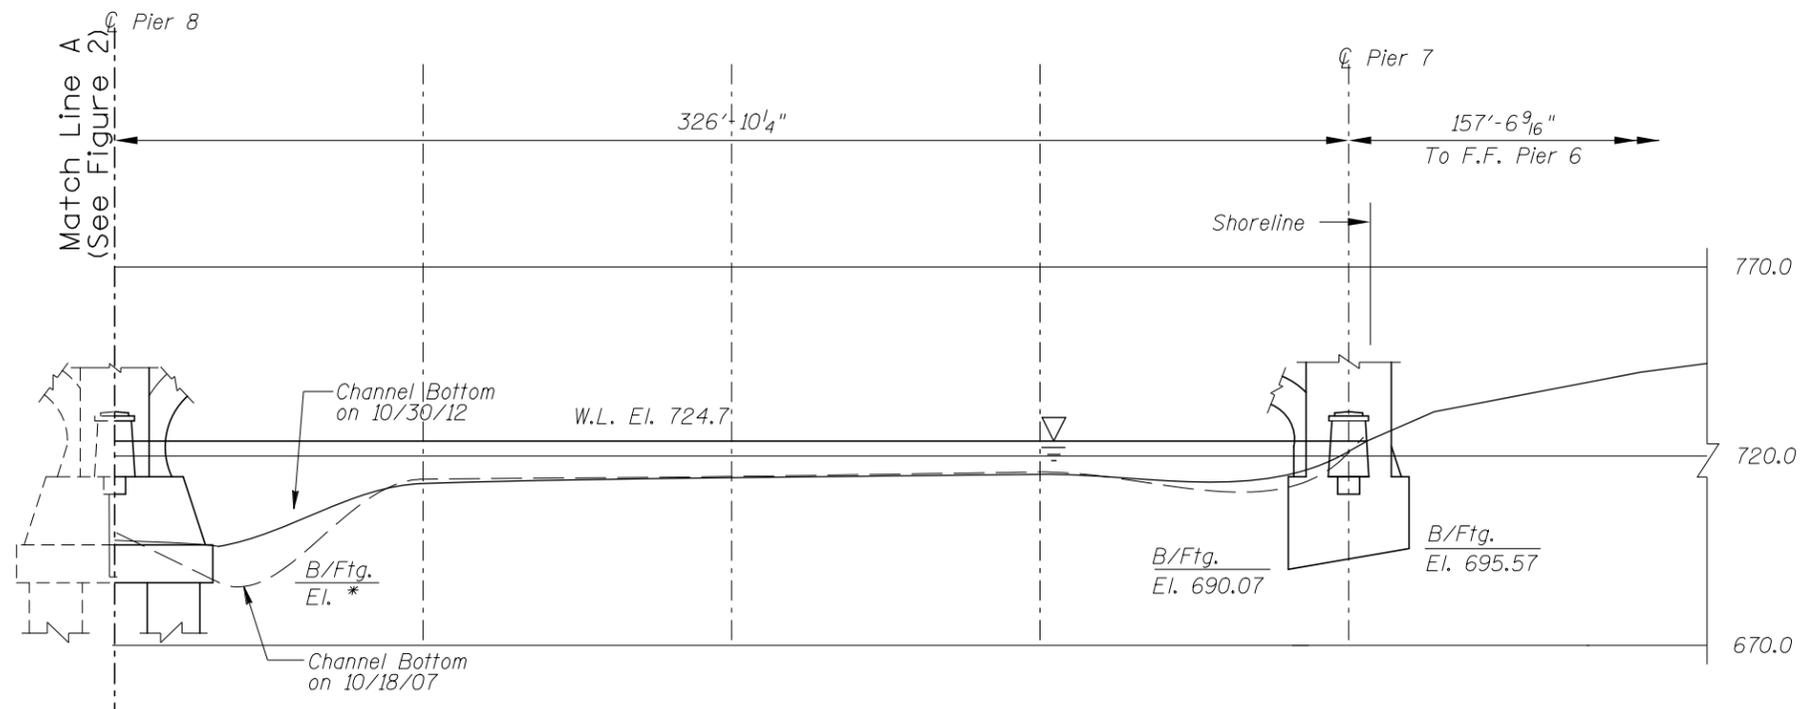
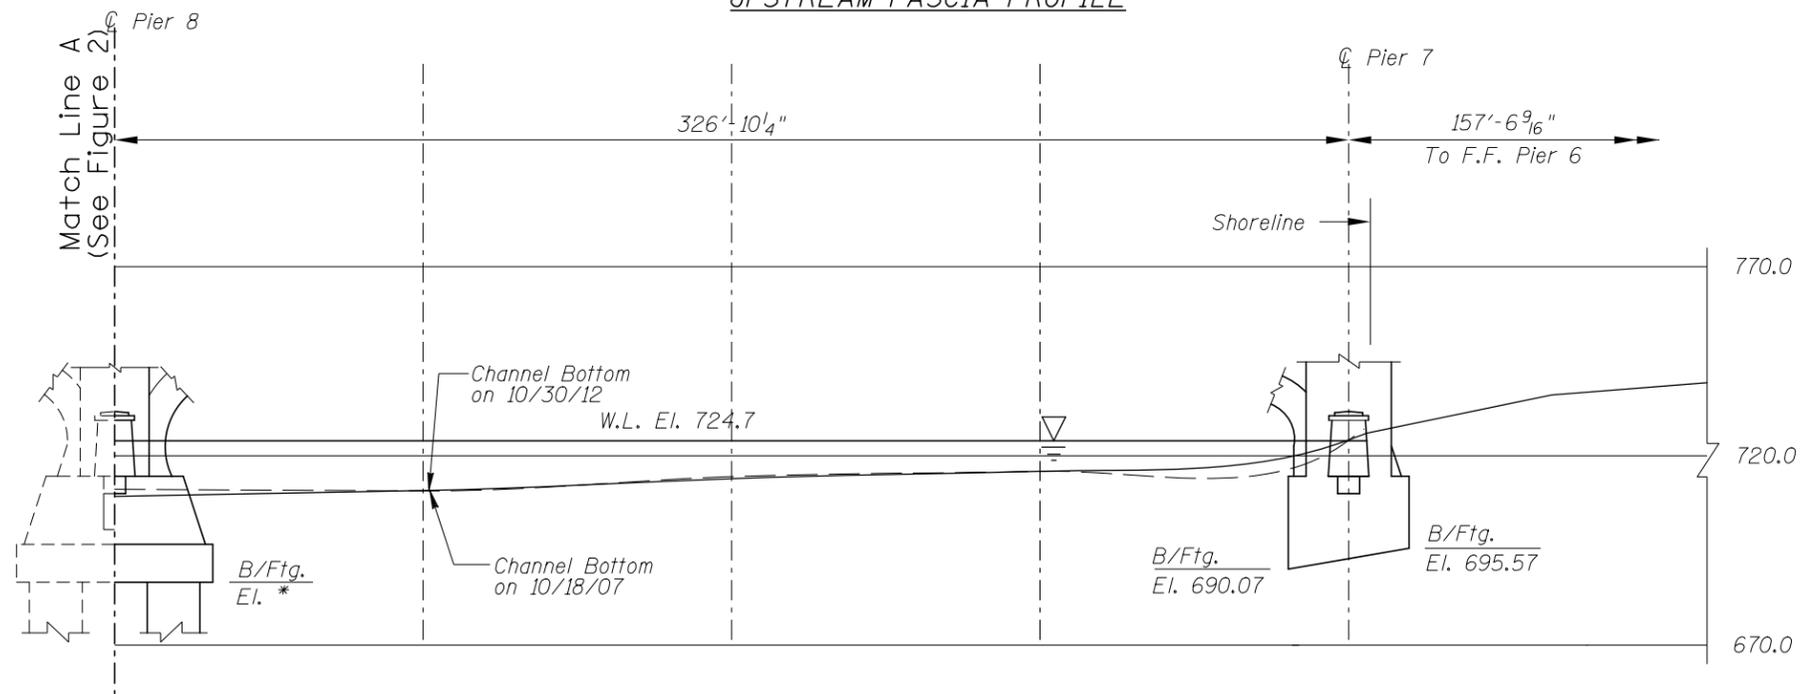
* The bottom of footing elevation noted on the Design Plans does not correspond to the soundings and/or undermining detected at the time of the underwater inspection.
