UNDERWATER BRIDGE INSPECTION REPORT

STRUCTURE NO. 62082
CSAH 3 (Lake Street/Marshall Avenue)
OVER THE
MISSISSIPPI RIVER
HENNEPIN/RAMSEY COUNTY

AUGUST 29, 2012

BY
COLLINS ENGINEERS, INC.

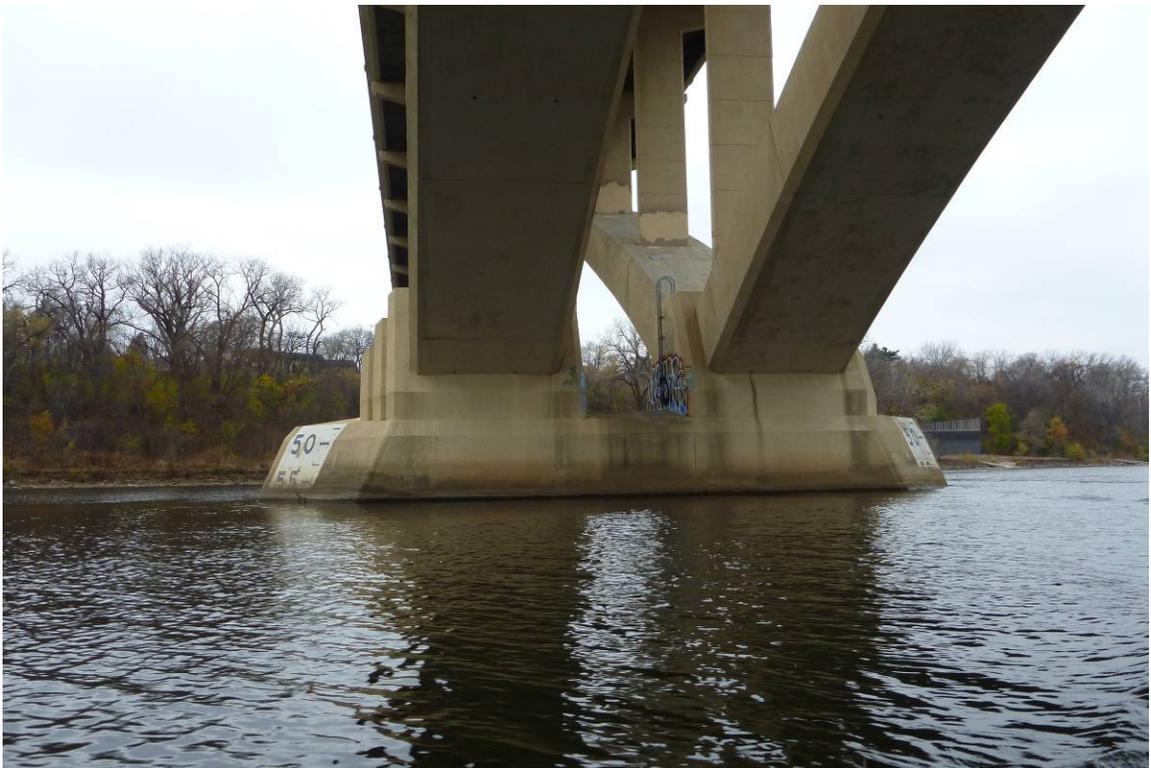
The substructure unit inspected at Bridge No. 62082, Pier 5, was found to be in overall good condition with no defects of structural significance observed. In general, the concrete of the pier was sound with only some random minor hairline cracking. A scour depression was observed at the upstream half of the pier resulting in footing exposure with up to full vertical height of the footing exposed.

Photograph 2. View of Pier 5, Looking Northwest.

- (A) Monitor the exposure of the footing and partial exposure of the seal at the upstream nose of Pier 5, and if found to be progressing, additional measures may then be warranted.

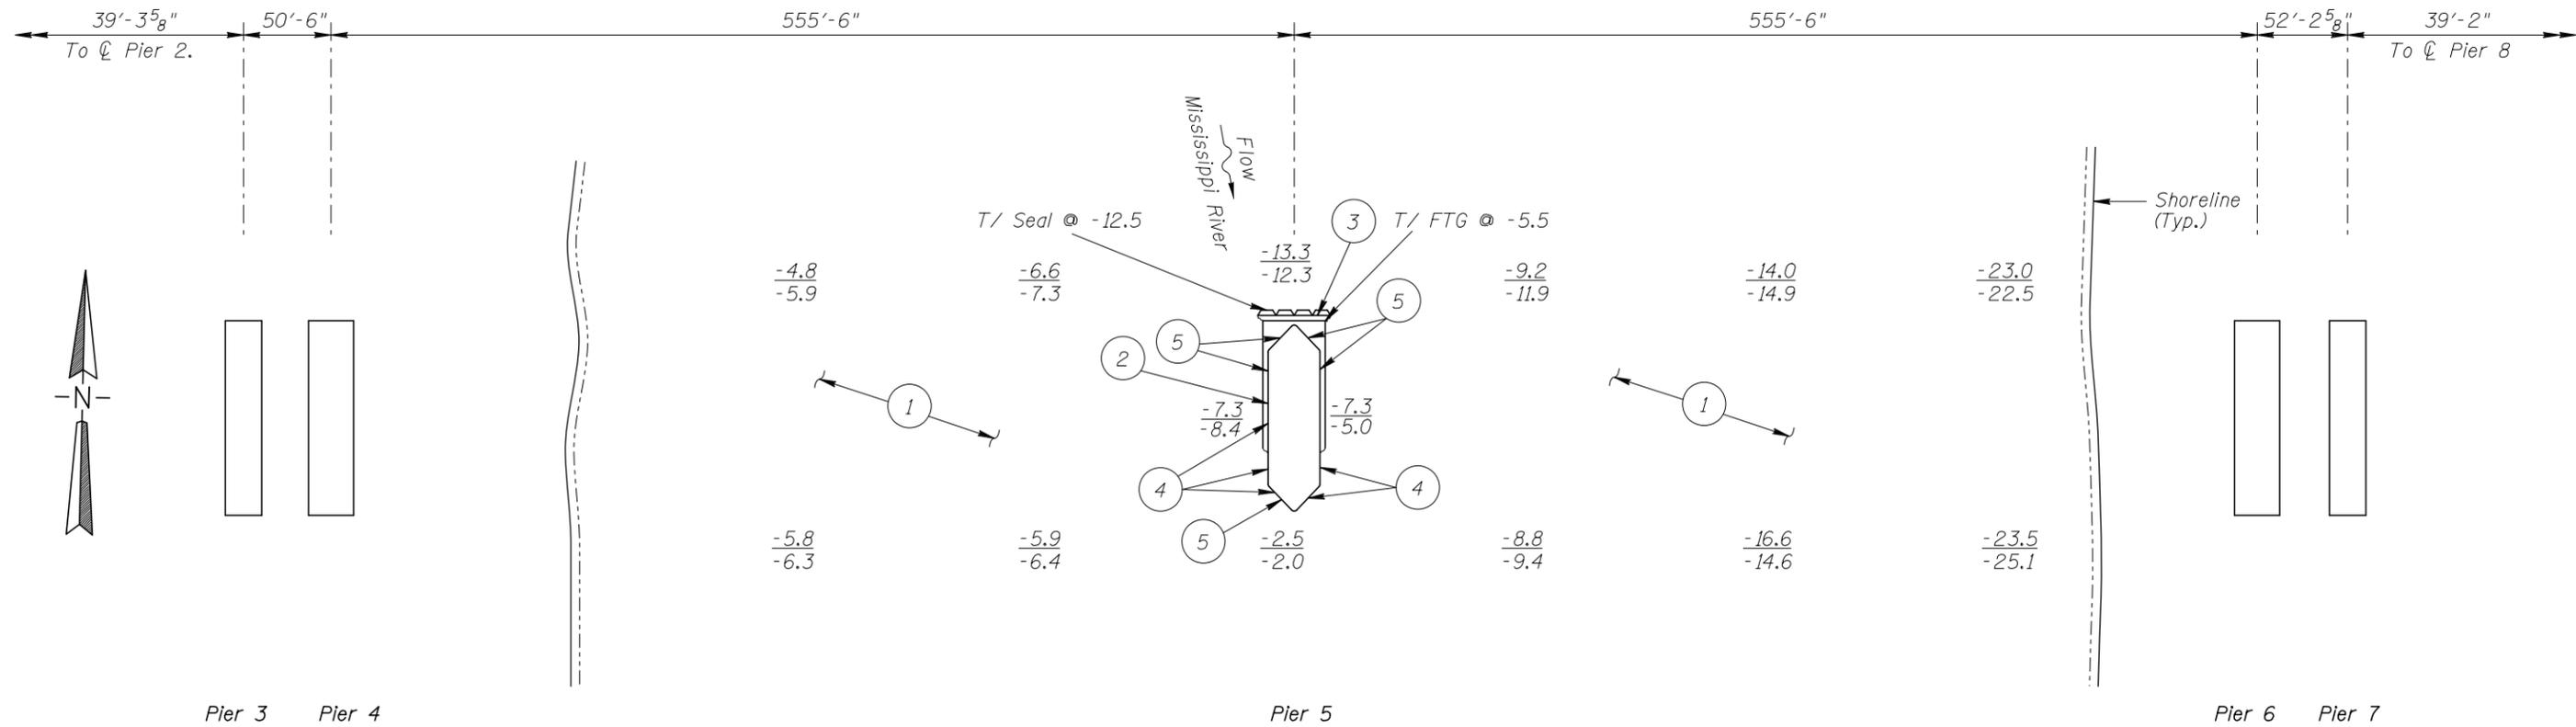
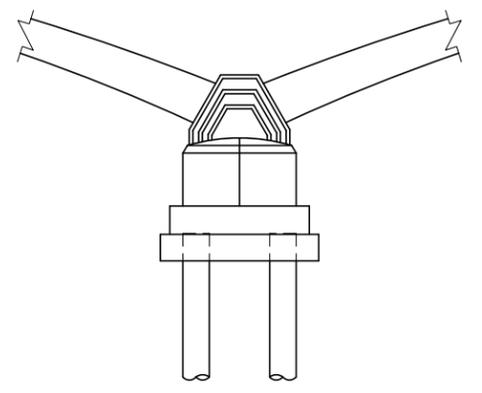
SOUNDING PLAN

- 1 The channel bottom material consisted of sand and concrete rubble with up to 6 inches of probe rod penetration. There was also random pieces of scrap steel scattered around the pier on the channel bottom.

- 2 The concrete around the pier was in good and sound condition with a light layer of aquatic growth that extended from the waterline to the channel bottom.

- 3 Footing exposure was observed at the upstream nose of Pier 5 and extended for 3/4 of the pier length along both sides of the pier. At the upstream nose, the full 7 feet of the vertical face of the footing was exposed (top of seal was even with the channel bottom). The footing and seal exposure is due to localized scour, with an approximate depth of 5 to 7 feet, around the upstream end of the pier.

- 4 A hairline vertical crack was observed extending from the top of the pier to the channel bottom.
- 5 A hairline vertical crack was observed extending from the top of the pier to 1 foot above channel bottom.
