UNDERWATER BRIDGE INSPECTION REPORT

STRUCTURE NO. 62555A

WABASHA STREET NORTH BOUND (MSAS 235 NB)

MINNESOTA DEPARTMENT OF TRANSPORTATION
UNDERWATER BRIDGE INSPECTION

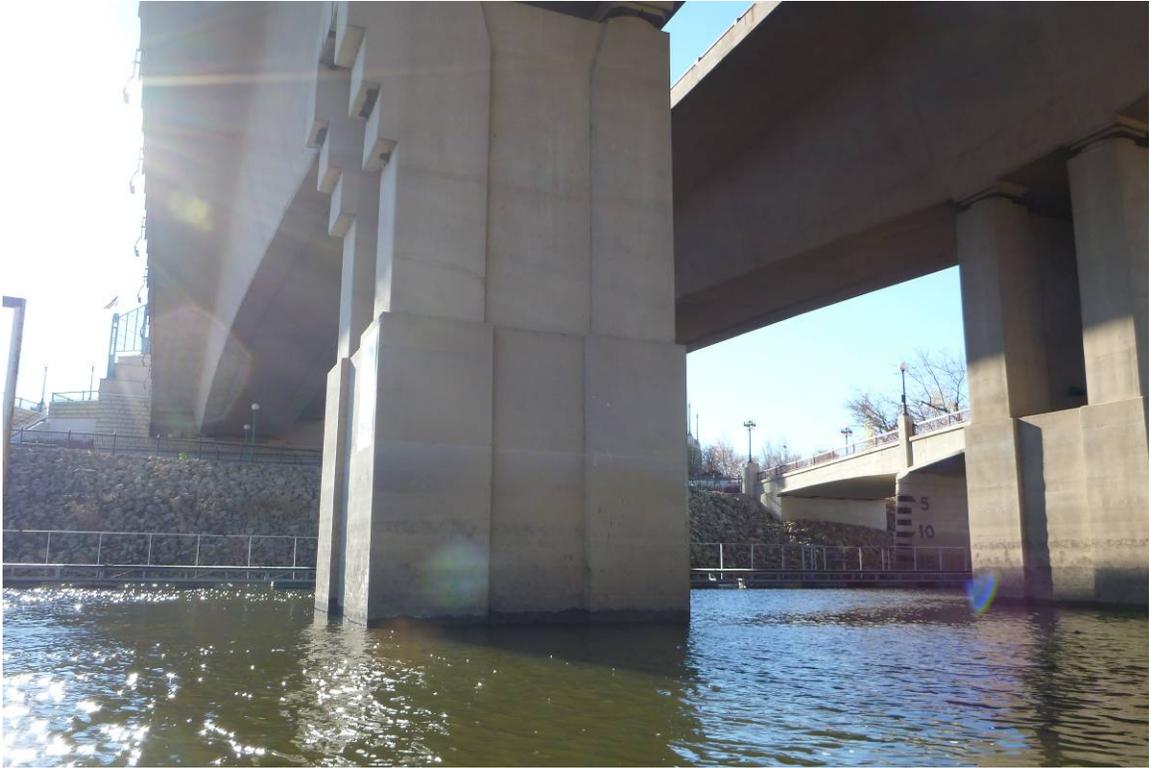
Photograph 1. View of Pier 3, Looking South

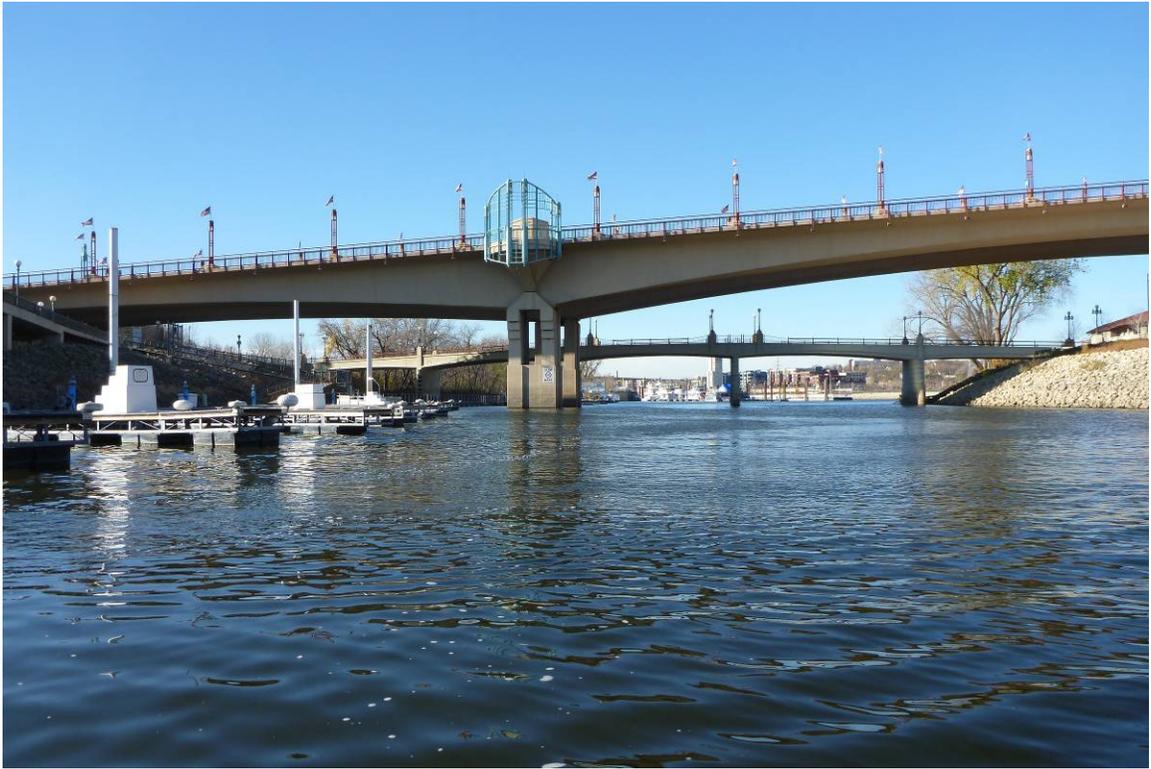
Photograph 2. Overall View of Structure, Looking West.

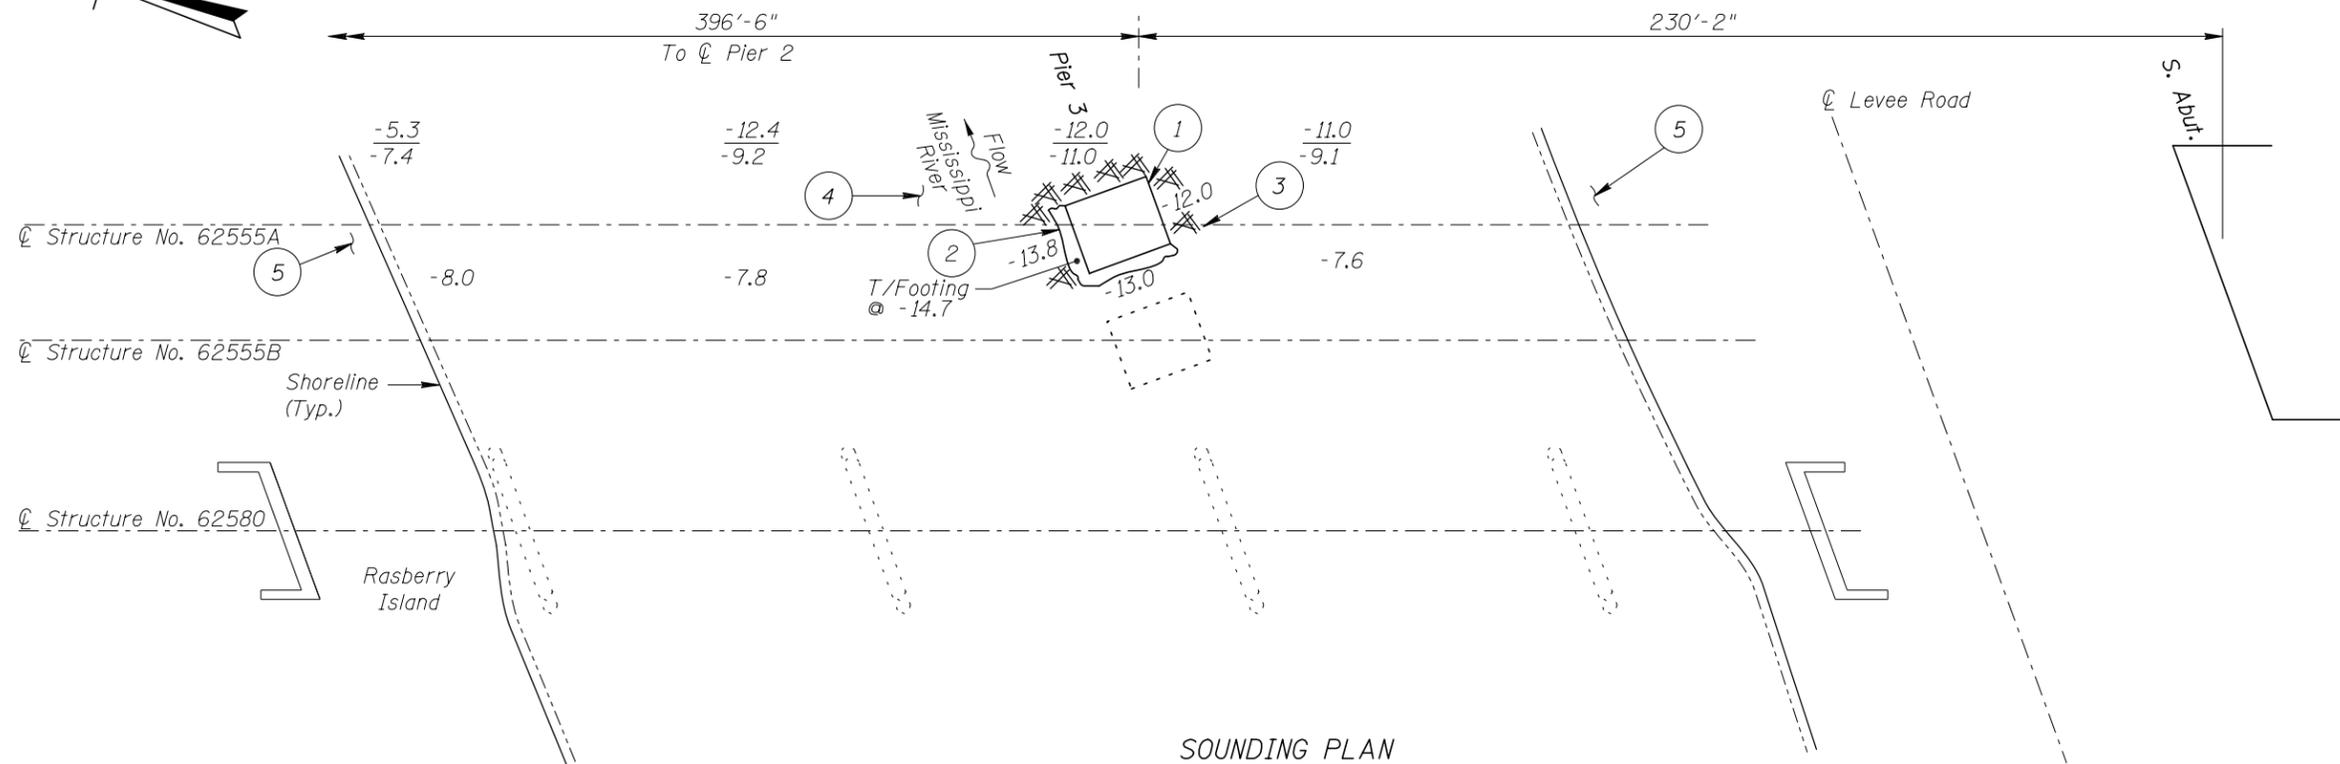
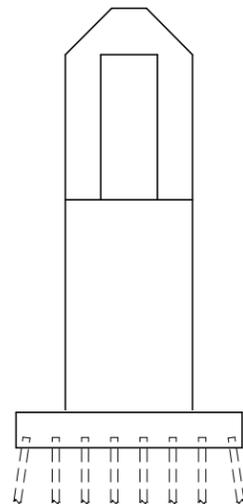
TYPICAL END VIEW OF PIER

- 1 The concrete was in good and sound condition with no structurally significant defects observed.
- 2 A 6 foot wide portion of the top of the footing was exposed along the entire upstream side and north face of Pier 3.
- 3 A minor accumulation of timber debris, consisting of 12 inch diameter logs, was observed at the downstream end and sides of the pier column extending from the channel bottom up 1 to 3 feet.
- 4 The channel bottom material around Pier 3 consisted of sandy infilling allowing up to 1 foot of probe rod penetration.
- 5 The embankments were well armored with 1 foot diameter riprap.
