UNDERWATER BRIDGE INSPECTION REPORT

STRUCTURE NO. 62555B

WABASHA STREET SOUTH BOUND (MASA 235 SB)

MISSISSIPPI RIVER

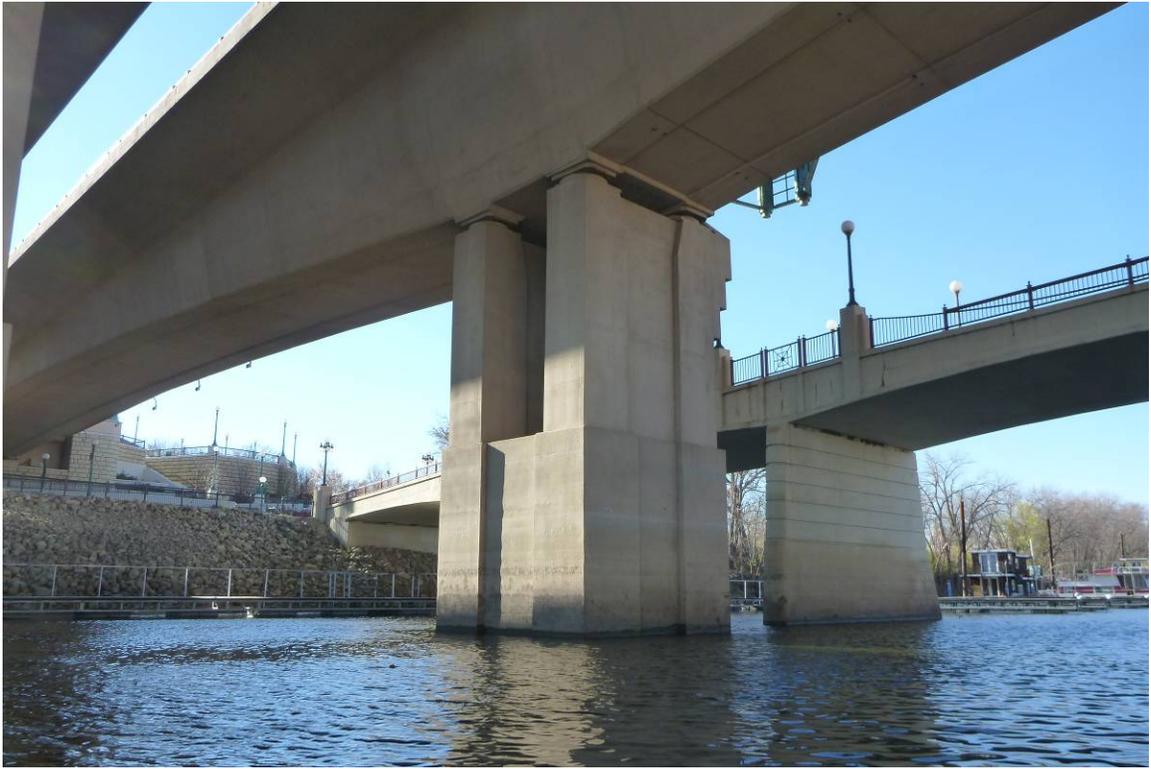
The concrete substructure unit inspected at Bridge No. 62555B, Pier 3, was found to be in good condition with no defects of structural significance observed. The concrete of the pier column was smooth and sound. The channel bottom appeared stable at the time of the inspection with no significant scour.

Photograph 1. View of Pier 3, Looking Southwest.

- (A) Reinspect the submerged substructure units at the normal maximum recommended (NBIS) interval of sixty (60) months.

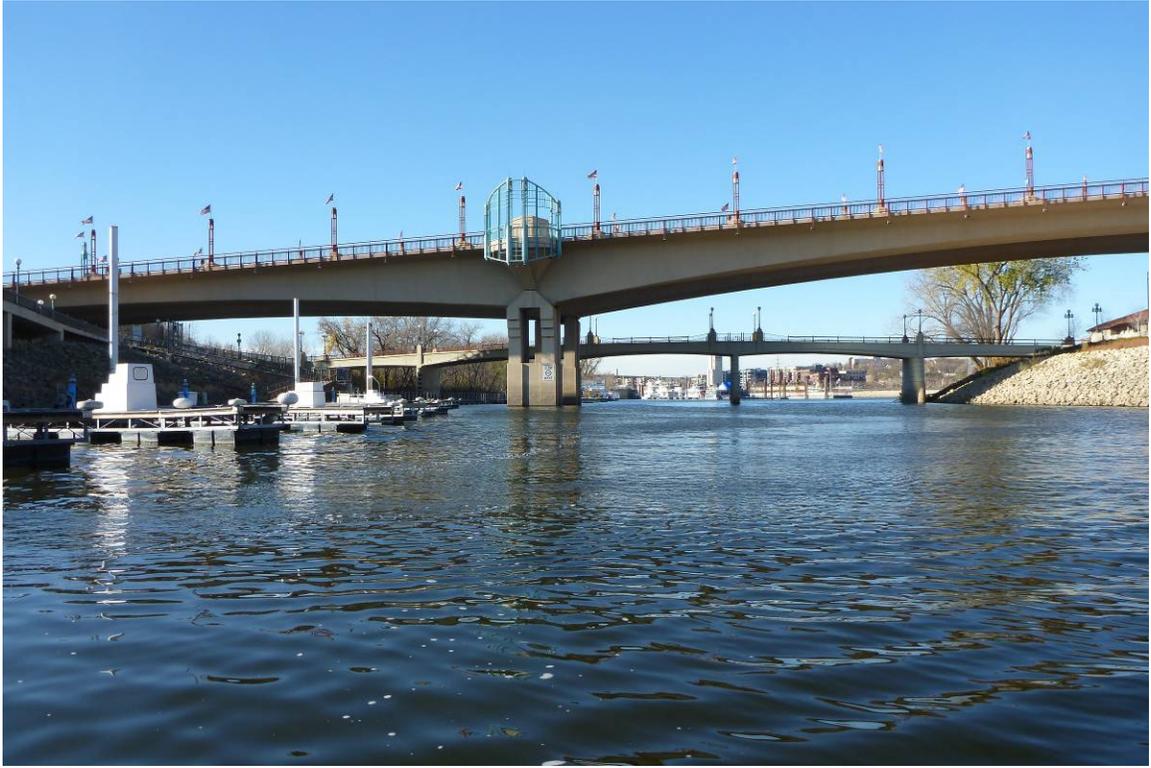
Photograph 2. Overall View of the Structure, Looking West.

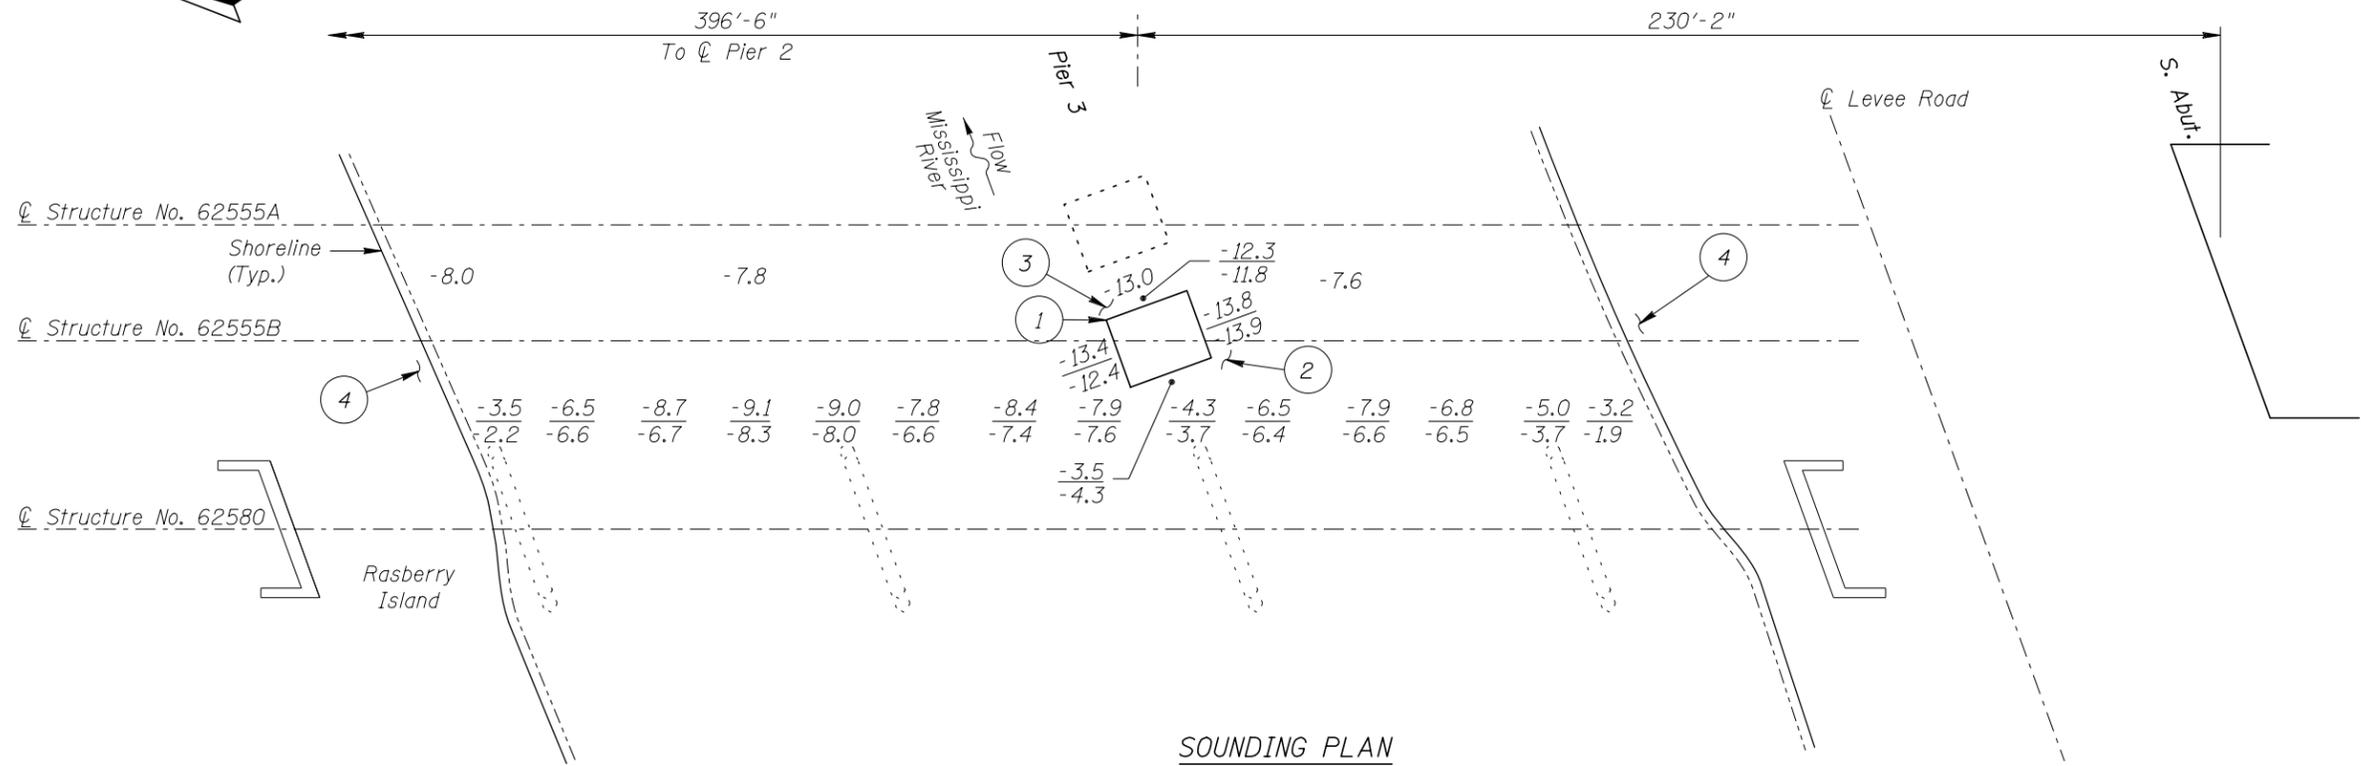
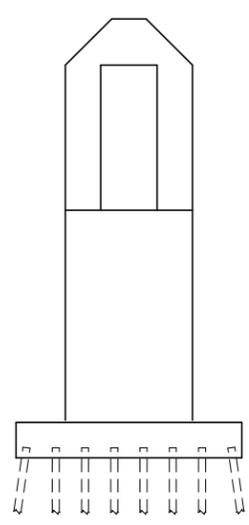
SOUNDING PLAN

- ① The concrete was in good and sound condition with no structurally significant defects observed.
- ② The channel bottom material consisted of riprap up to 1 foot in diameter at the upstream nose of the pier.
- ③ The channel bottom material downstream of the pier consisted of sandy infilling allowing up to 1 foot of probe rod penetration.
- ④ The embankments were well armored with 1 foot diameter riprap.
