UNDERWATER BRIDGE INSPECTION REPORT

STRUCTURE NO. 62580
RASPBERRY ISLAND (SERVICE) ROAD
OVER THE
MISSISSIPPI RIVER
CITY OF ST PAUL, RAMSEY COUNTY

OCTOBER 31, 2012
PREPARED FOR THE
MINNESOTA DEPARTMENT OF TRANSPORTATION
BY
COLLINS ENGINEERS, INC.
JOB NO. 7423

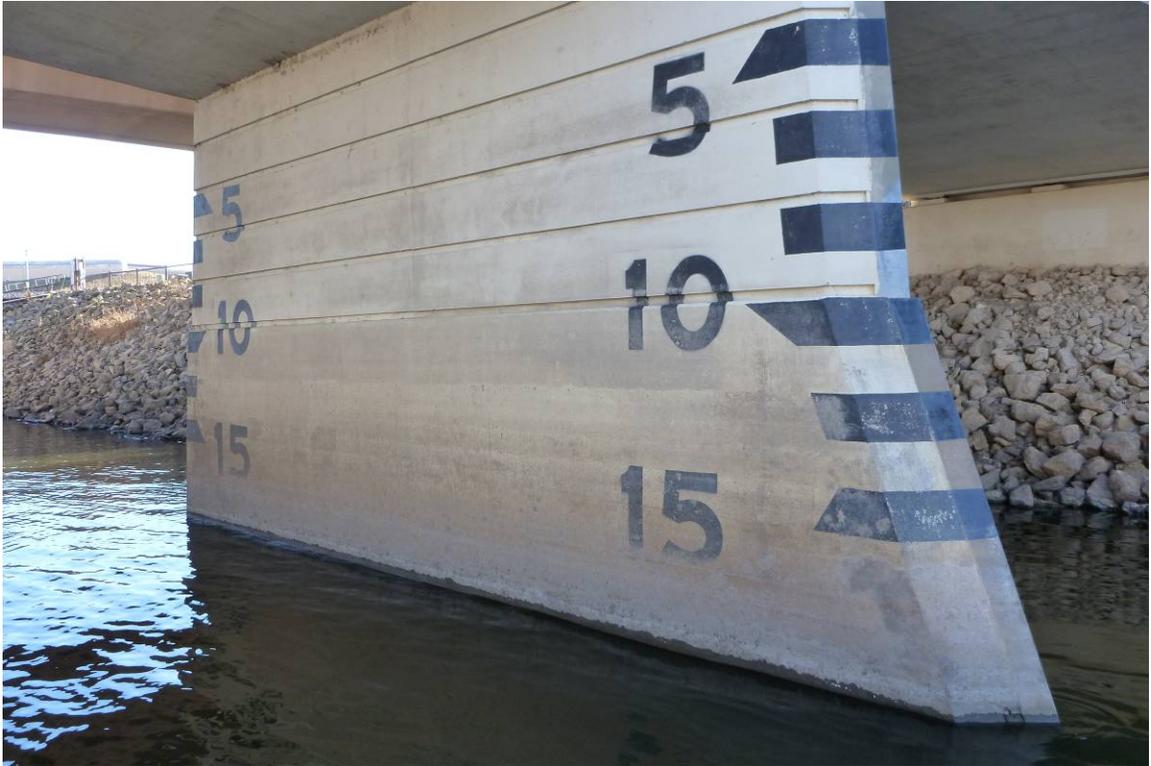
Photograph 1. View of Pier 1, Looking Southeast.

- (A) The channel bottom material consisted of 2 inch diameter gravel with random riprap at the upstream ends of Piers 1 and 2 with minimal probe rod penetration, and sand allowing up to 6 inches of probe rod penetration at Pier 3. Along Pier 4, 6 inch diameter cobbles and gravel were observed.

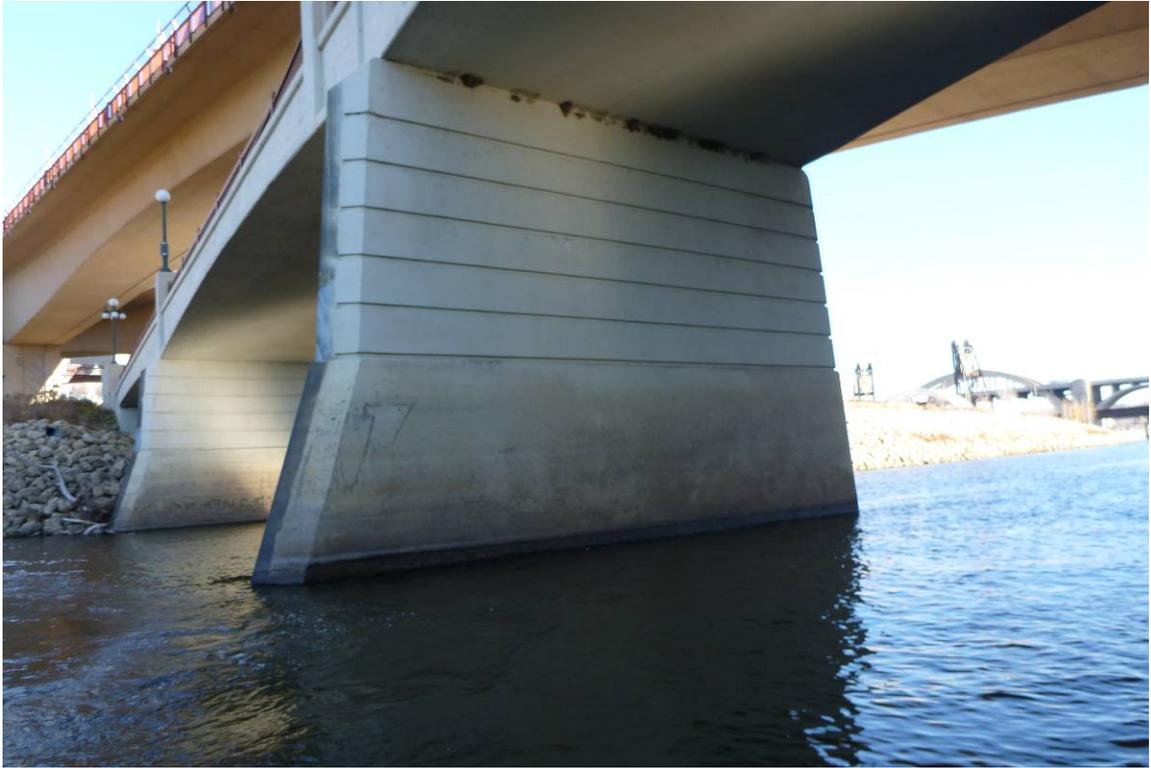
Photograph 3. View of Pier 3, Looking North

- (B) A minor accumulation of timber debris, with pieces up to 12 inches in diameter, was observed on the channel bottom randomly scattered throughout the piles of Pier 3 extending from channel bottom up 2 to 3 feet.

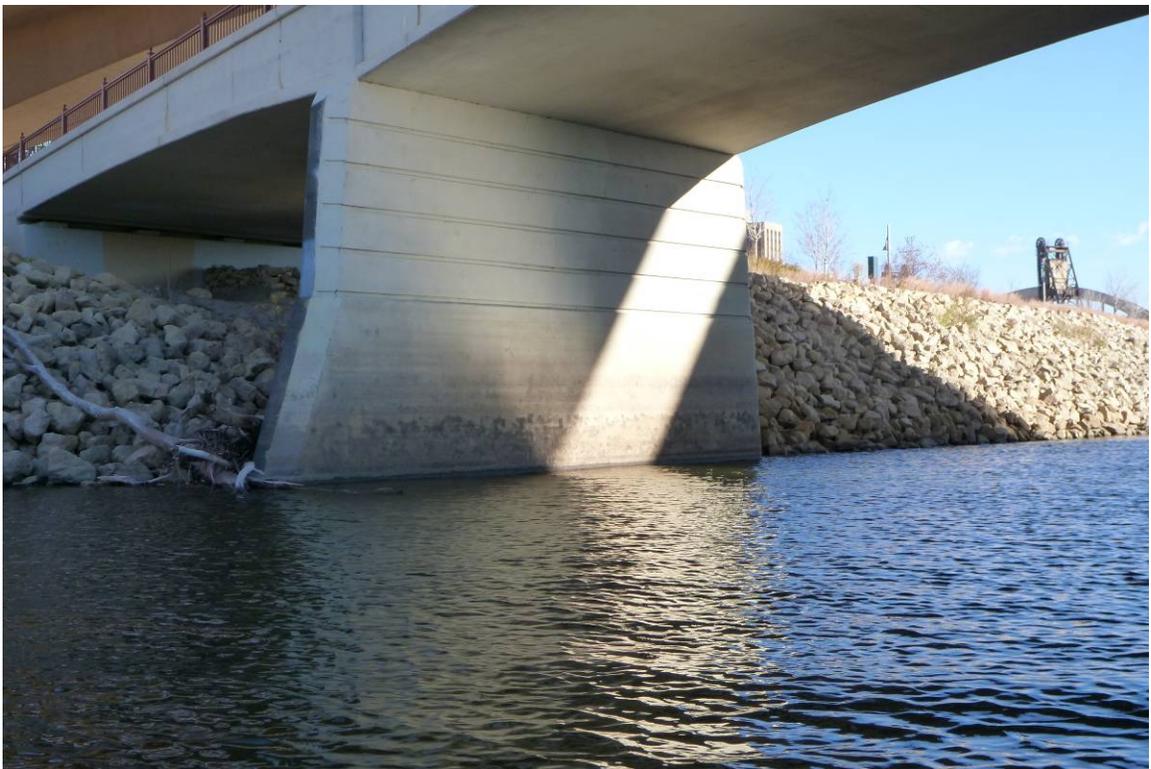
Photograph 4. View of Pier 4, Looking North.

- (C) Timber formwork and steel angles were observed at the base of the concrete shaft of Pier 4. The bottom of the shaft was poorly formed with rough edges and reinforcing steel protruding from the base.

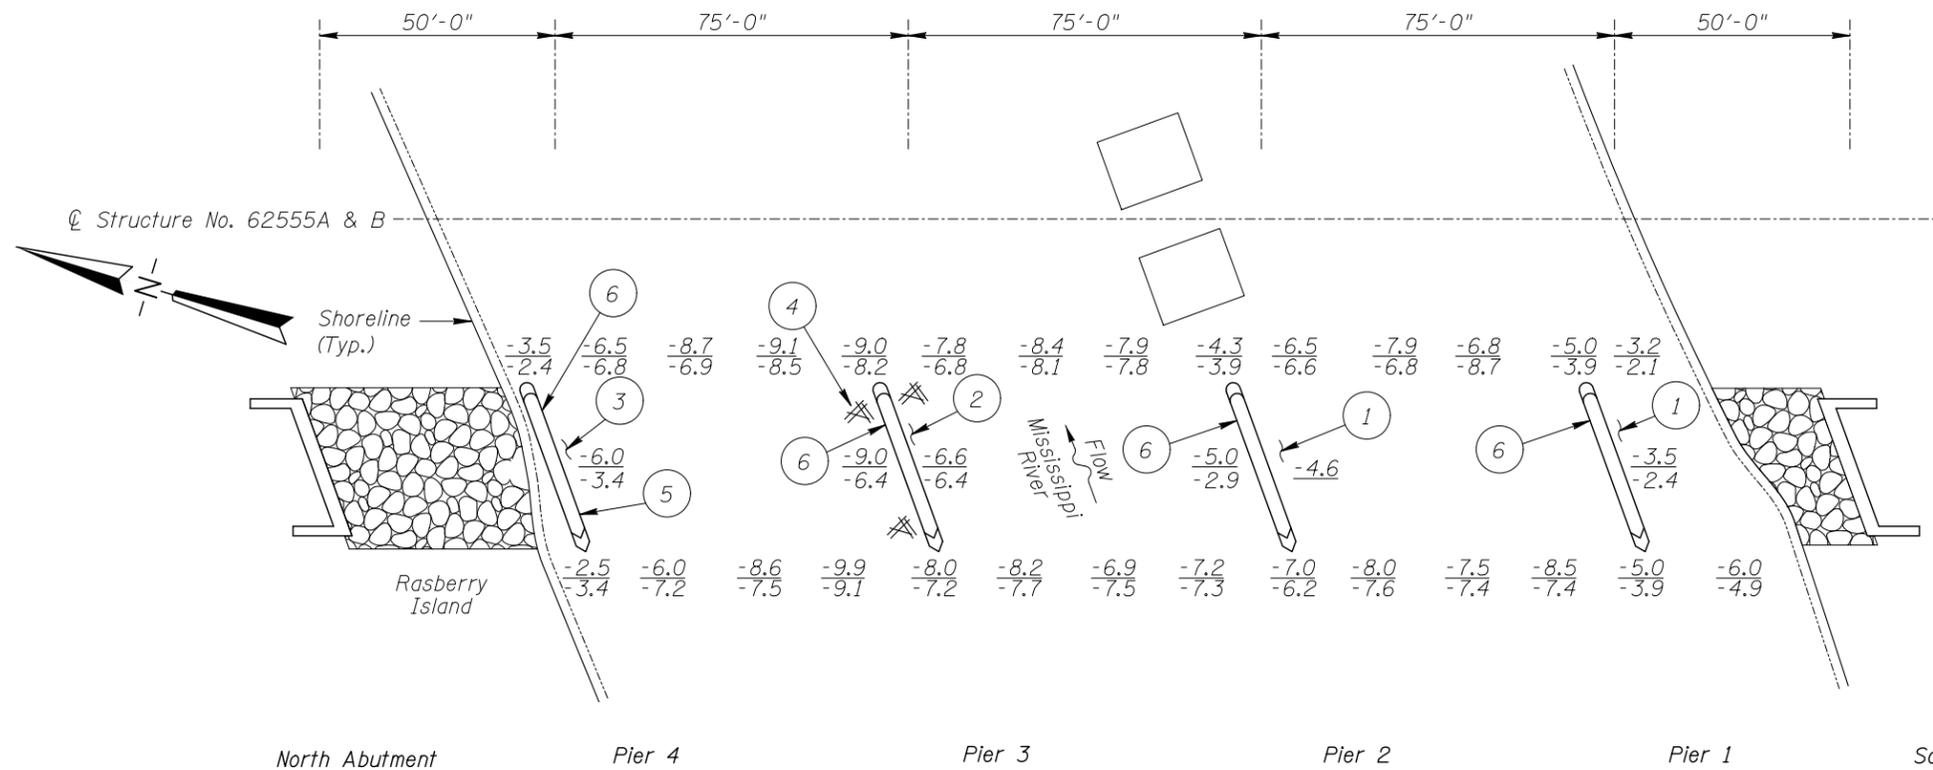
SOUNDING PLAN

- 1 The channel bottom material consisted of 2 inch diameter gravel with random riprap at the upstream end and with minimal probe rod penetration.
- 2 The channel bottom material consisted of sand allowing up to 6 inches of probe rod penetration.

- 3 The channel bottom material consisted of 6 inch diameter cobbles and gravel.
- 4 A minor accumulation of timber debris, with pieces up to 12 inches in diameter, was observed on the channel bottom randomly scattered throughout the piles of Pier 3 extending from channel bottom up 2 to 3 feet.

- 5 Timber formwork and steel angles were observed at the base of the concrete shaft of Pier 4. The bottom of the shaft was poorly formed with rough edges and reinforcing steel protruding from the base.

- 6 The concrete shafts were in good and sound condition and extended 2 feet below the waterline. The submerged steel piles exhibited light surface corrosion with rust nodules up to 1/4 inch in diameter.
