UNDERWATER BRIDGE INSPECTION REPORT

STRUCTURE NO. 6556

MAY 22, 2012

COLLINS ENGINEERS, INC.

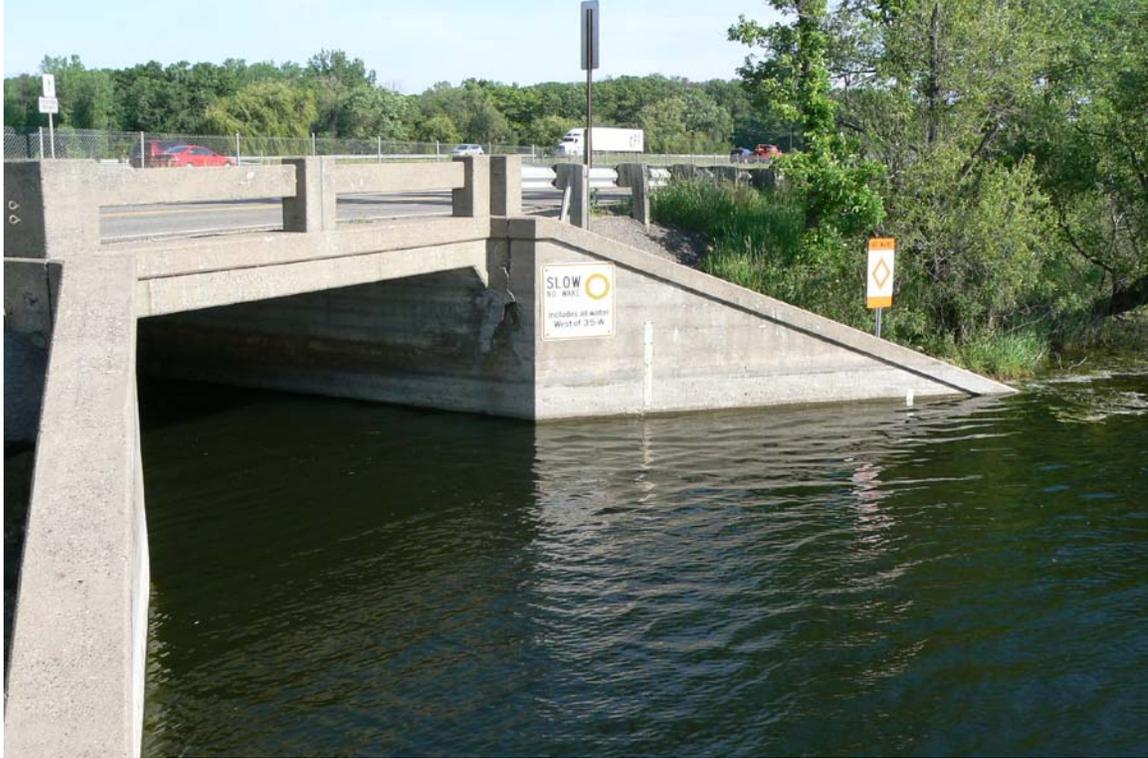
- (A) A spall measuring 3 feet wide by 1 foot high with a typical penetration of 1 inch and a maximum penetration of 2 inches was observed at the east wingwall of the North Abutment extending from 3 feet above the waterline to 2 feet below the top of the wingwall.
- (B) An area of poorly consolidated concrete was observed at the west end of the North Abutment at 5 feet below the waterline. The area measured 2 feet wide by 1 foot high with up to 1.5 inches of penetration.
- (C) The channel bottom material consisted of silt, gravel, and stones up to 12 inches in diameter with up to 4 inches of probe rod penetration.

Photograph 1. View of the North Abutment and Northeast Wingwall, Looking Northwest.

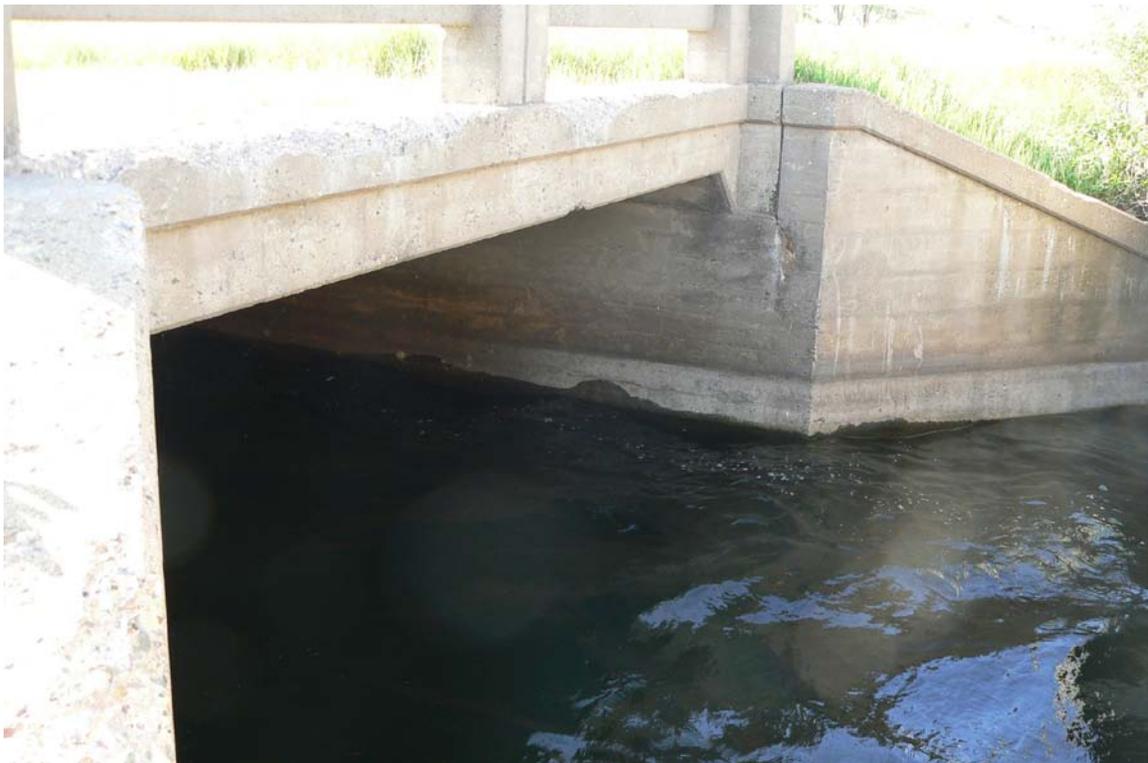
Photograph 2. View of South Abutment and Southwest Wingwall, Looking Southeast.

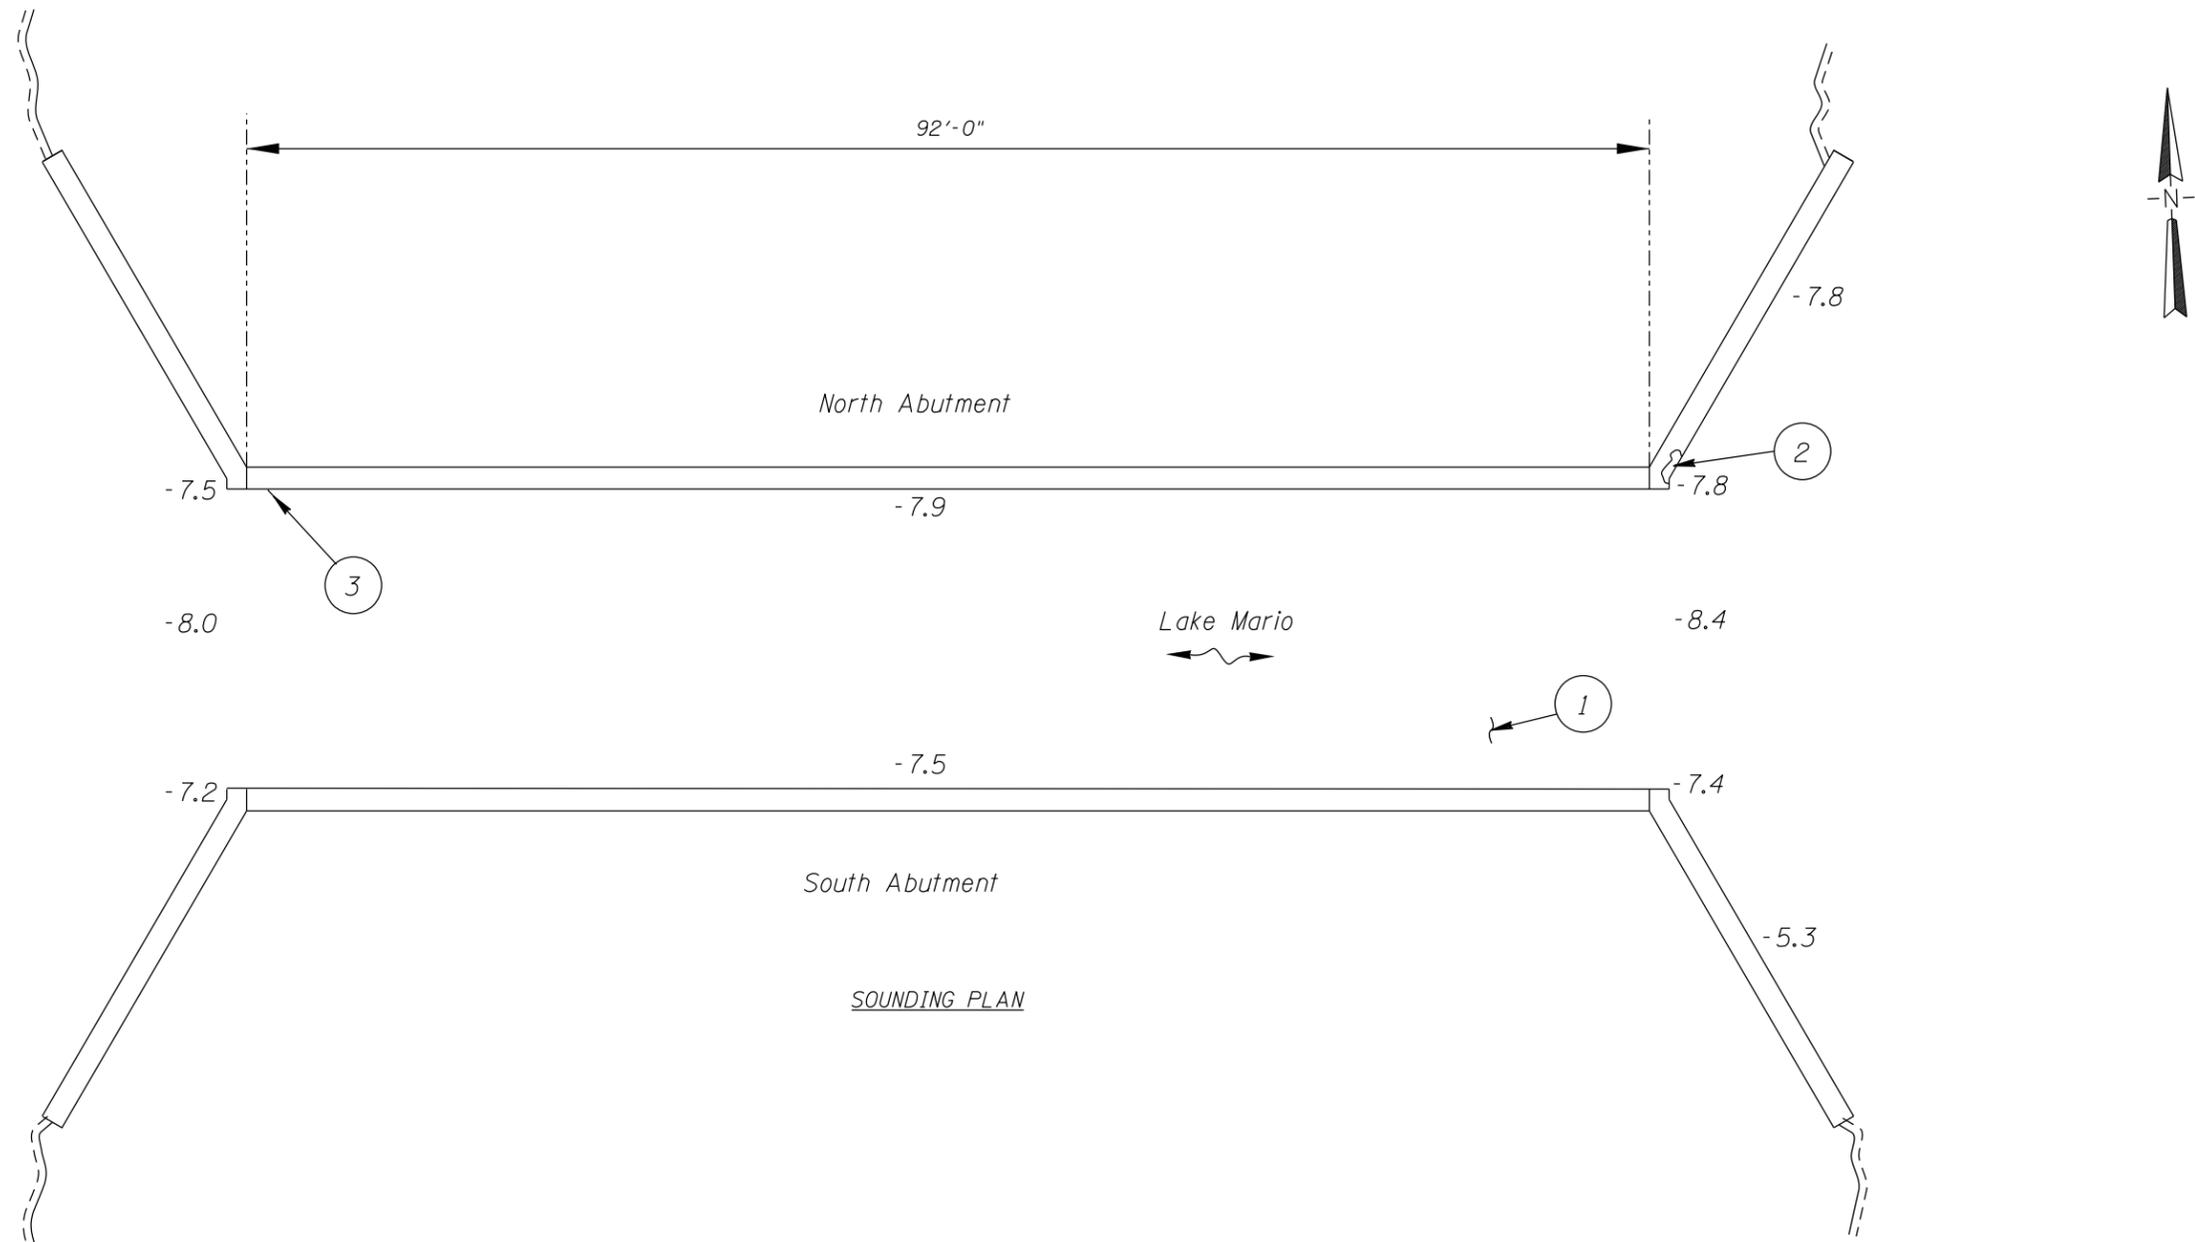
- 1 The channel bottom material consisted of silt, gravel, and stones up to 12 inches in diameter with up to 4 inches of probe rod penetration.
- 2 A spall, 3 feet wide by 1 foot high, with a typical penetration of 1 inch and a maximum penetration of 2 inches was observed at the northeast wingwall extending from 3 feet above the waterline to 2 feet below the top of the headwall. No reinforcing steel was exposed.
- 3 Area of poorly consolidated concrete at the west end of the North Abutment at 5 feet below the waterline. The area measured 2 feet wide by 1 foot high with a maximum penetration of 1.5 inches.
