UNDERWATER BRIDGE INSPECTION REPORT

STRUCTURE NO. 70002

THE MINNESOTA RIVER

JOB NO. 2107

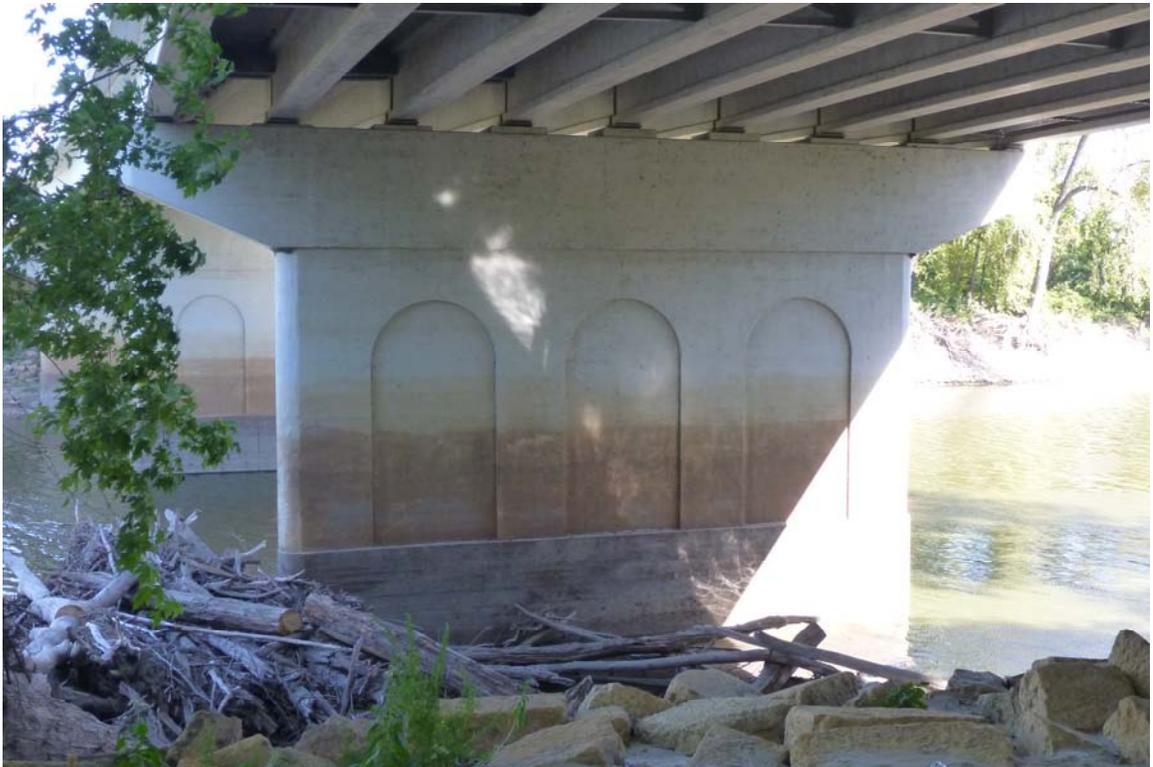
Photograph 2. View of Pier 3, Looking Northwest

- 4 A very heavy accumulation of timber debris consisting of mixed sized drift pieces up to 2.5 feet in diameter, was observed extending across the upstream nose and along both faces of Pier 3. The debris extended up to 50 feet off the pier nose and face and onto the south embankment.

- (A) Remove the timber debris at Piers 3 and 4. The current extent of debris can adversely affect the scour conditions at the bridge and creates a potential for significant lateral forces exerted on the substructure.

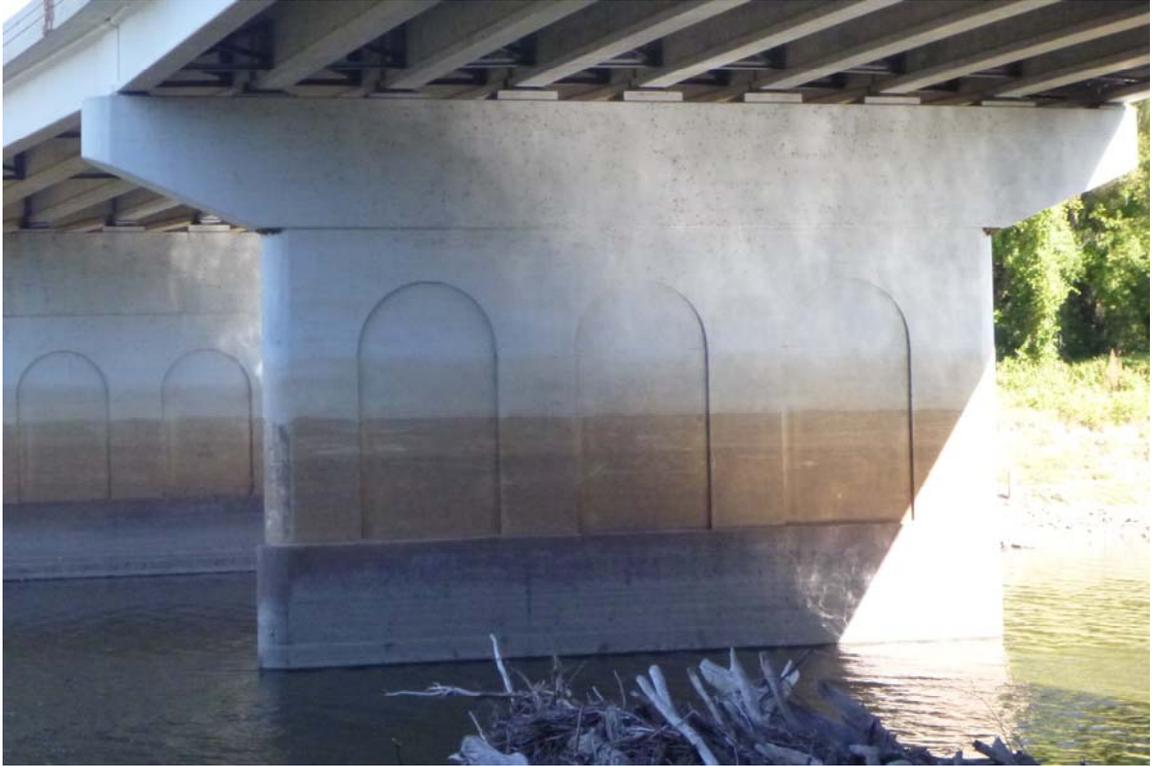
Photograph 3. View of Pier 4 and Timber Debris, Looking North.

- 5 The channel bottom of Pier 4 consisted of silt, gravel, and clay with up to 6 inches of penetration.
- 6 A moderate accumulation of timber debris consisting of 12 inch diameter and smaller logs and branches was observed from the upstream nose to the upstream quarter points on both sides of Pier 4, extending from the channel bottom up approx. 5 feet.

- 7 A scour depression 5 feet in radius by 2 feet deep was observed at the upstream end of Pier 4.
- 8 The channel bottom of Pier 5 consisted of clay and silt with up to 1.5 feet of probe rod penetration and also stones 6 inches in diameter located at the upstream end.

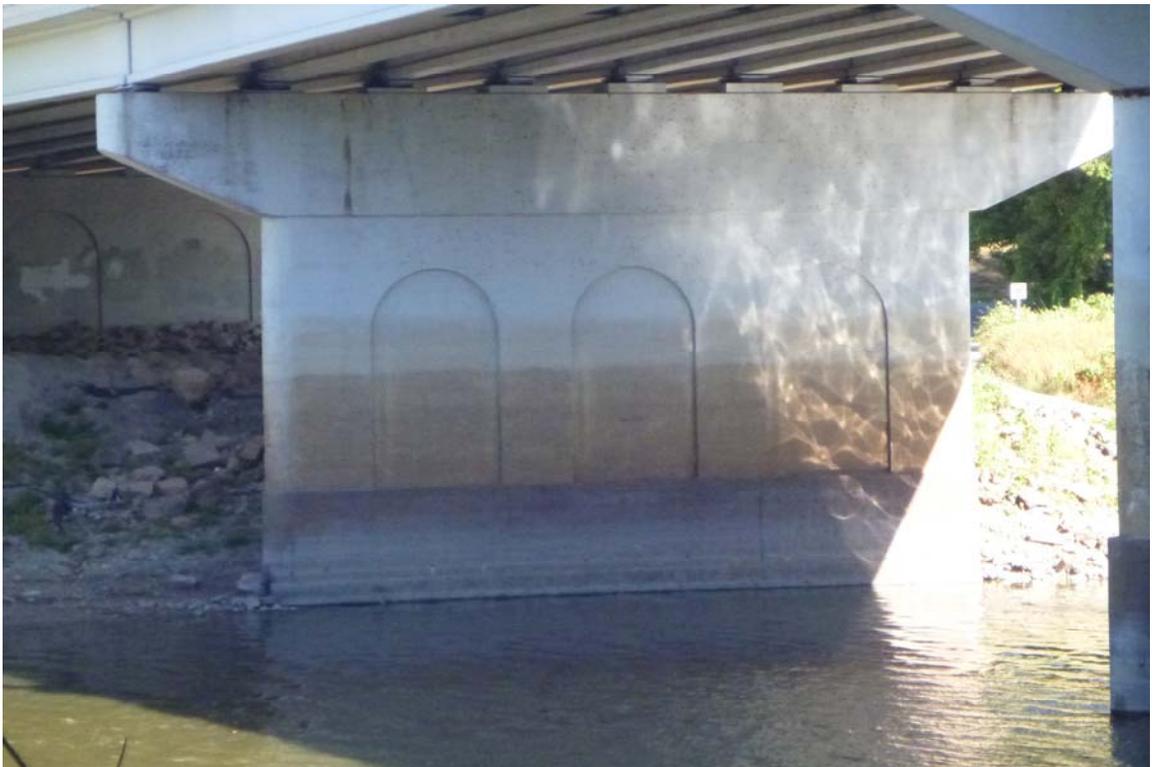
Photograph 4. View of Pier 5, Looking North.

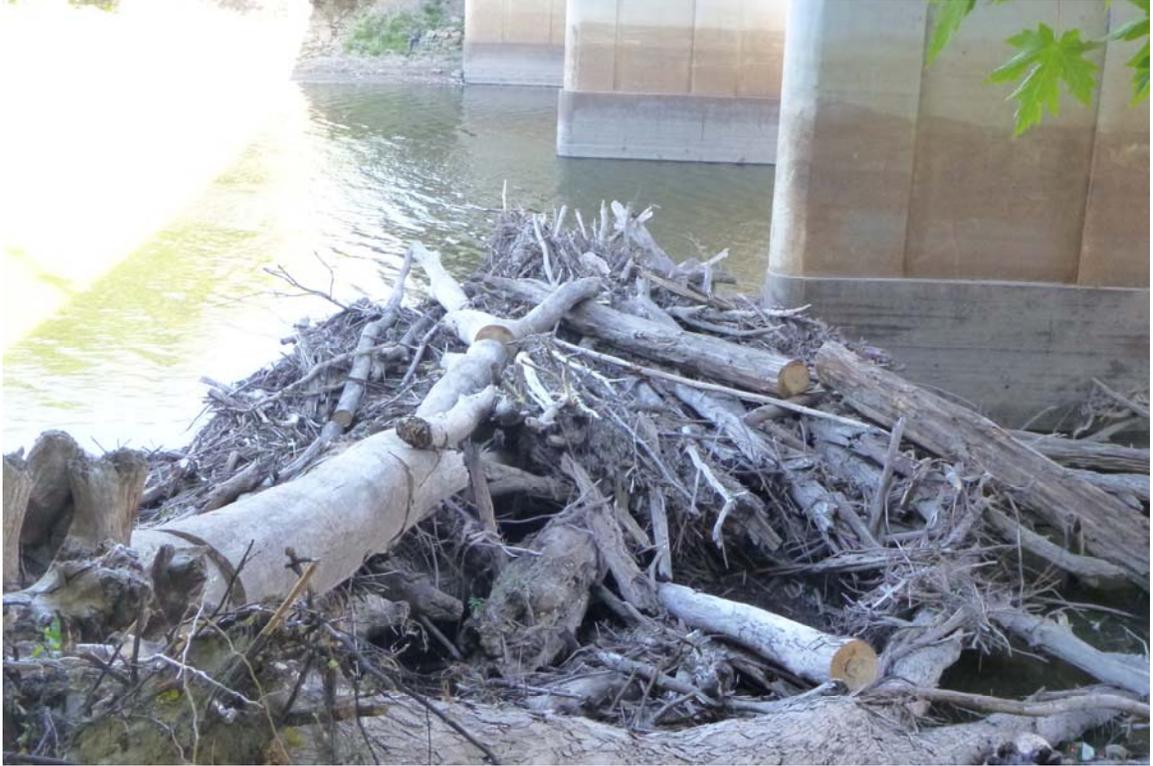
Photograph 5. View of Timber Debris at Pier 3, Looking Northwest.

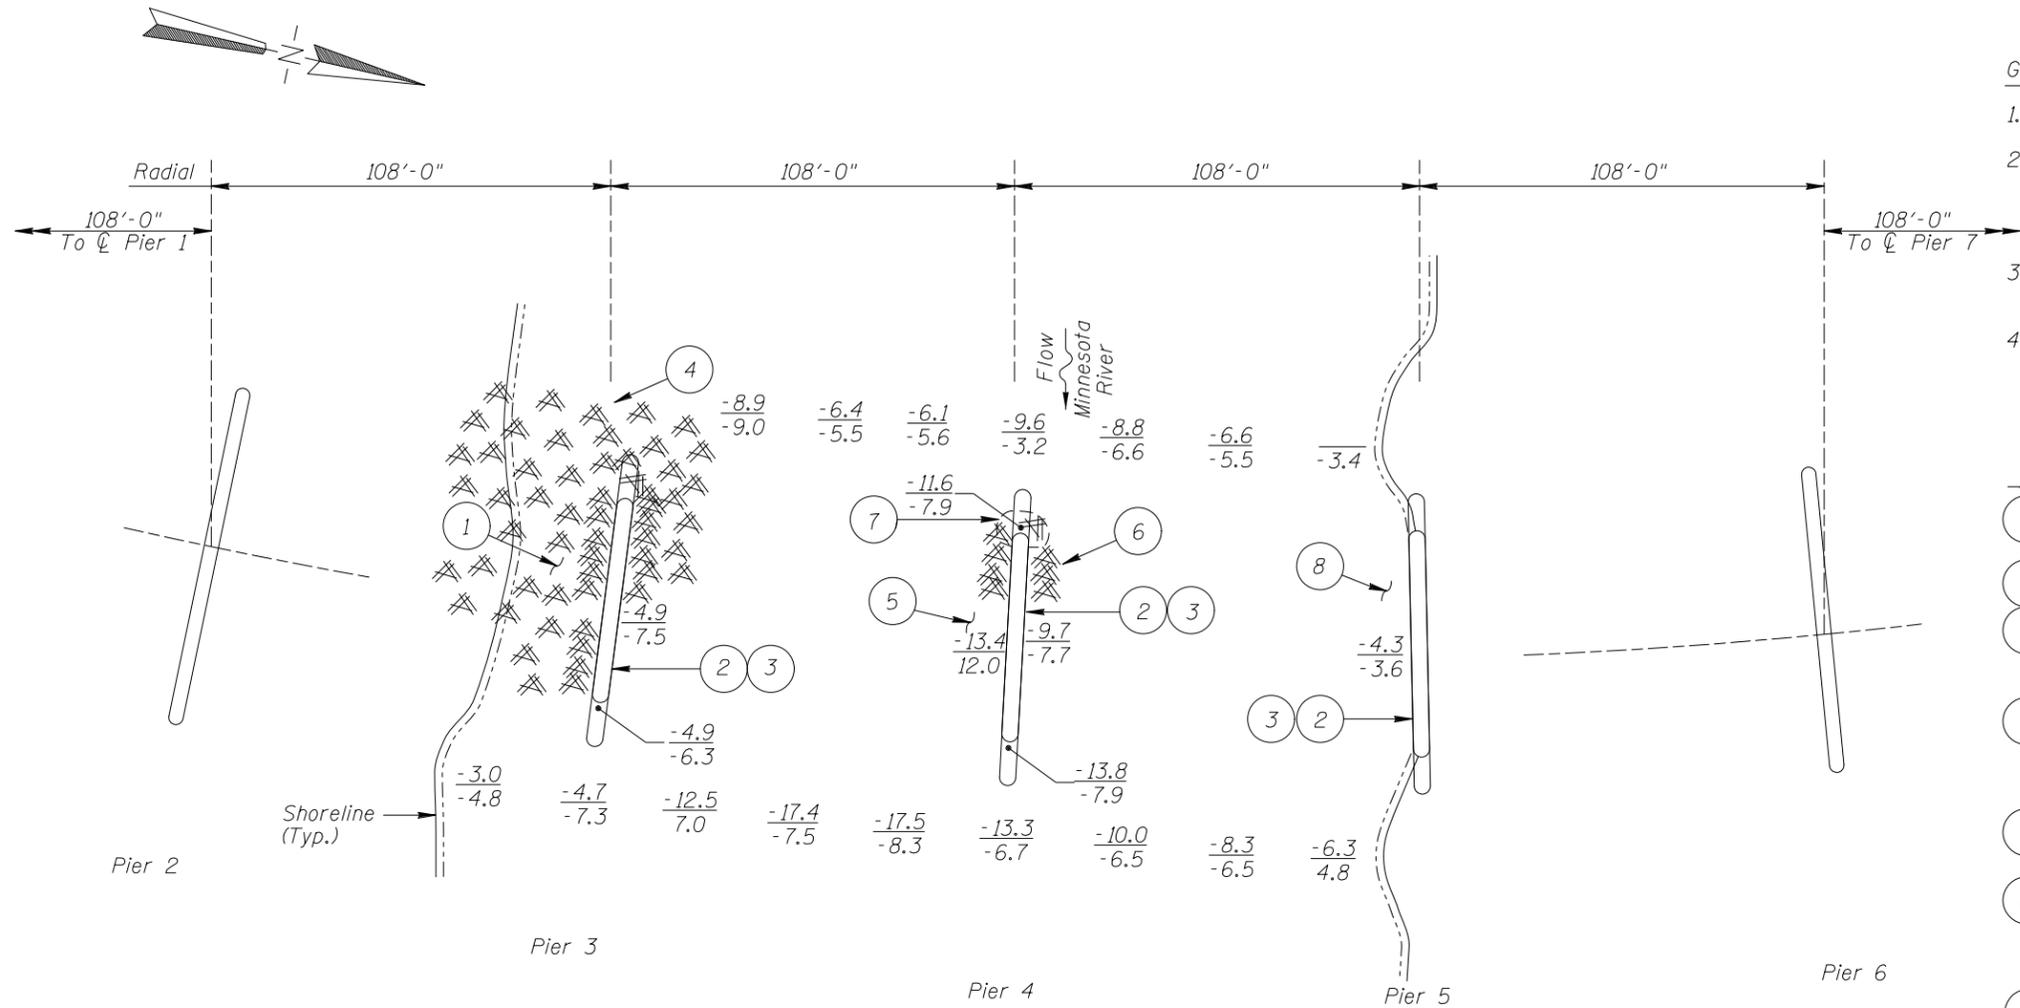
INSPECTION AND SOUNDING PLAN

- 1 The channel bottom at Pier 3 consisted of gravel with silt with up to 1 foot of probe rod penetration.
- 2 The concrete was smooth and sound at all of the piers.

- 3 Random vertical cracks with efflorescence were observed from the top of the shaft ledge to the channel bottom. There were typically two cracks on each pier located near the third points with 1/8 inch maximum width.
