UNDERWATER BRIDGE INSPECTION REPORT

STRUCTURE NO. 70532

CSAH NO. 9

MINNESOTA RIVER

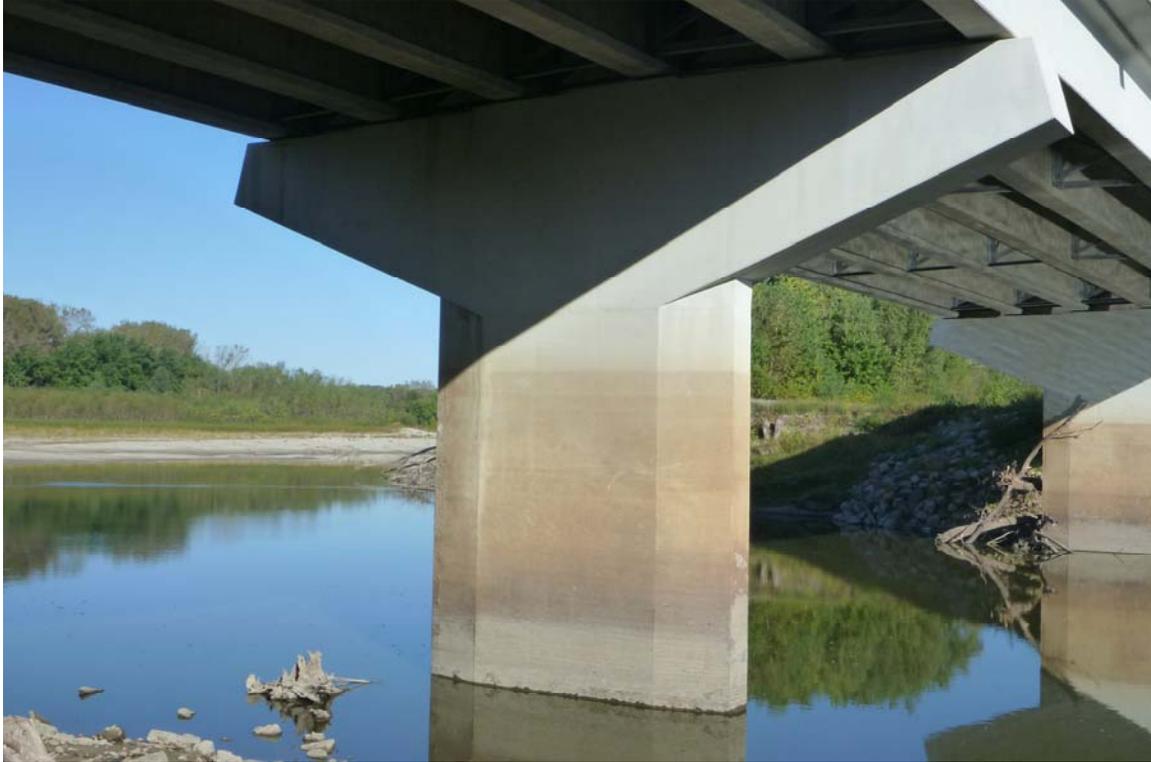
Photograph 1. View of Pier 1 and Timber Debris, Looking Northwest.

- 3 A moderate accumulation of timber debris, consisting of up to 12 inch diameter drift pieces, was observed at the upstream nose of Pier 1, extending up to 5 feet off the pier nose and from the channel bottom to the waterline.

Consider removing the timber debris during future maintenance operations.

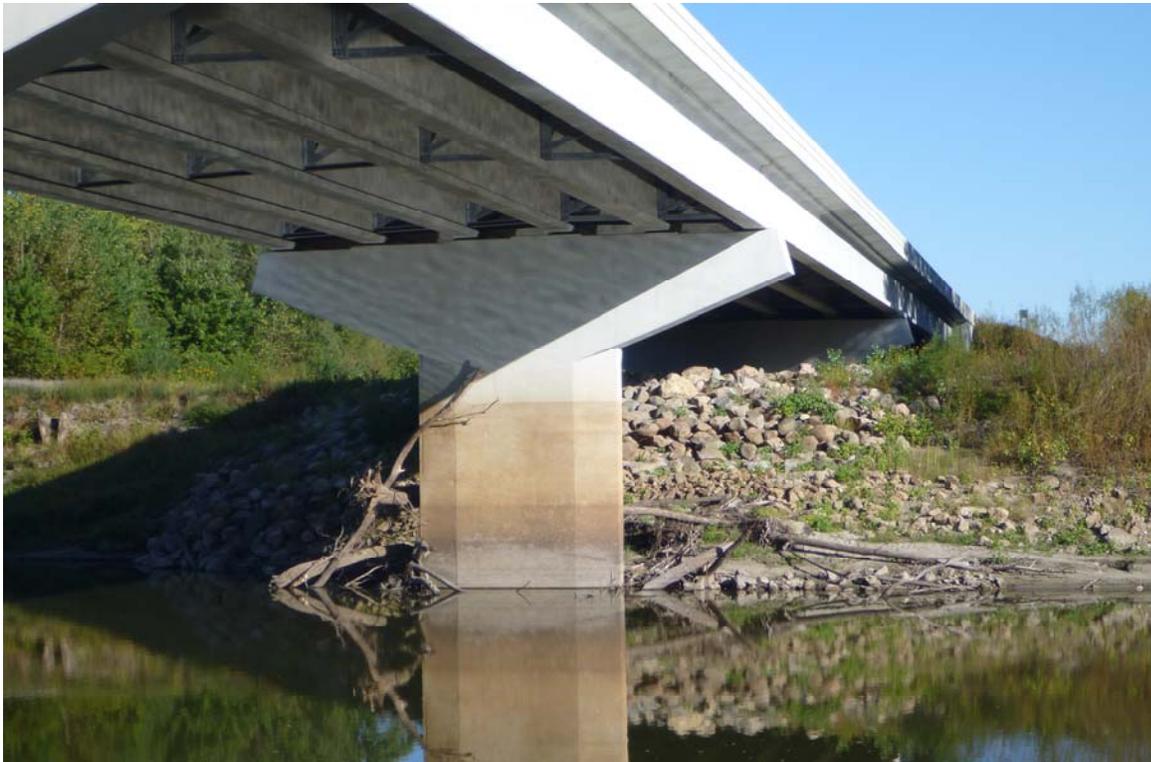
Photograph 2. View of Pier 2, Looking Northwest.

- INSPECTION NOTES:**
- 1 The channel bottom consisted of firm silty clay with a maximum probe rod penetration of 3 inches.
  - 2 A heavy accumulation of timber debris consisting of logs and branches 18 inches in diameter and smaller was observed around the entire perimeter of Pier 2 extending 10 feet off the upstream nose and faces and from the channel bottom to 7 feet above the waterline.

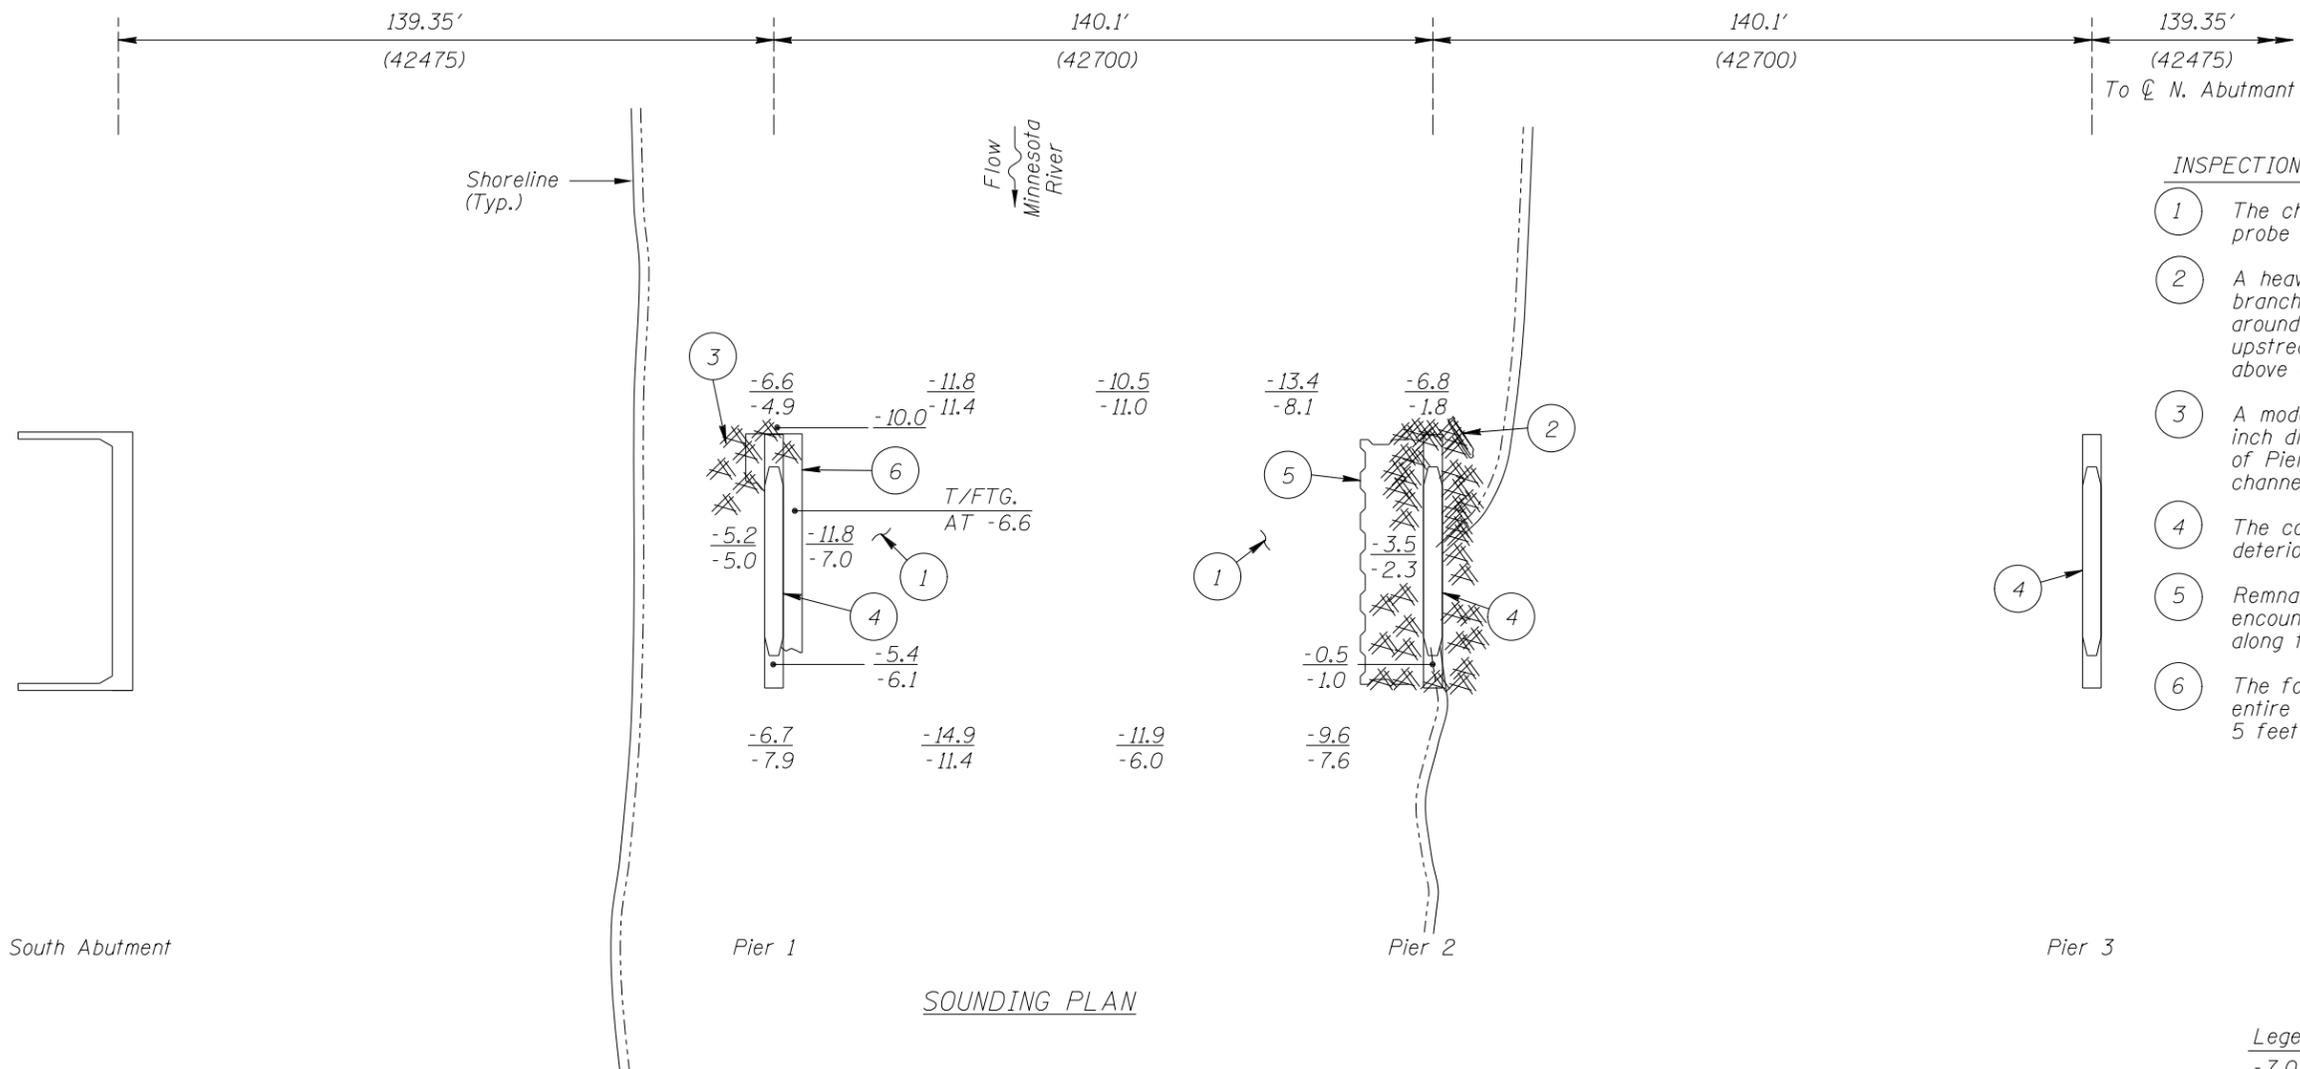
- 4 The concrete was smooth and sound with no notable defects or deterioration.
  - 5 Remnants of a old abandoned sheet pile cofferdam were encountered extending 2 to 3 feet up out of the channel bottom along the south face of pier 2.

- 6 The footing was exposed at the upstream nose and along the entire north face of Pier 1 with a maximum vertical exposure of 5 feet near the midpoint of the pier.

Consider placement of scour countermeasures to inhibit any further foundation exposure at Pier 1. Considerations should also be given to performing scour analysis of the bridge.

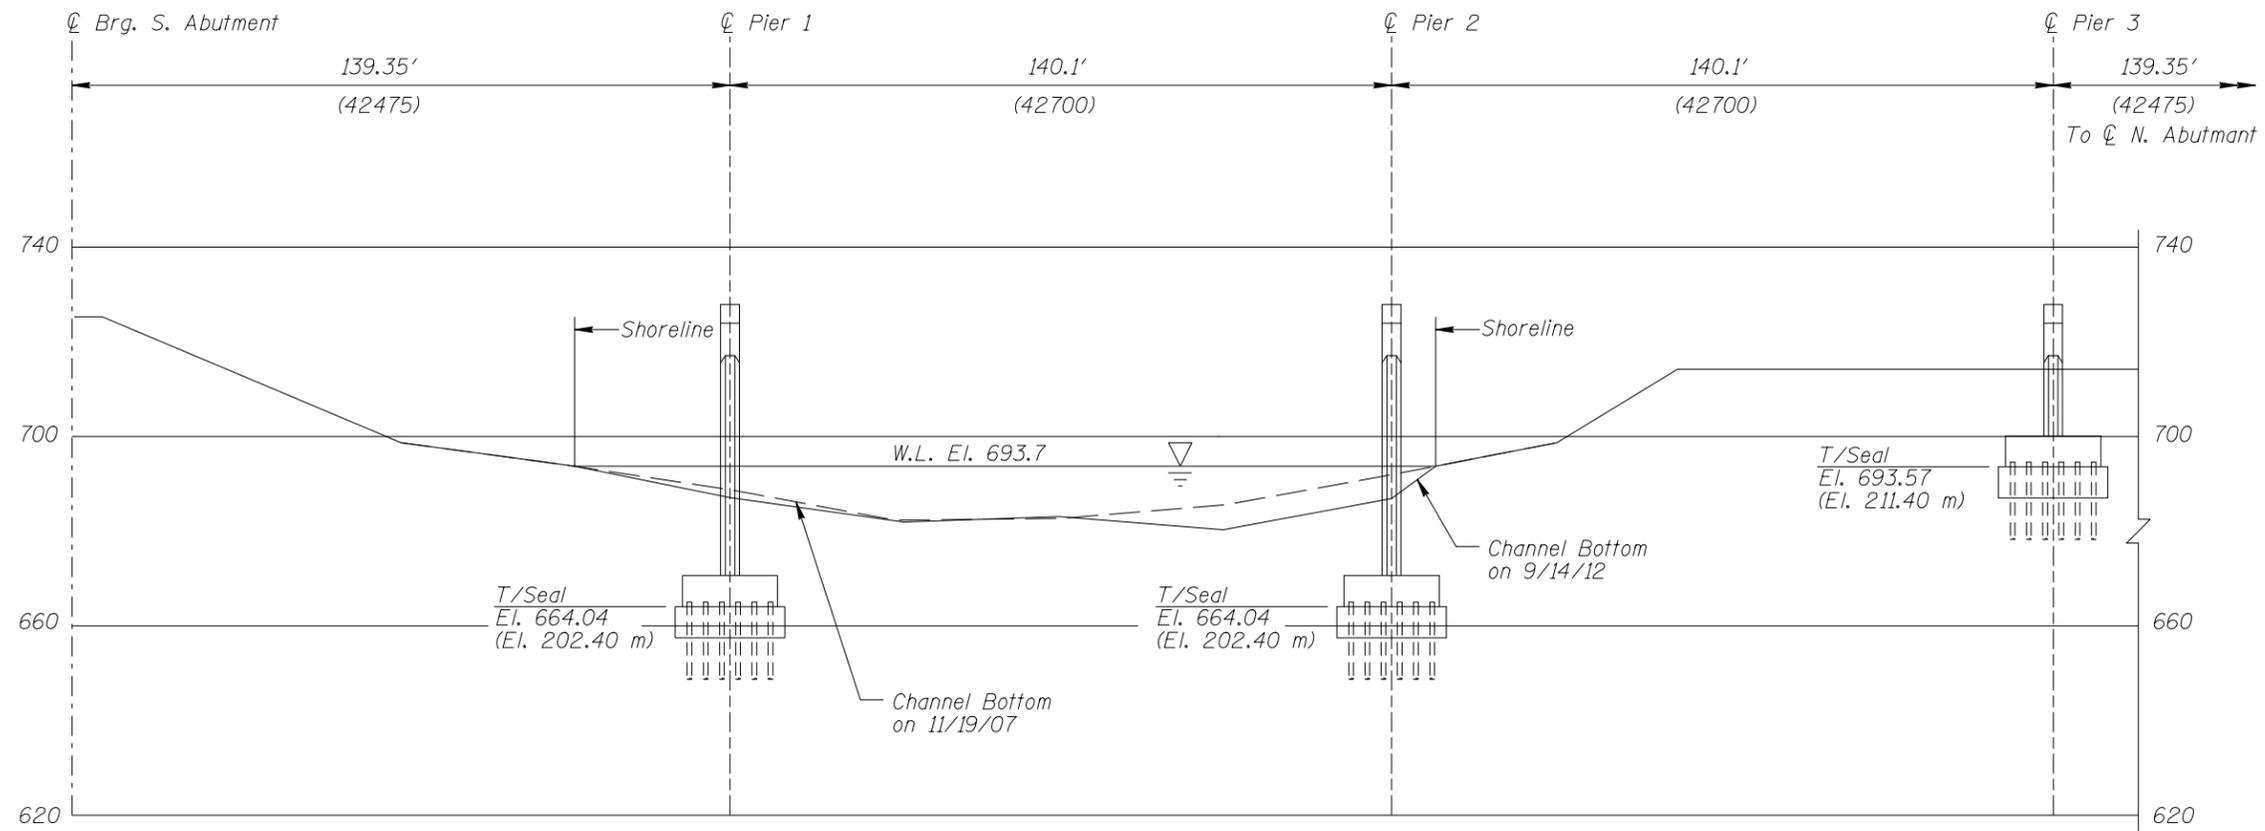
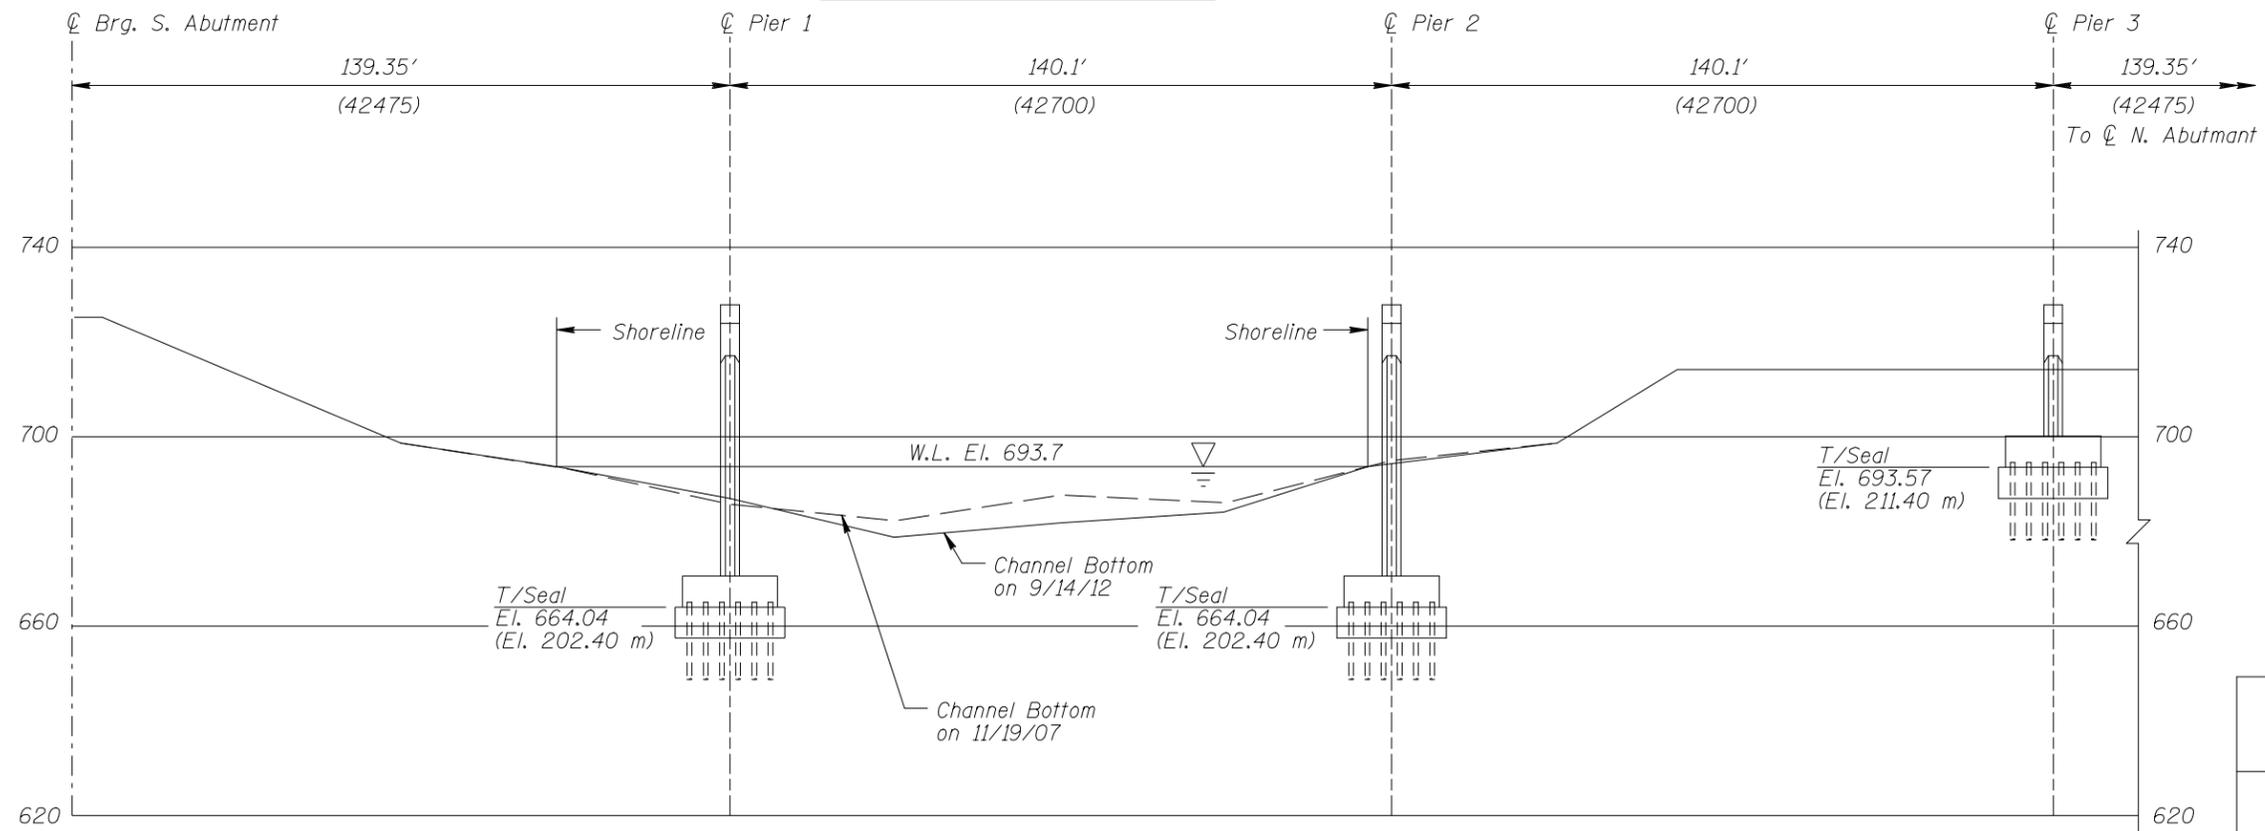
UPSTREAM FASCIA PROFILE

DOWNSTREAM FASCIA PROFILE
