UNDERWATER BRIDGE INSPECTION REPORT

STRUCTURE NO. 70535

CSAH NO. 1

MINNESOTA RIVER

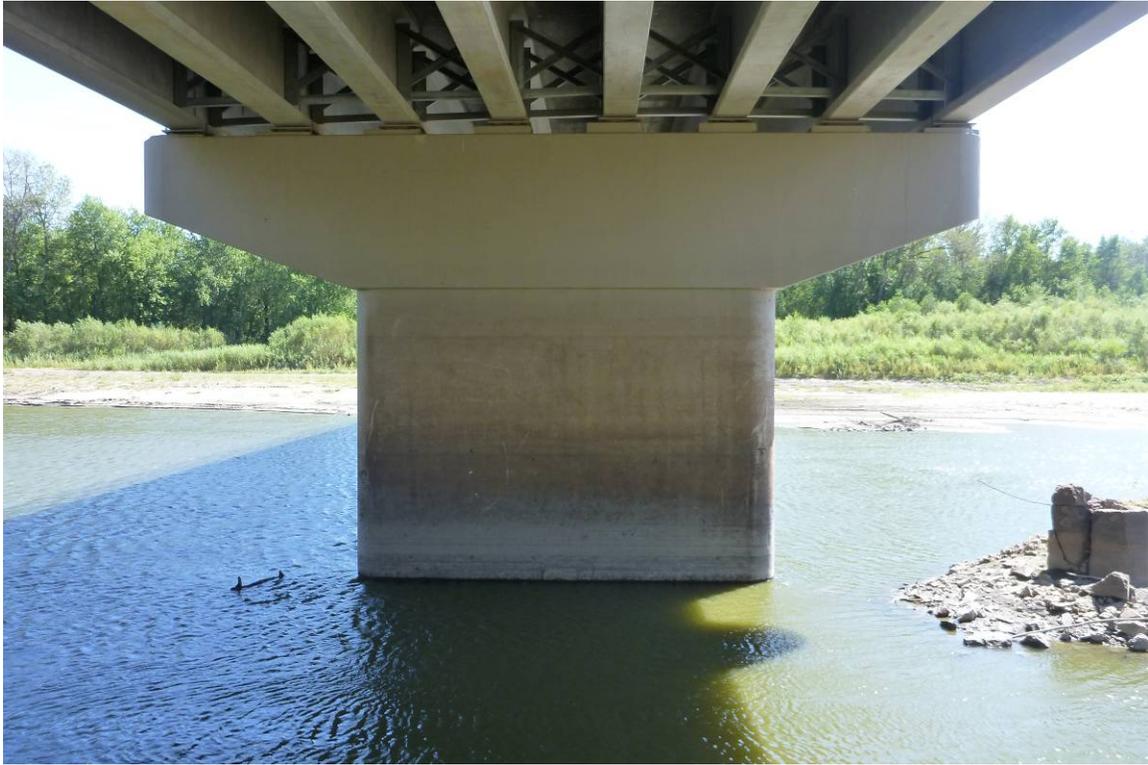
Photograph 1. View of Pier 1, Looking East.

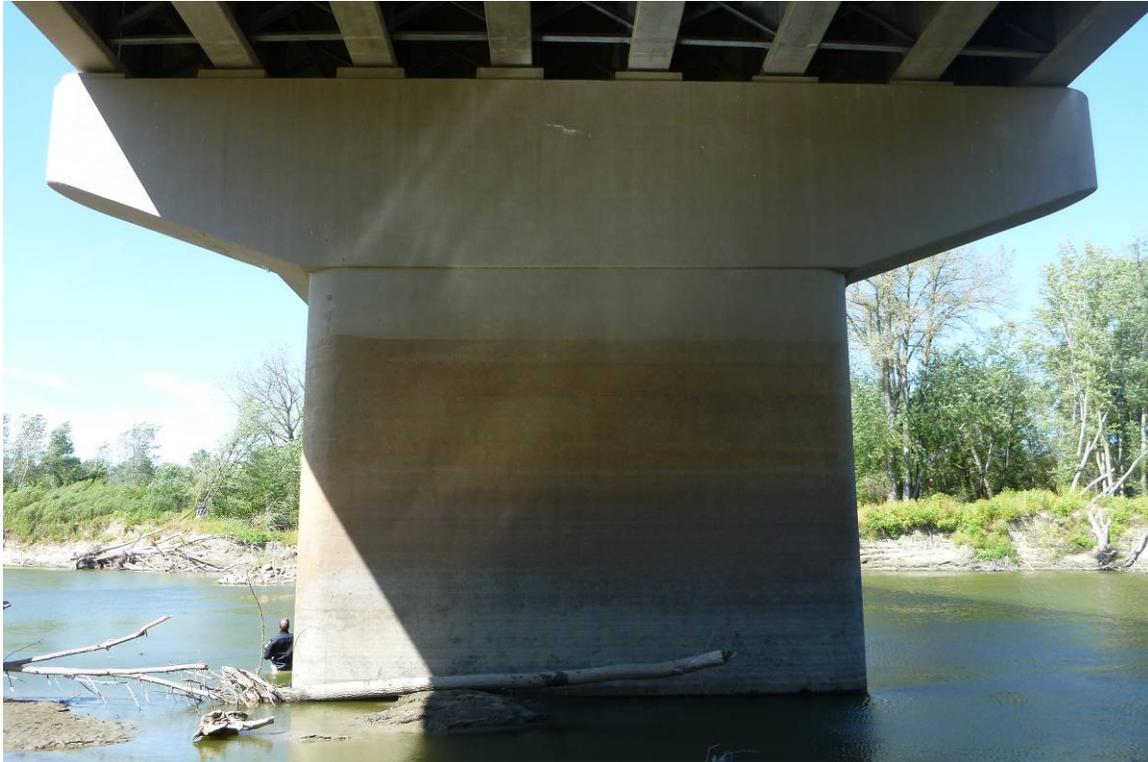
Photograph 2. View of Pier 2, Looking West.

Monitor the extent of the timber debris accumulation at Pier 2, and if found to be increasing, removal during routine maintenance may become necessary.

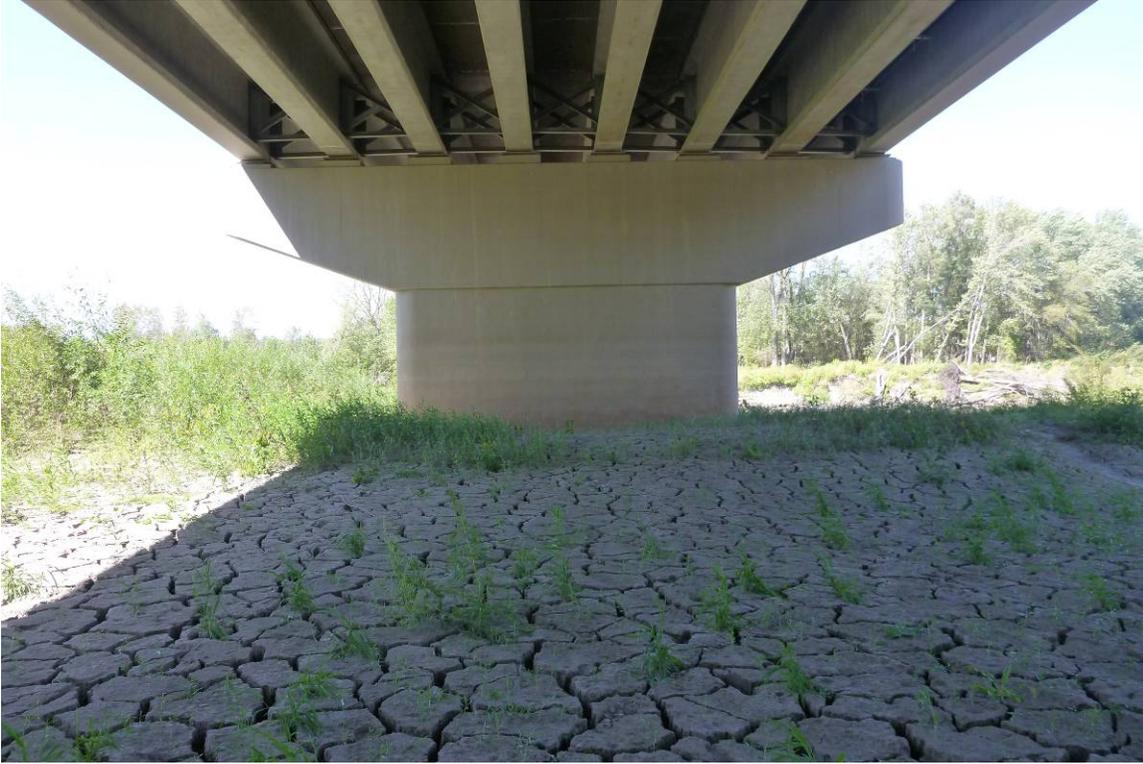
Photograph 3. View of Pier 3, Looking West.

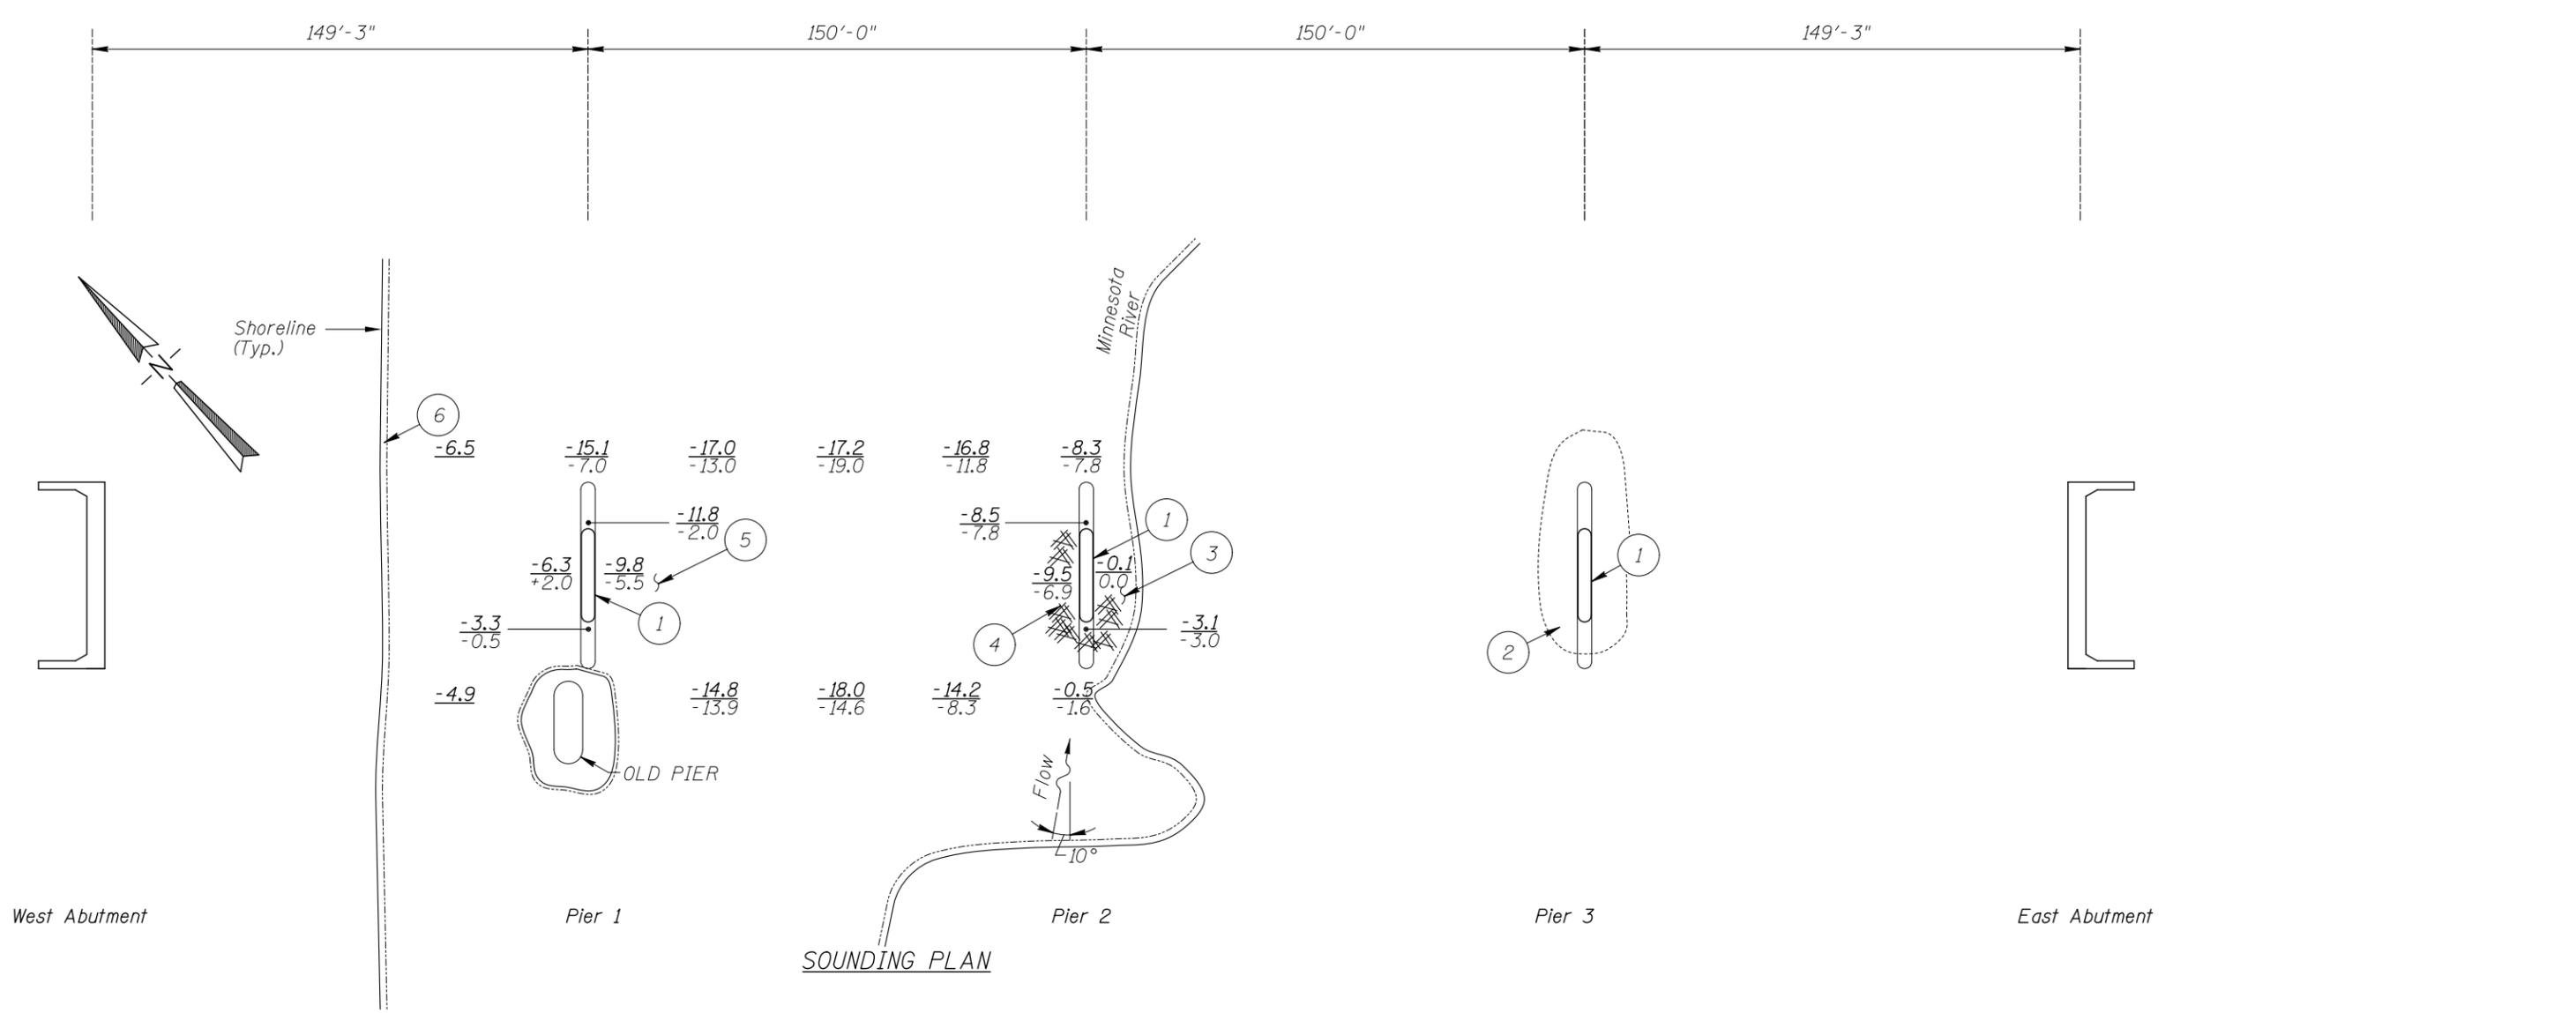
- 1 The concrete was smooth and sound with no notable defects.
- 2 A 10 foot radius scour depression 5 to 6 feet deep was observed all around the perimeter of Pier 3. The scour hole was dry at the time of inspection.
- 3 The channel bottom consisted of silty clay and rocks with 12 inches maximum probe rod penetration.
- 4 A moderate accumulation of timber debris consisting of 1-foot-diameter and smaller logs and branches was observed at the upstream nose of Pier 2 from the channel bottom up 4 feet and along the west face from the upstream end of the midpoint from the channel bottom up 2 feet.
- 5 The channel bottom consisted of silty clay with 6 inches maximum probe rod penetration along the east face and 6" diameter rocks along the west face of Pier 1.
- 6 Heavy embankment erosion along the west shoreline consisting of up to 15 foot high vertical banks.
