UNDERWATER BRIDGE INSPECTION REPORT

STRUCTURE NO. 90608
MINNETONKA BOULEVARD
OVER
ST. ALBAN'S BAY
DISTRICT 5 – CITY OF EXCELSIOR AND CITY OF GREENWOOD

JUNE 6, 2012

PREPARED FOR THE
MINNESOTA DEPARTMENT OF TRANSPORTATION

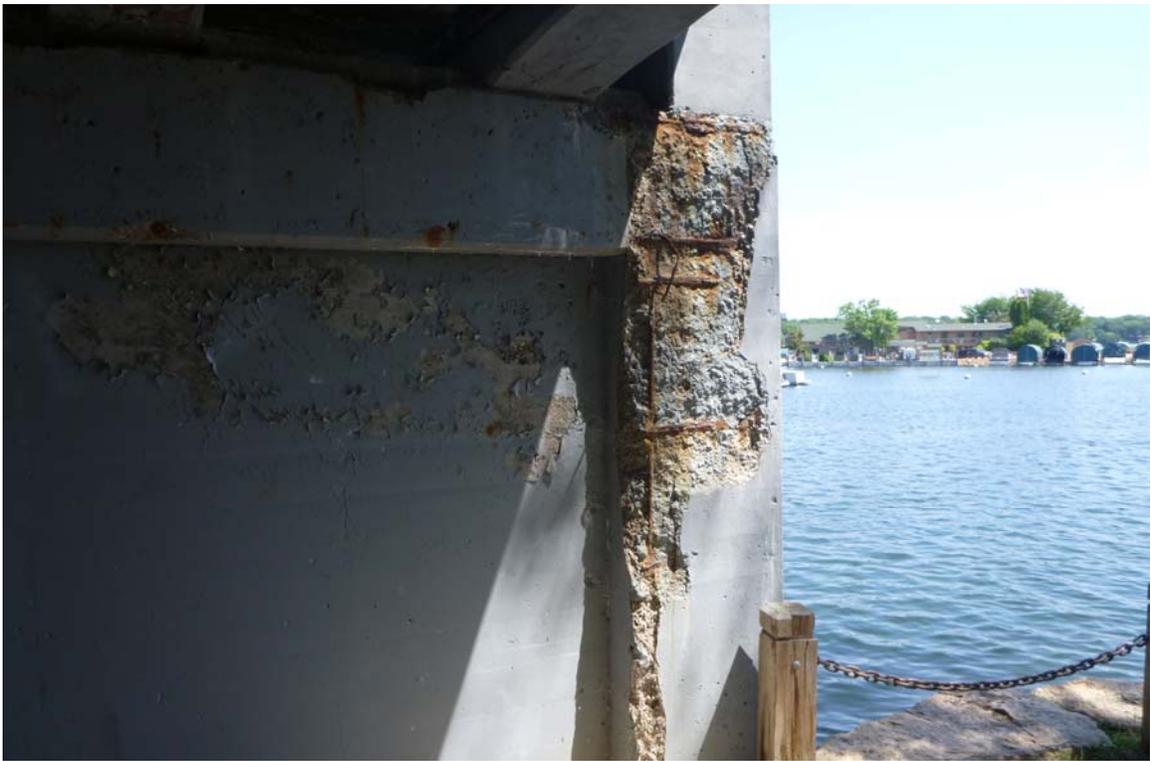
- (F) A spall with exposed reinforcing steel was observed on the southwest corner of east end of Pier 1 extending from the top of the pier cap to 3 feet above the waterline and measuring up to 3 feet in width with penetrations up to 3 inches deep. Exposed reinforcing steel exhibited up to 50% section loss.

- (G) A spall with exposed reinforcing steel was observed on the northwest corner of the east end of Pier 1 extending from the top of the pier cap to the waterline and measuring 6 to 18 inches wide with penetrations up to 5 inches deep and 25% section loss of the reinforcing steel.

Photograph 2. View of Spall at the East End of Pier 1 with Exposed Reinforcing Steel, Looking Northeast.

- (A) To inhibit further, more detrimental deterioration, repair the areas of section loss (spalling with exposed reinforcing steel) by removing all unsound concrete, cleaning the reinforcing steel, and patching with a concrete mix designed to promote high durability and low permeability.

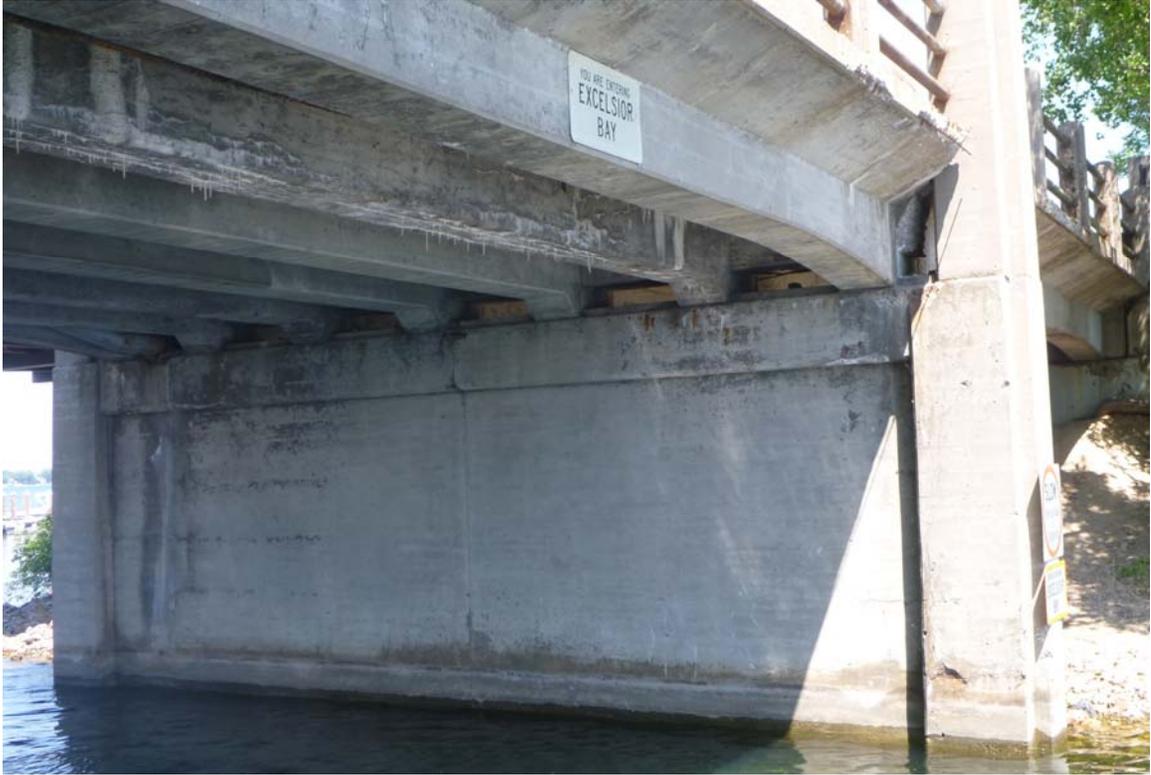
Photograph 3. View of Pier 2, Looking Northwest.

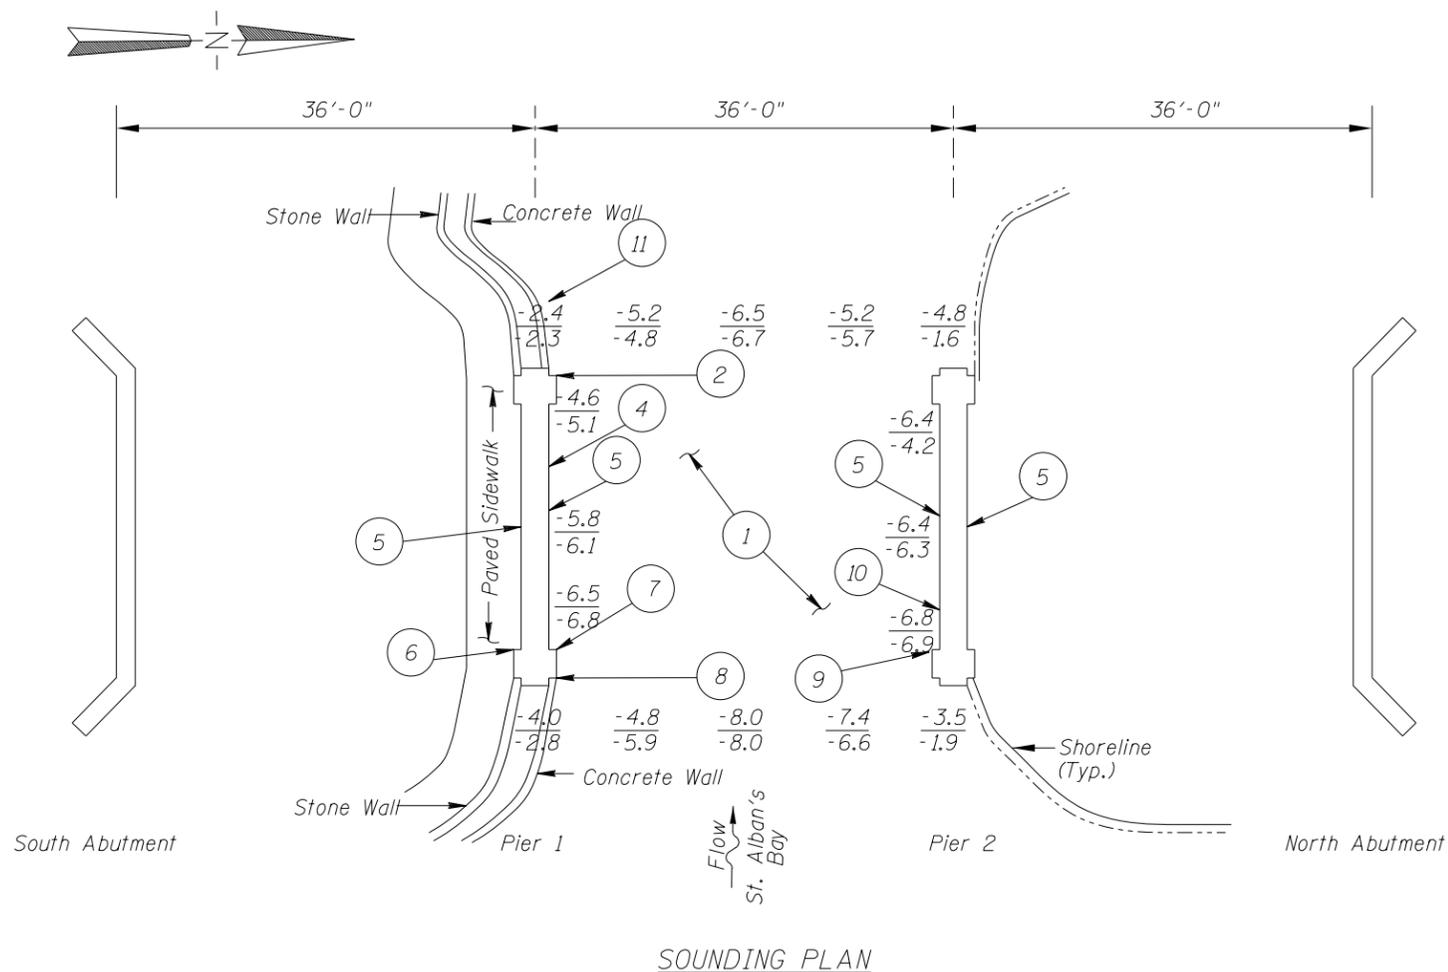
- 1 The channel bottom material consisted of sand with up to 4 inches probe rod penetration. The channel bottom material along Pier 1 consisted of 1 to 2 inch diameter stone with no appreciable probe rod penetration. The channel bottom material along Pier 2 consisted of sand and gravel with up to 2 inches of probe rod penetration.

- 2 A spall with associated cracking was observed on the northwest corner of the west end of Pier 1 and was located at the waterline measuring 10 inches high by 18 inches wide with 1 inch maximum penetration.

- 3 A 1/16 inch layer of marine growth was observed on all below water surfaces.
- 4 Two horizontal cracks up to 1/8 inch wide were observed near the waterline. The cracks extended from the midpoint of the pier to the west end.

- 5 A vertical crack along the construction joint was observed near the center of the pier and extended from the top of the pier cap to the channel bottom with 1/8 inch maximum width. Minor section loss and differential movement up to 1/8 inch was observed in the north face crack on Pier 1 from the waterline to the channel bottom.

- 6 A spall with exposed reinforcing steel was observed on the southwest corner of east end of Pier 1 extending from the top of the pier cap to 3 feet above the waterline and measuring up to 3 feet in width with penetrations up to 3 inches deep. Exposed reinforcing steel exhibited up to 50% section loss.

- 7 A spall with exposed reinforcing steel was observed on the northwest corner of the east end of Pier 1 extending from the top of the pier cap to the waterline and measuring 6 to 18 inches wide with penetrations up to 5 inches deep and 25% section loss for the reinforcing bars.

- 8 A spall with associated cracks was observed on northeast corner of the east end of Pier 1 from 1.5 feet to 3.5 feet above the waterline. Area measured 8 inches wide with 2 inch penetration with no exposed reinforcing steel.

- 9 A spall with exposed reinforcing steel was observed at the southwest corner at the east end of Pier 2 and was located from 2 to 4 feet above the waterline. Area was up to 15 inches wide with a maximum penetration of 1.5 inch. The exposed reinforcing steel exhibited up to 50% section loss.

- 10 Three horizontal cracks were observed from waterline up 4 feet. The cracks typically extended along the entire south face of the pier and were up to 1/16 inch wide.

- 11 The west end of the concrete river wall was undermined along a 3 foot length with a cavity measuring 6 inches high with up to 2 feet of horizontal penetration.

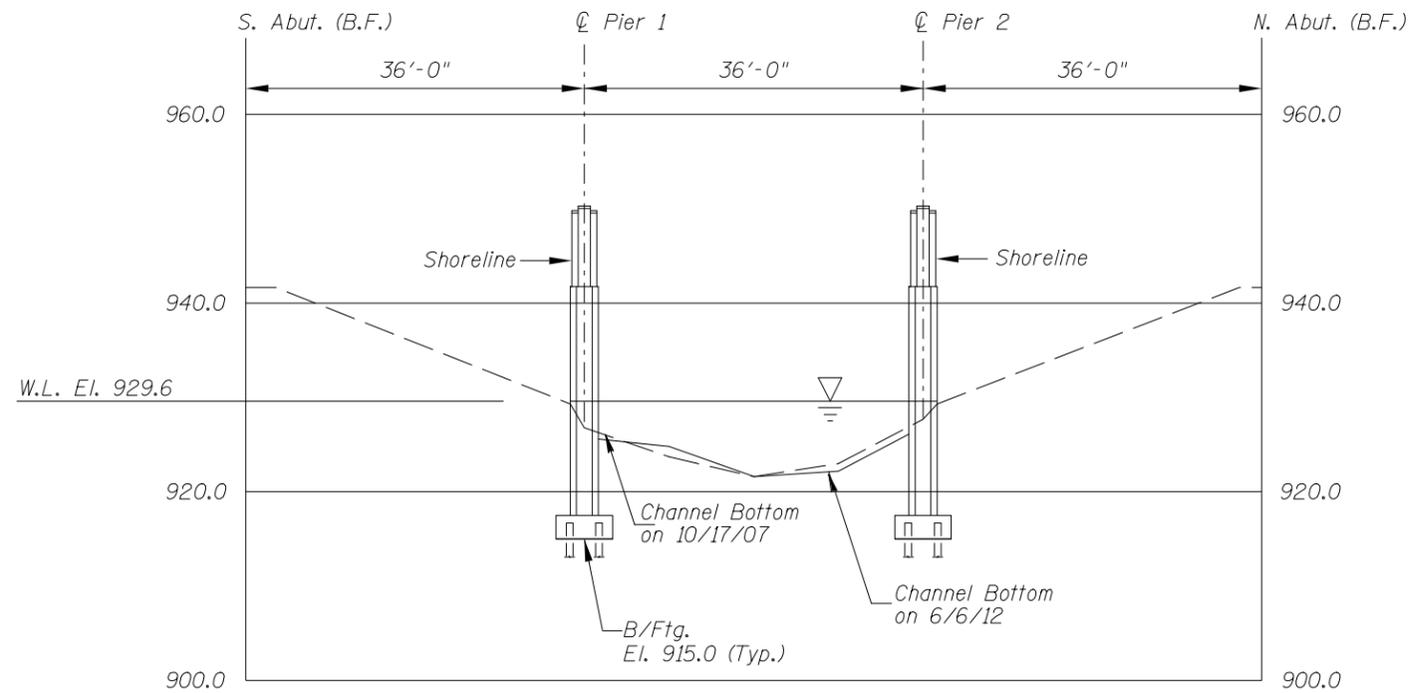
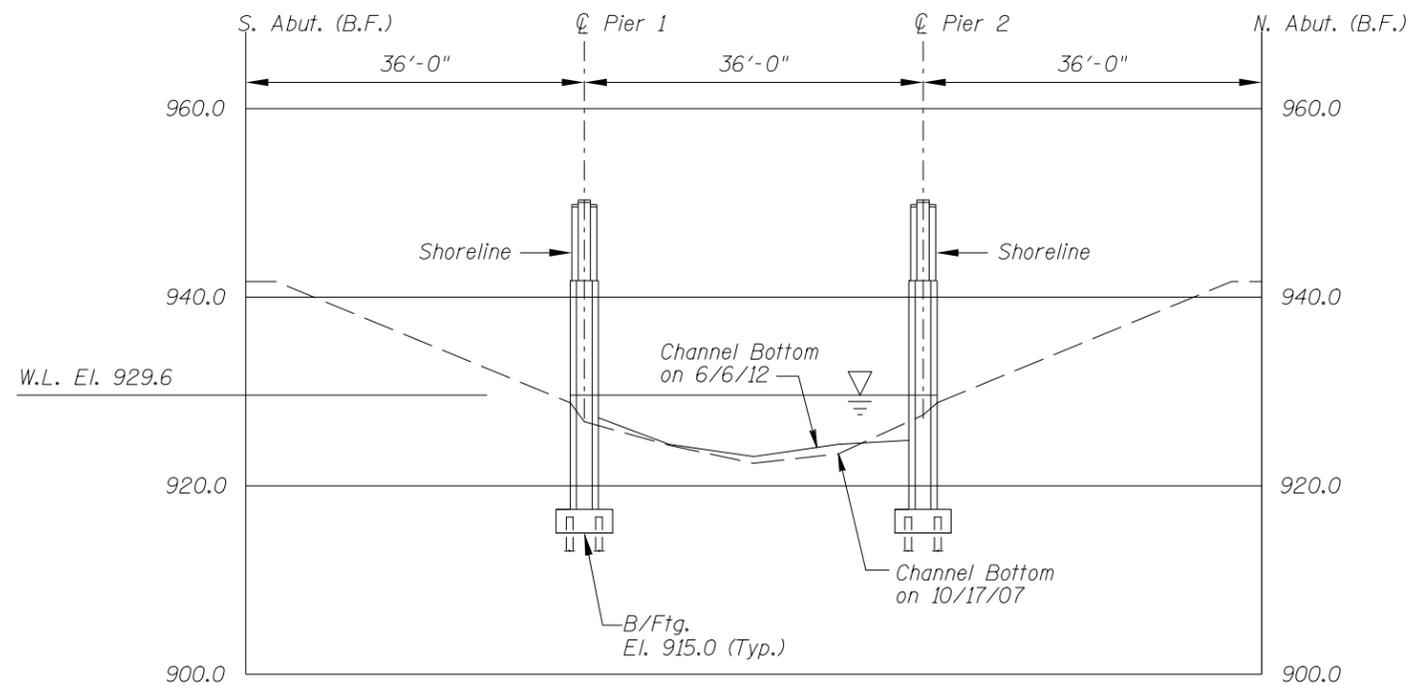
UPSTREAM FASCIA PROFILE

DOWNSTREAM FASCIA PROFILE
