UNDERWATER BRIDGE INSPECTION REPORT

STRUCTURE NO. 9360

MISSISSIPPI RIVER

OCTOBER 29, 2012

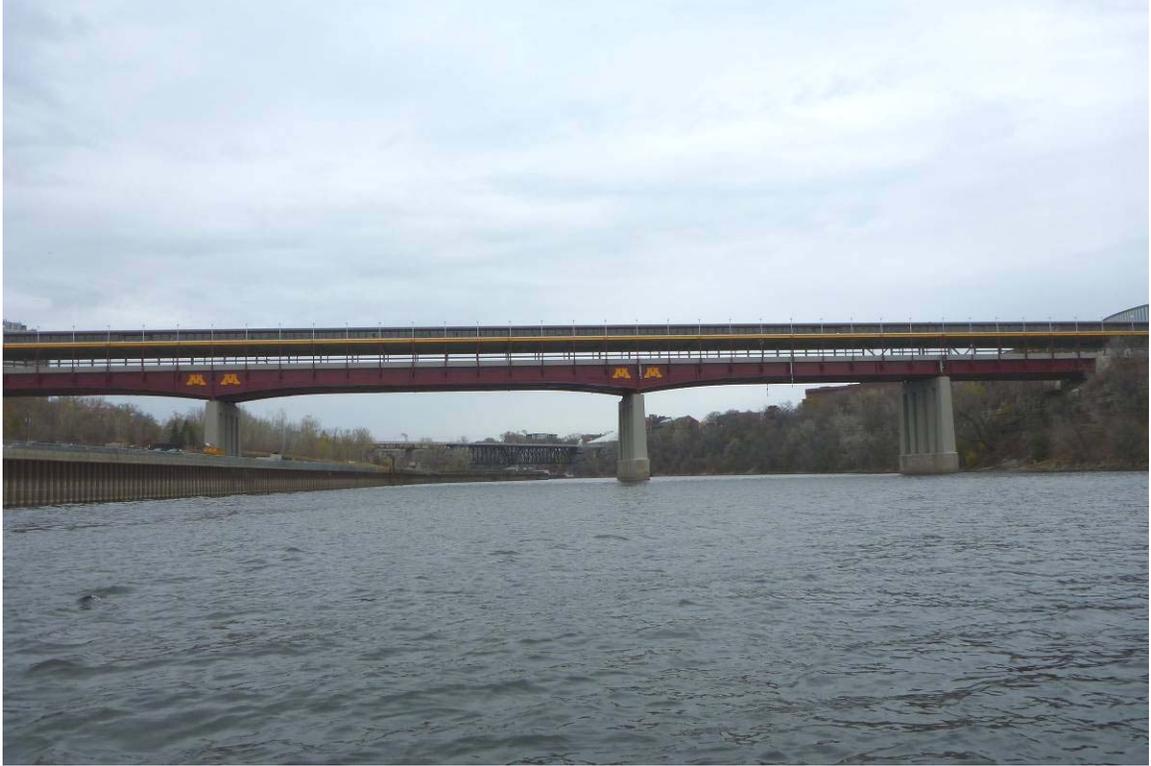
Photograph 1. Overall View of the Structure, Looking North.

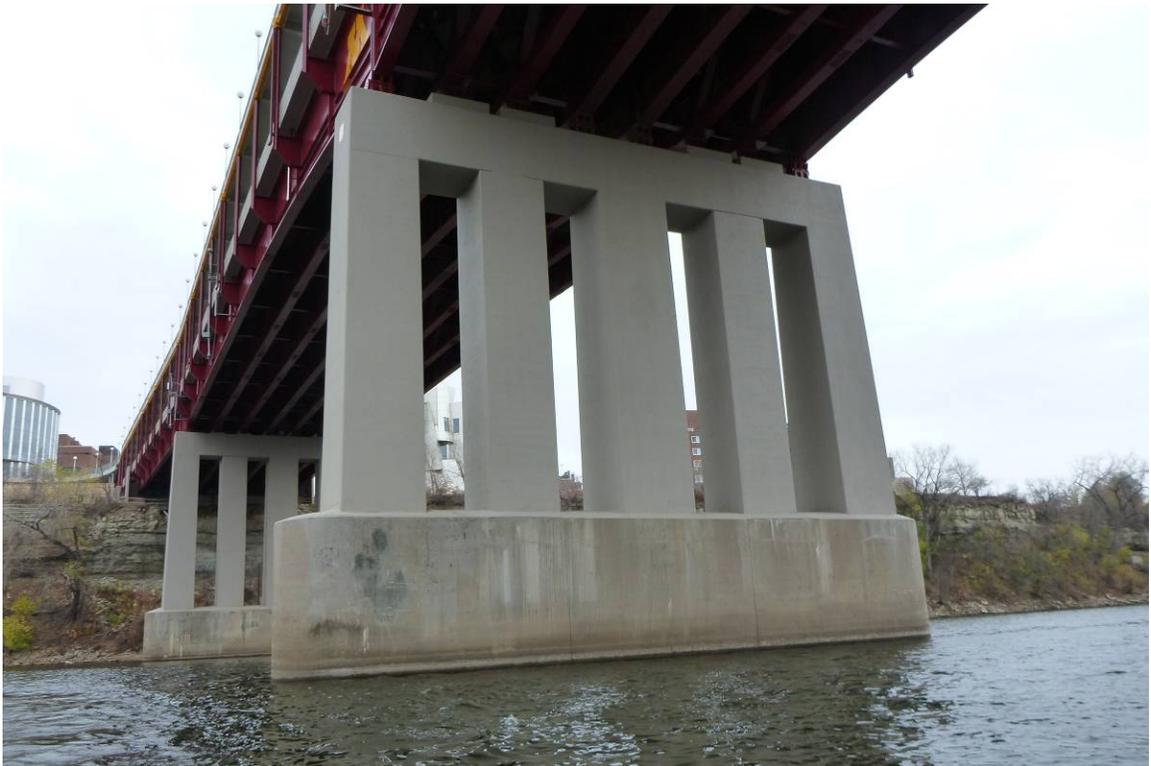
Photograph 2. View of West Pier, Looking Southeast.

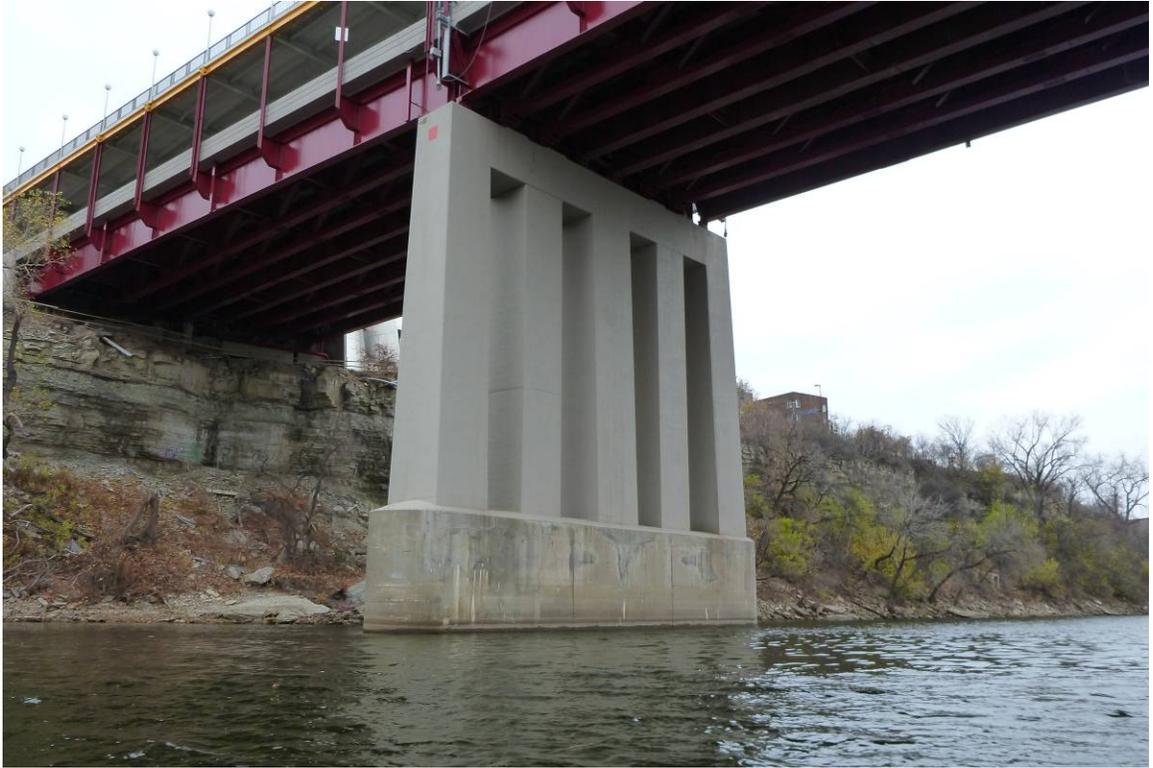
Photograph 3. View of East Pier, Looking Southeast.

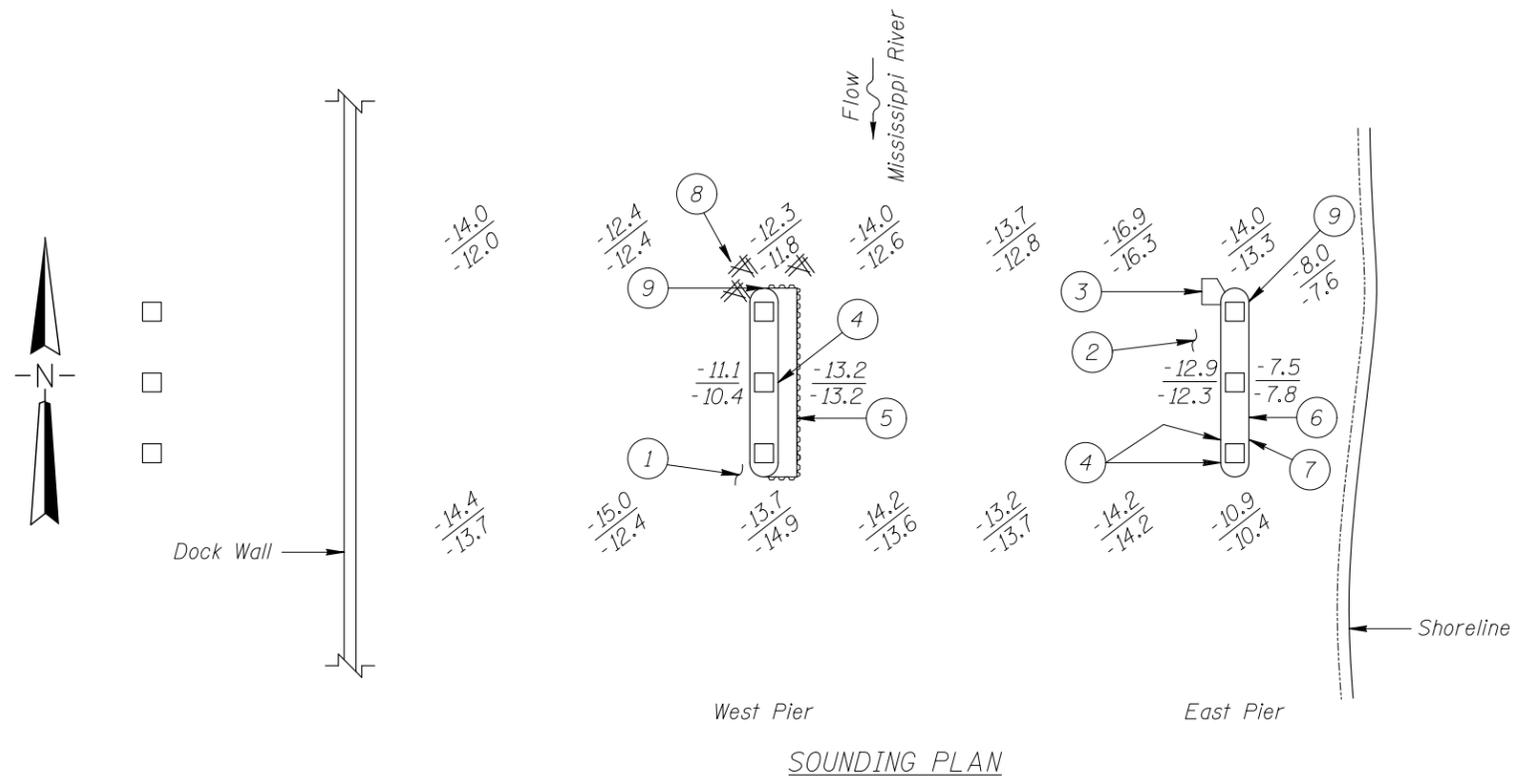
SOUNDING PLAN

- 1 The channel bottom around the West Pier consisted of 2 to 3 foot diameter riprap along the upstream nose. The west side of the pier consisted of sand and gravel with 6 inch of maximum probe rod penetration.

- 2 The channel bottom all around the East Pier consisted of 2 to 3 foot diameter riprap.
- 3 Partial footing exposure was observed at the northwest corner of the East Pier, 4 feet wide by 10 feet long with 1 foot of vertical exposure.

- 4 Several vertical hairline crack with efflorescence were randomly observed on both piers extending from the top of the web wall to the waterline with 1/16 inch maximum width.

- 5 Footing exposure was present all along the east face of the West Pier with 1 foot of maximum vertical exposure at the downstream nose and protruding reinforcing steel.

- 6 Map hairline cracking was noted in random areas along the East face of East Pier.
- 7 A spall was observed along a joint at 1 foot below the waterline down 2 feet and was 2 inches wide with up to 1 inch of penetration.

- 8 Minor accumulation of 4 to 6 inch diameter was present timber debris around the upstream nose of the West Pier. Sheet piling was observed along the edge of the footing and reinforcing steel was protruding from the top of the footing.

- 9 Random scaling (heavier at upstream noses) was present on both piers from waterline to 3 feet below waterline with 1/2 inch maximum penetration.

- (A) Monitor footing exposure during future underwater inspections.
- (B) Reinspect the submerged substructure units at the normal maximum recommended (NBIS) interval of sixty (60) months.
