UNDERWATER BRIDGE INSPECTION REPORT

STRUCTURE NO. 94246
ABANDONED RAILROAD (PEDESTRIAN BRIDGE)
OVER THE
MISSISSIPPI RIVER
HENNEPIN COUNTY, CITY OF MINNEAPOLIS

OCTOBER 29, 2012
PREPARED FOR THE
MINNESOTA DEPARTMENT OF TRANSPORTATION
BY
COLLINS ENGINEERS, INC.
JOB NO. 7423

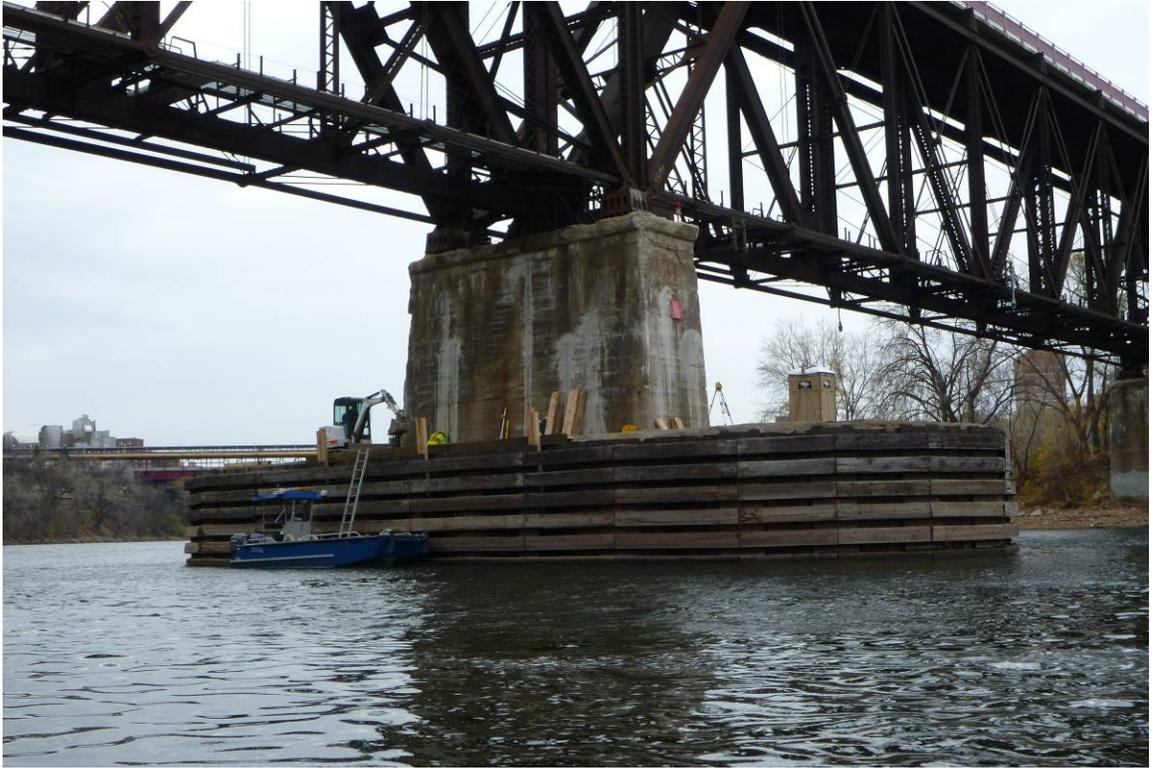
Photograph 1. View of Upstream End of Pier 4, Looking Southwest.

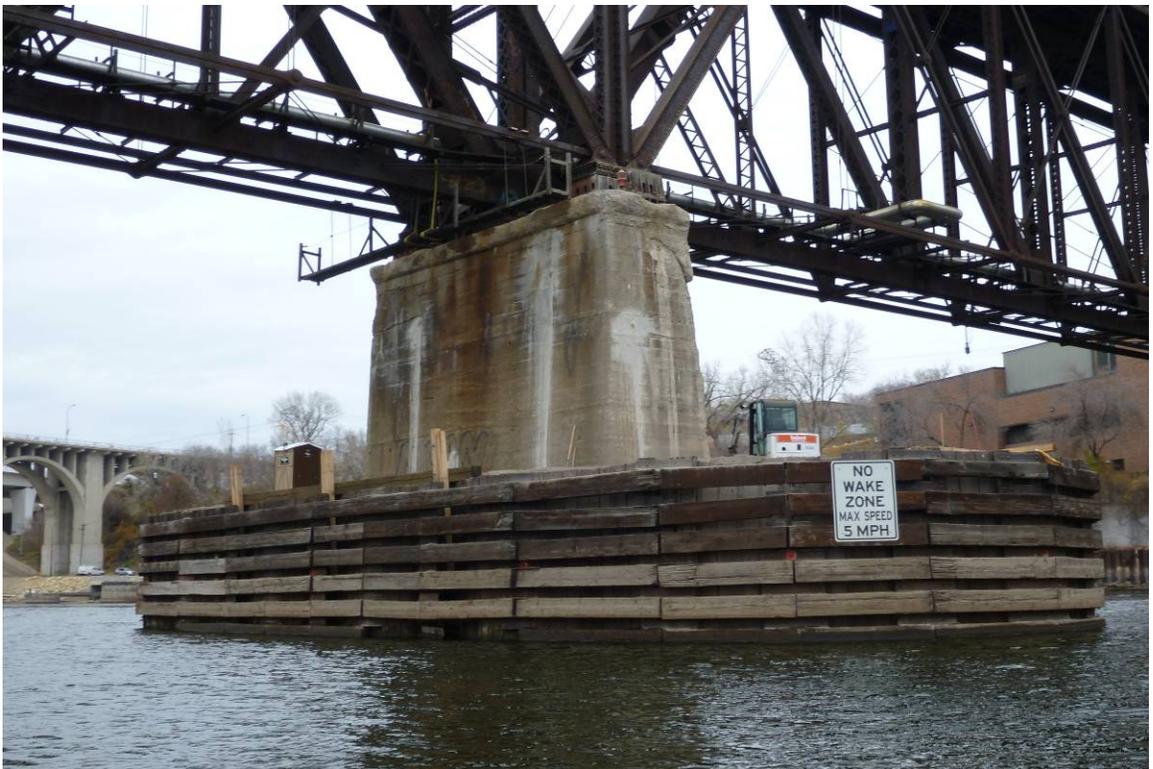
Photograph 2. View of Downstream End of Pier 4, Looking Northeast.

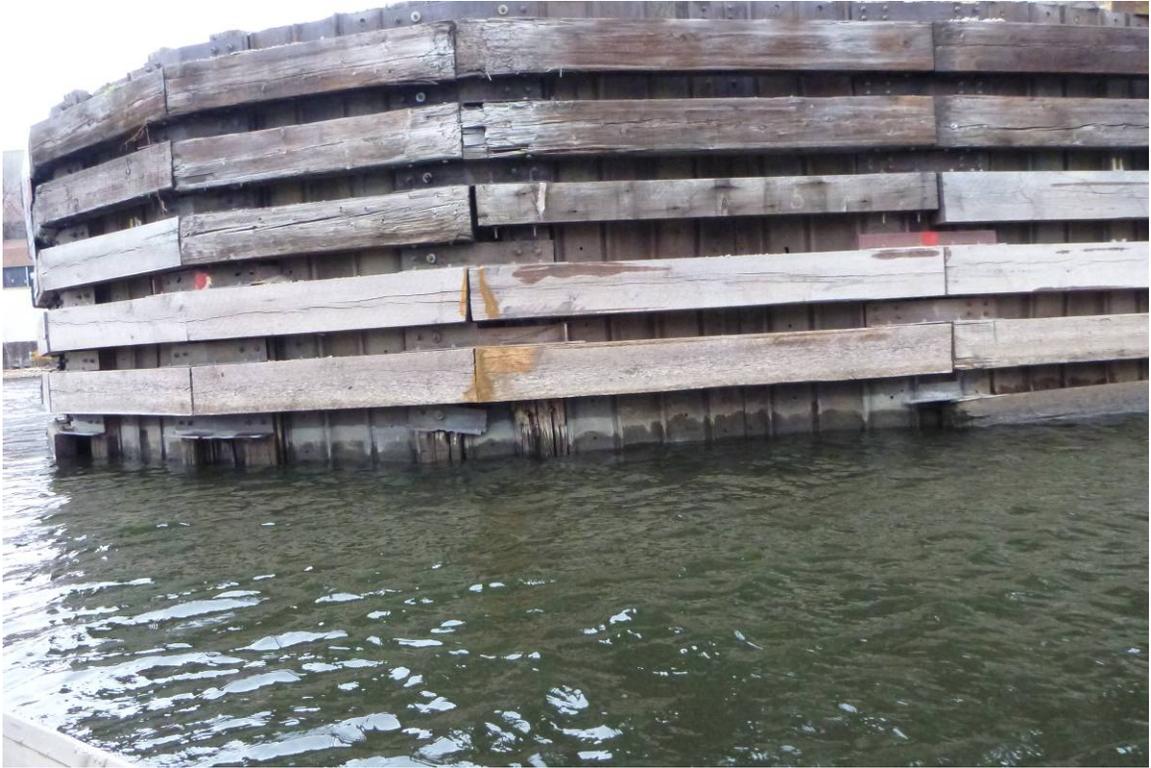
Photograph 3. View of the Damaged Fender System at Upstream Nose of Pier 4, Looking West.

- (A) Depending on the proposed future use of the structure, consideration can be given to replacing the missing, deteriorated and damaged timber fender components during normal maintenance operations.

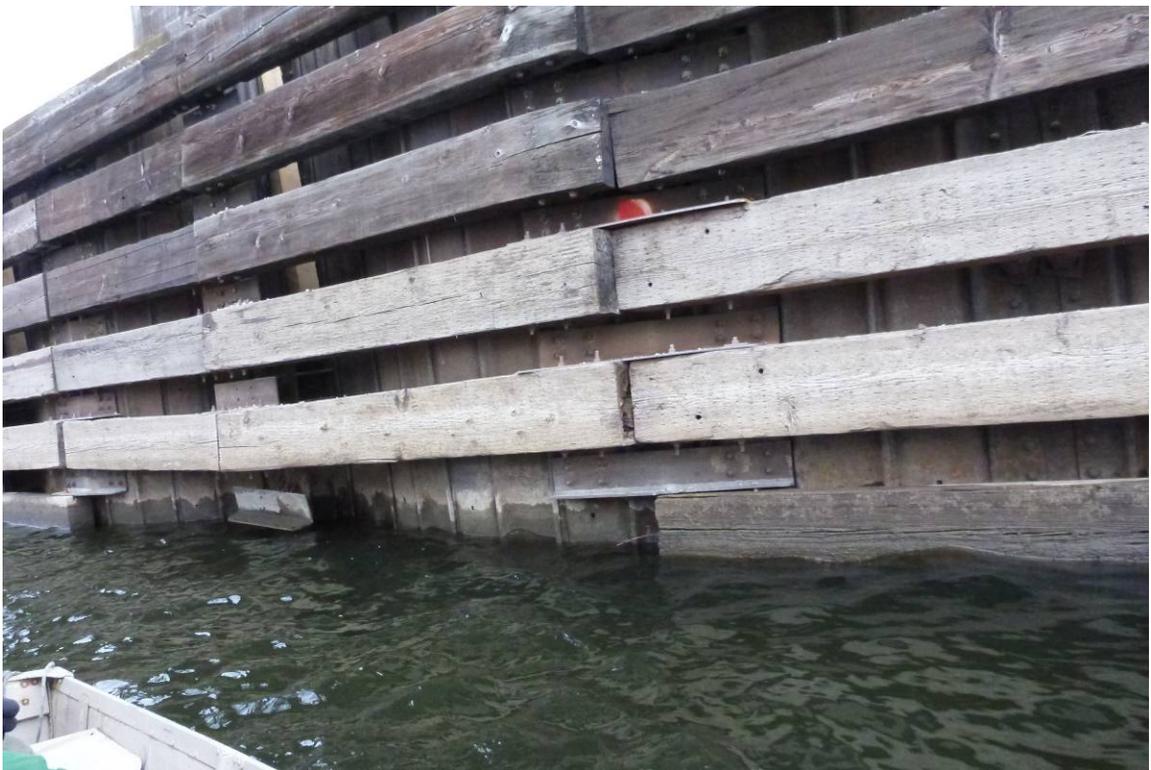
Photograph 4. View of the Damaged Fender System at Downstream Half of Pier 4, Looking West.

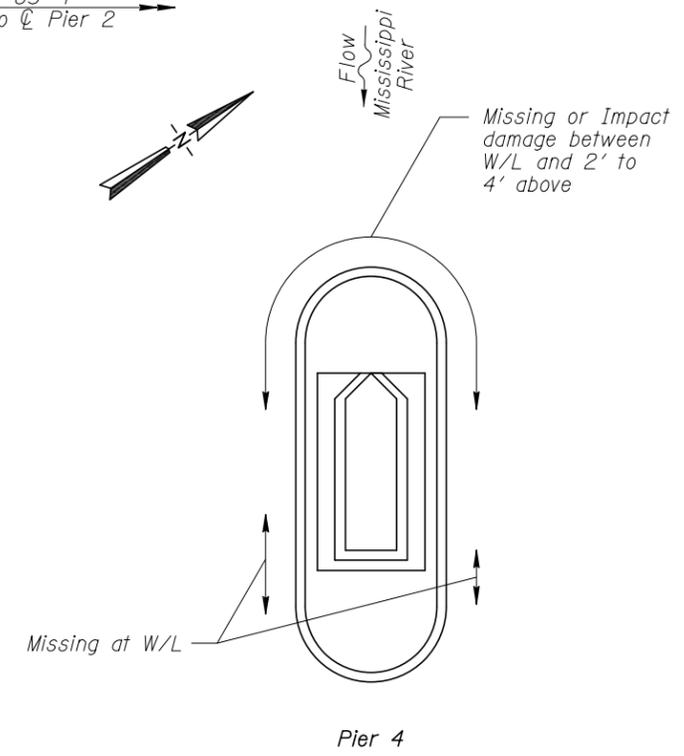
FENDER DAMAGE PLAN
Other random less significant deterioration and impact damage also present.

- 1 The channel bottom material consisted of sand, gravel and areas of riprap, 3 feet diameter and smaller, allowing 2 inches of probe rod penetration.
- 2 The steel sheeting encasing the concrete pier below water displayed a 1/8 inch layer of light to moderate corrosion, random 1 inch diameter rust nodules, and random 1/8 inch deep pitting.
- 3 Fender system timber whalers were in fair to poor condition with some areas of decay and rot at the waterline and several failed connections. Moderate impact damage was evident in several locations around the pier perimeter. (See Fender Damage Plan).
