UNDERWATER BRIDGE INSPECTION REPORT

STRUCTURE NO. L5733
ABANDONED RAILROAD
OVER THE
MISSISSIPPI RIVER
CITY OF MINNEAPOLIS, HENNEPIN COUNTY

OCTOBER 29, 2012
PREPARED FOR THE
MINNESOTA DEPARTMENT OF TRANSPORTATION
BY
COLLINS ENGINEERS, INC.

MINNESOTA DEPARTMENT OF TRANSPORTATION
UNDERWATER BRIDGE INSPECTION

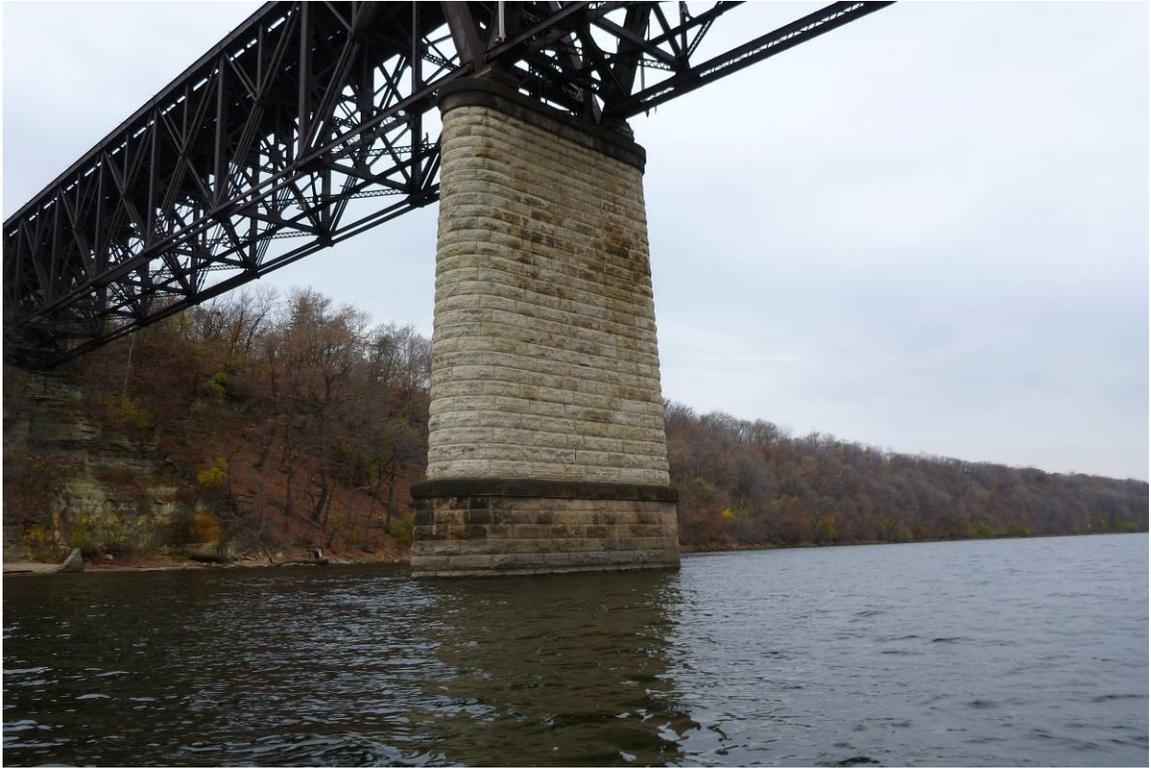
Photograph 1. View of West Pier, Looking Northwest.

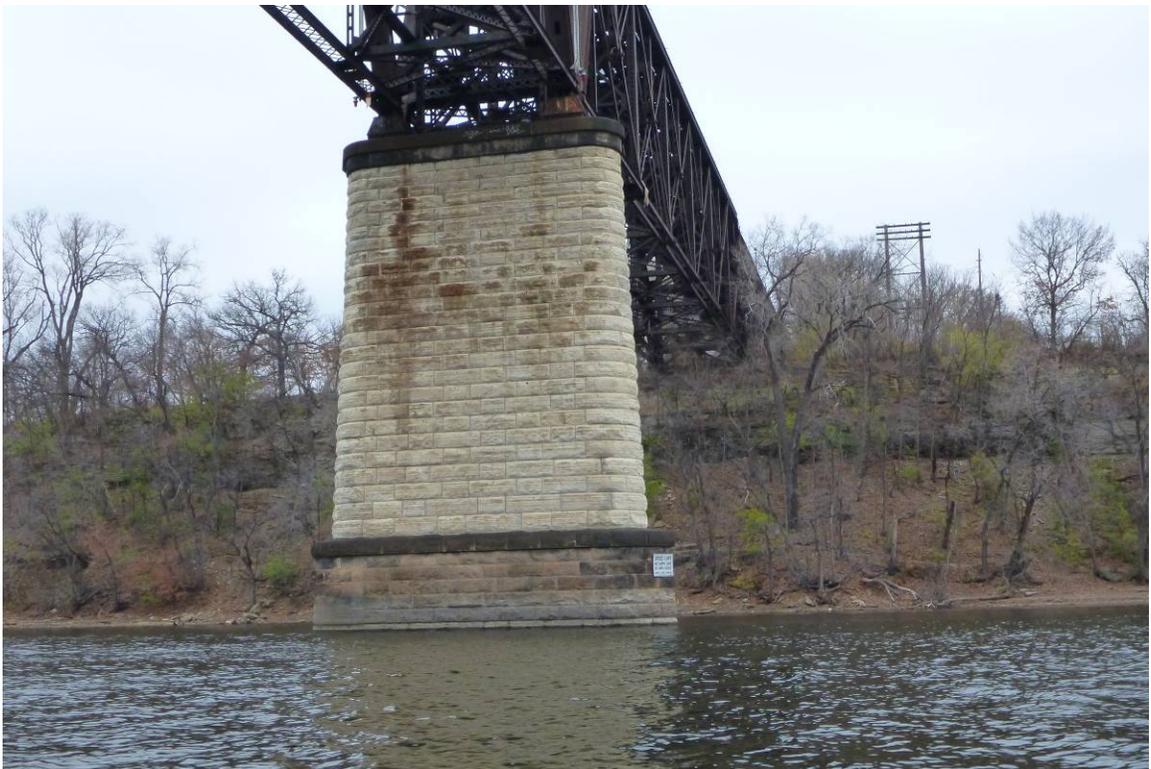
Photograph 2. View of East Pier, Looking Northeast.

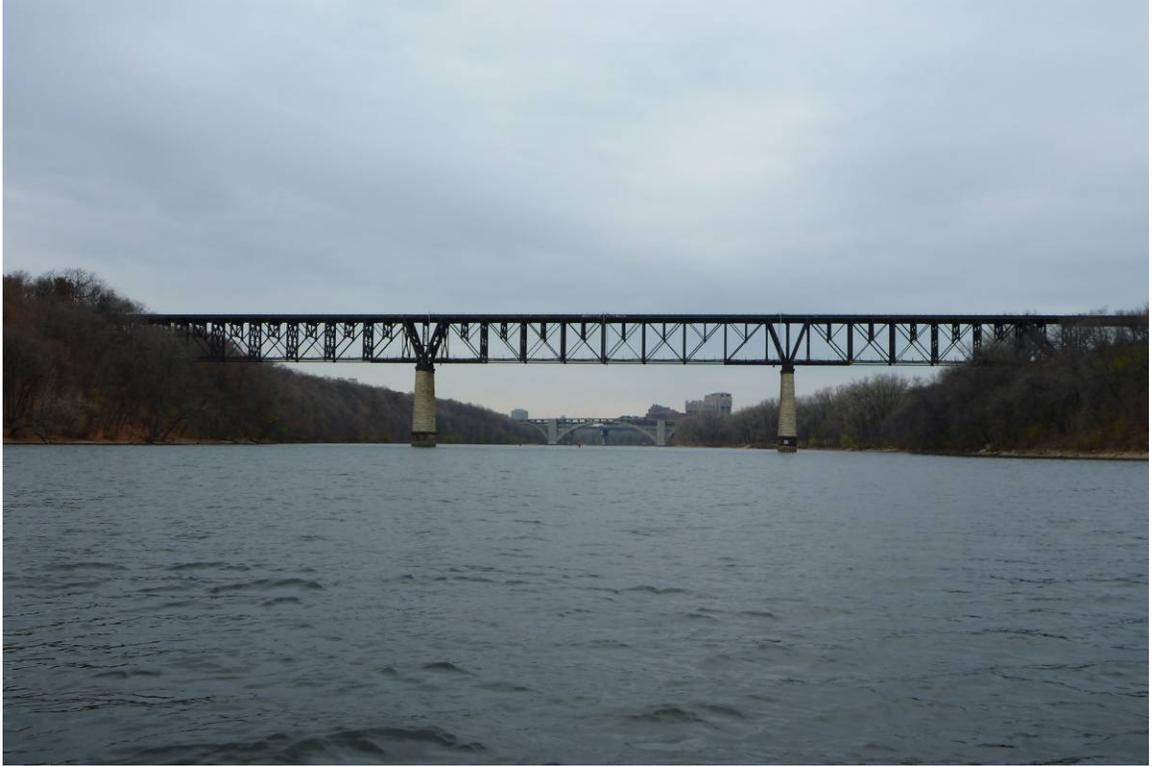
Photograph 3. Overall View of Structure, Looking North.

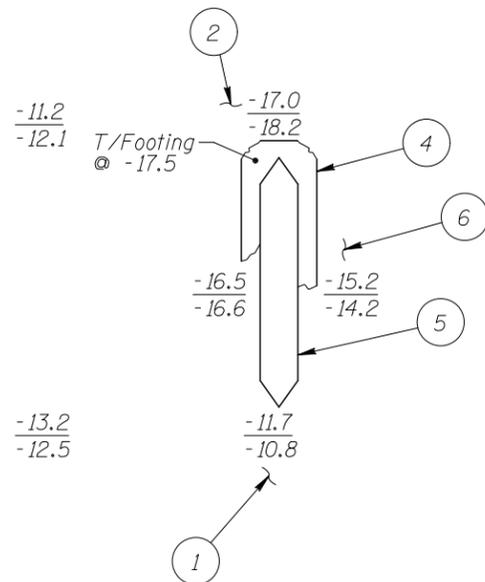
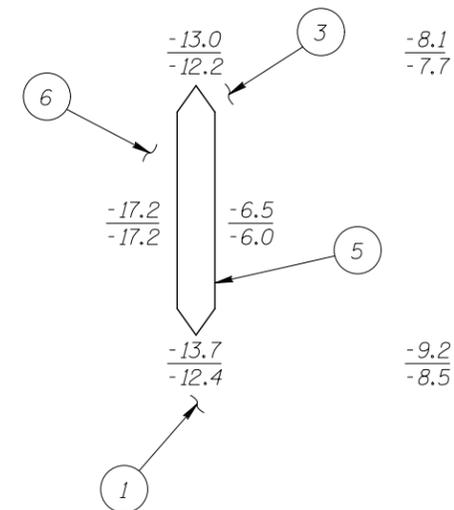
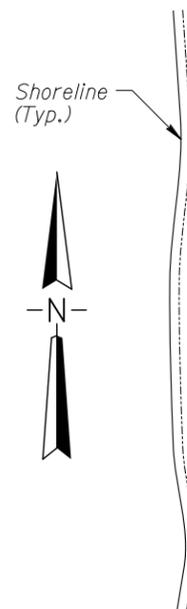
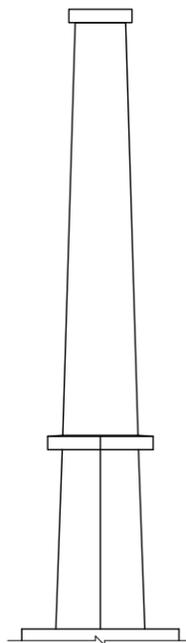
SOUNDING PLAN

- 1 The channel bottom material consisted of sand infilling at the downstream end of both piers allowing up to 1 foot of probe rod penetration.
- 2 The channel bottom material consisted of riprap 1 to 2 feet in diameter at the upstream nose and 6 to 8 inch diameter riprap and sand along both sides of the West Pier.

- 3 The channel bottom consisted of riprap 1 to 4 feet in diameter at the upstream nose and 6 to 8 inch diameter riprap and sand along both sides of the East Pier.

- 4 The top of the footing was partially exposed from the quarter point along the west face, around the upstream nose, and to the midpoint along the east face. No vertical face exposure was present.

- 5 The stone masonry was in good condition with minor hairline to 1/8 inch (maximum) wide cracks observed in the mortar joints at random locations.
- 6 A light accumulation of steel debris was observed scattered on the channel bottom around both piers.

- (A) Monitor the extent of footing exposure during future underwater inspections.
- (B) Reinspect the submerged substructure units at the normal maximum recommended (NBIS) interval of sixty (60) months.
