UNDERWATER BRIDGE INSPECTION REPORT

STRUCTURE NO. L5773
MUN 1 (BLACK DOG RD.)
OVER
BLACK DOG CREEK
CITY OF BURNSVILLE

MAY 21, 2012

BY
COLLINS ENGINEERS, INC.

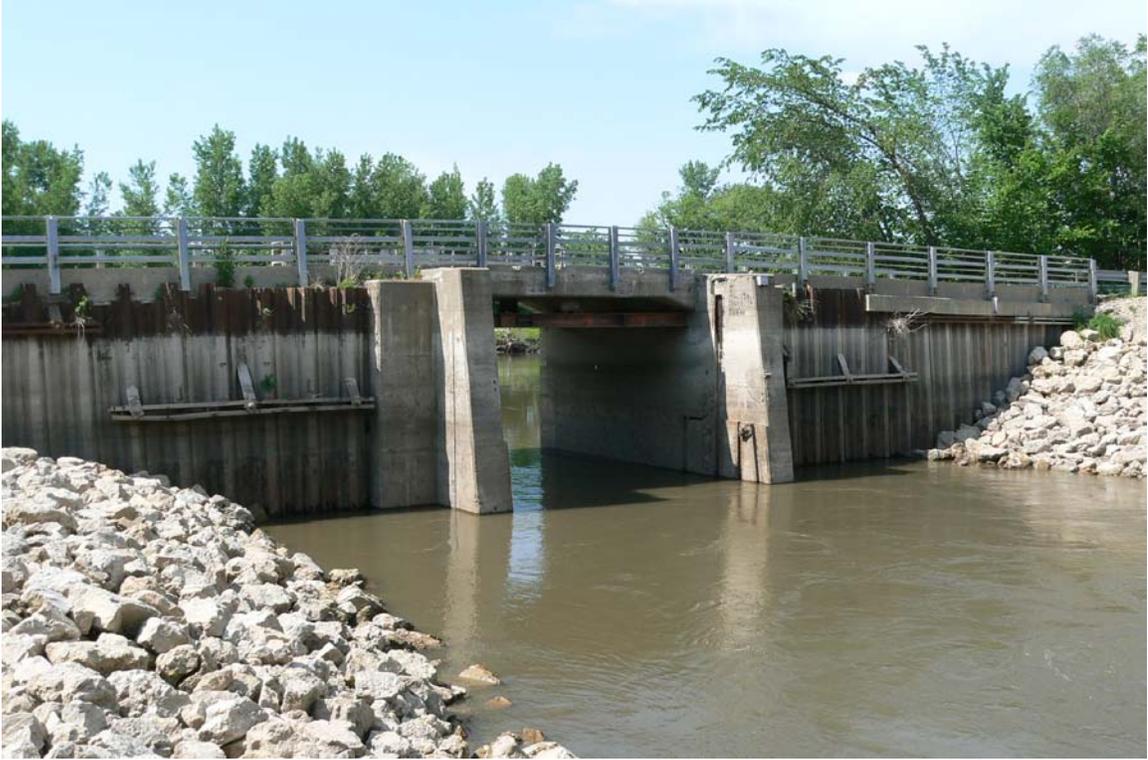
Photograph 1. View of the Upstream Fascia, Looking Northeast.

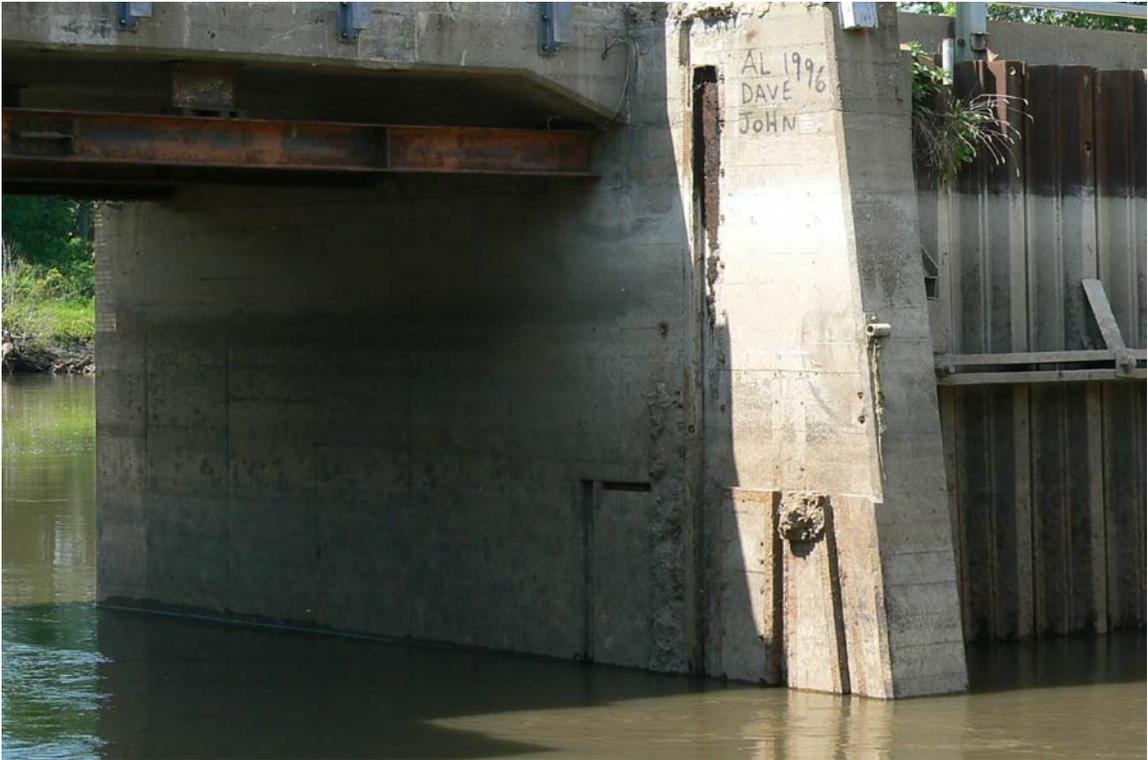
- (B) The concrete surfaces of the East and West Abutments were typically sound with no significant deterioration observed.
- (C) The concrete apron/toe was exposed along the entire downstream face with up to 6 inches of vertical exposure. No undermining was observed.

Photograph 2. View of the East Abutment, Looking Northeast.

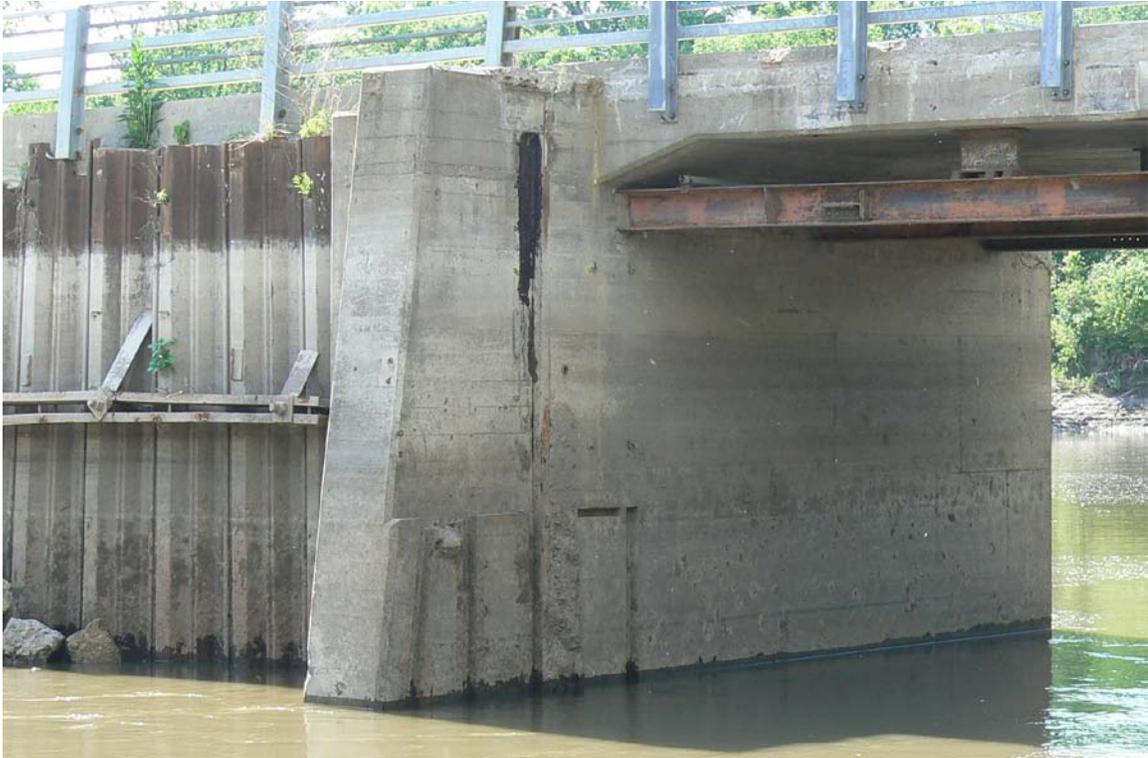
Photograph 3. View of the West Abutment, Looking Northwest.

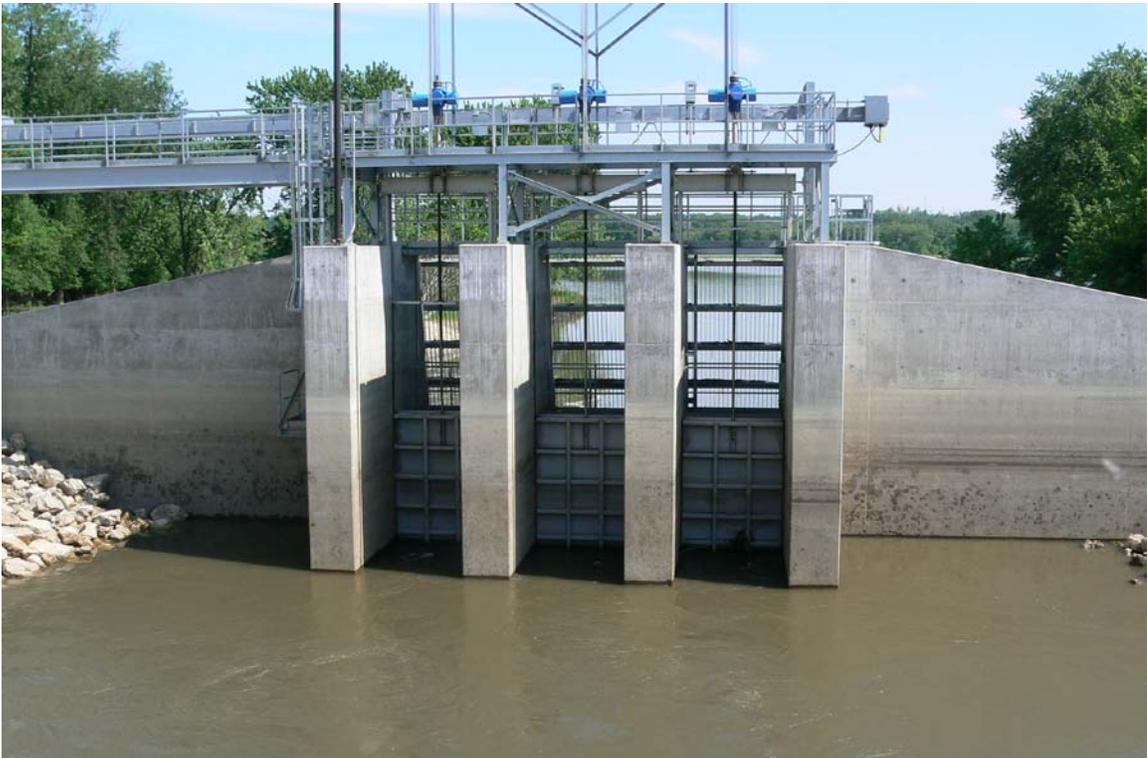
- (A) The channel bottom material through the structure consisted of a concrete floor slab. The channel bottom material upstream of the structure consisted of construction debris and riprap up to 2 feet in diameter. The channel bottom material downstream of the structure consisted of silty clay with up to 6 inches of probe rod penetration.

Photograph 4. View of the Upstream Channel and New Dam Structure, Looking South.

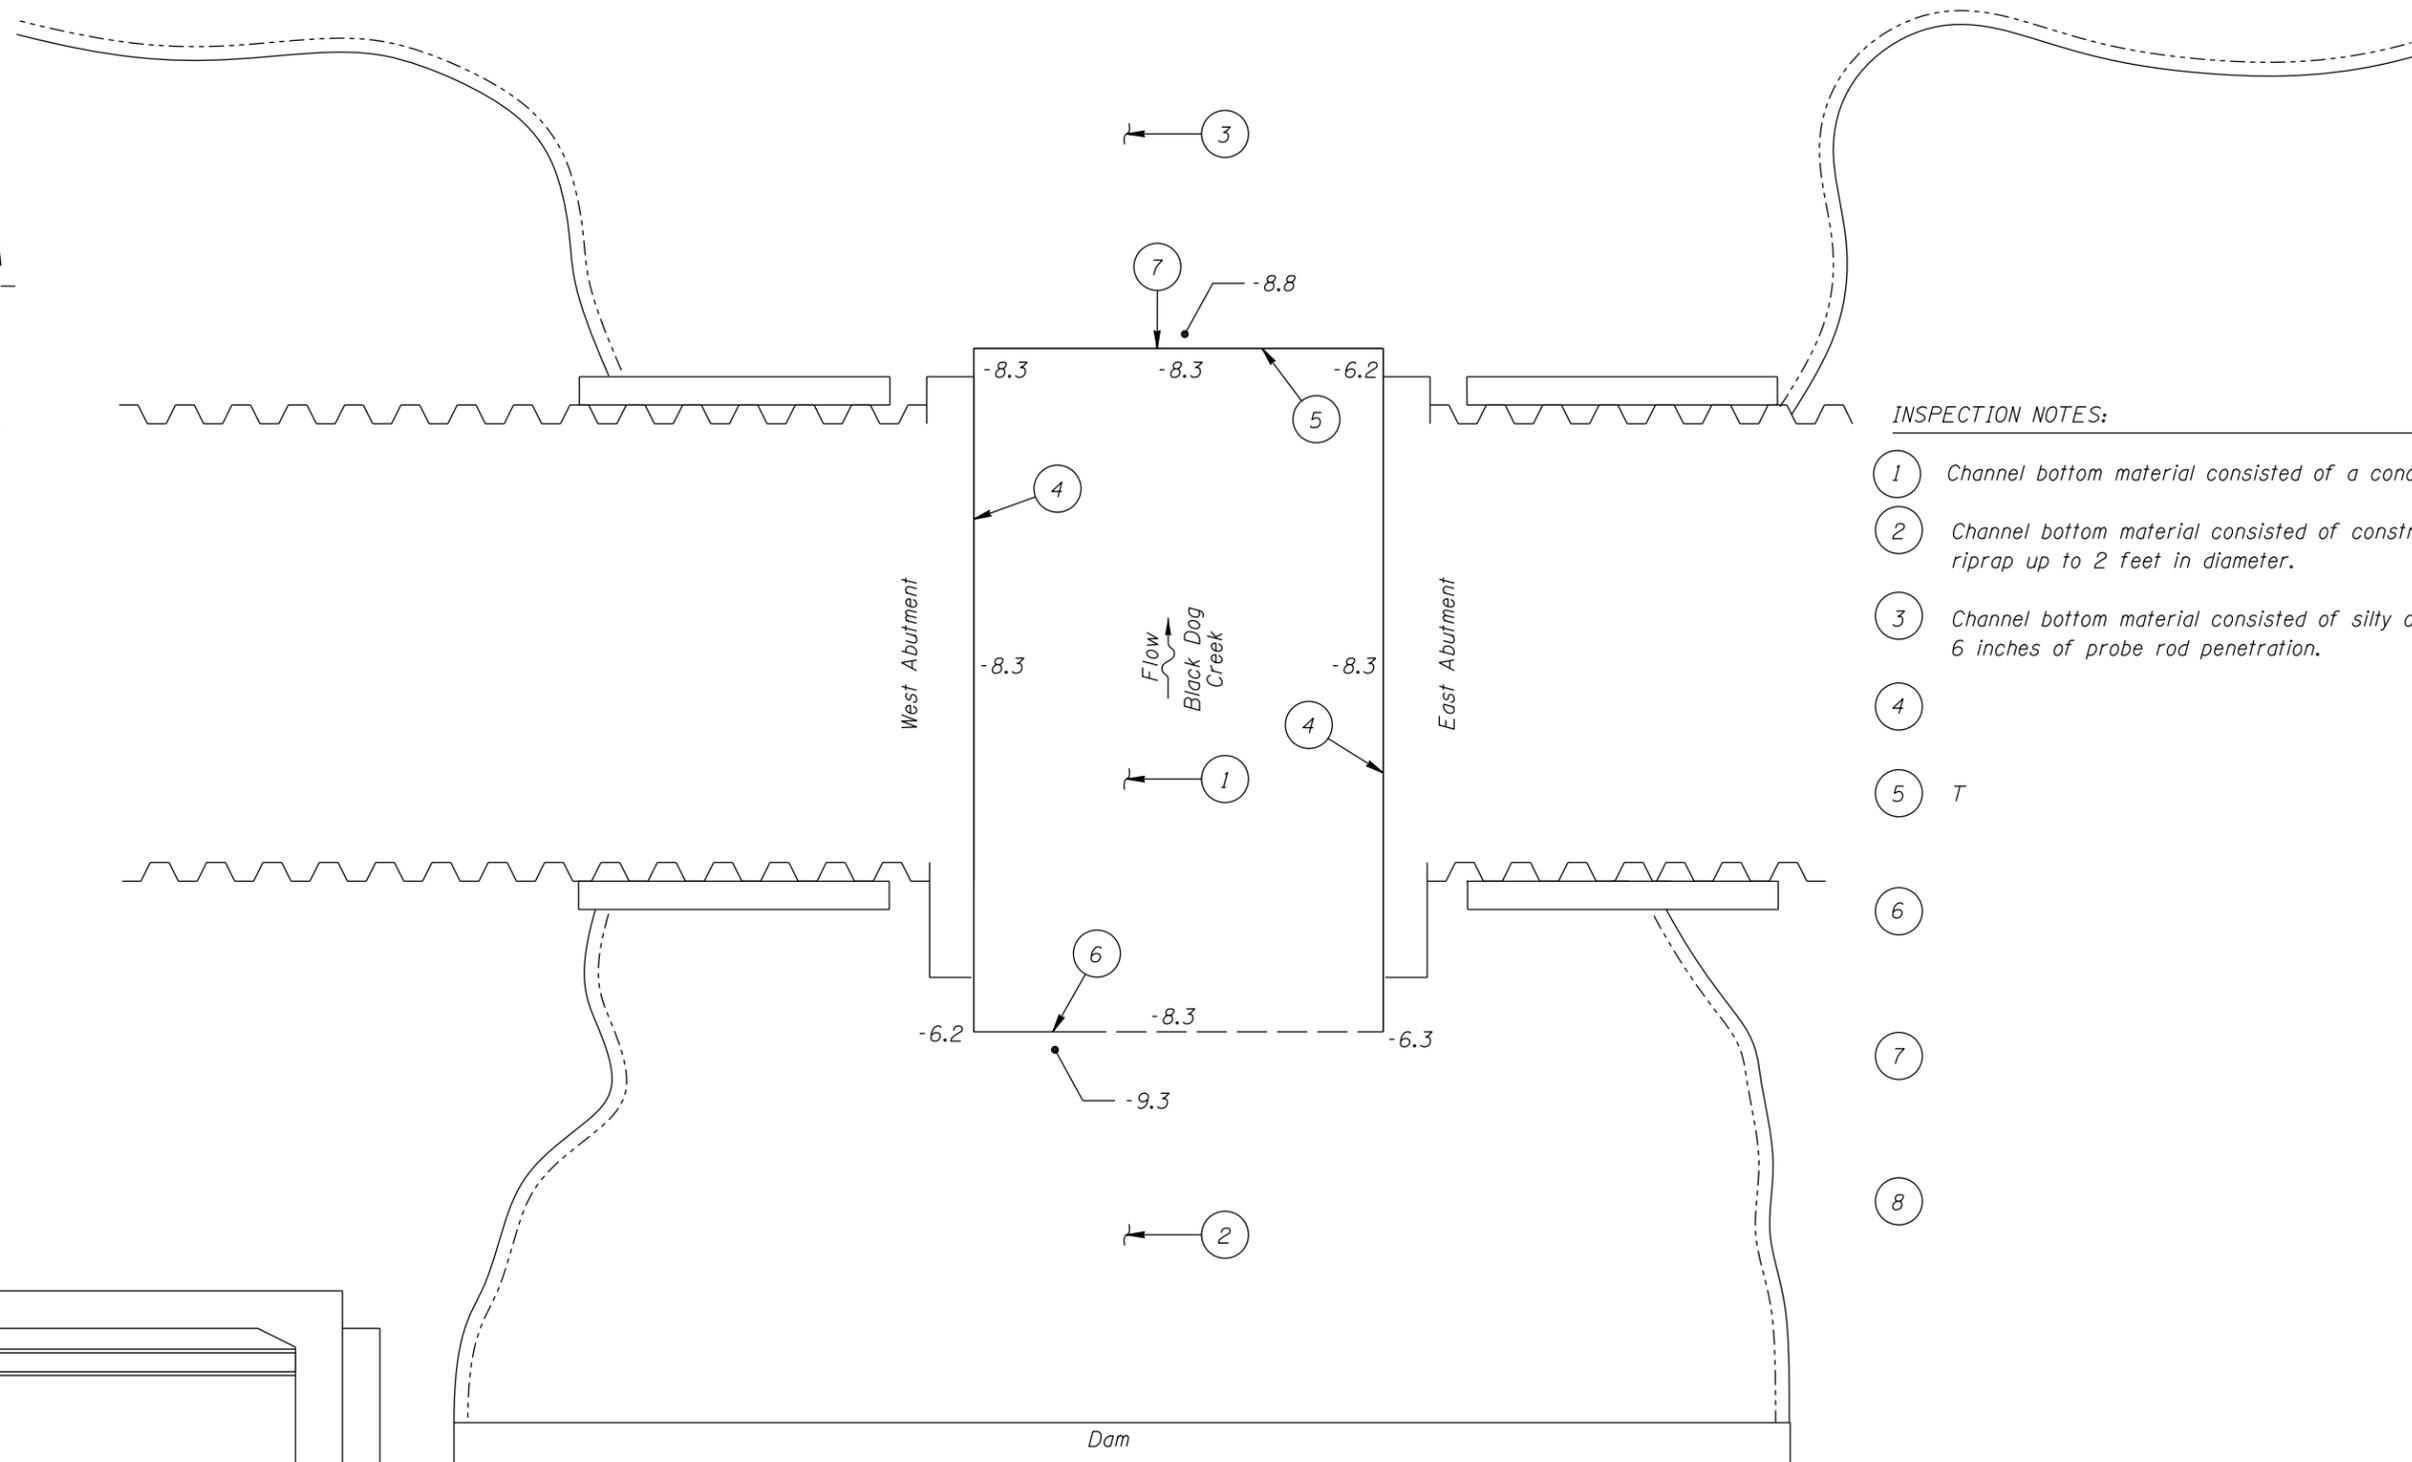
INSPECTION AND SOUNDING PLAN

- ① Channel bottom material consisted of a concrete floor.
- ② Channel bottom material consisted of construction debris and riprap up to 2 feet in diameter.
- ③ Channel bottom material consisted of silty clay with up to 6 inches of probe rod penetration.
- ④
- ⑤ T
- ⑥
- ⑦
- ⑧

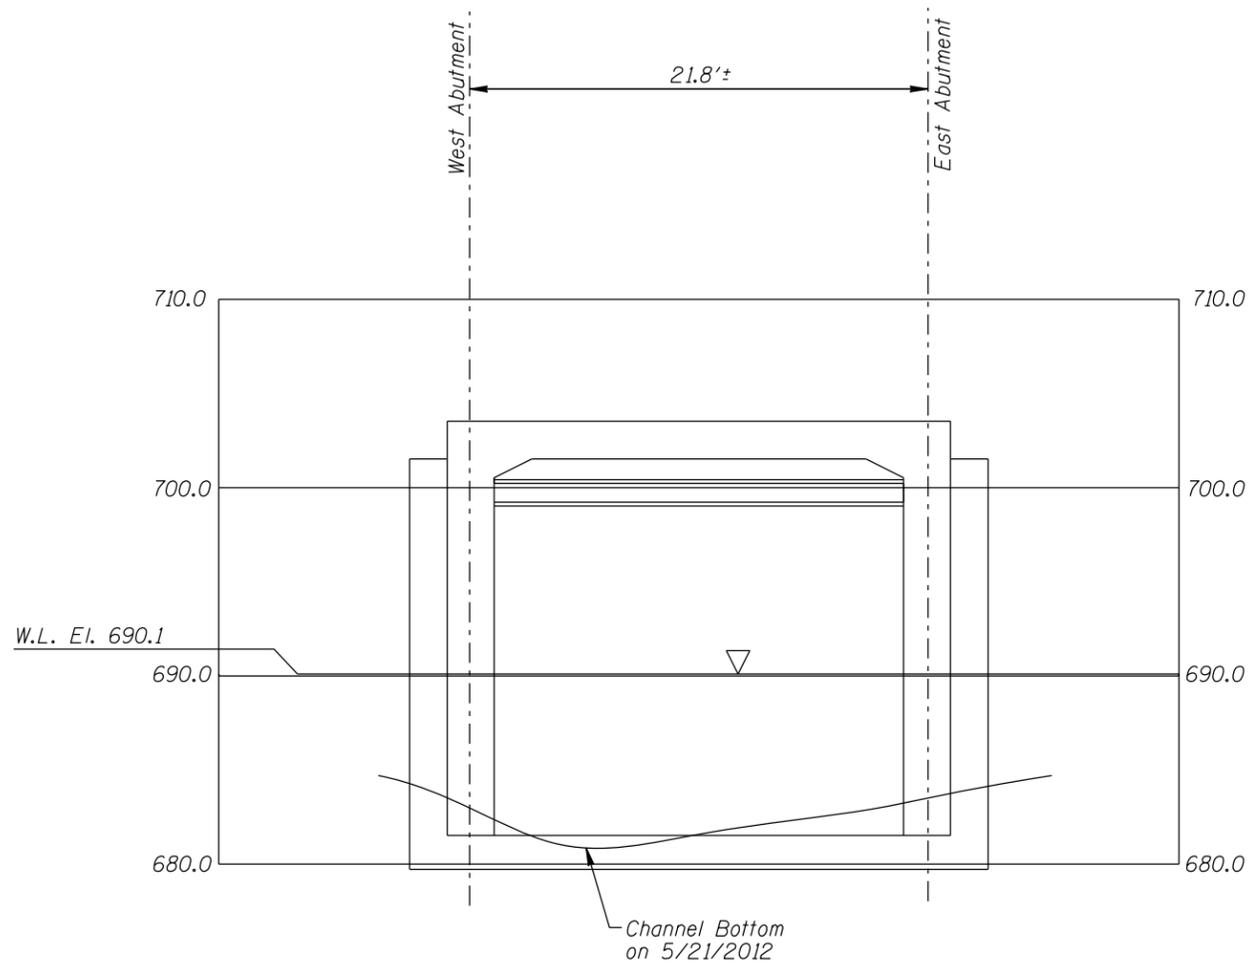
UPSTREAM FASCIA PROFILE

- (D) The concrete apron/toe was exposed along the upstream face from the west abutment to the west quarter point with up to 1 foot of vertical exposure. No undermining was observed.
