## Chapter 8 Inspection and Evaluation of Timber Superstructures

### Topic 8.1 Solid Sawn Timber Bridges

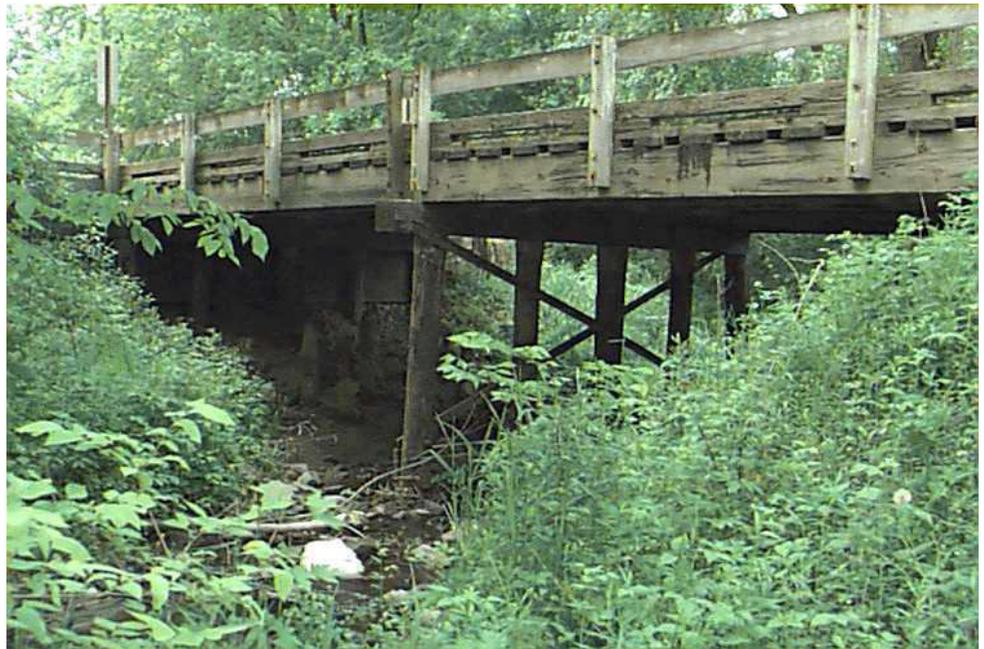
**Figure 8.1.1** Elevation View of a Solid Sawn Multi-Beam Bridge

Timber bridges are gaining resurgence in popularity in some parts the United States. There are two basic classifications in timber construction: solid sawn and glued-laminated (glulam). A solid sawn beam is a section of tree cut to the desired size at a saw mill. Solid sawn multi-beam bridges are the simplest type of timber bridge (see Figure 8.1.1).

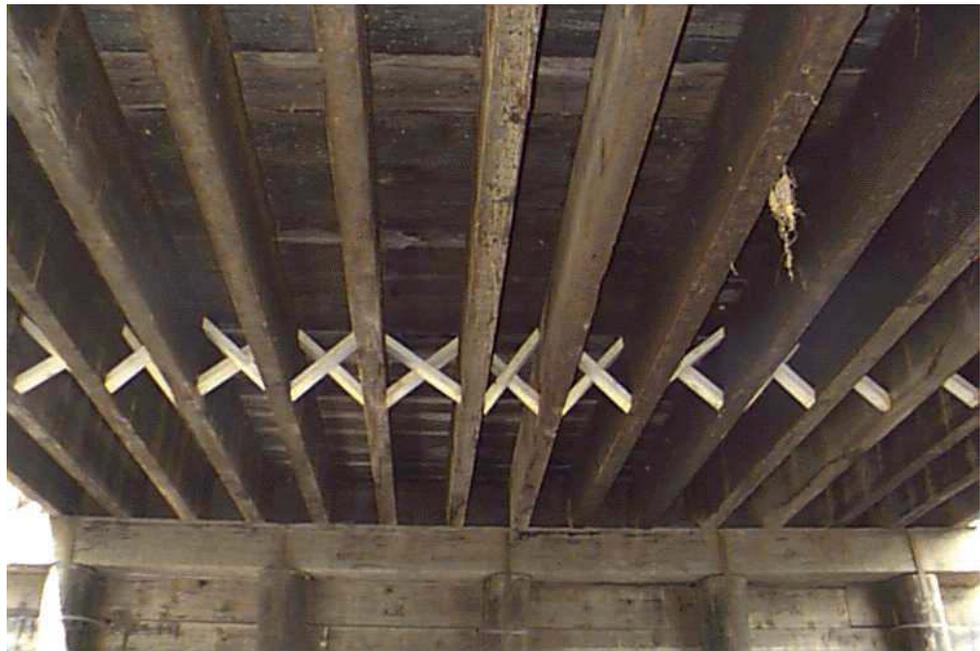
**Figure 8.1.2** Underside View of a Solid Sawn Multi-Beam Bridge

Solid sawn multi-beam bridges consist of multiple solid sawn beams spanning between substructure units (see Figure 8.1.2). The deck is supported by the beams and is typically comprised of transversely laid timber planks, and longitudinally laid planks called runners. Sometimes a bituminous wearing surface is placed on the deck planks to provide a skid resistant riding surface for vehicles, as well as a protective surface for the planks. Beam sizes typically range from approximately 6 inches by 12 inches to 8 inches by 16 inches, and the beams are usually spaced about 24 inches on center.

The primary members of solid sawn multi-beam bridges are the beams, and the secondary members are the diaphragms or cross bracing if present (see Figure 8.1.2). These bridges usually have timber diaphragms or cross bracing between beams at several locations along the span.

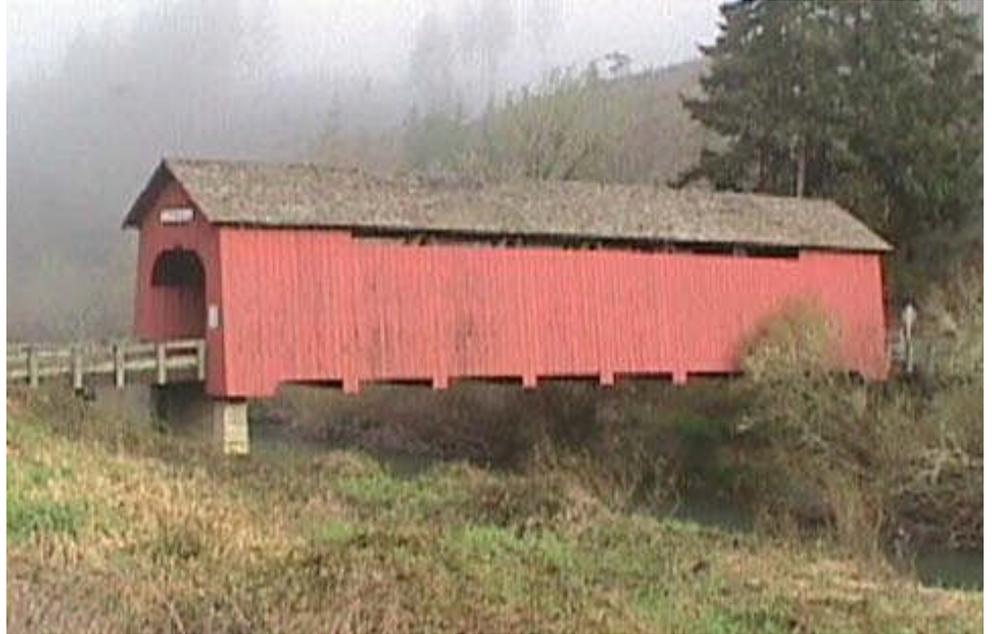
**Figure 8.1.3** Elevation View of Covered Bridge

Covered bridges are generally found along rural roads and get their name from the walls and roof which protect the bridge superstructure (see Figures 8.1.3 and 8.1.4). Covered bridges are usually owned by local municipalities, although some are owned by states or private individuals. Some still carry highway traffic, but many are only open to pedestrians or light weight vehicles. While most covered bridges were built during the 1800's and early 1900's, there are a number of covered bridges being built today as historic reconstruction projects.

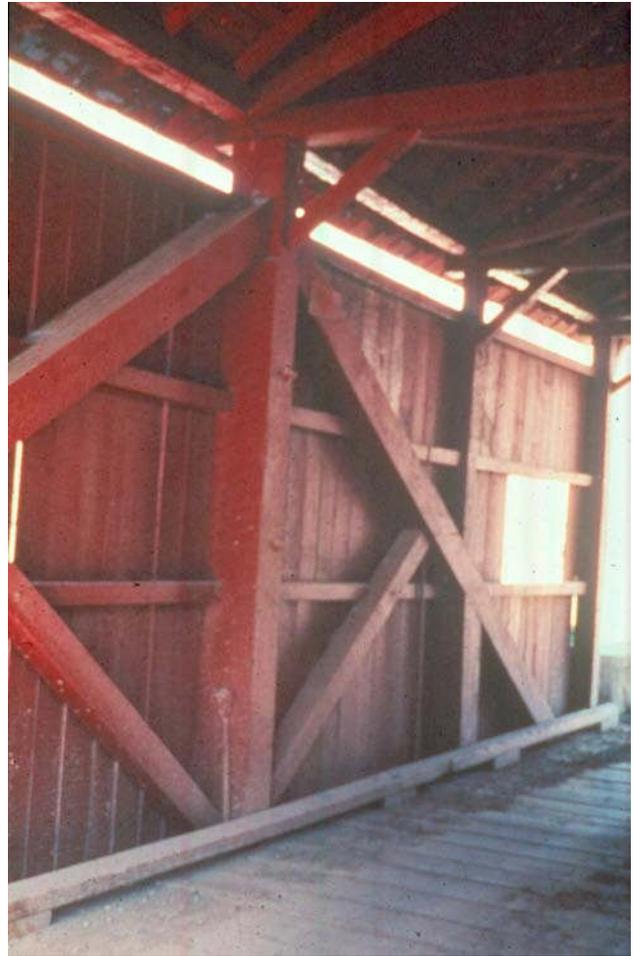
**Figure 8.1.4** Inside View of Covered Bridge Showing King Post Truss Design

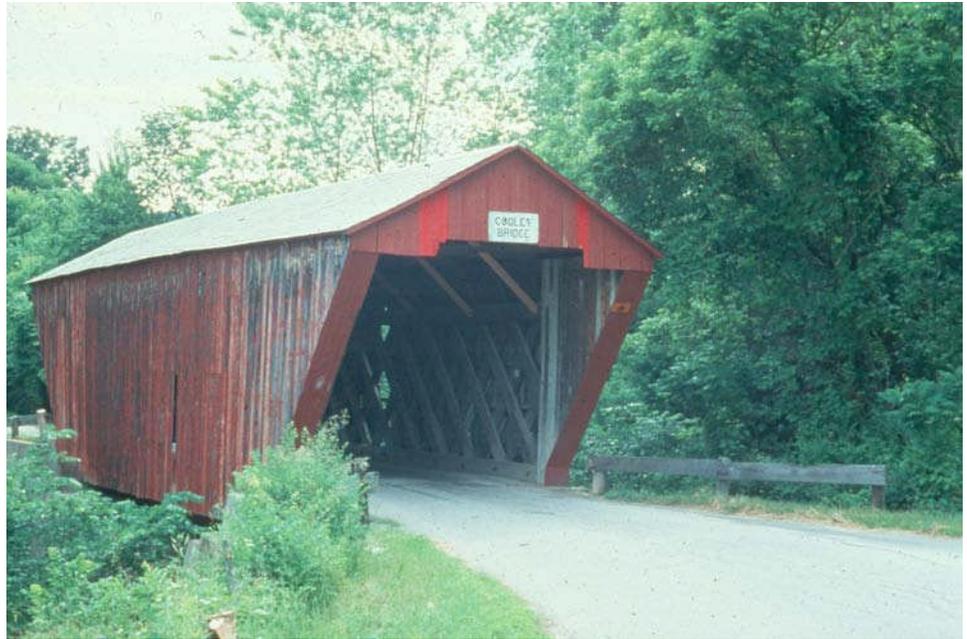
**Figure 8.1.5** Town Truss Covered Bridge

The majority of covered bridges are essentially truss bridges (see Figure 8.1.5). Solid sawn timber members make up the trusses of these historic structures. The covers on the bridges prevent decay of the truss and are responsible for their longevity. Typical truss types for covered bridges include the king post, queen post, Town, Warren, and Howe (see Figure 8.1.6). The floor system consists of timber deck planks, stringers, and floorbeams. The span lengths of covered bridges generally range from 50 to 100 feet, although many are well over 100 feet and some span over 200 feet.

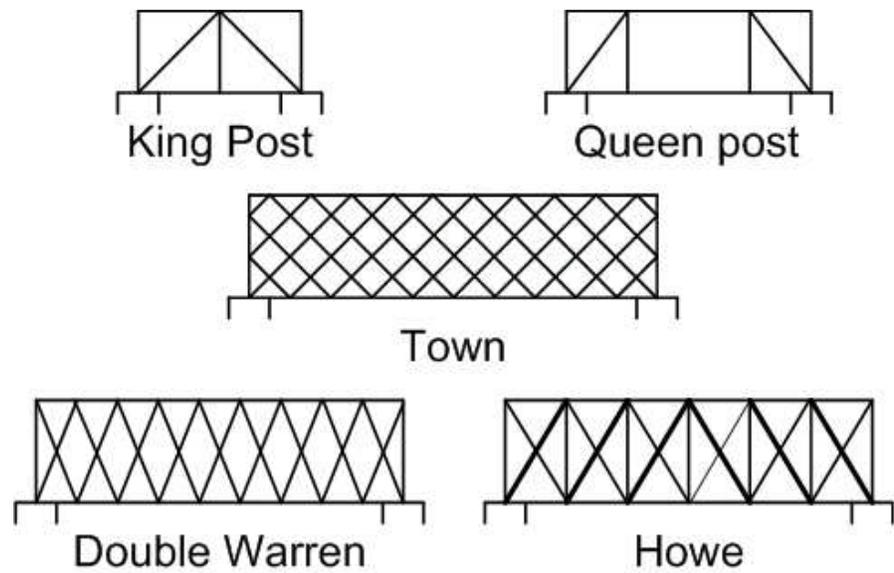
**Figure 8.1.6** Common Covered Bridge Trusses

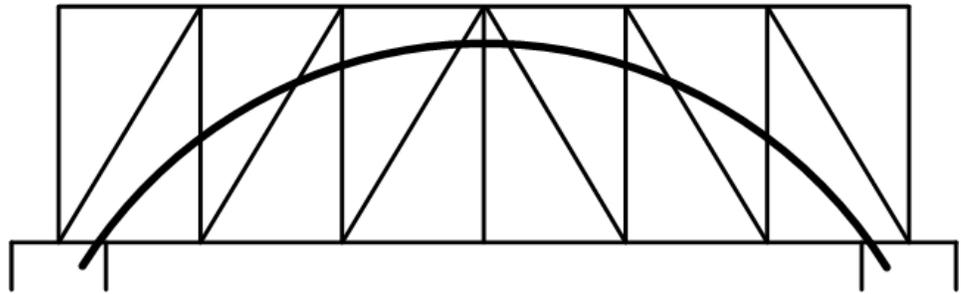
**Figure 8.1.7** Schematic of Burr Arch-truss Covered Bridge

Timber arches were first used in covered bridges by Theodore Burr to strengthen the series of truss configurations normally used in covered bridges. These became known as Burr arch-trusses (see Figures 8.1.7, 8.1.8 and 8.1.9). The arch served as the main supporting element, and the king posts simply strengthened the arch. The span lengths for Burr-arch truss bridges generally range from 50 to 175 feet. Because of their greater strength, many of these structures still exist today.

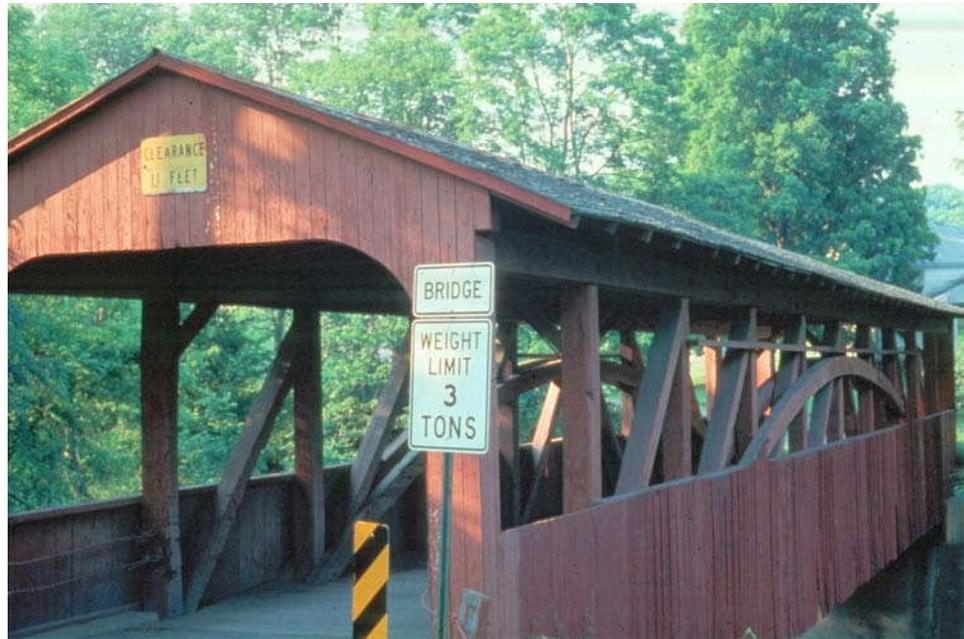
**Figure 8.1.8** Burr Arch-truss Covered Bridge

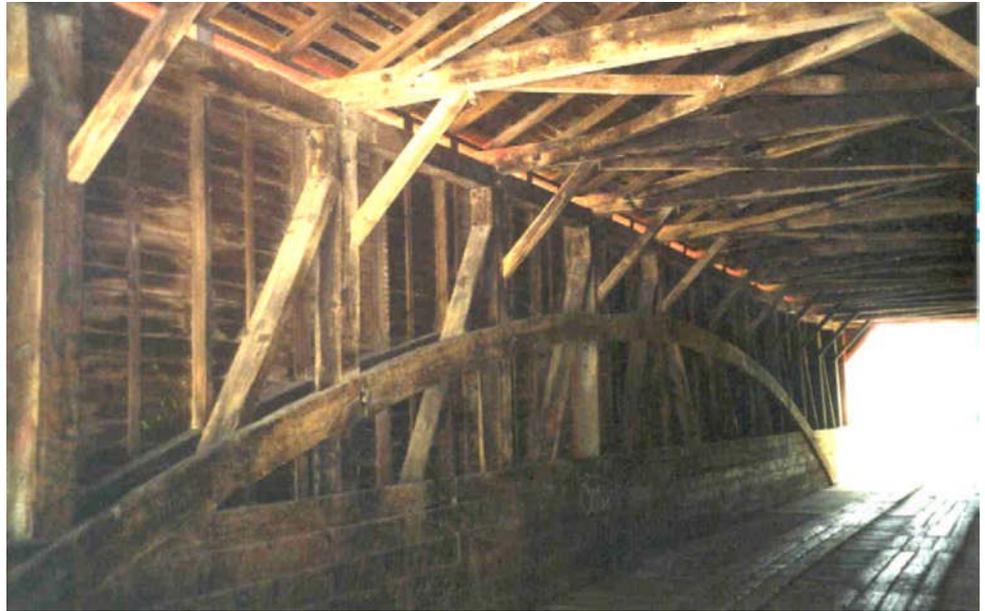
**Figure 8.1.9** Inside View of Covered Bridge with Burr Arch-truss Design

The primary members in truss and arch structures are the truss members (chords, diagonals, and verticals), arch ribs, stringers, and floorbeams (see Figures 8.1.9 and 8.1.10). The secondary members are the diaphragms and cross bracing between stringers, the upper and lower lateral bracing, sway bracing, and the covers on the roof and sides when present.

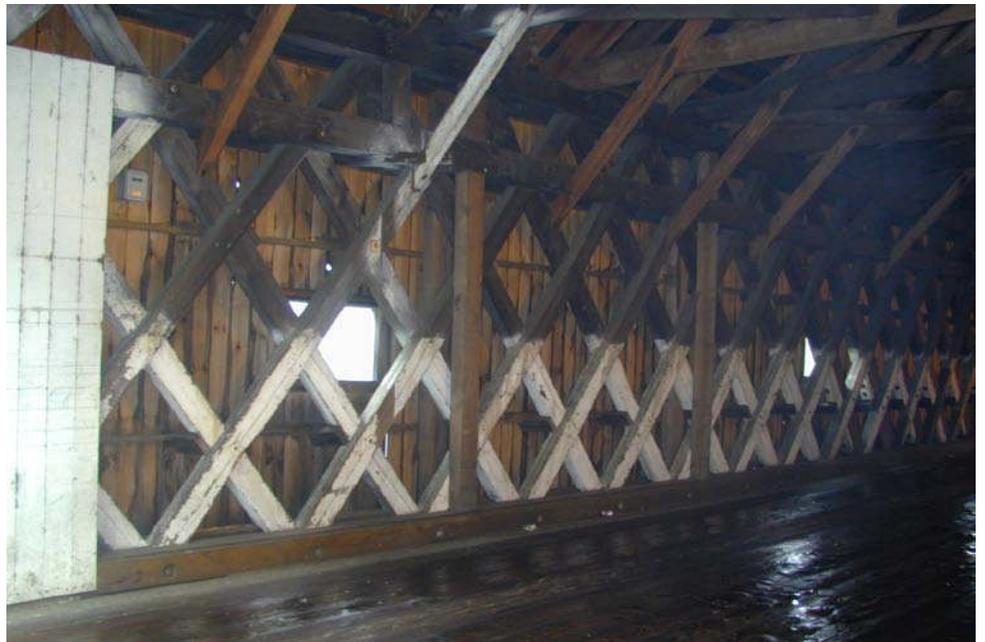
**Figure 8.1.10** Town Truss Design

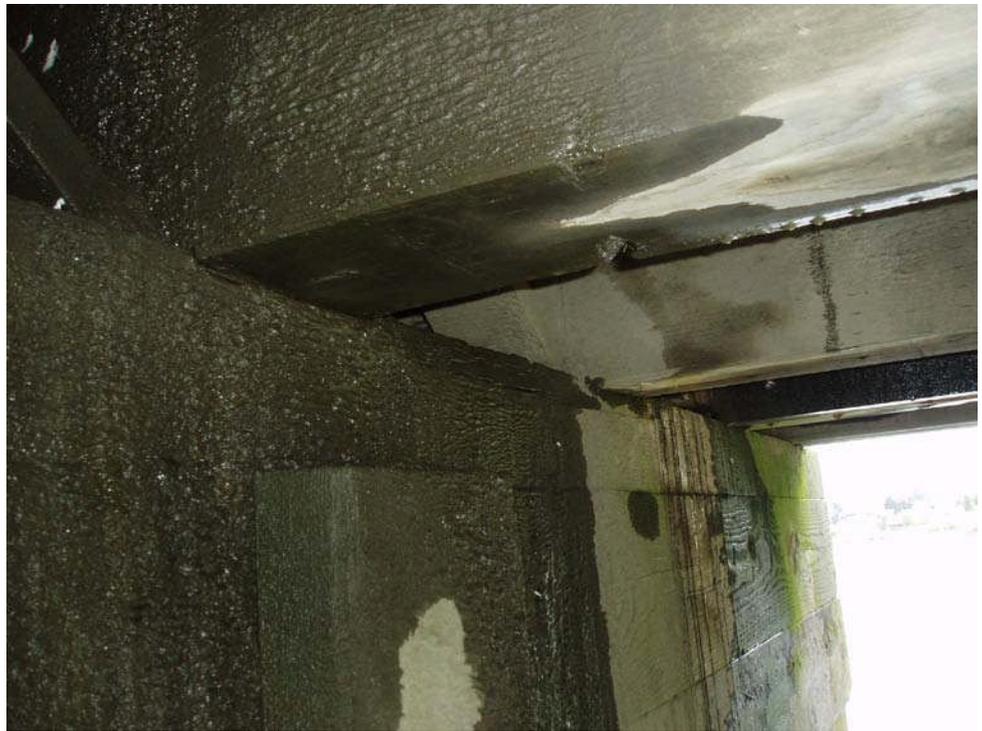
**Figure 8.1.11** Bearing Area of Typical Solid Sawn Beam

Check the bearing areas for crushing of the beams near the bearing seat (see Figure 8.1.11). Investigate for decay and insect damage by visual inspection and sounding and/or probing at the ends of the beams where dirt, debris, and moisture tend to accumulate. Also verify the condition and operation of the bearing devices, if they are present (see Topic 11.1).

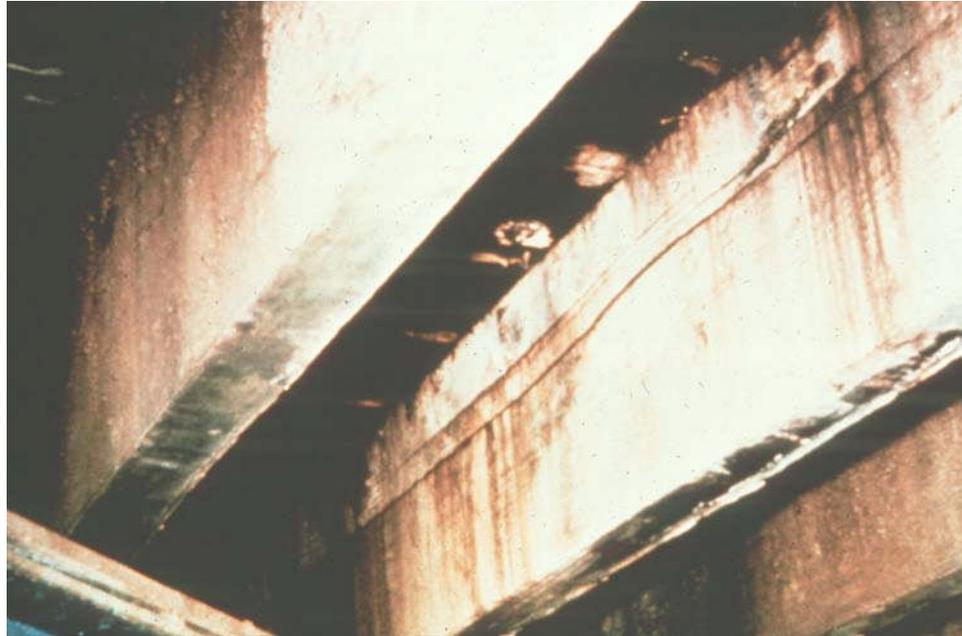
**Figure 8.1.12** Horizontal Shear Crack in a Timber Beam

Investigate the area near the supports for the presence of horizontal shear cracking. The presence of transverse cracks on the underside of the girders or horizontal

cracks on the sides of the girders indicate the onset of shear failure. These cracks can propagate quickly toward midspan and represent lost moment capacity of up to 75% (see Figure 8.1.12). Measure these cracks carefully for length, width, and if possible, the depth.

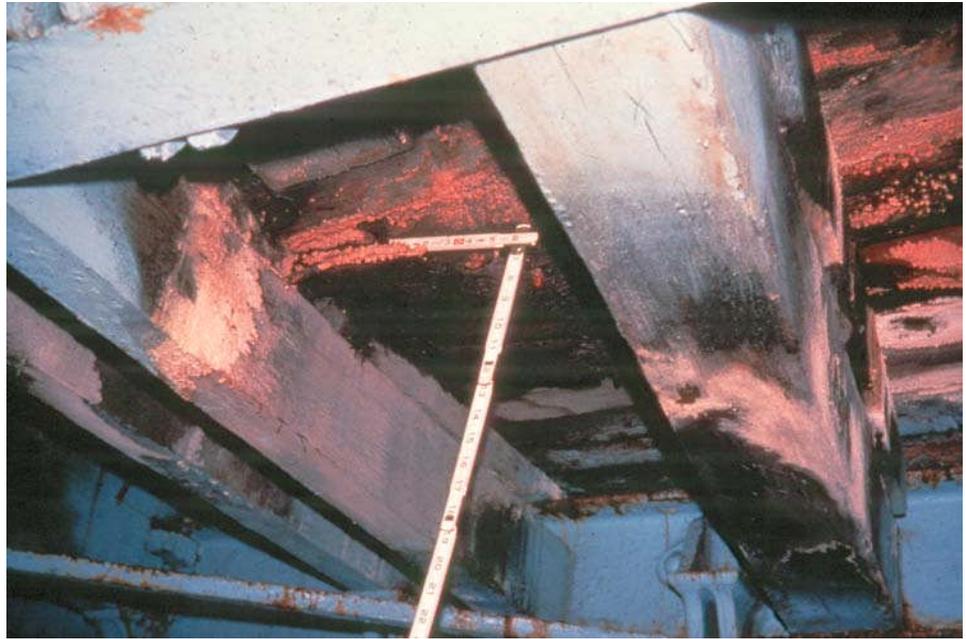
**Figure 8.1.13** Decay in a Timber Beam

Investigate for signs of decay along the full length of the beam but especially where the beam is subjected to continual wetness and areas that trap moisture. These include member interfaces between deck planks and stringers, deck planks and beams, beams and bearing seats, stringers and floorbeams, floorbeams and trusses, truss member connections, arch connections, and any fastener location.

(see Figure 8.1.13).

Decay and chemical attack may be evidenced by discolored wood, brown and white rot, the formation of fruiting bodies (the result of fungal attacks, which produce disc-shaped bodies that distribute reproductive spores), “sunken” faces in the wood, or soft “punky” texture of the wood. When surface probing for expected decay is inconclusive, the next step is to drill the suspect area. If this has been done in a previous inspection, examine the drill hole area carefully for proper preservation treatment and dowel plug installations.

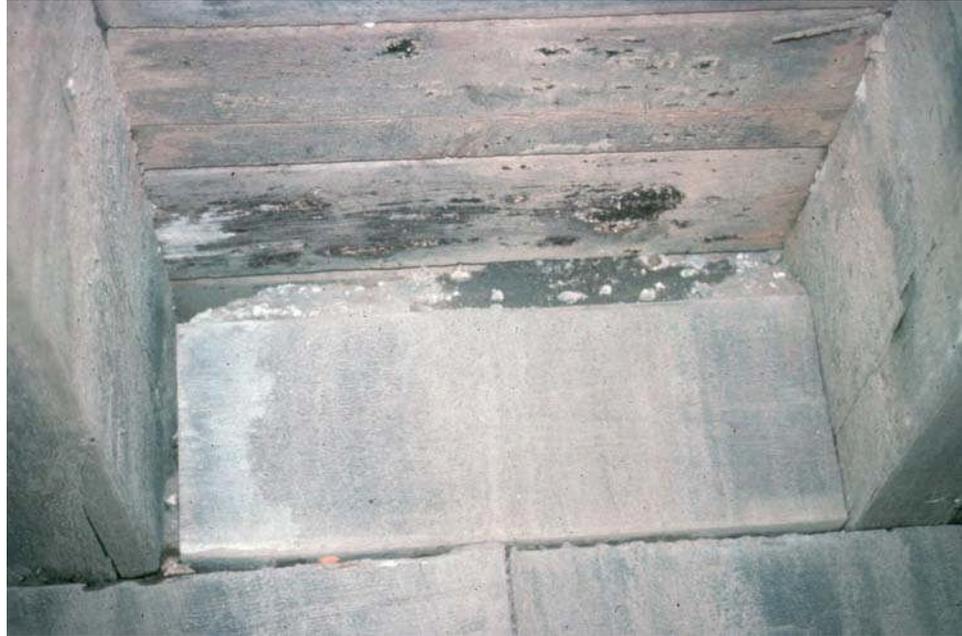
**Figure 8.1.14** Typical Timber End Diaphragm

Inspect bracing members for decay and fire damage. Examine connections of bracing to beams for tightness, cracked or split members, and corroded, loose, or missing fasteners (see Figure 8.1.14). Deteriorated secondary members may indicate problems in the primary members.

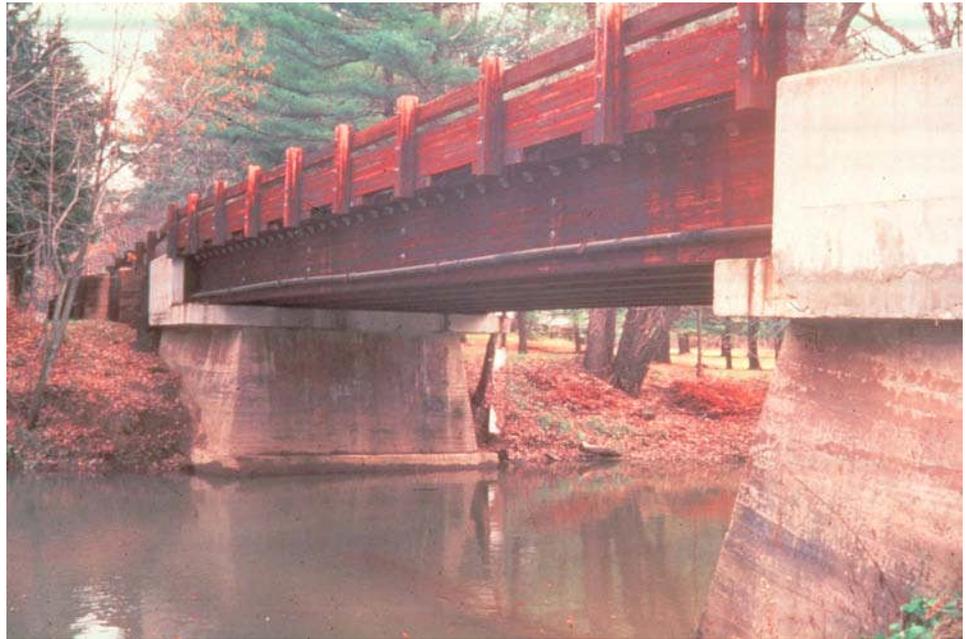
**Figure 8.2.1** Elevation View of a Glulam Multi-beam Bridge

A glued-laminated (glulam) member is made by gluing strips of wood together to form a structural member of the desired size. An advantage of glulam members is that they allow for a higher utilization of the wood, since a lower grade of material can be used to fabricate these members. Many strength reducing characteristics of wood, such as knots and checks, are minimized due to relatively small laminate dimensions. Also, the size and length of a glulam member is not limited by the size or length of a tree. Strips of wood used in glulam members are generally 3/4 to 1-1/2 inches thick (see Figures 8.2.1 and 8.2.2).

Glulam multi-beam bridges are very similar to solid sawn multi-beam bridges, but they generally use larger members to span greater distances. Glulam multi-beam bridges are typically simple span designs (see Figure 8.2.1). They usually support a deck consisting of glulam panels with a bituminous wearing surface. Beam sizes typically range from 6 inches by 24 inches to 12-1/4 inches by 60 inches, and the beams are usually spaced 5'-6" to 6'-6" on center (see Figure 8.2.2).

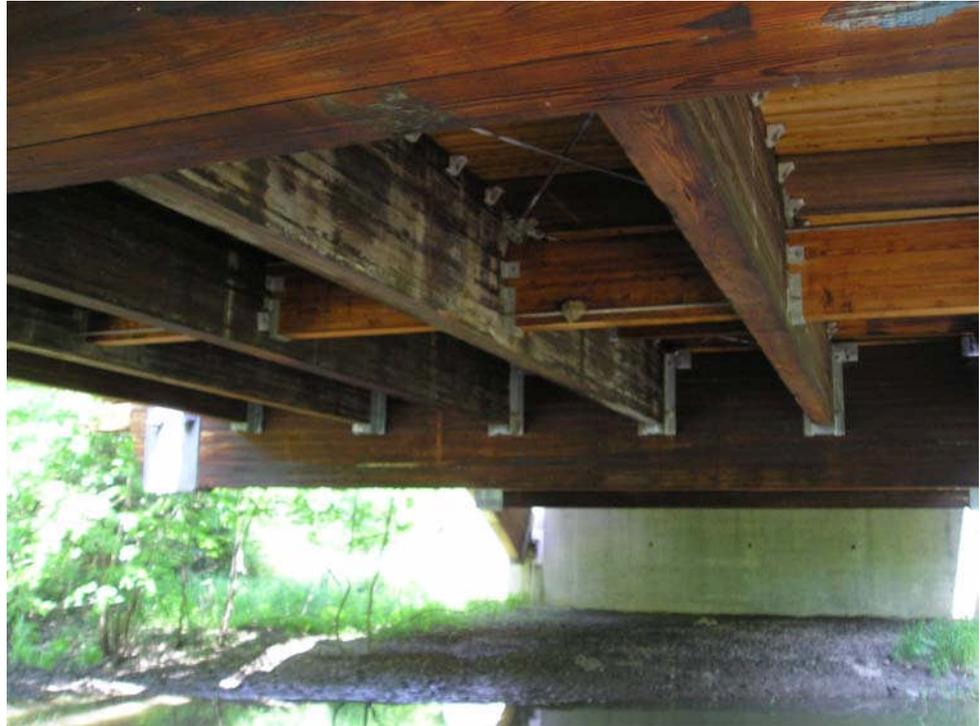
**Figure 8.2.2** Underside View of a Glulam Multi-beam Bridge

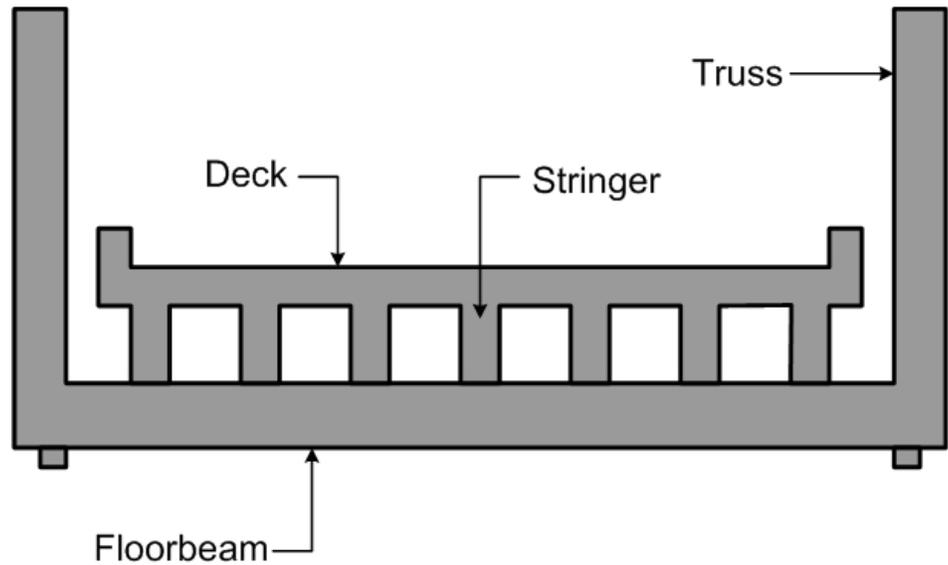
**Figure 8.2.3** Timber Through Truss Typical Section

Trusses may be of the through-type or of the deck-type. Usually the floor system consists of a timber deck supported by timber stringers and floorbeams, which are supported by the trusses (see Figures 8.2.3 and 8.2.4). Timber trusses are generally used for spans that are not economically feasible for timber multi-beam bridges. Timber trusses are practical for spans that range from 150 to 250 feet (see Figure 8.2.5).

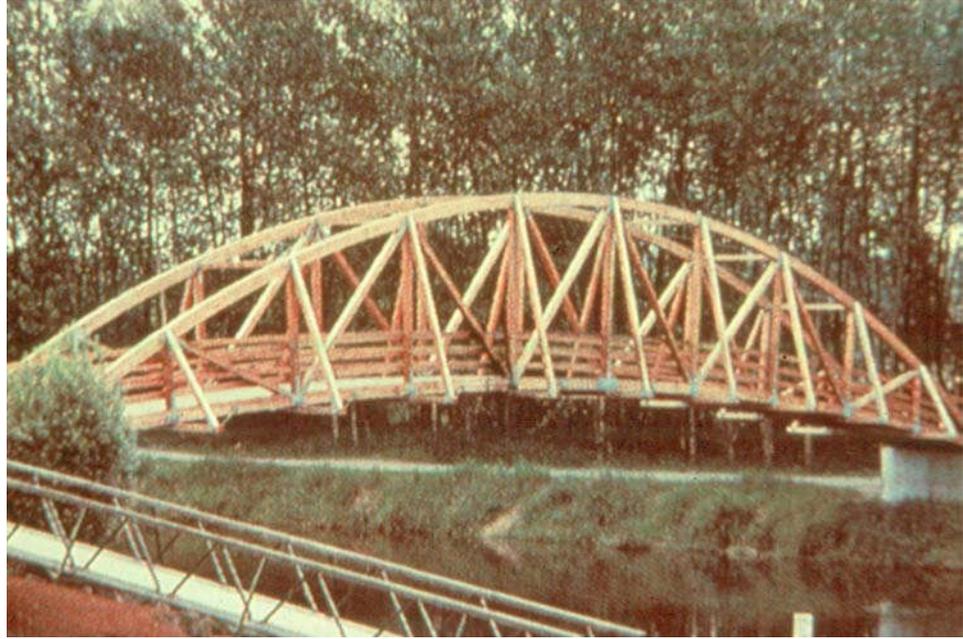
**Figure 8.2.4** Bowstring Truss Pedestrian Bridge

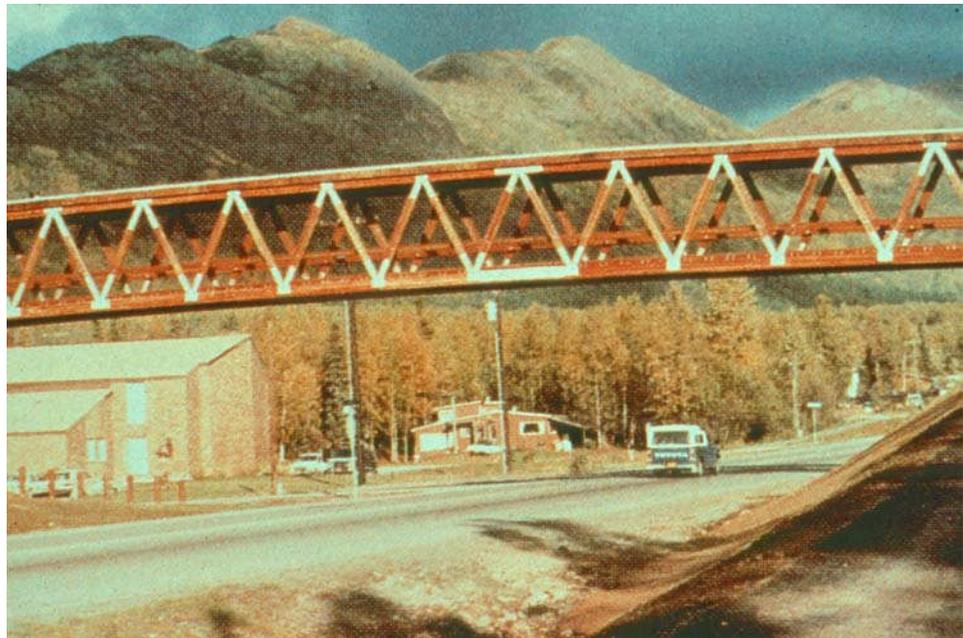
**Figure 8.2.5** Parallel Chord Truss Pedestrian Bridge (Eagle River, Alaska)

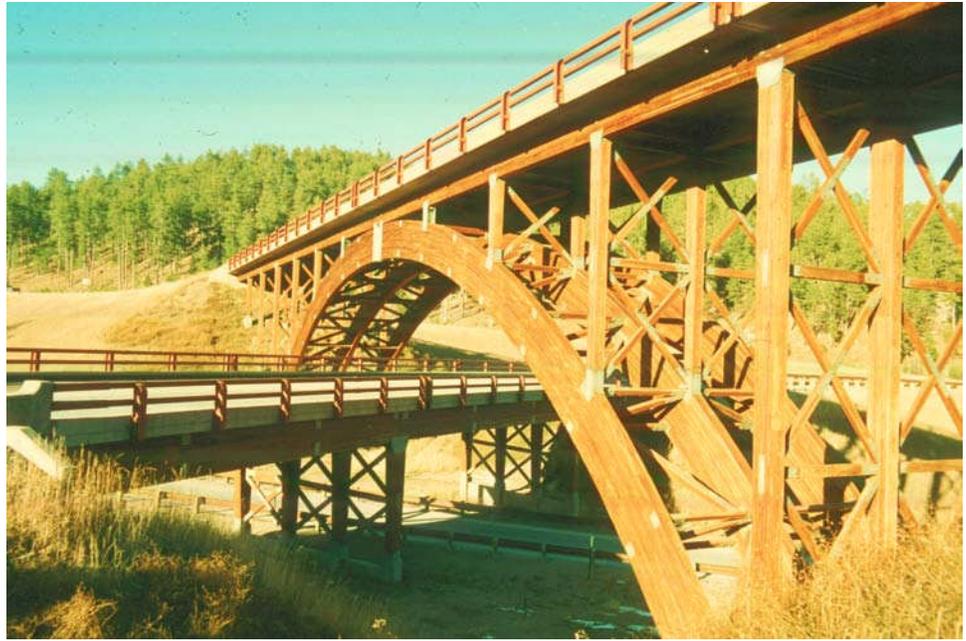
**Figure 8.2.6** Glulam Arch Bridge over Glulam Multi-beam Bridge (Keystone Wye interchange, South Dakota)

Glulam arch bridges usually consist of two- or three-hinged deck arches, which support a glulam deck and floor system (see Figures 8.2.6 and 8.2.7). Glulam arches are practical for spans of up to about 300 feet. Arches are used in locations such as parks where aesthetics is important.

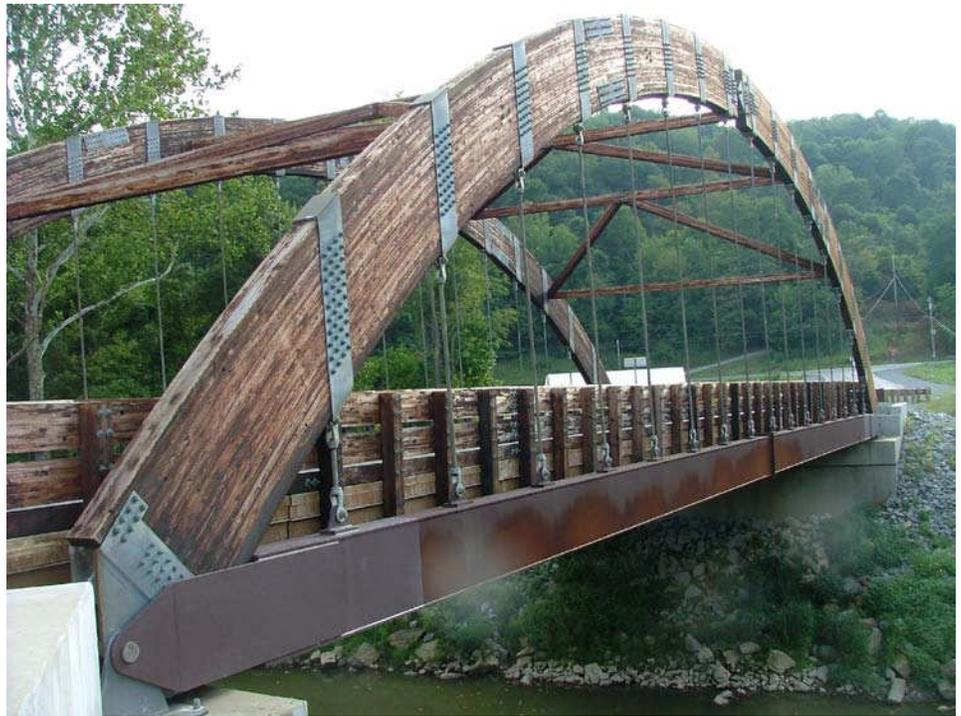
**Figure 8.2.7** Glulam Arch Bridge (West Virginia)

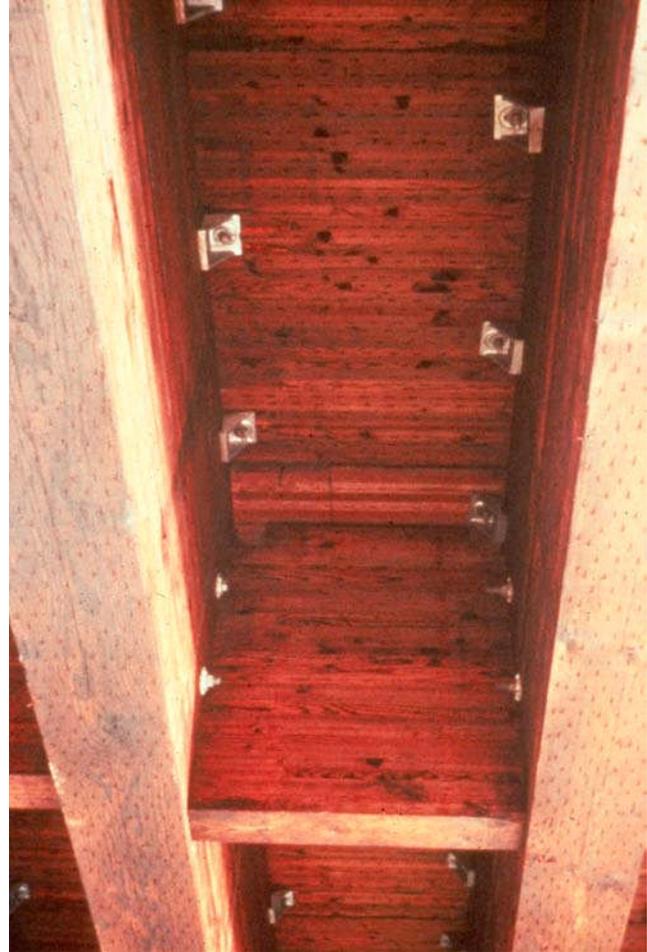
**Figure 8.2.8** Typical Glulam Diaphragm

The primary members of glulam arch and truss structures are the arch, truss, stringers, and floorbeams, spandrel bents and hangers. The secondary members include the diaphragms and cross bracing between the stringers and the lateral bracing between the arch or truss.

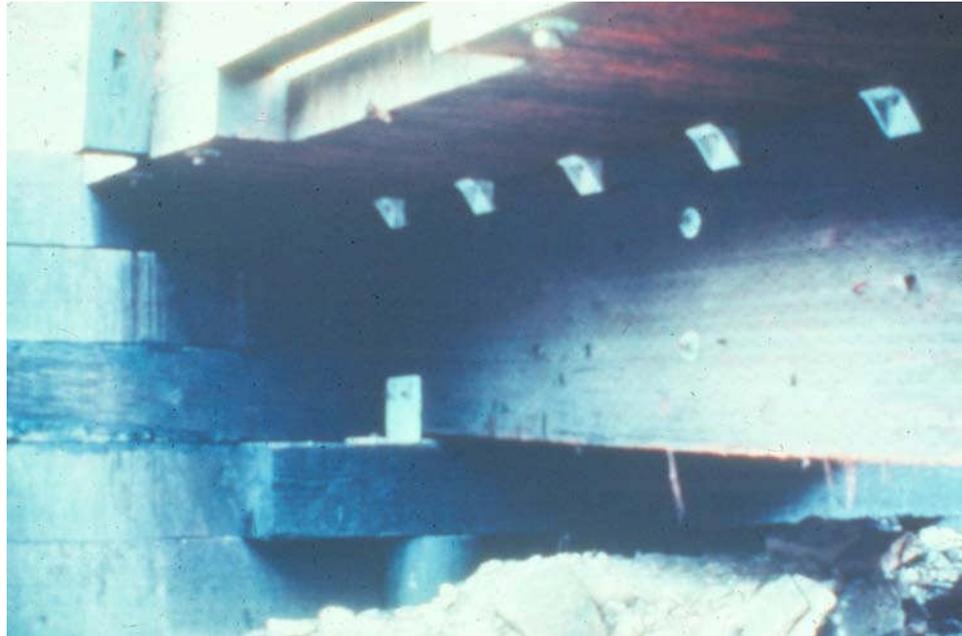
**Figure 8.2.9** Bearing Area of Typical Glulam Beam

Inspect the bearing areas for crushing of the beams (see Figure 8.2.9). Investigate for decay and insect damage by visual inspection, sounding, and/or probing at the ends of the beams. Also check the condition and operation of the bearing devices if they are present (see Topic 11.1).

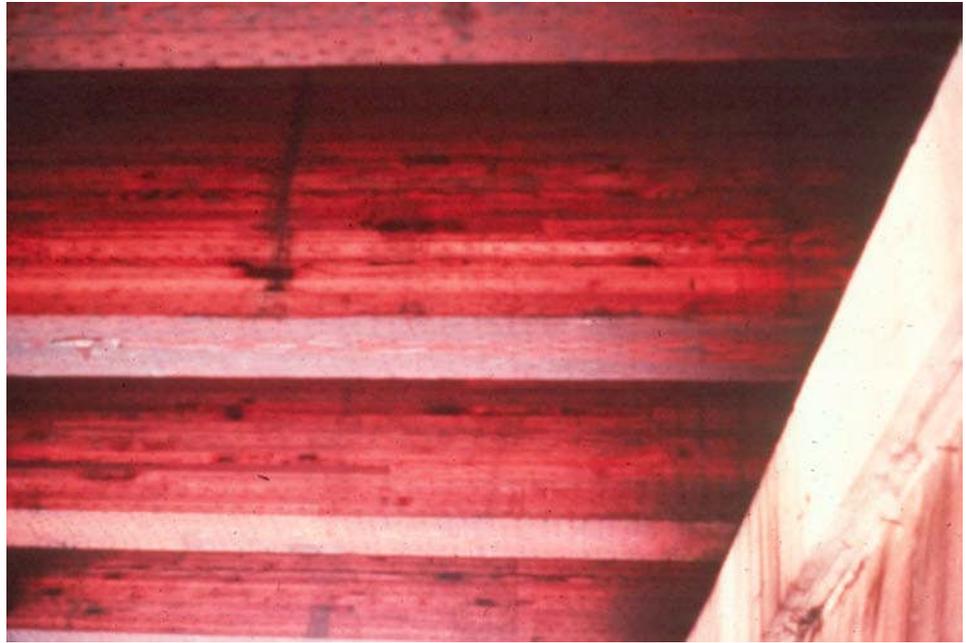
**Figure 8.2.10** Close-up View of Glulam Bridge Showing Laminations

Examine for horizontal shear cracks and delaminations near the ends of the beam. Delaminations (i.e., separations in the laminations) can occur due to either failure of the glue or failure at the bond between the glue and the lamination (see Figure 8.2.10). Delaminations that extend completely through the cross section of the member are considered severe since this makes the member act as two smaller members. Delaminations that are located near the center of the cross section are more serious than those near the top or bottom of the beam. Delaminations directly through a connector are also undesirable.

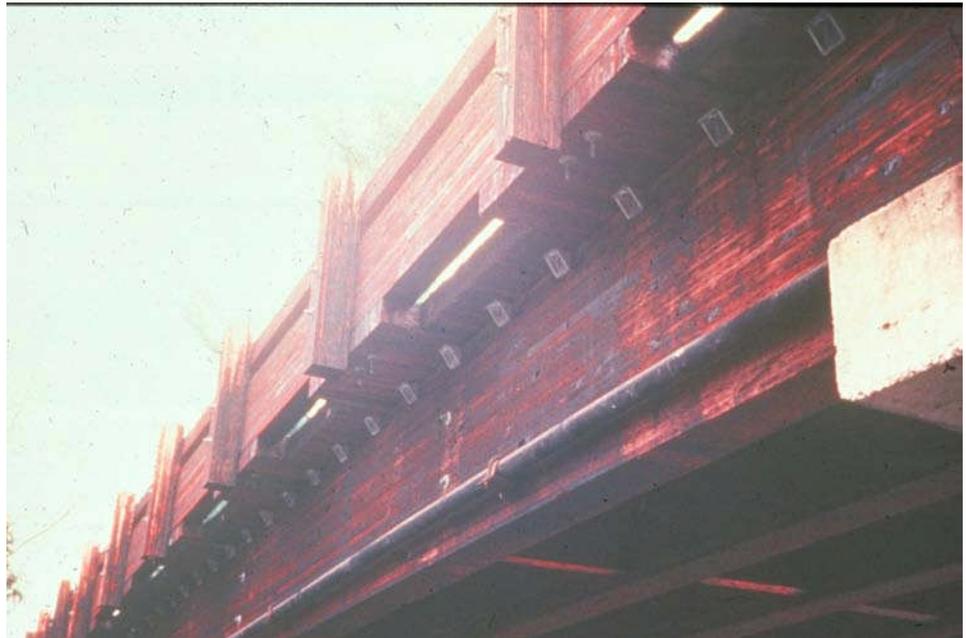
**Figure 8.2.11** Elevation View of Beam of Glulam Multi-beam Bridge

Examine the zone of maximum tension for signs of structural distress (see Figure 8.2.11). The maximum tension generally occurs at the bottom half of the middle third of the beam span. Investigate for section loss due to decay or fire, especially near mid-span. Inspect for excessive deflection or sagging in the beams.

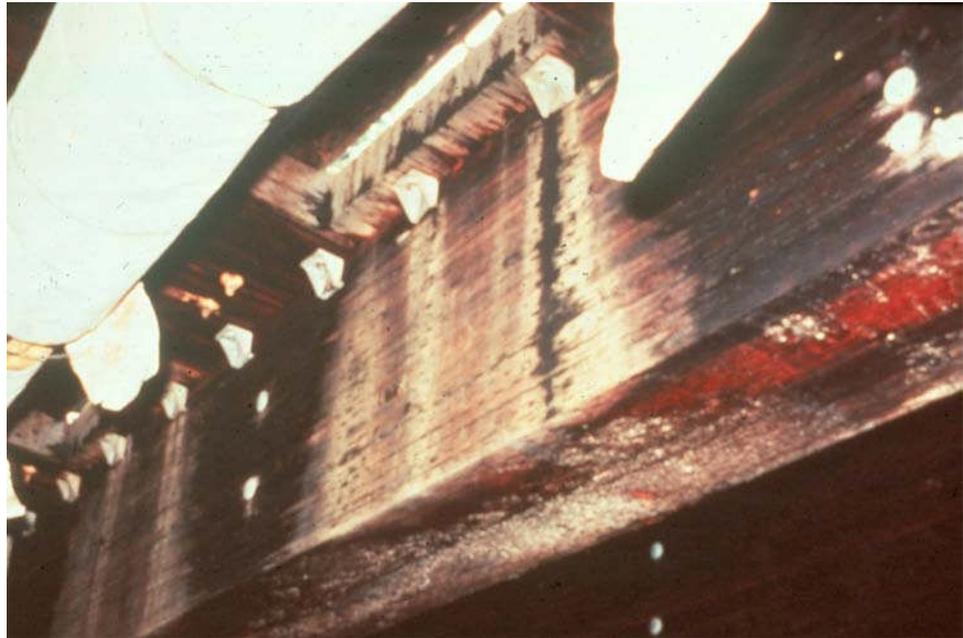
**Figure 8.2.12** Decay on Glulam Beam

Investigate for signs of decay along the full length of the member but especially where the beam is subjected to continual wetness or prolonged exposure to moisture (see Figure 8.2.12). Decay and chemical attack may be evidenced by discolored wood, brown and white rot, the formation of fruiting bodies (the result of fungal attacks, which produce disc-shaped bodies that distribute reproductive spores), "sunken" faces in the wood, or the soft "punky" texture of the wood.

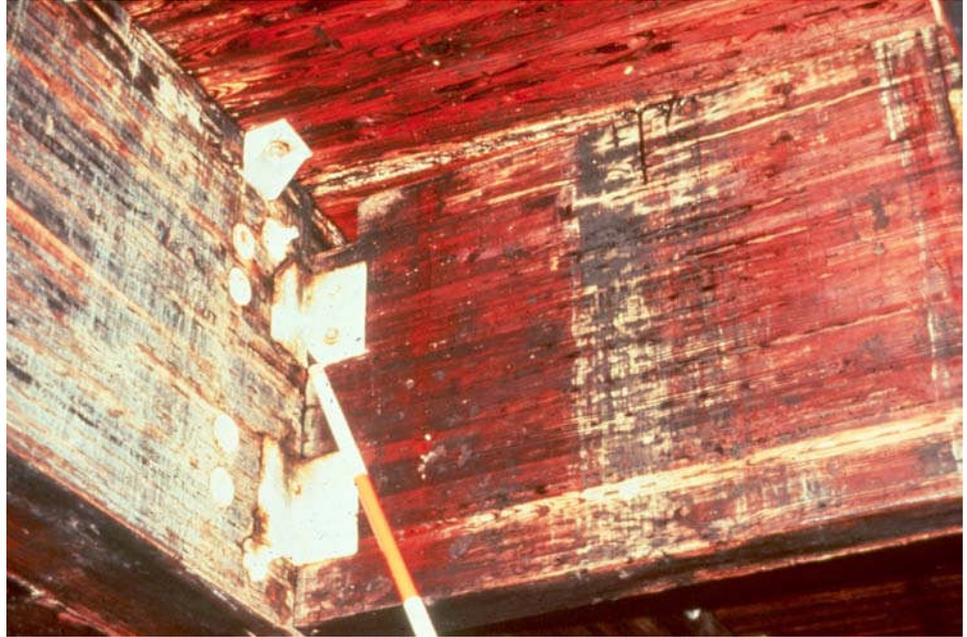
**Figure 8.2.13** Typical Diaphragm for a Glulam Multi-beam Bridge

Examine diaphragms for decay, fire damage, and insect damage (see Figure 8.2.13). Check steel cross bracing for corrosion, bowing, or buckling (see Figure 8.2.14). Examine connections for tightness, cracks and splits, and corroded, loose,

Inspect any fastener for corrosion, tightness, and missing parts (see Figure 8.2.13).

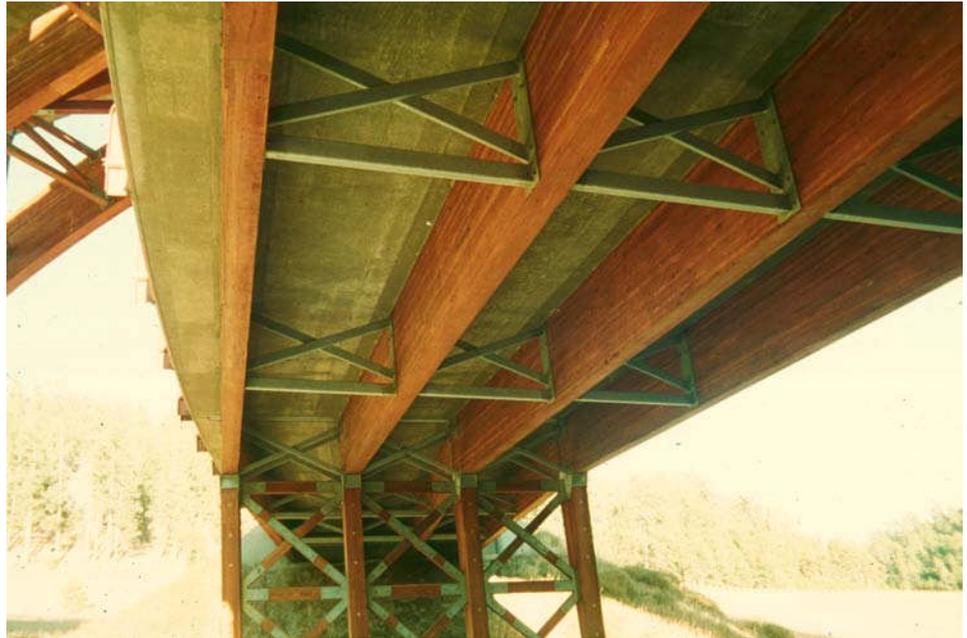
**Figure 8.2.14** Glulam Beams with Numerous Fastener Locations

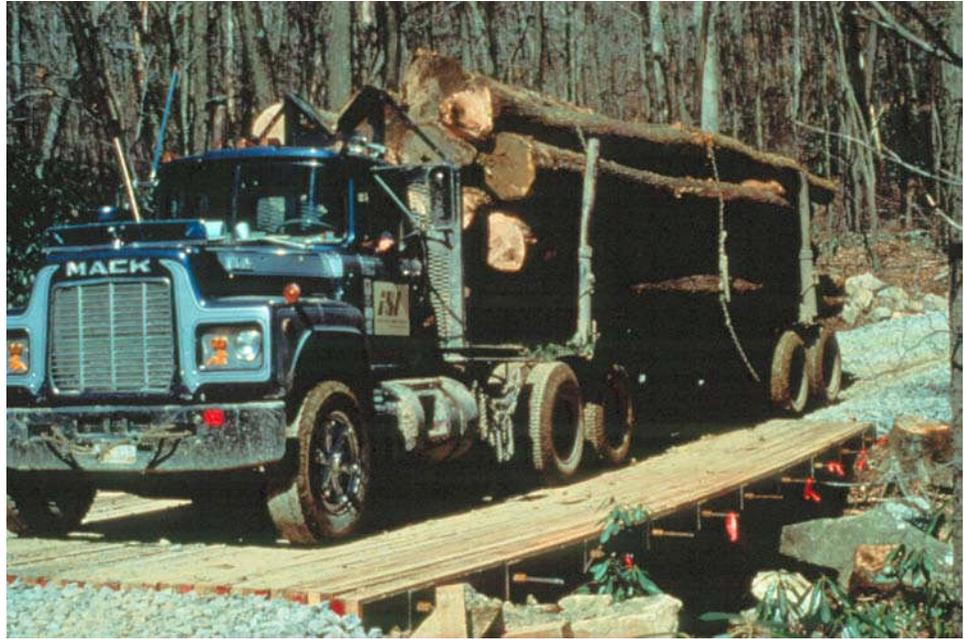
**Figure 8.3.1** Stress-Laminated Timber Slab Bridge Carrying a 90,000-Pound Logging Truck (Source: Barry Dickson, West Virginia University)

Stress-laminated timber bridges were first developed in Canada, in 1976, by the Ontario Ministry of Transportation and Communications. These bridges consist of multiple planks mechanically clamped together using metal rods to perform as one unit (see Figure 8.3.1). The compression induced frictional resistance within the timber laminations is the mechanism that makes this structural system effective.

Stress-laminated timber slab bridges can be used for simple spans of up to 50 feet and are capable of carrying modern highway loadings (see Figures 8.3.1 and 8.3.3). Stressed deck bridges have also been constructed using glulam members. Combining glulam technology with stress-lamination increases practical span lengths to 65 feet (see Figure 8.3.4).

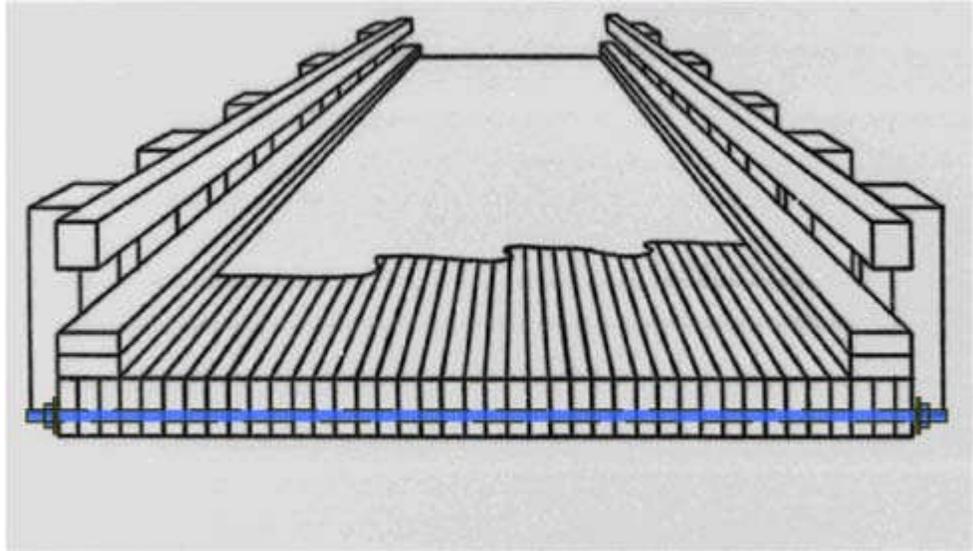
**Figure 8.3.2** Typical Section of a Stress-Laminated Timber Slab Bridge

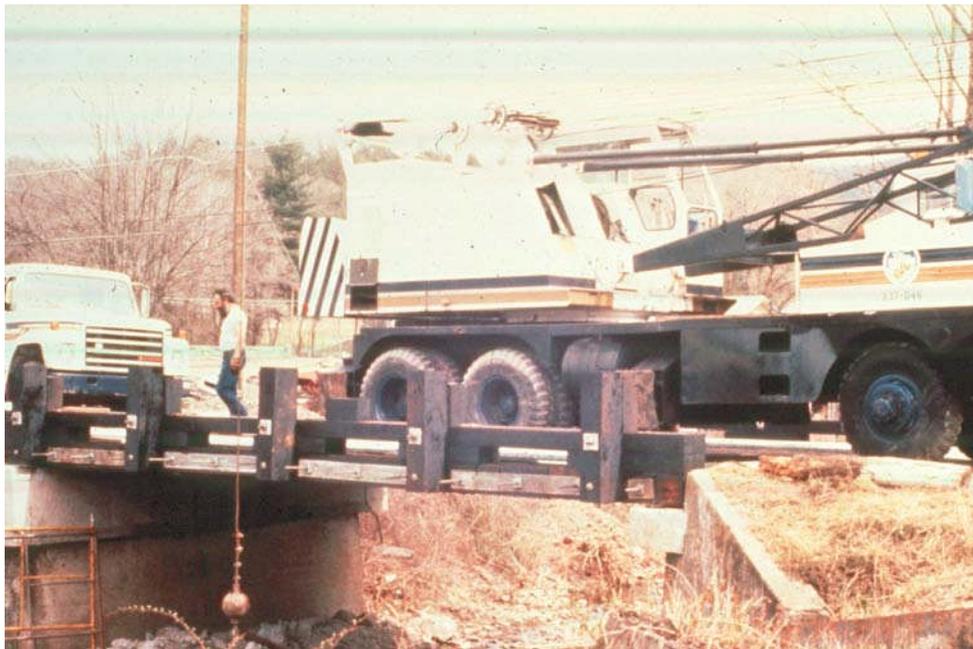
**Figure 8.3.3** Stress-Laminated Timber Slab Bridge

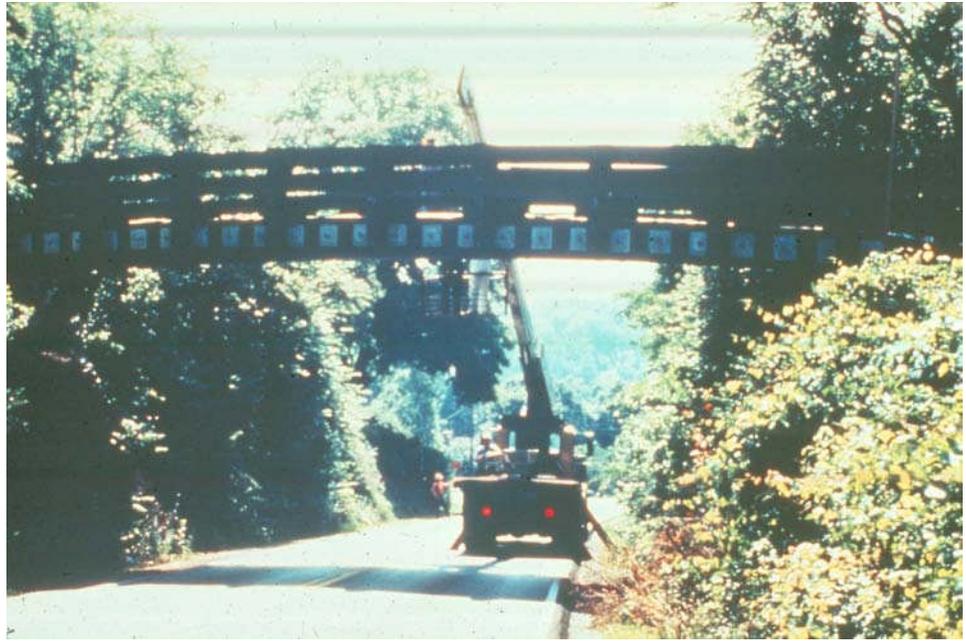
**Figure 8.3.4** Glulam Stress-Laminated Timber Slab Bridge
