## Chapter 8 Inspection and Evaluation of Timber Superstructures

### Topic 8.1 Solid Sawn Timber Bridges

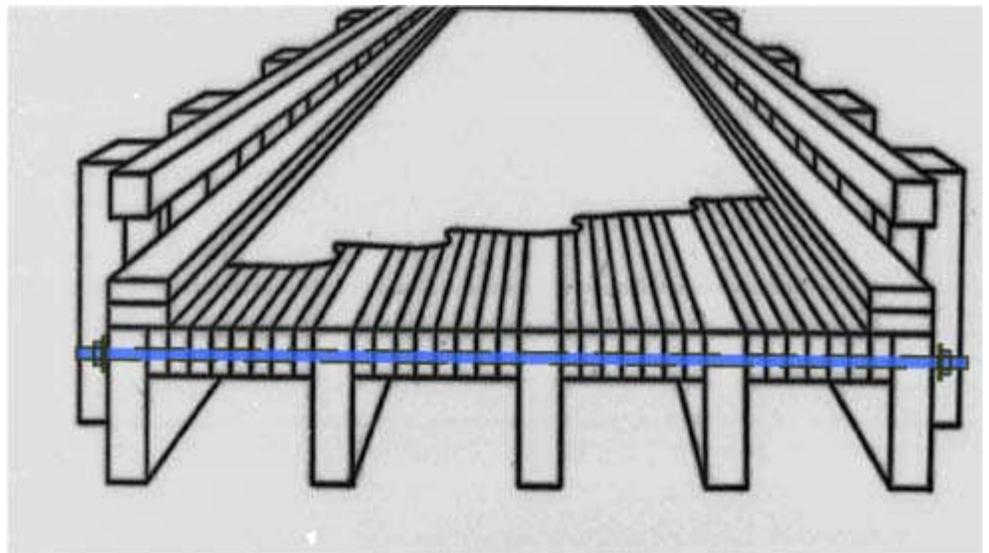
**Figure 8.3.5** Typical Section of a Stress-Laminated Timber Tee Beam Bridge  
(Source: Barry Dickson, West Virginia University)

The idea for stress-laminated timber tee beam bridges was developed at West Virginia University. These bridges consist of a stress-laminated deck and glulam beams (see Figure 8.3.5). High strength steel rods are used to join the stress-laminated deck and glulam beams together to form stress-laminated timber tee beams. The first structure of this type was built in 1988, near Charleston, West Virginia. It is 75 feet long and has stressing rods spaced at two feet. This bridge has performed well, which encouraged longer span lengths to be constructed. The average span length for stress-laminated tee beam bridges ranges between 25 and 85 feet (see Figure 8.3.6).

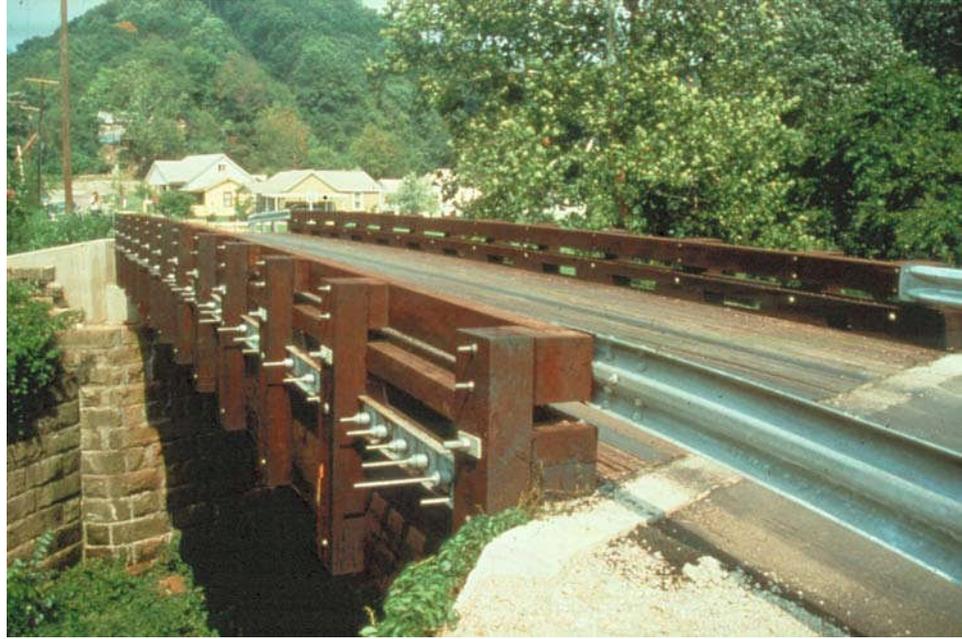
**Figure 8.3.6** Elevation View of Stress-Laminated Timber Tee Beam Bridge (West Virginia)

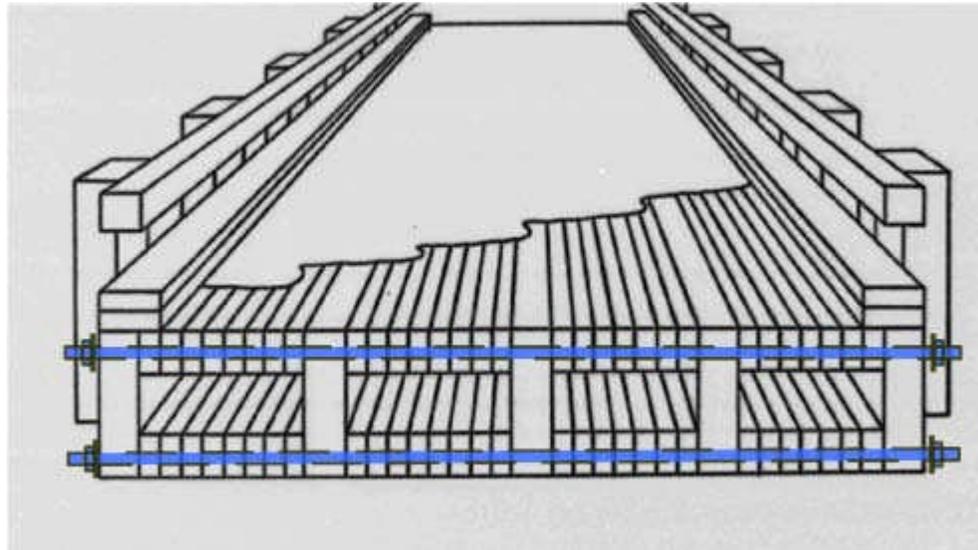
**Figure 8.3.7** Typical Section of a Stress-Laminated Timber Box Beam (Source: Barry Dickson, West Virginia University)

Stress-laminated timber box beam bridges represent further development of timber bridges by West Virginia University. These bridges consist of adjacent box beam panels individually comprised of stress-laminated flanges and glulam beam webs (see Figure 8.3.7). This bridge type is also known as a cellular stressed deck. Average span lengths range between 35 and 65 feet, with longer maximum spans (see Figure 8.3.8).

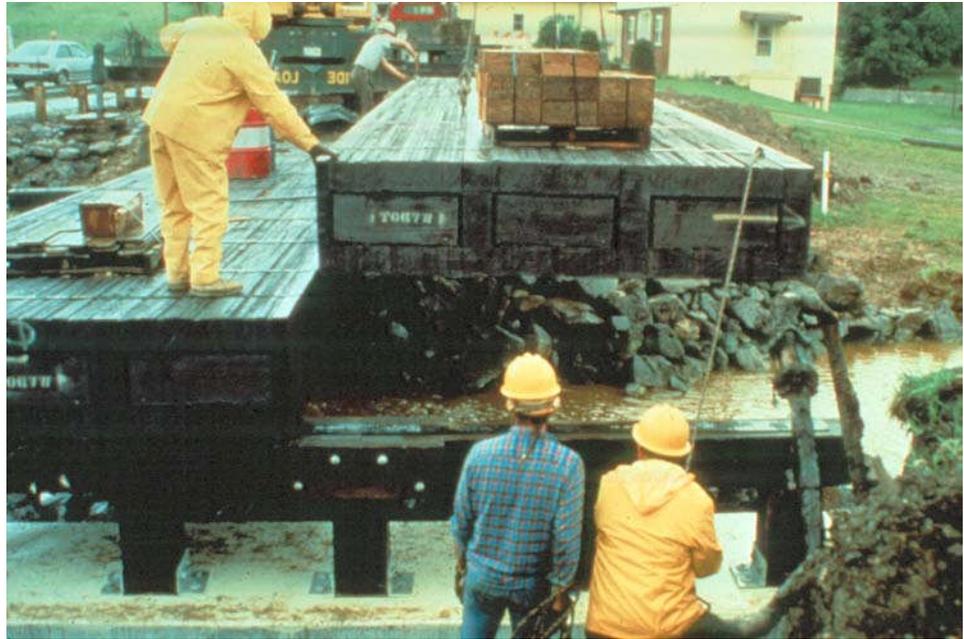
**Figure 8.3.8** Stress-Laminated Timber Box Beam Bridge Being Erected

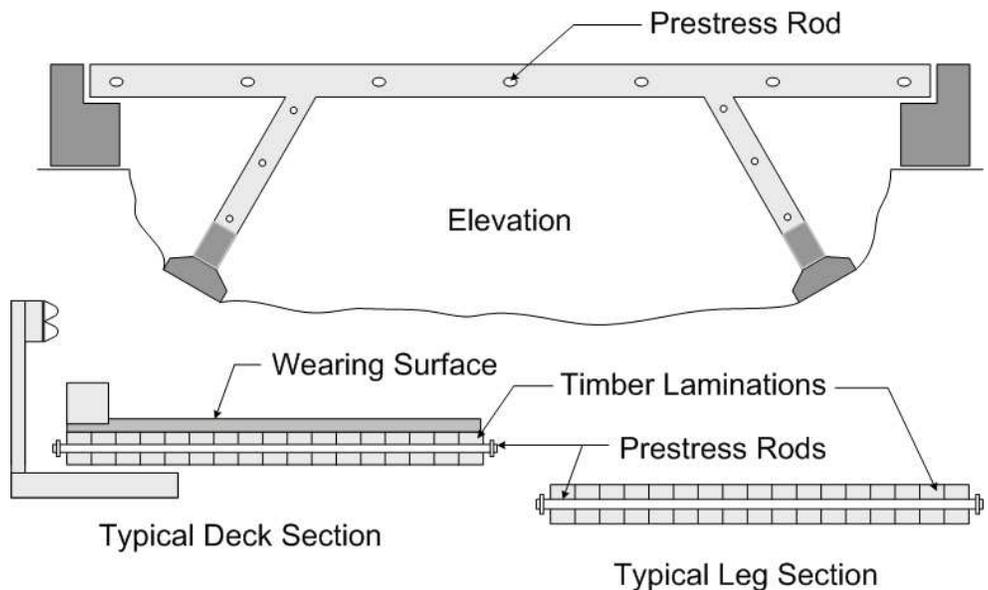
**Figure 8.3.9** Stress-Laminated Timber K-frame Bridge

Stressed K-frame bridges represent further development of the stressed deck bridge by the Ontario Ministry of Transportation and Communications. These bridges consist of three spans in which the stressed deck is supported at two intermediate points by stressed laminated timber struts (see Figure 8.3.9). This bridge type has been used for a bridge with a total length of excess of 100 feet, and it has a potential for center span lengths over 50 feet.

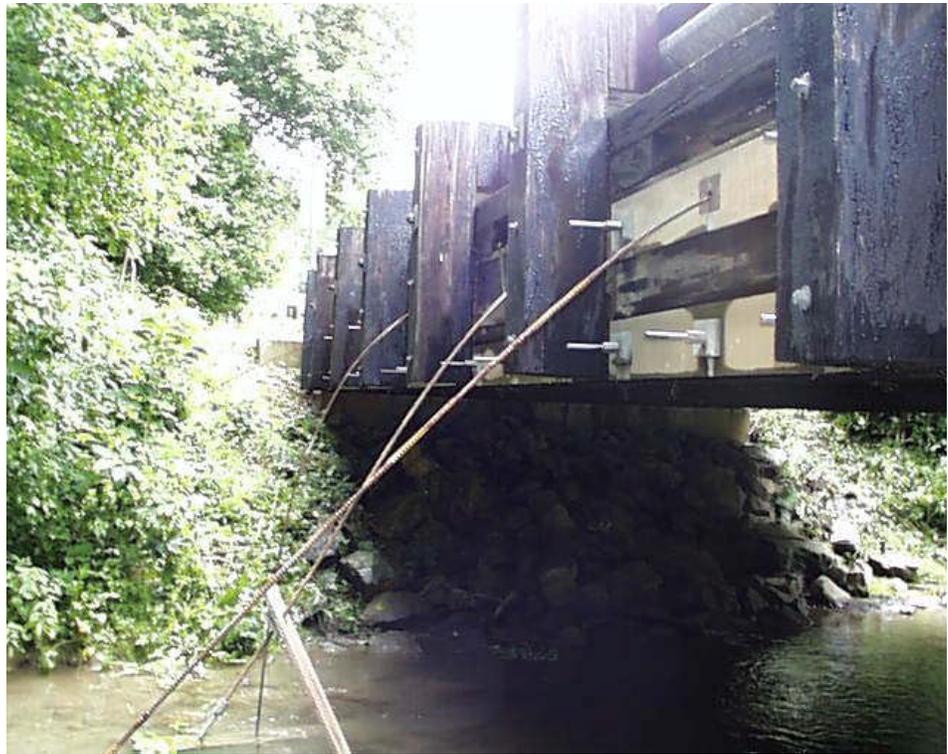
**Figure 8.3.10** Broken Stressing Rods

Examine the condition of the steel stressing rods, and inspect for crush and splits in the fascia members. Check for loss of prestress in the rods, which would be indicated by shifted planks in the stress-laminated timber element and excessive deflection or loose rods. This may be observed when the bridge is subject to a moving live load.

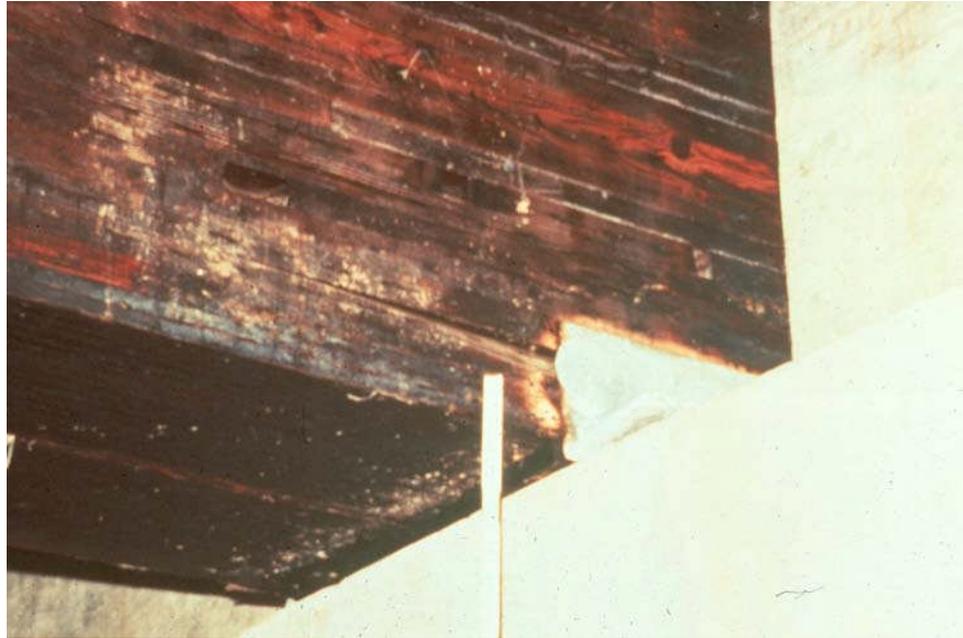
**Figure 8.3.11** Close-up View of End of a Stress-Laminated Timber Bridge Showing Laminations

Examine for horizontal shear cracks and delaminations near the ends of the beam. Delaminations (i.e., separations in the laminations) can occur due to either failure of the glue or failure at the bond between the glue and the lamination (see Figure 8.3.11). Delaminations that extend completely through the cross section of the member are the most severe since this makes the member act as two smaller members.

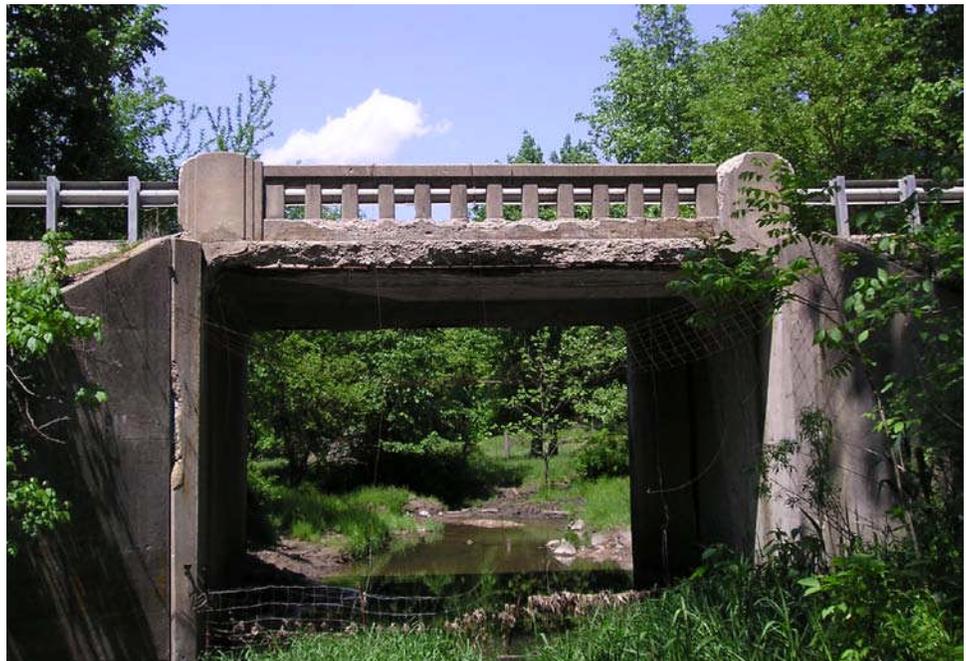
**Figure 9.1.1** Typical Simple Span Cast-in-Place Slab Bridge

The cast-in-place slab bridge is the simplest type of reinforced concrete bridge and was a common choice for construction in the early 1900's (see Figures 9.1.1 and 9.1.2). Sometimes the terms "deck" and "slab" are used interchangeably to describe the same bridge component. However, this is incorrect. A deck is supported by a superstructure unit (beams, girders, etc.), whereas a slab is a superstructure unit supported by a substructure unit (abutments, piers, bents, etc.). A deck can be loosely defined as the top surface of the bridge, which carries the traffic and distributes loads to the superstructure. A slab serves as the superstructure and the top surface that carries the traffic. Even though slabs are defined differently than decks, many of the design characteristics, wearing surfaces, protective systems, inspection methods and locations and, evaluation, are similar. See Topic 7.2 for further details.

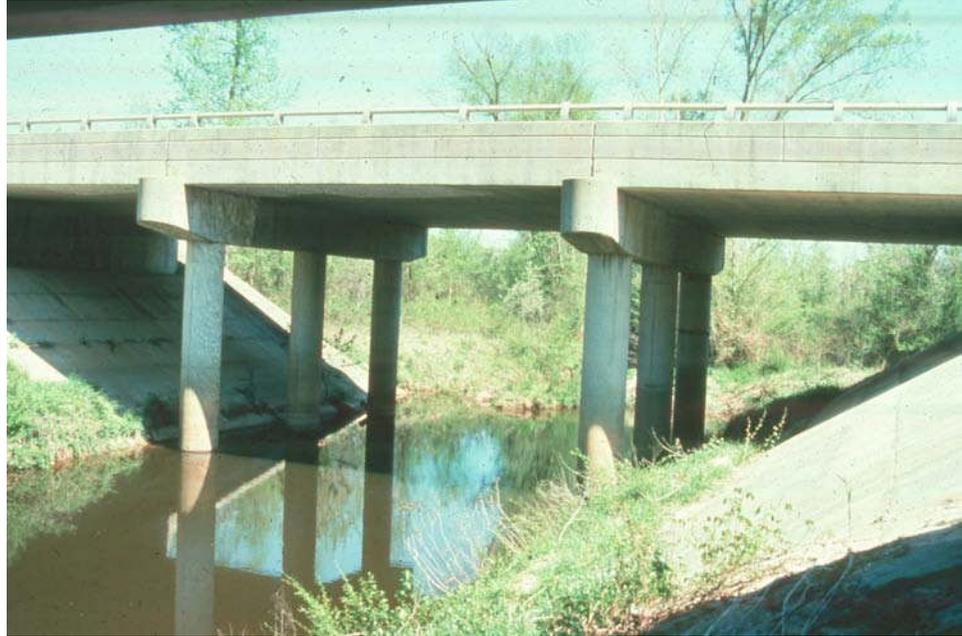
**Figure 9.1.2** Typical Multi-Span Cast-in-Place Slab Bridge

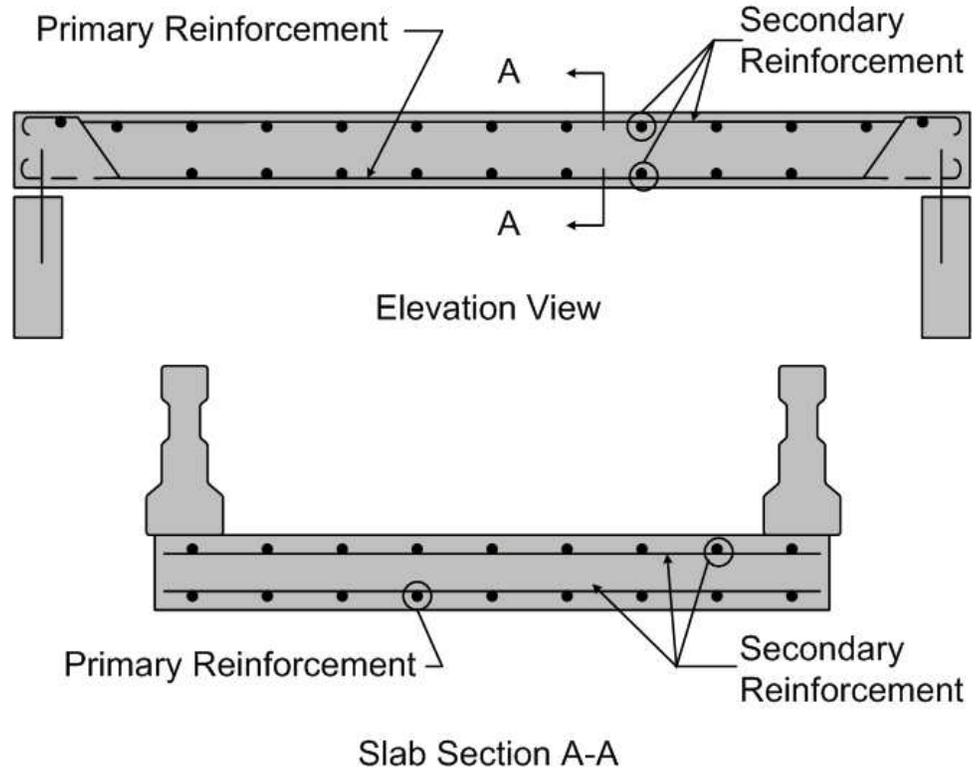
**Figure 9.1.3** Steel Reinforcement in a Simply Supported Concrete Slab

Nearly all slab bridges have a grid or mat of steel reinforcement in both the top and bottom of the slab that is formed by some combination of primary and secondary reinforcement (see Figure 9.1.3).

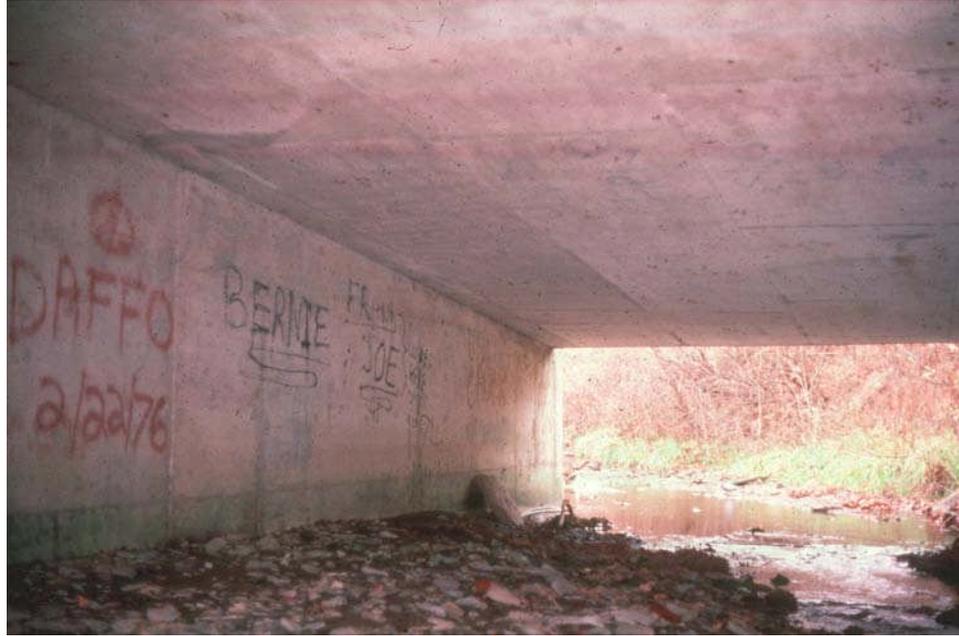
**Figure 9.1.4** Bearing Area: Cast-in-Place Slab

As detailed in Topic 7.2.6, bearing areas are located where one element "sits" on top of another element. For slabs, the bearing areas are located above the substructure supports.

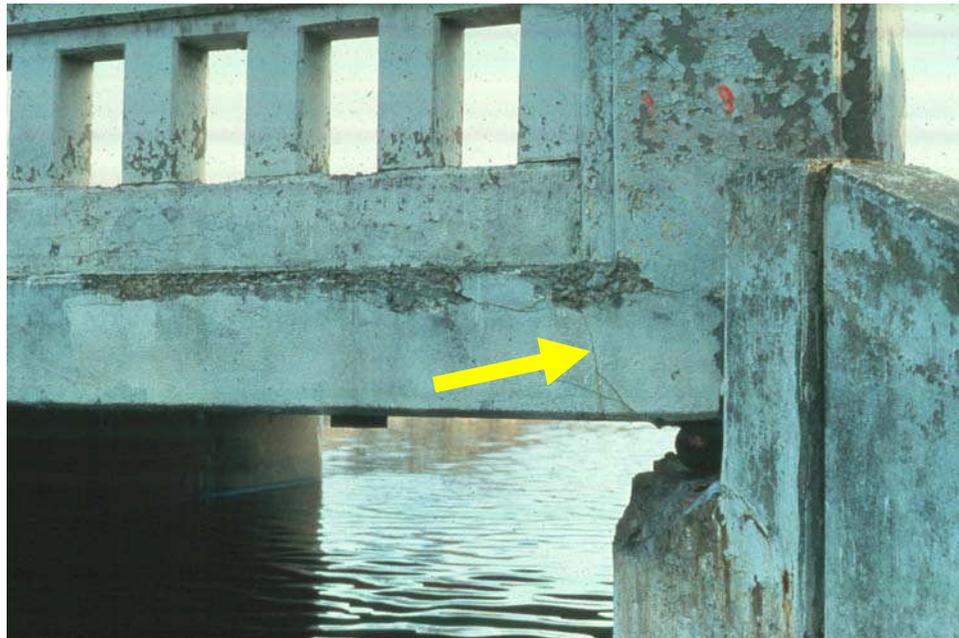
**Figure 9.1.5** Diagonal Shear Cracks Close to the Ends of a Slab Bridge

Investigate areas near the supports for shear cracking. The presence of transverse cracks on the underside near supports or diagonal cracks on the sides of the slab indicate the onset of an overstress for shear (see Figures 9.1.5 and 9.1.6). Carefully measure cracks as they may represent lost shear capacity.

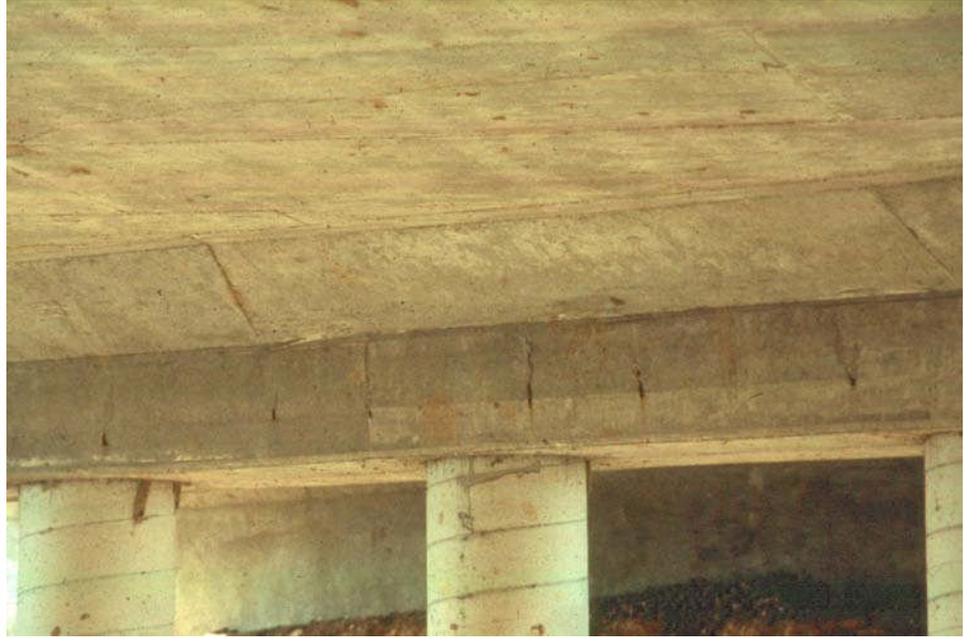
**Figure 9.1.6** Shear Zone on the Underside of a Continuous Slab Bridge Near a Pier

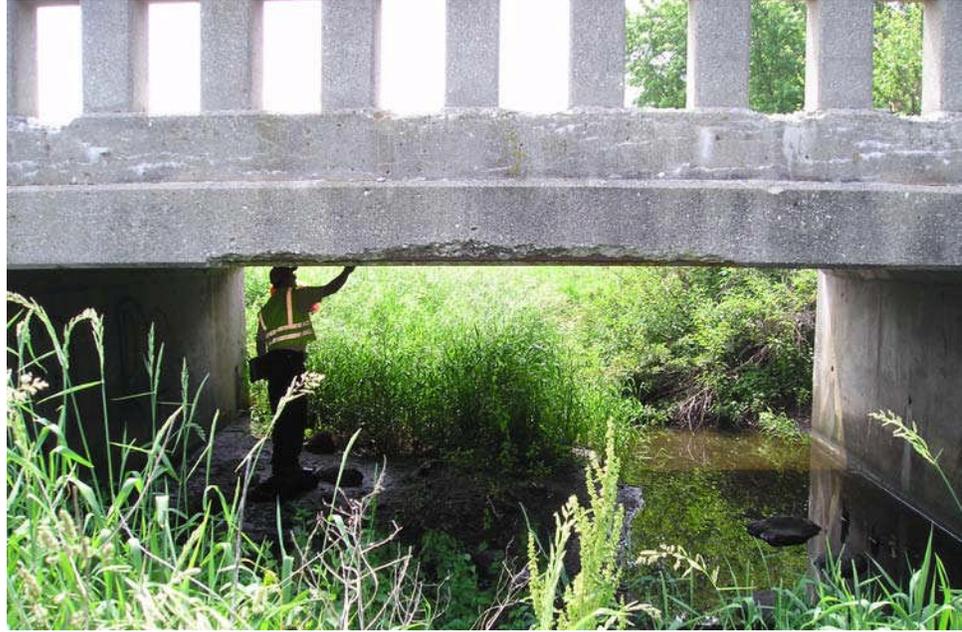
**Figure 9.1.7** Inspector examining and documenting deficiencies in concrete slab

Examine tension zones for flexure cracks, which would be perpendicular to the tensile forces and vertical on the sides and transverse across the slab. The tension zones are at midspan along the bottom of the slab for both simple and continuous span bridges. Additional tension zones are located on top of the slab over the piers for continuous spans. Cracks greater than 1/16 inch wide indicate overstress due to tensile forces caused by bending stresses. Check for efflorescence from cracks and, more significant, the discoloration of the concrete caused by rust stains from the reinforcing steel. In severe cases, the reinforcing steel may become exposed due to spalling. Document the remaining cross section of reinforcing steel since section loss will decrease live load capacity (see Figure 9.1.7).

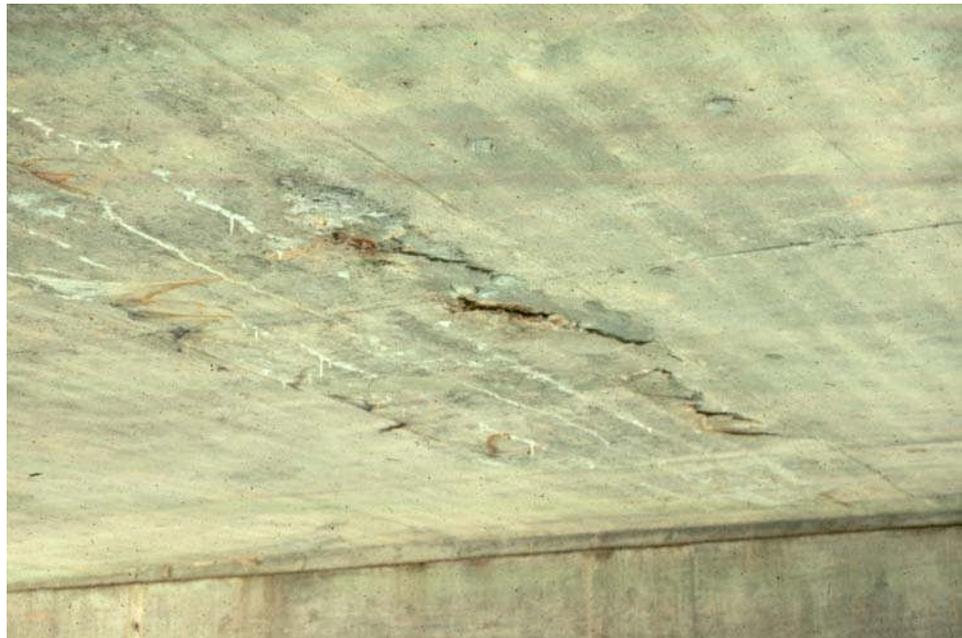
**Figure 9.1.8** Concrete Slab Tension Zone: Delamination, Efflorescence, Rust, and Stains

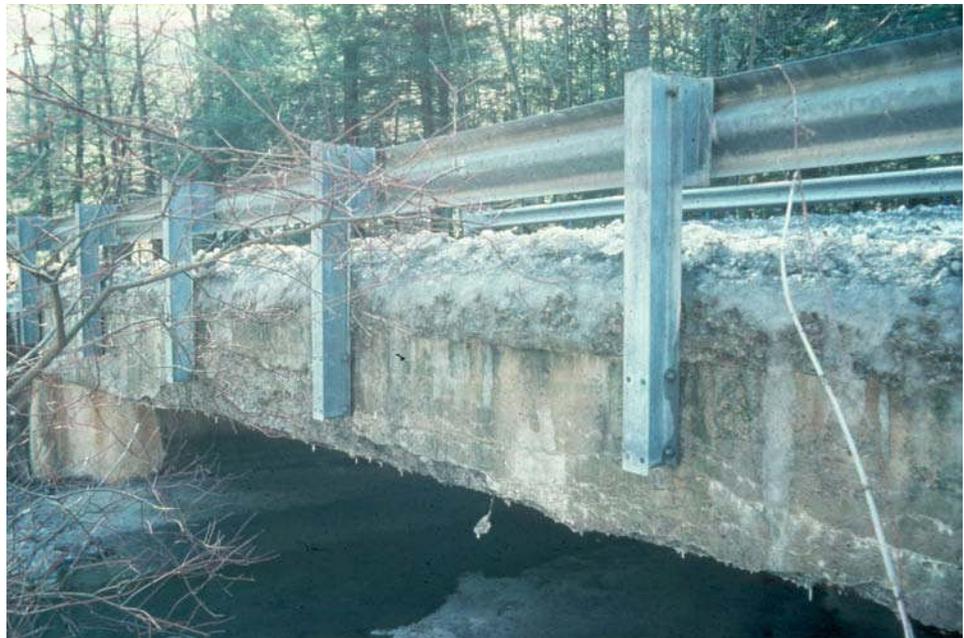
**Figure 9.1.9** Deteriorated Slab Fascia due to Roadway Deicing Agents
