PHASE I ENVIRONMENTAL SITE ASSESSMENT

**TZ90169
Proposed Truck Station Site
7907 Thunderbird Trail East
Eveleth, Minnesota 55734
340-0010-03220**

BAY WEST PROJECT NO. J180892

April 22, 2019

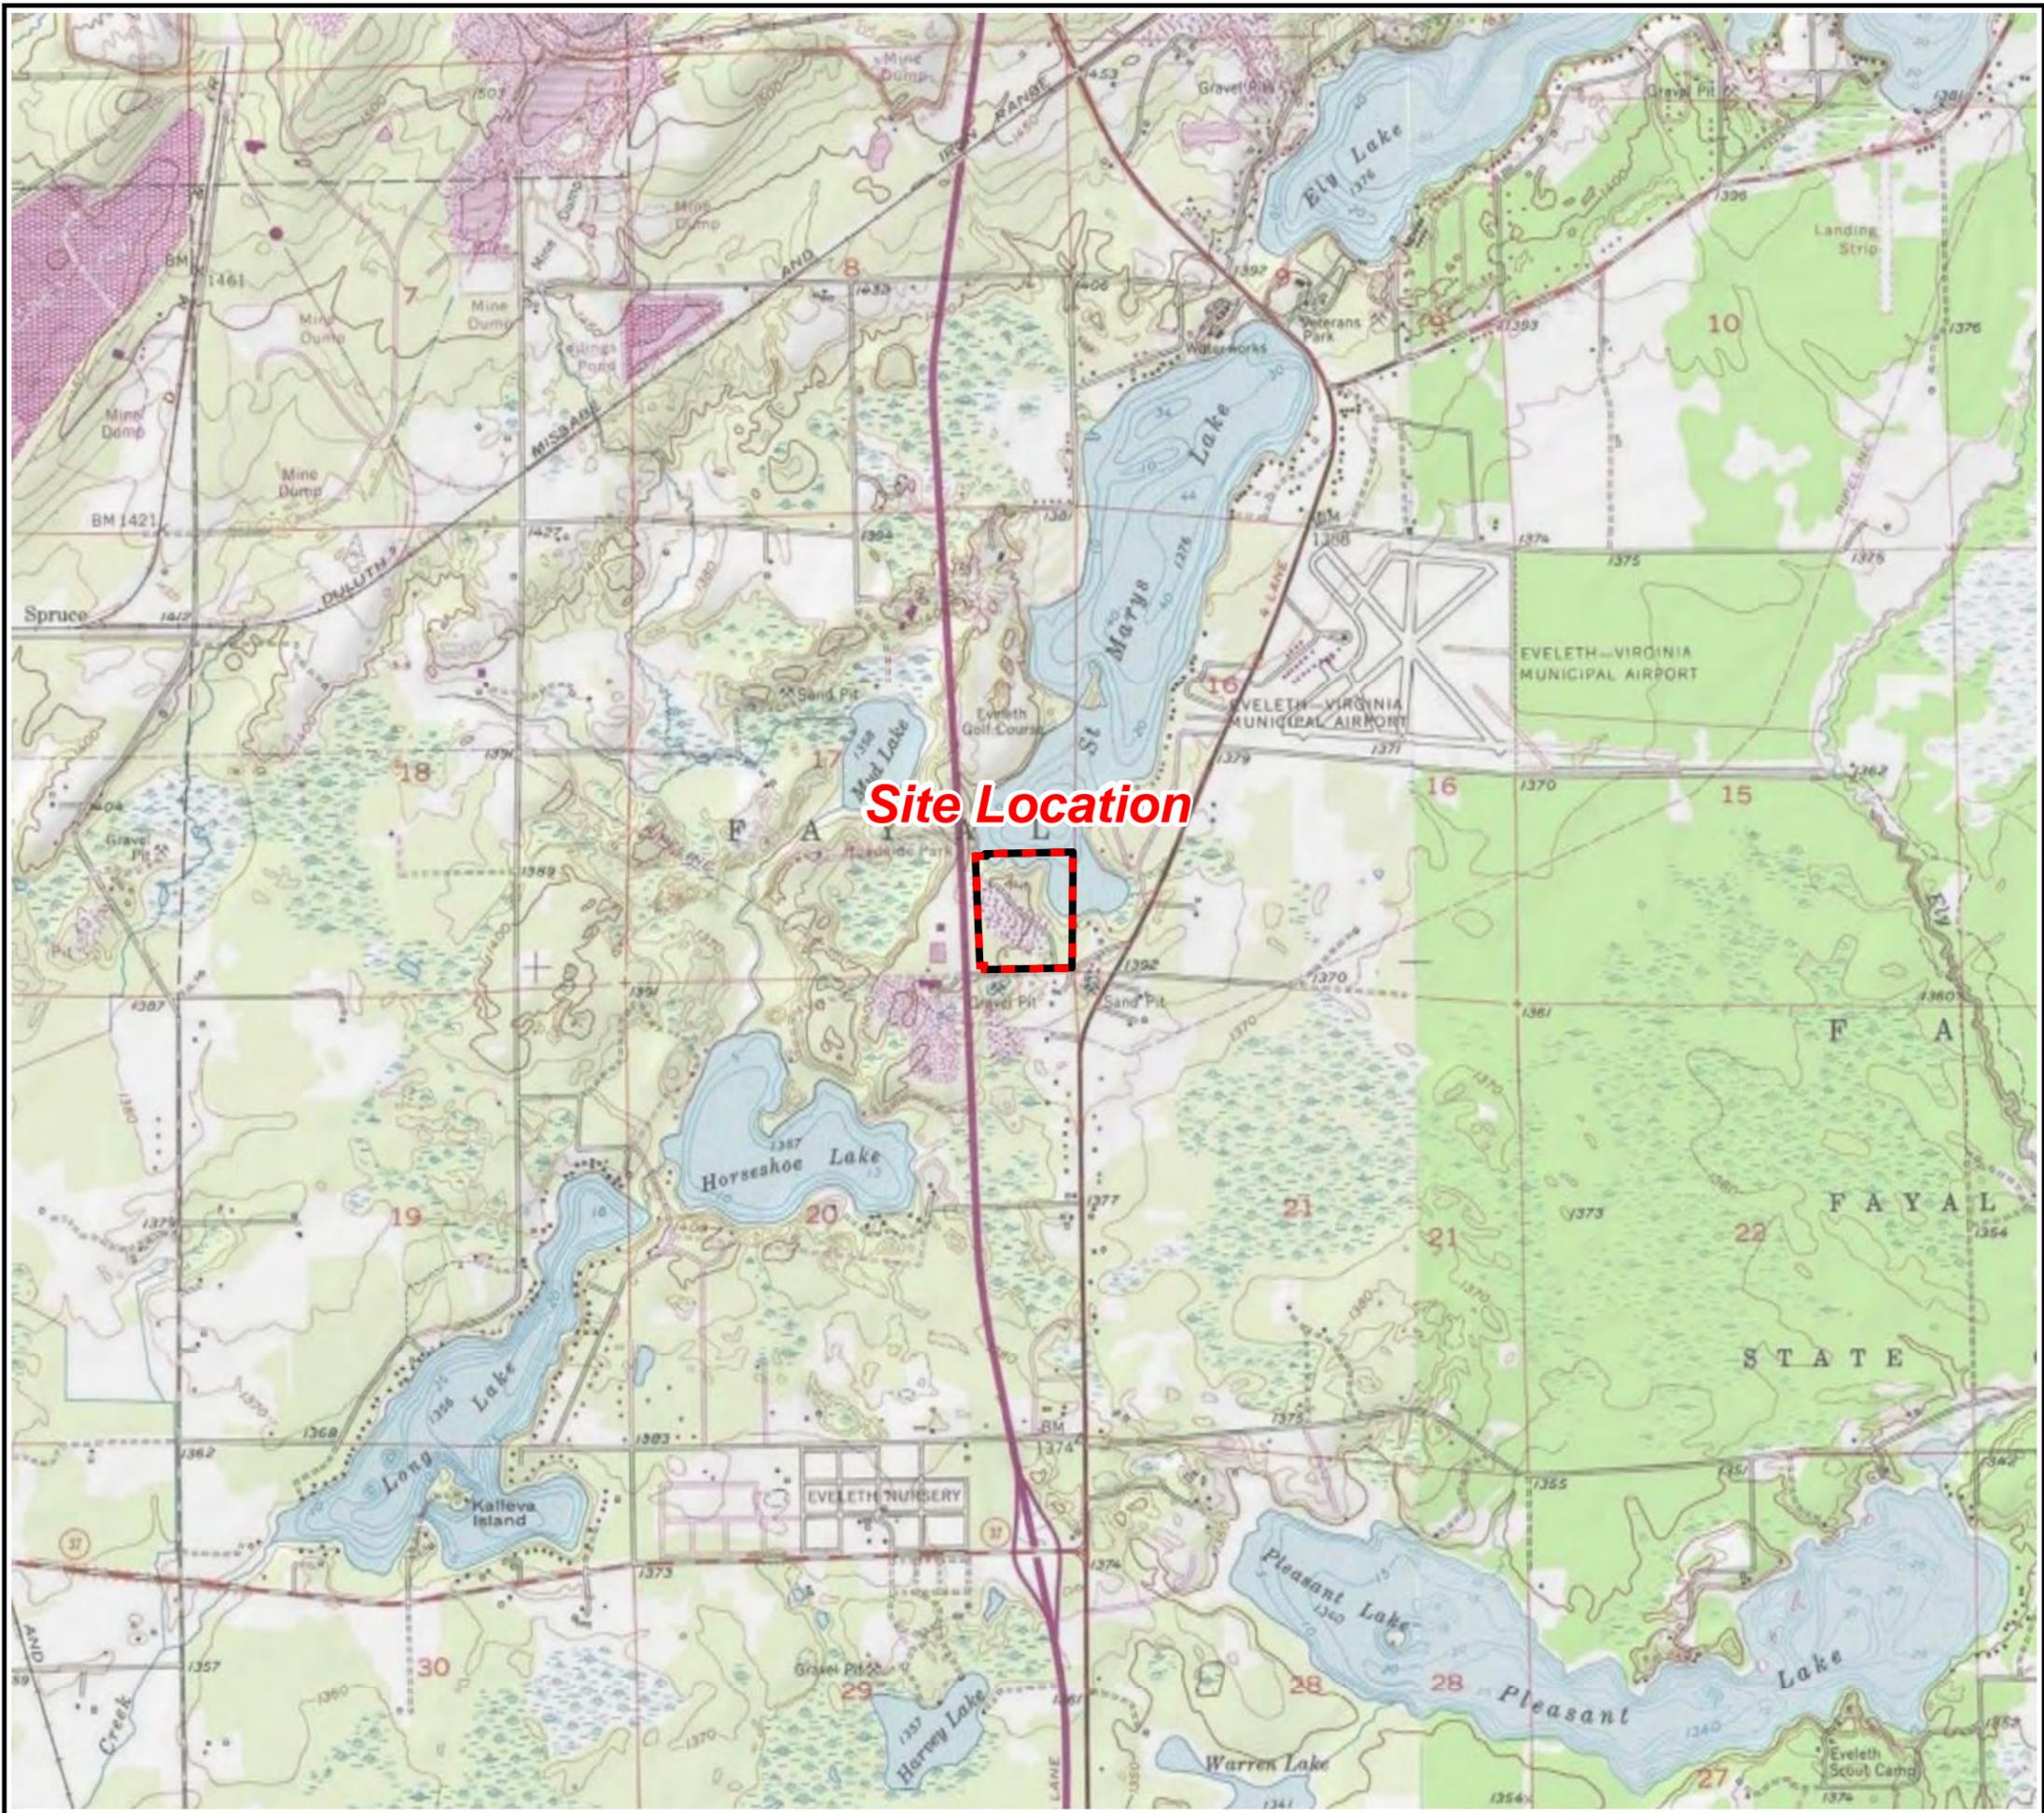
Figure 1

Based on the U.S. Geological Survey (USGS) *Eveleth, Minnesota, Quadrangle Topographic Map* dated 2013 and a review of Google Earth, the elevation of the Property ranges between approximately 1,375 to 1,410 feet above mean sea level. During the site reconnaissance, the Property was observed to be relatively flat with exception to the rim of the excavation surrounding the Property's center; the regional topography is also relatively flat with a regional gradient that trends to the northeast towards St. Mary's Lake. A copy of the topographic map is included located in **Figure 1**.

Site Location Map

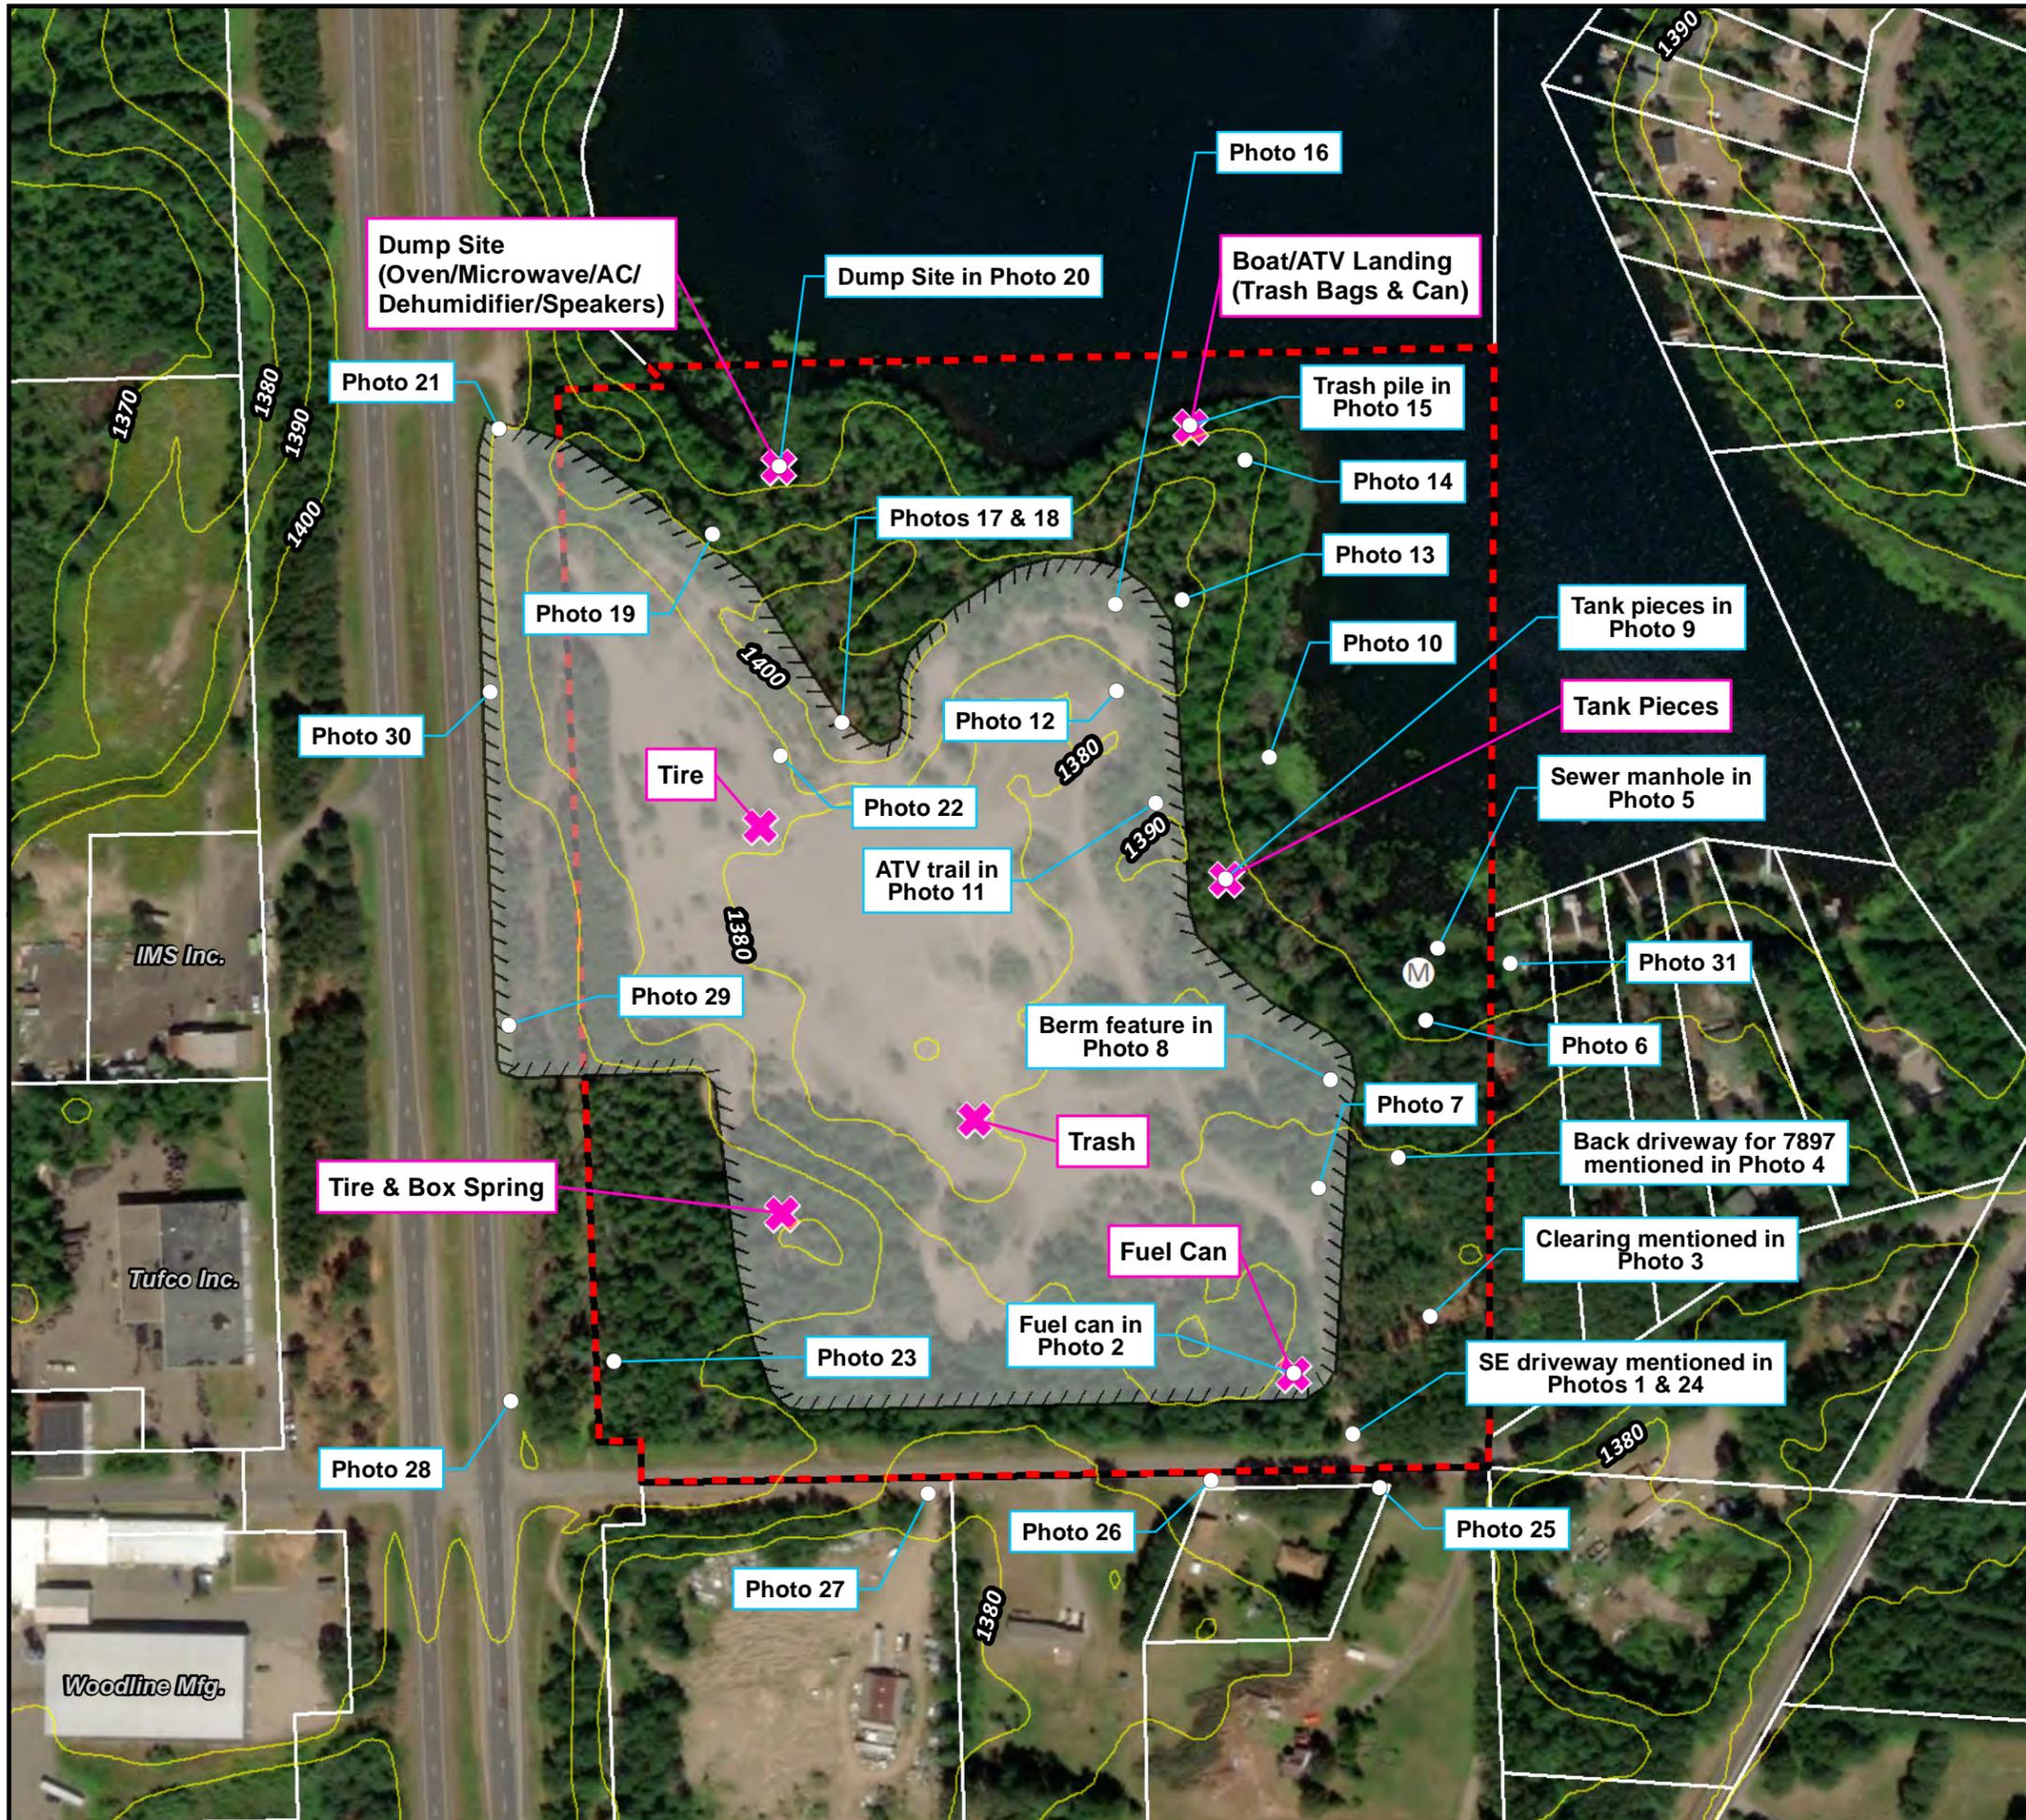
Figure 2 Site Detail & Photograph Location Map

Eveleth Truck Site TZ90169
7907 Thunderbird Trail East
Eveleth, MN 55734
PID: 340-0010-03220

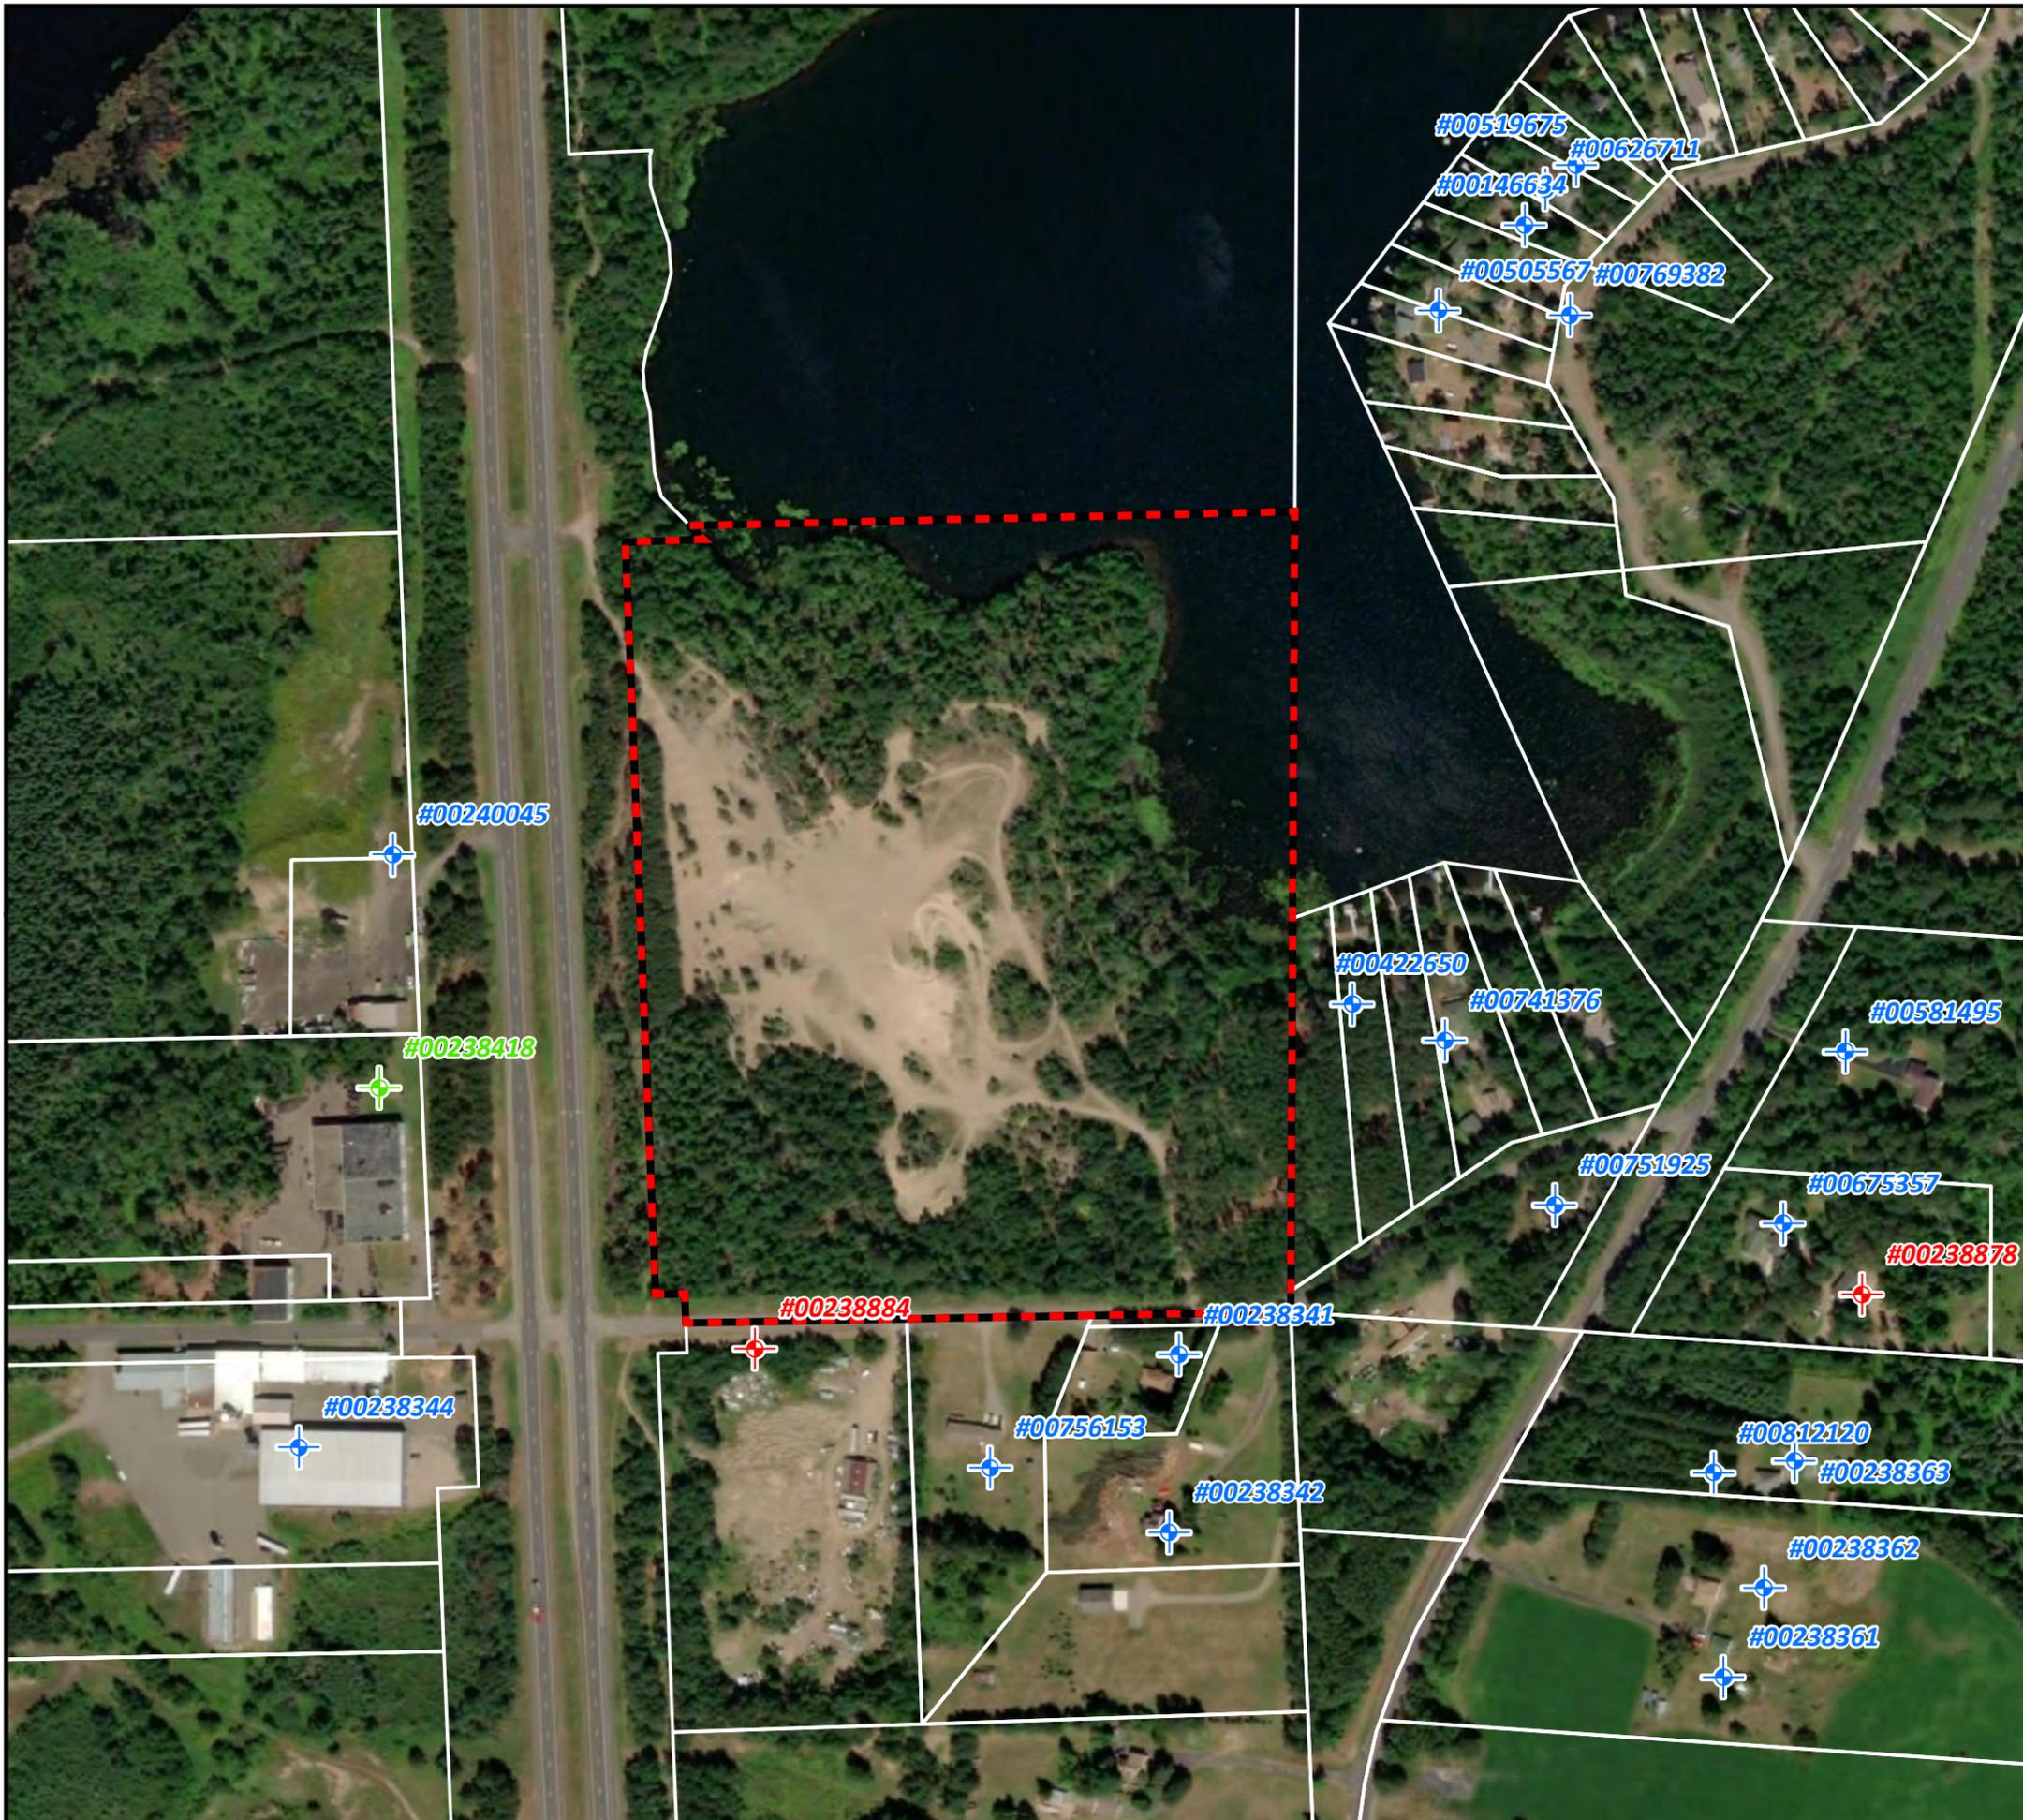
Figure 3

MDH Well Records

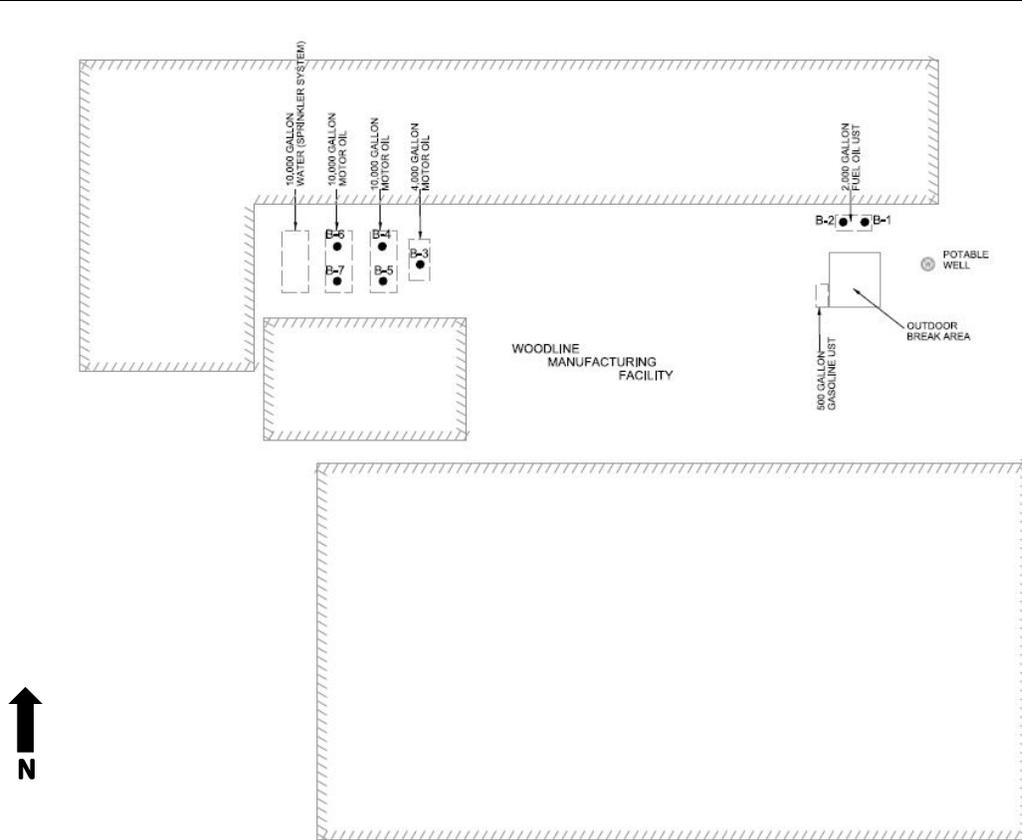
Figure showing former tank locations and sample locations at Leak Site #19187.

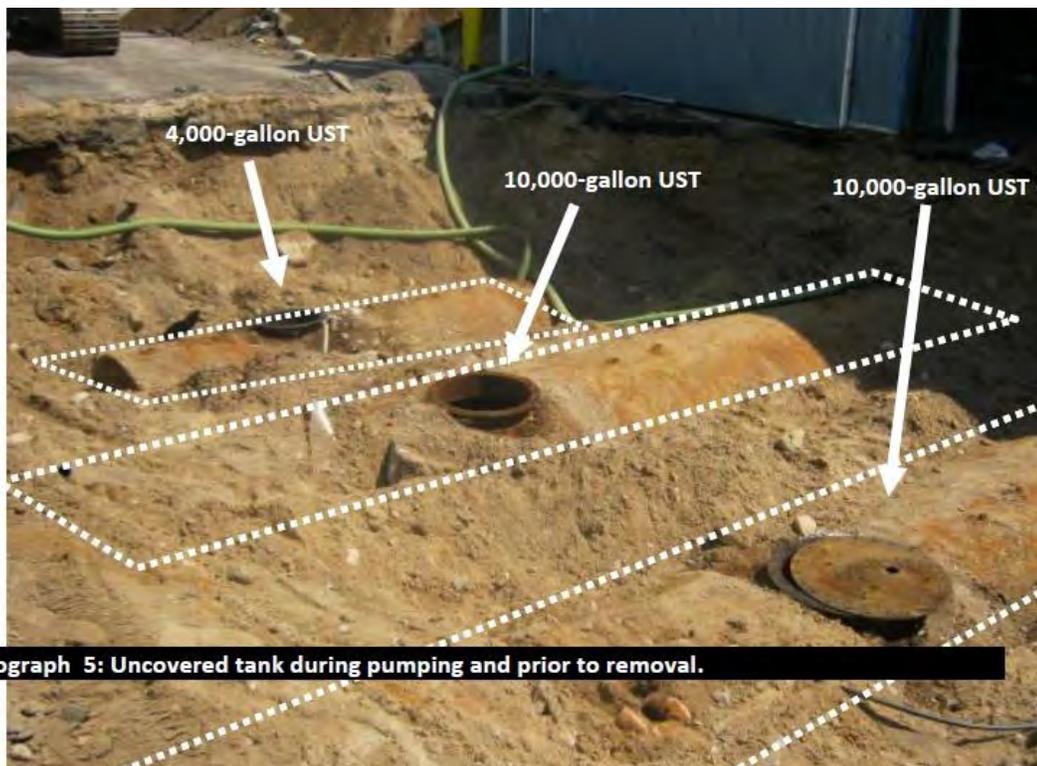
Photograph 5: Uncovered tank during pumping and prior to removal.

Figure showing uncovered tanks prior to removal from the 2013 MSA excavation report for Leak Site #19187.

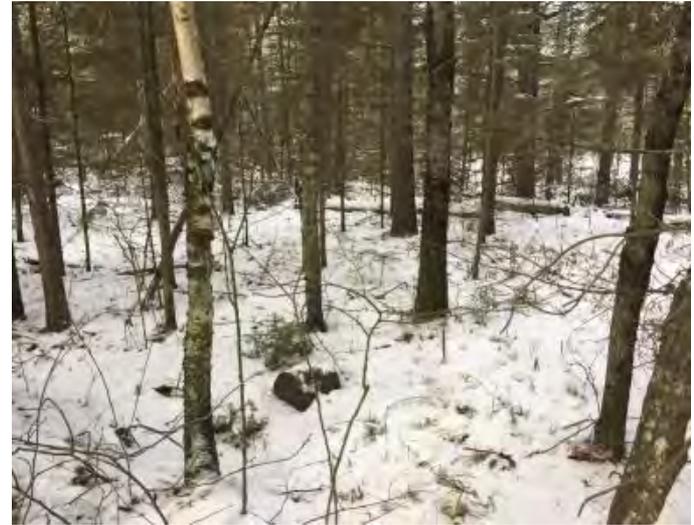
Photo 2: Old fuel can near SE driveway; facing W

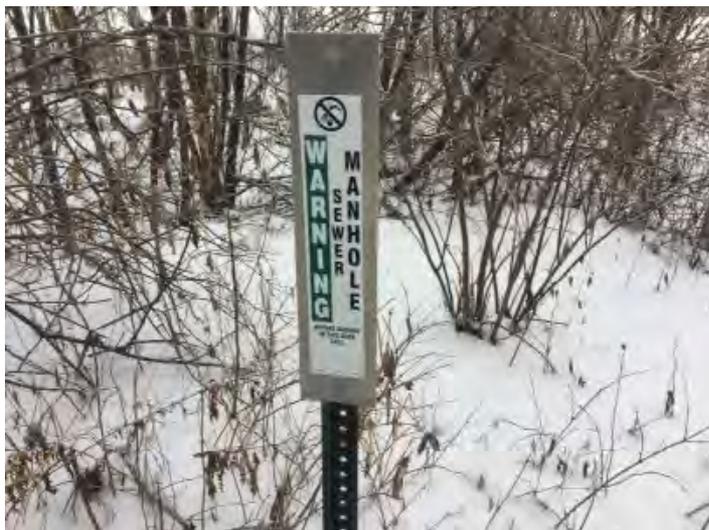
Bay West did not observe indications of wastewater discharges on the Property at the time of the site reconnaissance; however, wastewater discharge infrastructure was observed. A sanitary sewer lift station was observed in the south right-of-way of Thunderbird Trail E located south of the Property. A sign denoting a sewer manhole was observed near the eastern edge of the Property just south of the shore of St. Mary's Lake. No other indications of wastewater discharge infrastructure were observed on the Property at the time of the site reconnaissance.

Photo 5: Sign for sewer manhole just south of lakeshore along E side of property; facing N

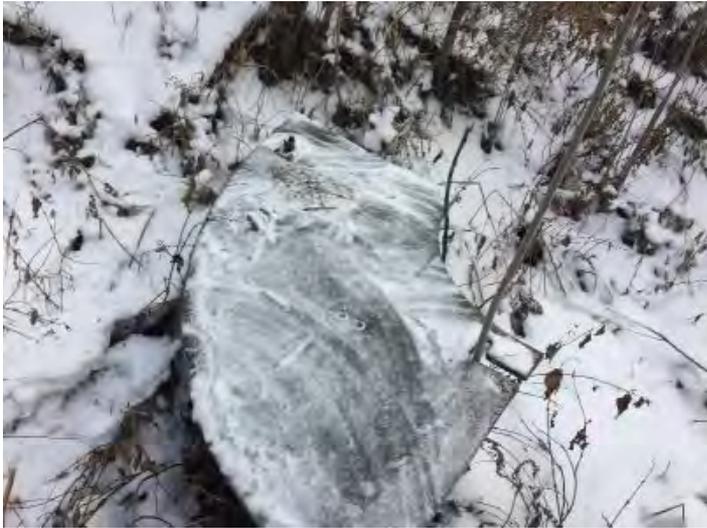
Photo 9: Apparent piece of old tank of some sort along trail between gravel pit and lake (see map)

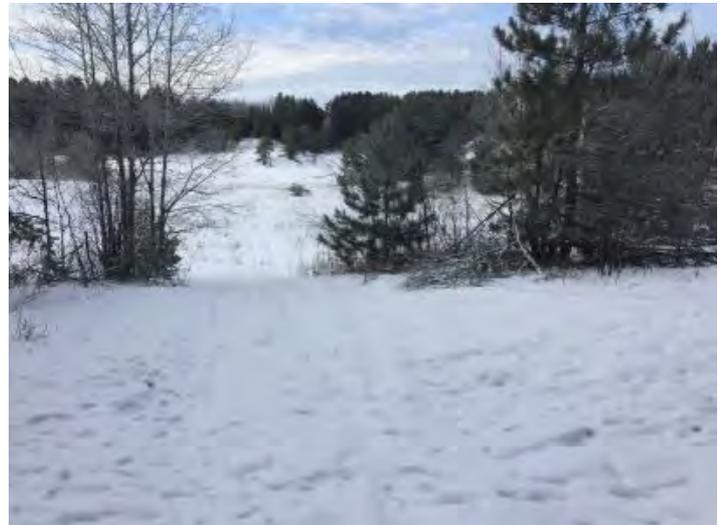
Bay West observed evidence of extensive ATV usage within and around the open gravel pit portion of the Property in the form of ATV tracks in the snow, and an established trail system in the woods around the pit.

Photo 12: Example of ATV usage in gravel pit at site; facing SW

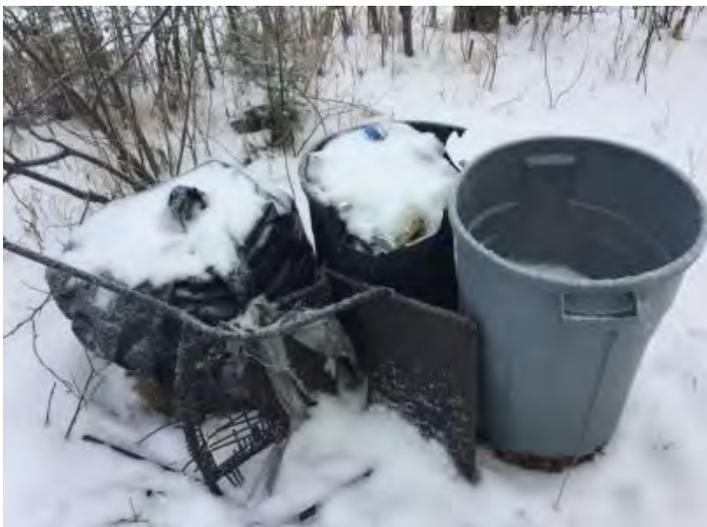
Photo 15: Trash pile at “boat landing” on NE point of land

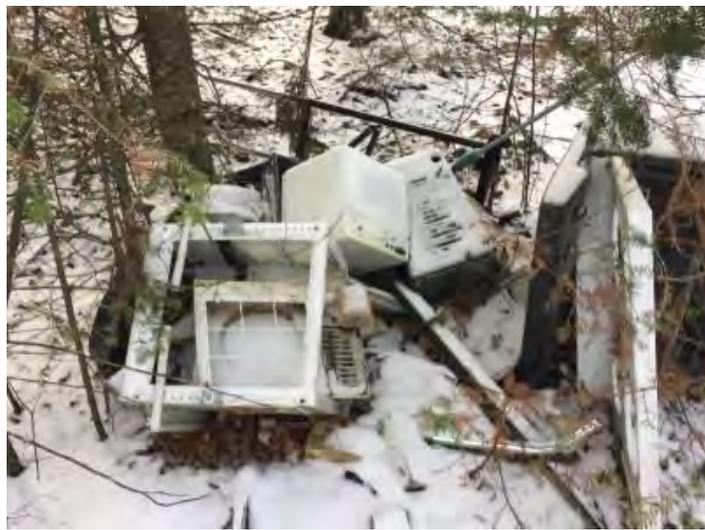
Bay West observed indications of waste disposal on the Property at the time of the site reconnaissance. One location in the woods north of the open gravel pit had an appliance pile that contained items such as an oven/range, a microwave, a dehumidifier, an air conditioner, and speakers. Bay West also observed concrete blocks, a dinner plate, charred wood, and an empty wooden box near the appliance pile. Two locations contained neatly centralized general trash (i.e. beer cans, cigarette packs, and sports drink bottles) including garbage cans and bags. One of these locations was observed at an apparent boat landing along the ATV trail on the shore of St. Mary's Lake in the northeast corner of the Property. The other was within the gravel pit in the central portion of the Property. Other individual items (i.e. old fuel can, laundry basket, box spring, tires) were also observed in different locations in the woods and in the gravel pit on the Property. The approximate locations of the appliance pile and other trash areas are marked on **Figure 2**. Photographs are also included in the attached photographic log in **Appendix H**.

Photo 20: Pile of appliances N of gravel pit (see map)

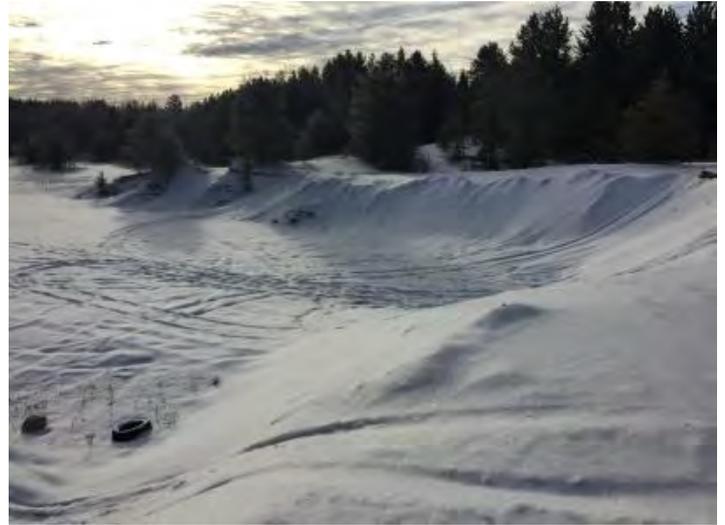
Photo 22: Topography of gravel pit and old tire near NW corner of pit; facing SW
