Geotechnical Conditions Memorandum

Kennedy Bridge Planning Study
US Trunk Highway 2 over Red River
State Project No. 6018-02
East Grand Forks, Minnesota
Grand Forks, North Dakota

Project BL-12-04987

Braun Intertec Corporation

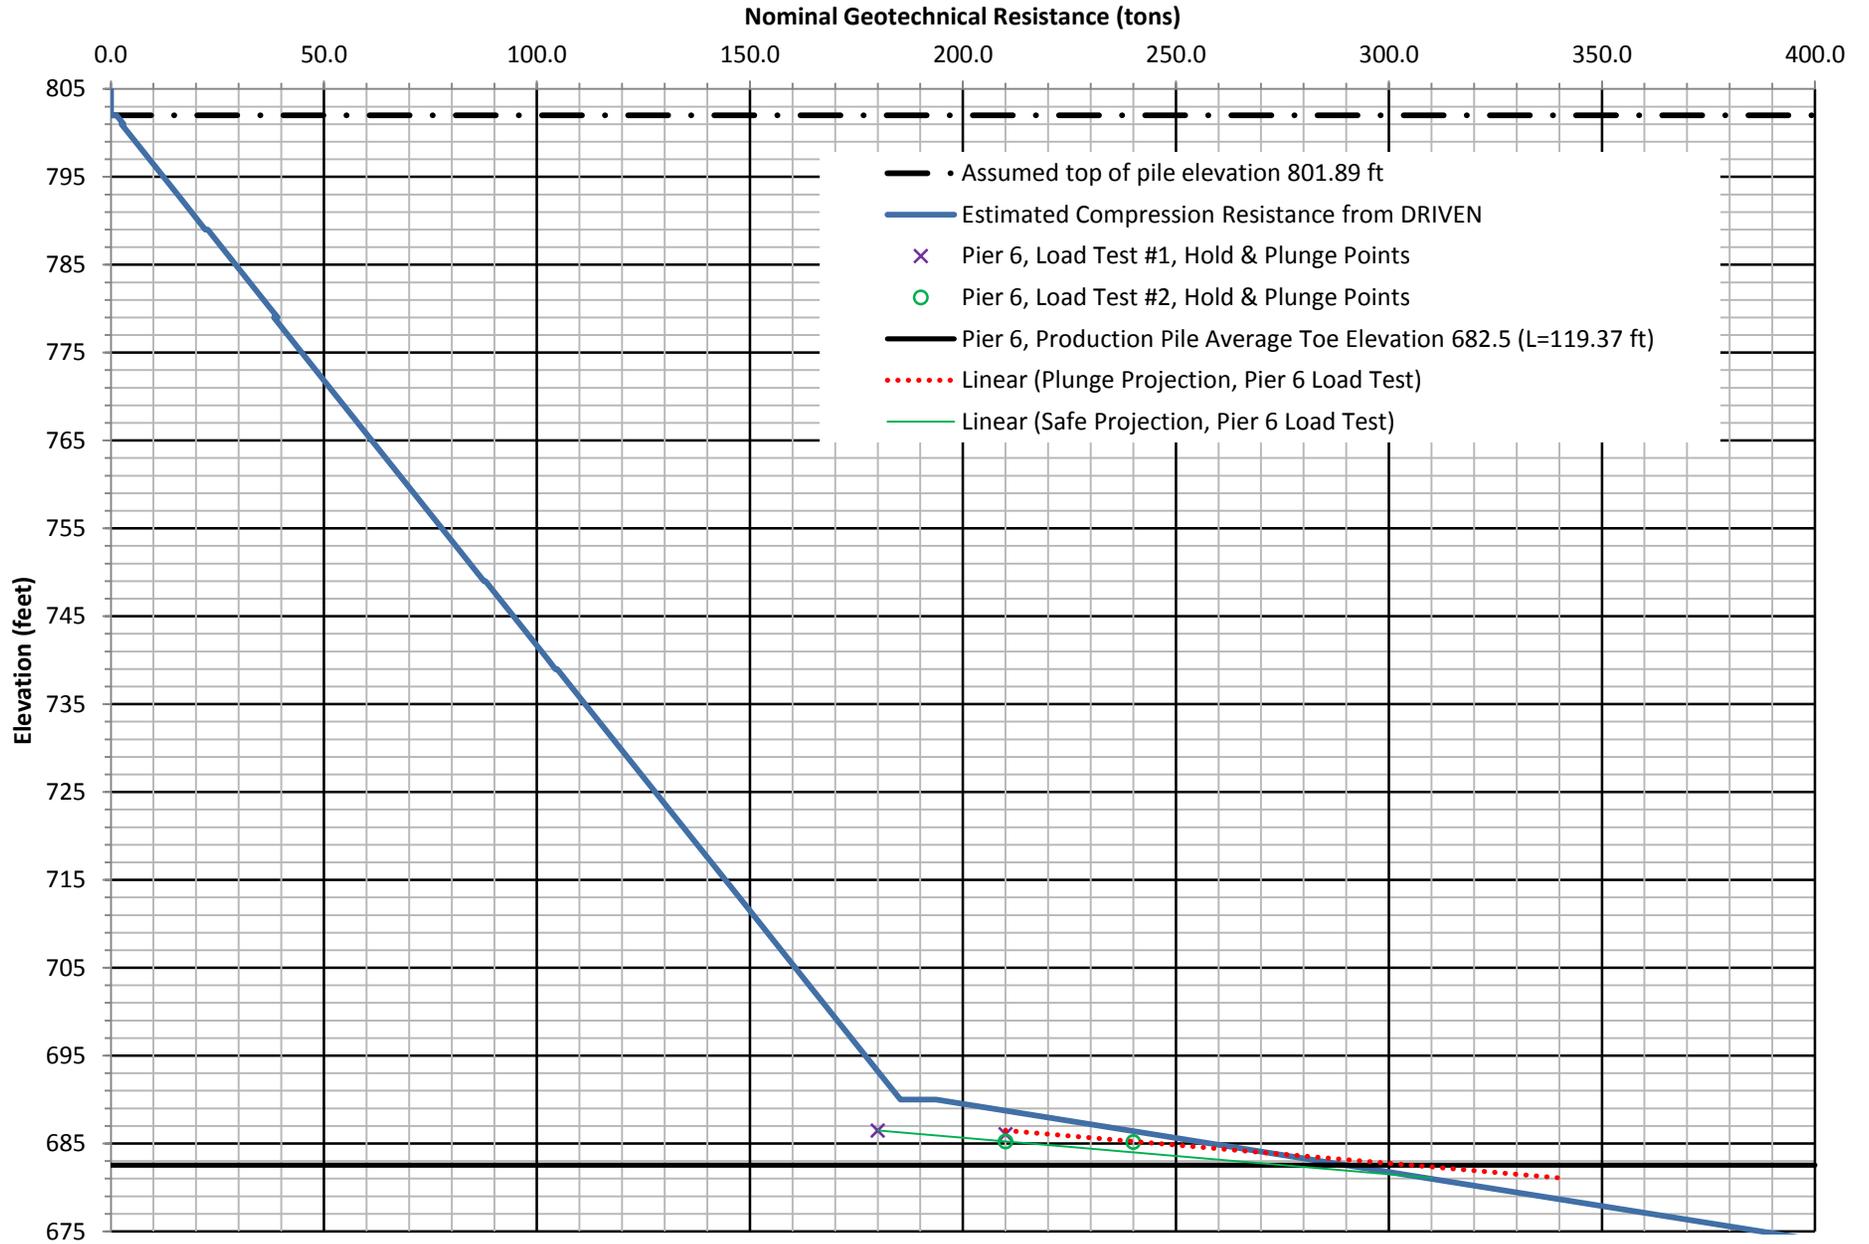
Nominal Geotechnical Resistance for Driven 14x73 H-Pile Pier 6, Boring B-8

Nominal Geotechnical Resistance for Driven 14x73 H-pile (2 pages)
