US Highway 14: Owatonna to Dodge Center Road Safety Audit Review Technical Report

September 26, 2013

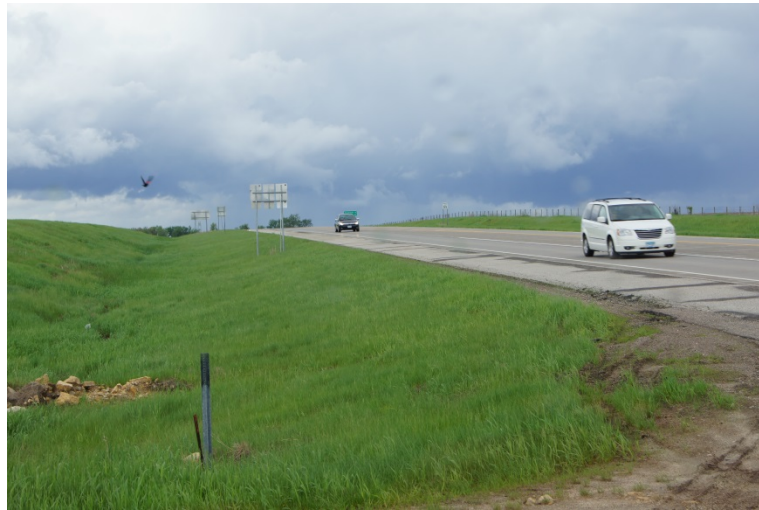
Figure 2 - USTH 14

MnDOT considers USTH 14 a medium priority interregional corridor serving much of southern Minnesota. The area of the audit is two-lane rural roadway with transition areas to four lanes at the east and west end of the study corridor. Access to the corridor is limited to 16 (approximately 1 per mile) at-grade, through-stop intersections between Owatonna and Dodge Center with Claremont, MN being the only incorporated town. A draft Environmental Impact Study concerning a corridor-wide expansion to four lanes was completed in the late 1990s, and the final EIS was completed in 2010. Other areas of USTH 14 have been converted to four lanes including Owatonna to Mankato in the west and Dodge Center to Rochester in the east.

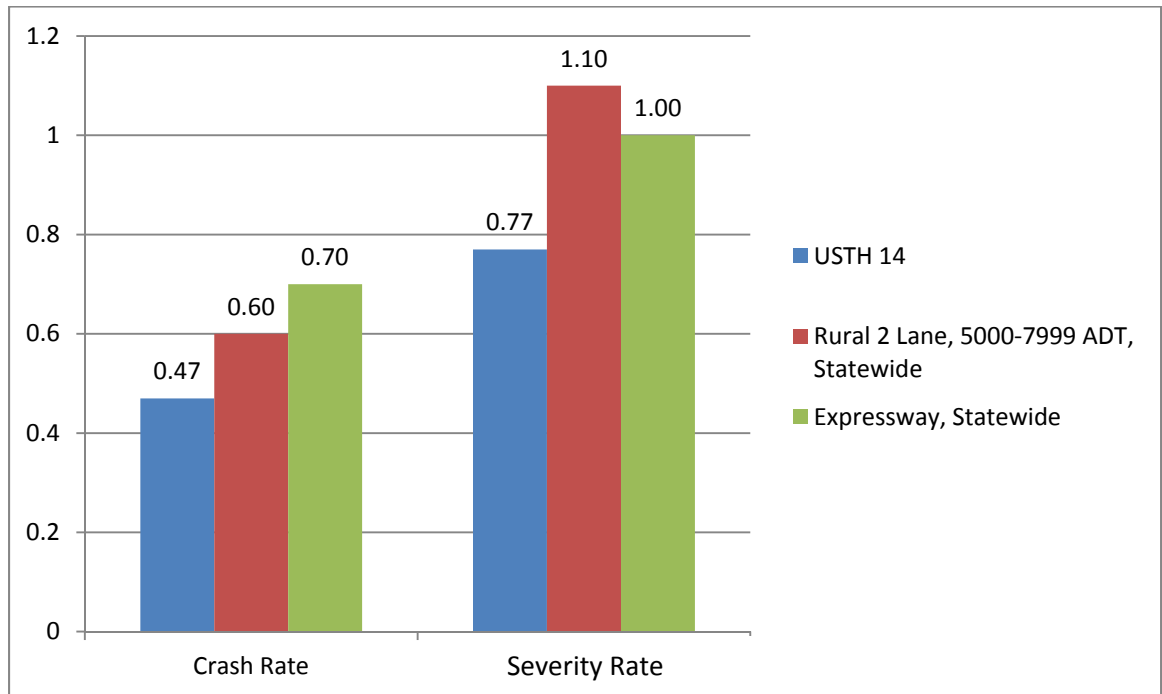
Figure 3 - Crash Rate and Severity Rate

- The USTH 14 Corridor from the TH 218 Interchange in Owatonna to Dodge Center reported 92 crashes between 2007 and 2011. If the crash rate is normalized to the volume of traffic on this section of highway, the frequency of crashes equates to 0.47 per million vehicle miles traveled (MVM). This is lower than the statewide rural two-lane highway and expressway averages.

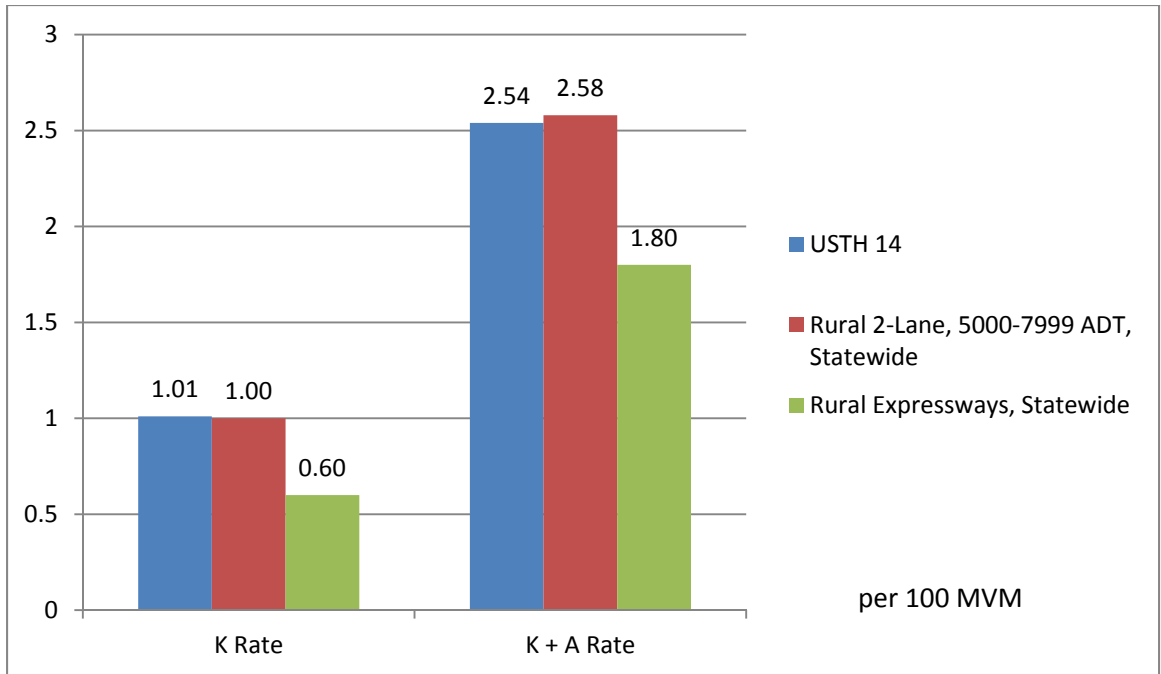
Figure 4 - Severe Crash Breakdown

- Out of 92 crashes, two were fatal and another three resulted in serious injury. The remaining 87 involved minor injuries or property damage.
- The severity rate of the corridor is 0.77 which is lower than the rural two-lane statewide average.
- If the K and A crashes are isolated, the analysis shows the rates are 0.010 fatal crashes MVM and the severe crash rate (K + A) 0.025.

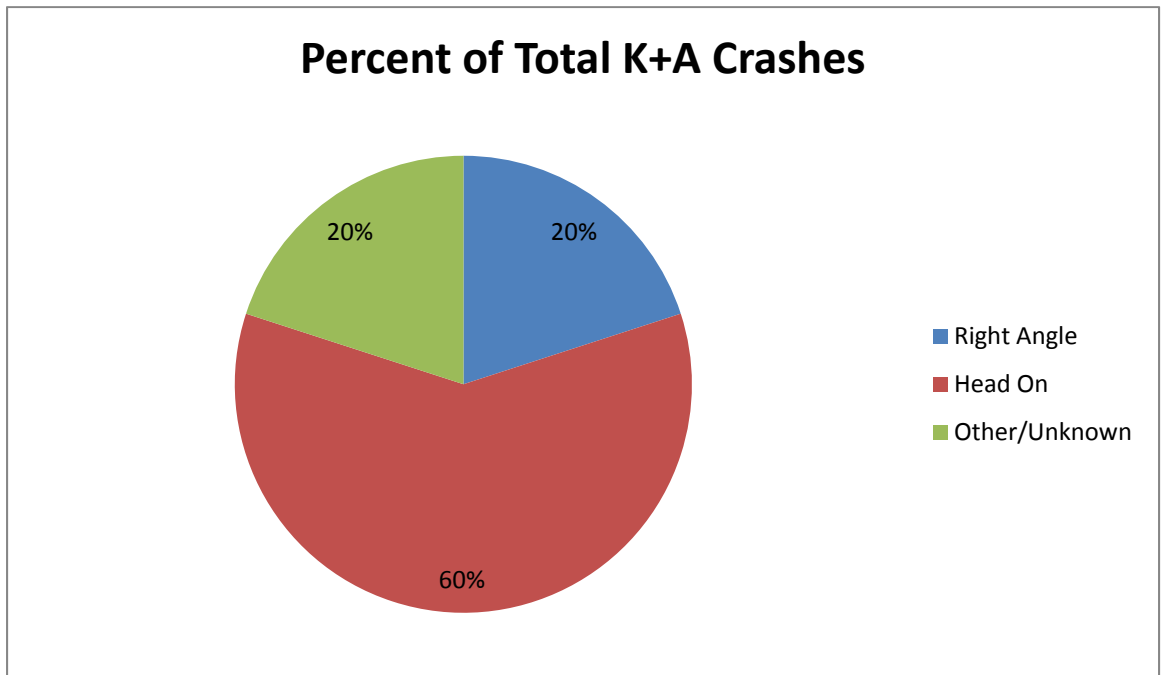
Figure 5 - Crash Type Comparison

- The percentage of K and A crashes appear to be much higher than the two-lane rural average in Minnesota, with K crashes (two) at 2.17% of the total and A crashes (four) at 4.35% of the total
- 60% (3) of the K or A crashes were head-on which is over two times the average for Minnesota two-lane rural highways. However, this figure is not statistically significant.

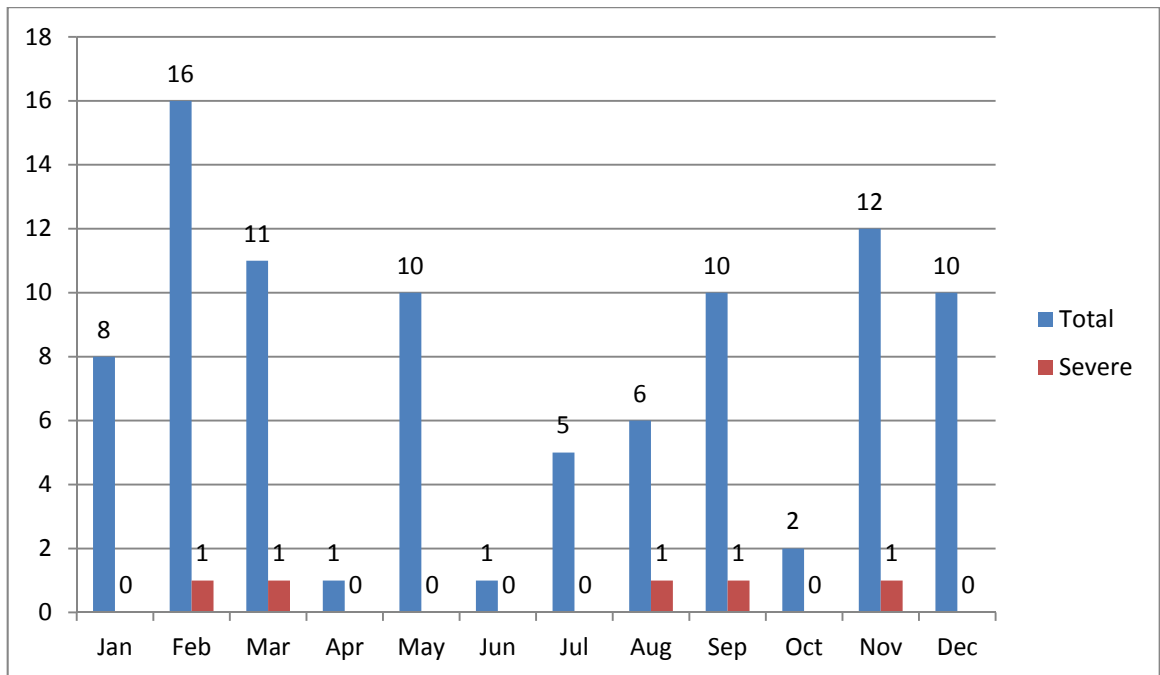
Figure 6 - Crashes by Month

There appears to be a higher concentration of crashes over the winter months, with November to March accounting for 62% of the total crashes and 60% of the severe crashes.

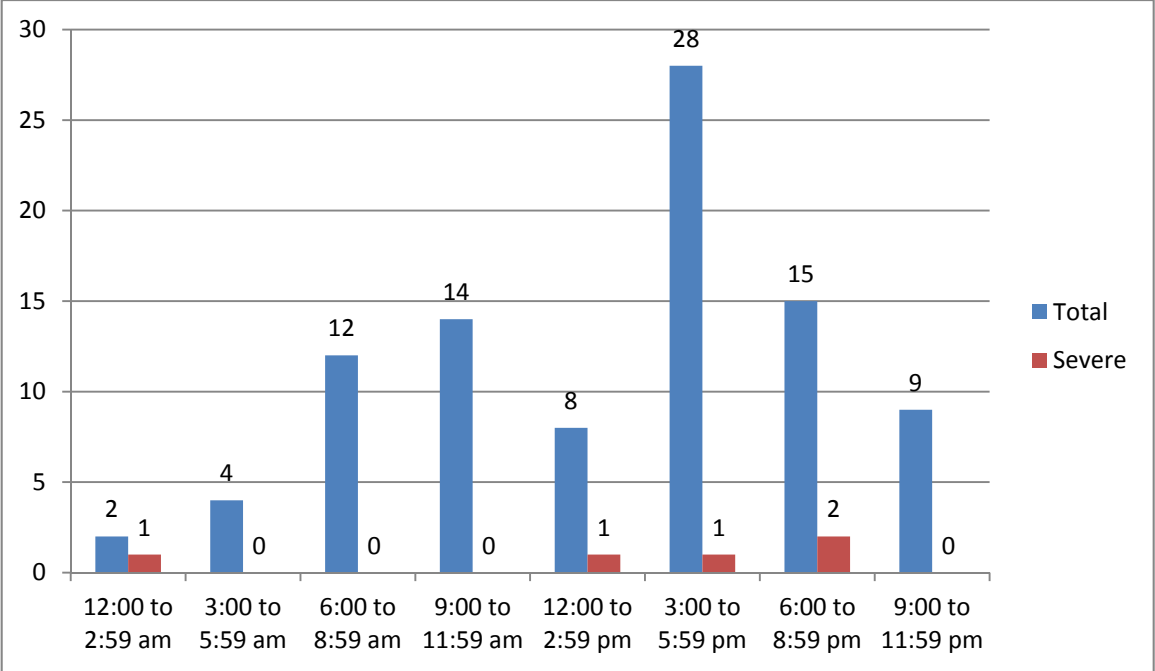
Figure 7 - Crashes by Time of Day

Crashes were more prevalent during the evening rush hours of 3:00 PM to 5:59 PM accounting for 30% of all crashes on the corridor. Two-thirds of the severe crashes occurred during and immediately after evening peak periods from 3:00 PM to 5:59 PM and 6:00 PM to 8:59 PM. This coincides with volume vs. time of day data for the corridor.

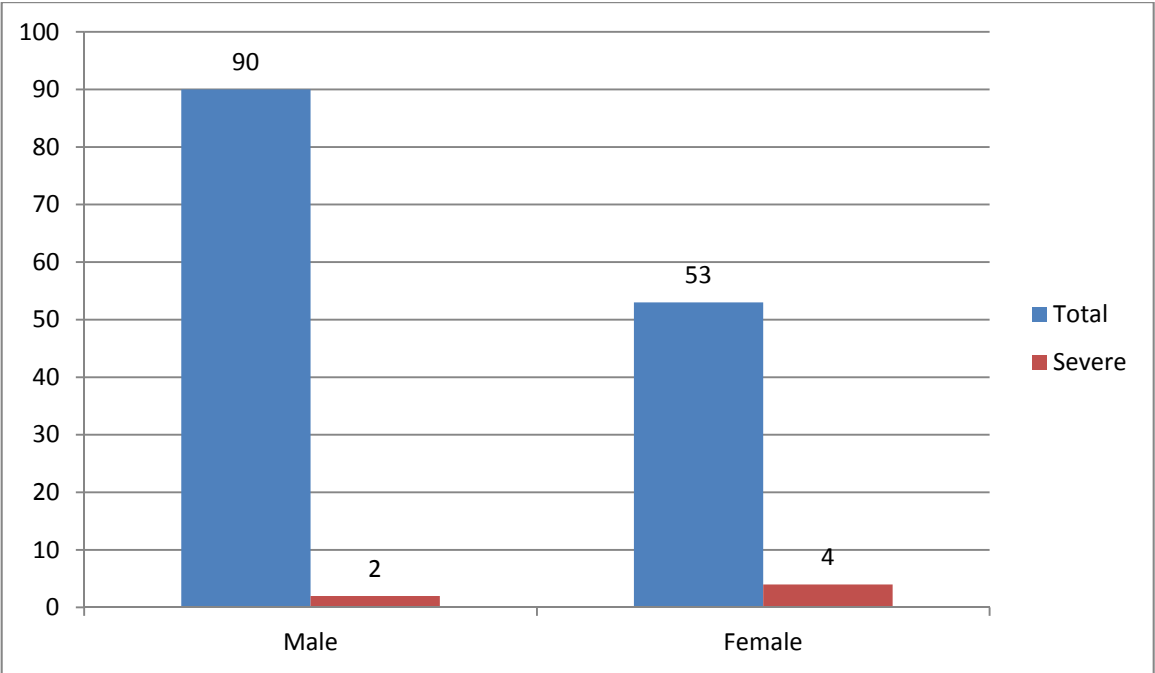
Figure 8 - Crashes by Gender

Gender data indicates that of all people involved in all crashes, 90 out of 144 were male, 53 were female and one was classified as unknown. The gender data for severe crashes shows male drivers involved in two severe crashes and women in four.

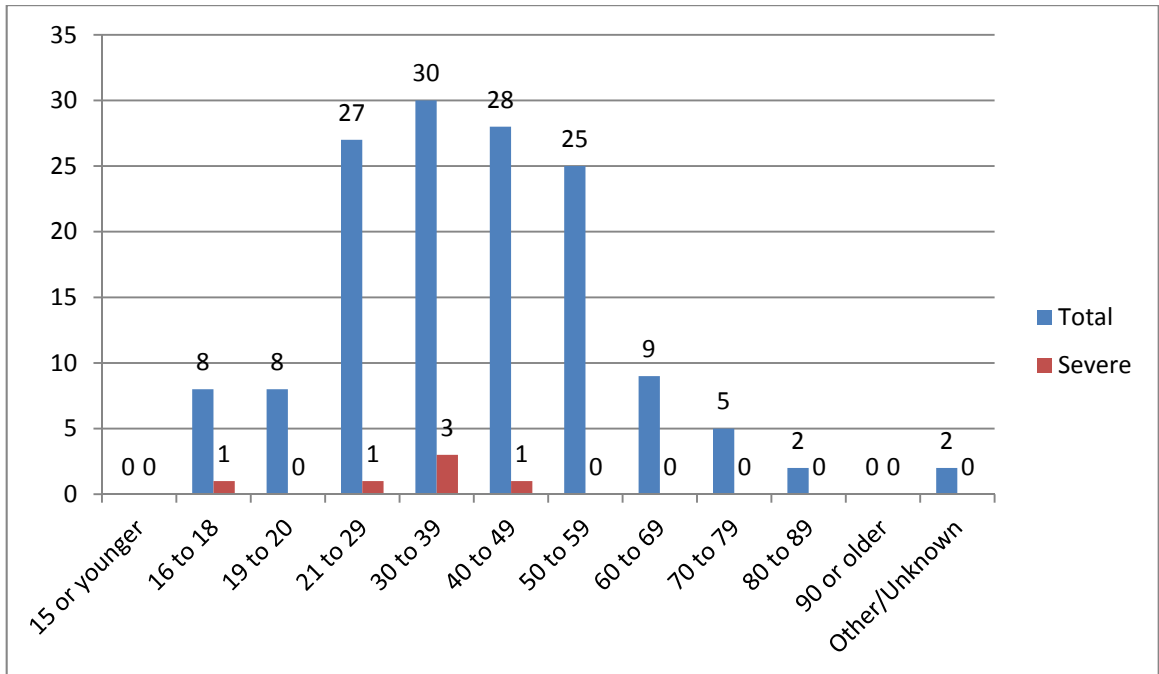
Figure 9 - Crashes by Age

Age distribution of crashes shows a nearly equal spread of 20% of crashes in each of the 21-29, 30-39, 40-49 age groups. The severe crashes are more prevalent in the 30-39 age groups accounting for nearly 40% of all severe crashes.

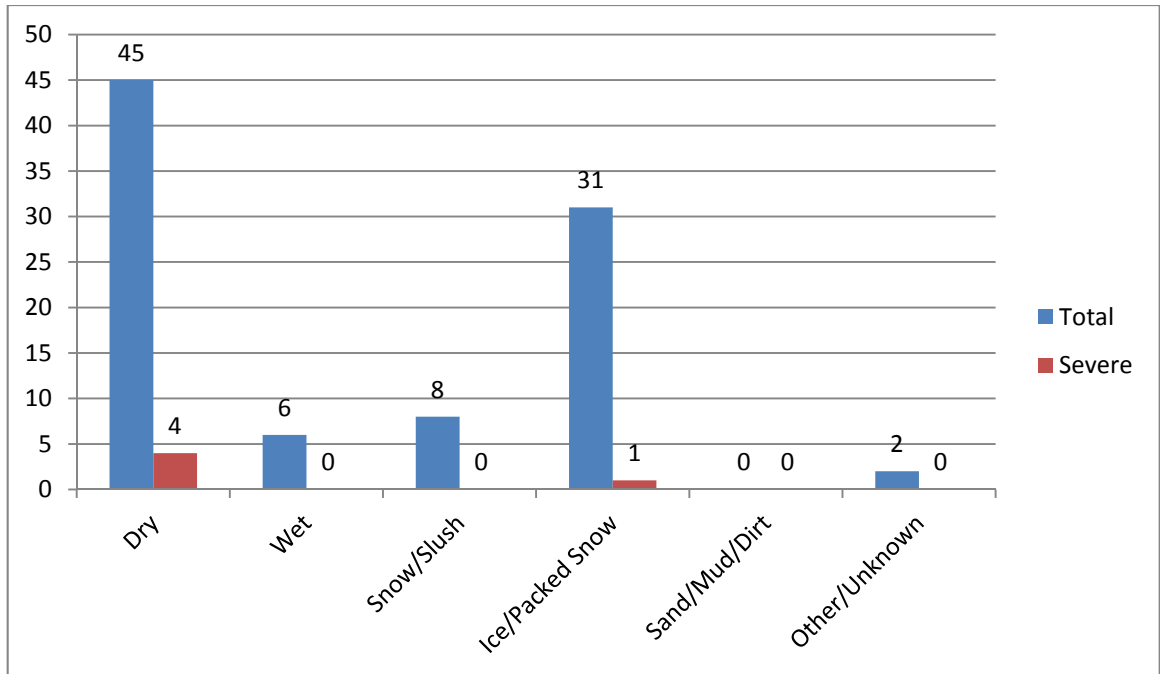
Figure 10 - Crashes by Roadway Condition

Roadway surface conditions show that nearly half of all crashes occur in dry conditions and ice or snow packed roadways contributed to 34% of crashes, nearly double what is expected. Four of five severe crashes occurred in dry conditions and a single severe crash occurred in icy or snow pack conditions. Snow and ice are contributing factors to crashes leading to many single vehicle crashes with a lower likelihood of severe crashes.

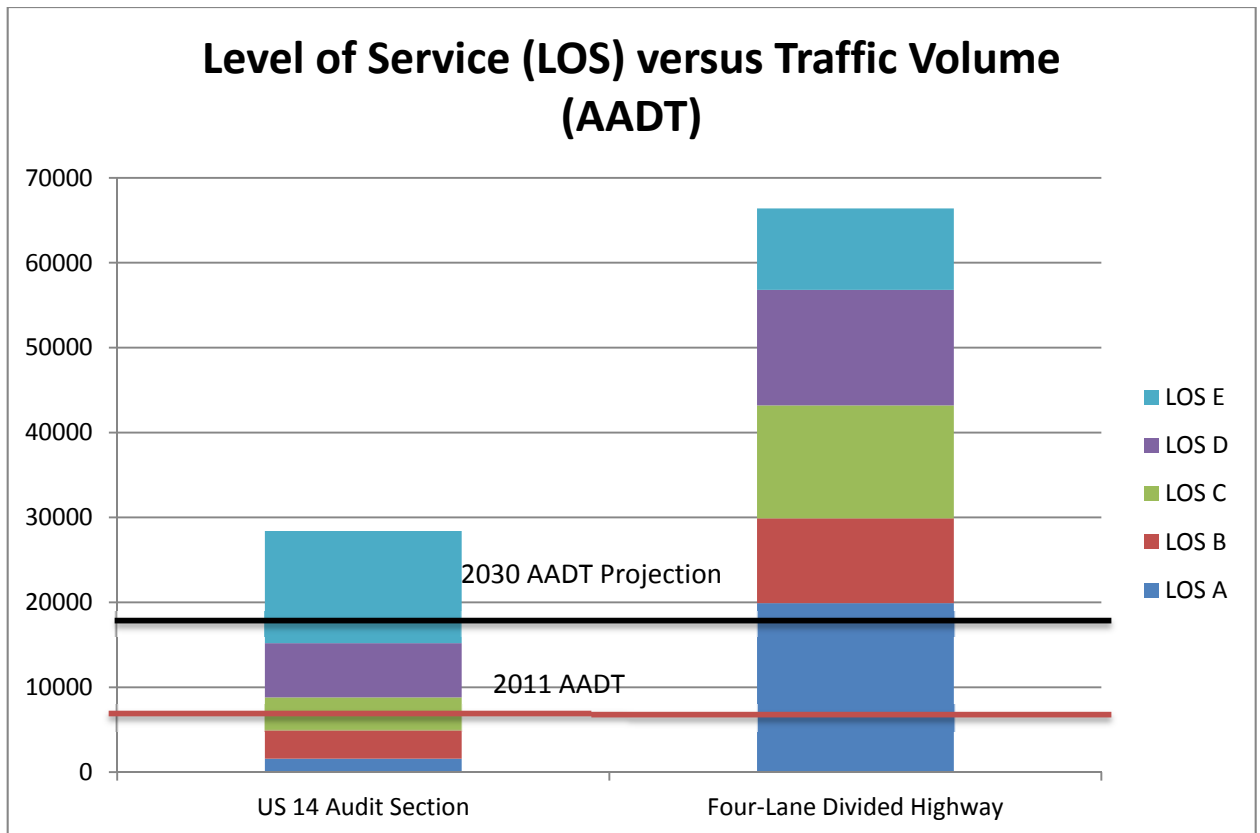
Figure 11 - 20 Year LOS and AADT Projections

Traffic forecasts for the next 20 years (2030) predict that the ADT of the corridor will more than double to 16,800. This projection was taken from the USTH 14 EIS from Owatonna to Dodge Center Final Environmental Impact Statement (EIS) and Final Section 4(f) Evaluation published in 2010, and represents potential volumes with a four-lane freeway system. The EIS states that a full realignment may be necessary over the next 20 years (preferred Alternative 3) that routes USTH 14 south of the Dakota, Minnesota, and Eastern (DM&E) Railroad line. These growth estimates are based on local development assumptions which are typically aggressive. These numbers are highly dependent on the economy, and the current outlook is more conservative than was being projected in the 2010 FEIS. These volumes likely will not be met until some date beyond the 2030 time horizon.

The corridor currently operates at a LOS of C based on the 2011 traffic volumes. Though MnDOT does not explicitly detail an acceptable level of service, the existing operation of USTH 14 would be considered acceptable by most standards. By 2030, traffic volumes will grow reducing the overall level of service experienced by travelers. With the four-lane expansion and realignment, the traffic will experience a LOS of A/B.

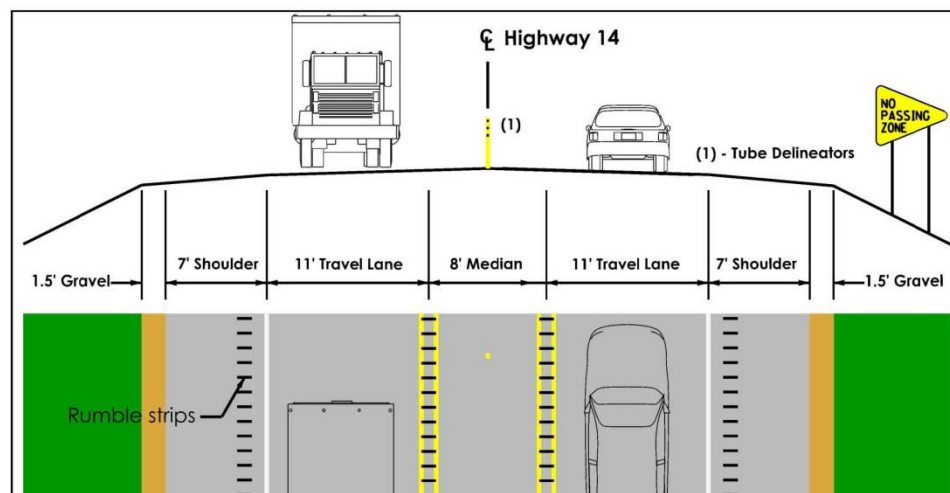
Figure 12 – Center Buffer Zone with Delineators Detail

A center buffer zone between lanes, 4-8 feet in width, creates an inside buffer zone between opposing lanes of traffic with rumble strips on the inside lane lines delineating the buffer zone. The installation of tube delineators allows the zone to be signed as no passing, but still allow full access at driveways and side streets.

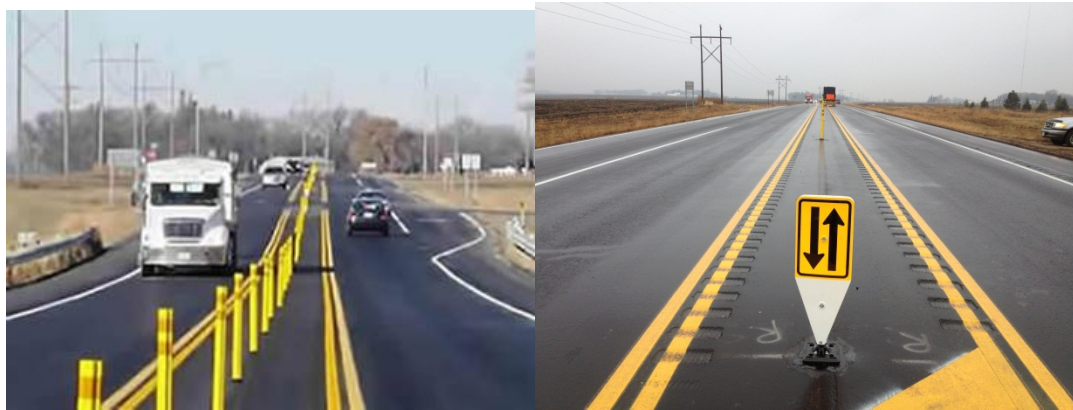
Figure 13 – Center Buffer Zone with Delineators (USTH 14 west of Mankato)

The Center Buffer Zone was installed on an experimental basis on USTH 14 in Nicollet County near Mankato and the effectiveness is still under investigation. It is worth noting that there have been no crashes during the first 10 months of the Nicollet County deployment. The benefits of the four-foot buffer come from the extra recovery time given to a vehicle that hits the centerline rumble strips and reacts accordingly. This option would require the use of approximately two feet of shoulder for each direction of travel once the lanes are reconfigured.

The use of the delineators in the center of the median is a maintenance concern. The delineator's primary function is to bring attention to the buffer and restrict passing. The use of delineators may not be necessary. The 4-foot buffer zone with rumble strips on the inside lane lines will give drivers two opportunities to regain focus on the road before crossing into oncoming traffic if they leave their lane. The research on USTH 14 near Mankato will likely show clear direction of the use of buffer zones and center-tube delineators.

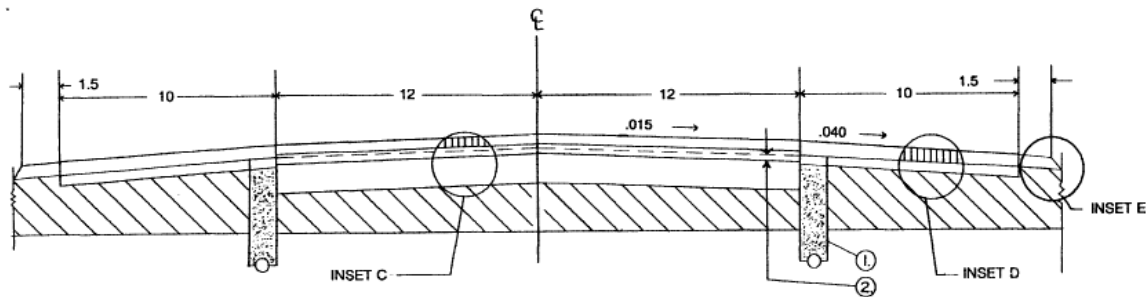
Figure 14 - Existing USTH 14 Pavement Section

As shown in the cross section below, the existing shoulder pavement section is currently insufficient to carry mainline traffic and would have to be reinforced or reconstructed.

THE TYPICAL SECTION ABOVE SHALL APPLY AS FOLLOWS :
STA. 459+36 - 894+09

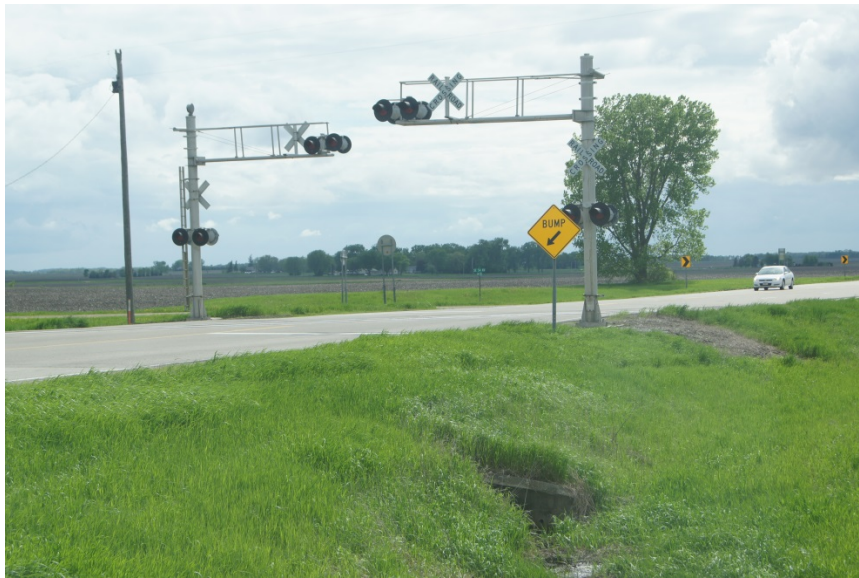
Figure 17 - Rail Crossing Bump Sign

- Improving the intersection lighting at 54th Avenue SE to highlight the intersection and the approach to the railroad tracks. Intersection lighting at this location may also improve curve visibility.
- Remove the Bump sign at the railroad tracks as there was no noticeable bump while crossing the tracks (or review for seasonal need).

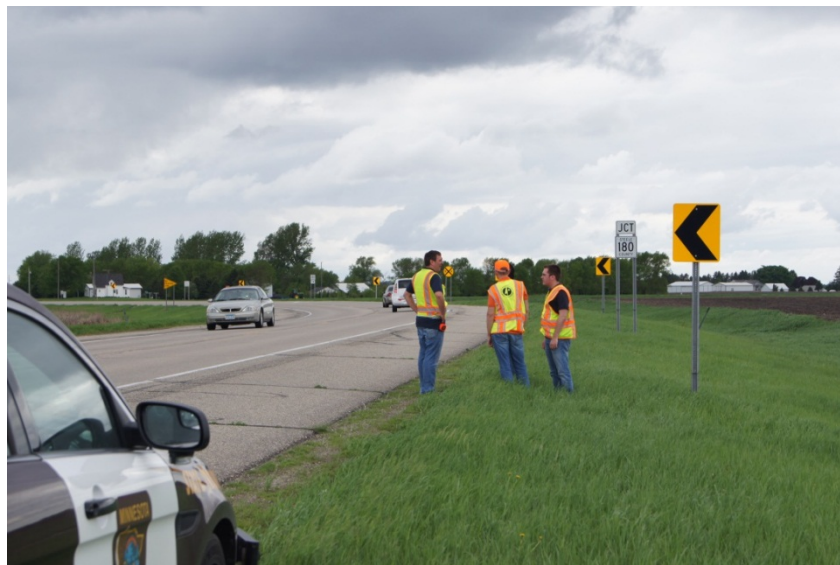
Figure 19 - WB Approach to RR Crossing

- There are no gates at the railroad crossing protecting USTH 14 traffic. District 6 should consider working with the MnDOT Rail Division to identify viable signing and control improvements at this location.

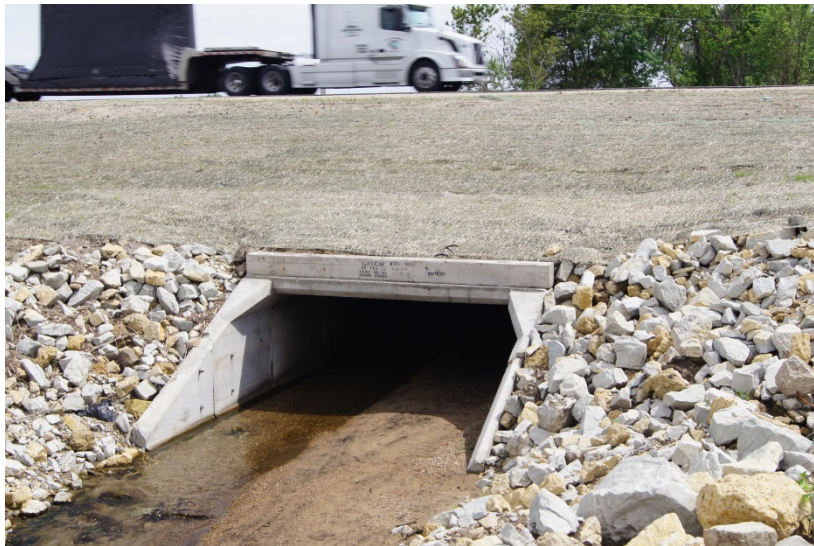
Figure 20 - Culvert Headwall

There are bypass issues here similar to Segment E, as well as a clear-zone issue due to culvert headwalls. Suggested improvements include:

- Review new culvert installation and riprap area off of the shoulder on both sides of USTH 14 just east of CSAH 5. There may be a need for guardrail at this location even though the obstruction is outside of the standard clear zone.
- Add a left-turn lane for westbound USTH 14 traffic turning left onto southbound CSAH 5. Vehicles are currently using the shoulder to get around left turning traffic.
