The Minnesota Department of Transportation (MnDOT) and its partners, the City of Montevideo and Chippewa County, conducted an ICE for the intersection of MN Highway 7 and County Road 15/24th Street.

#### What is an ICE?

ICE, or Intersection Control Evaluation, is a process to determine the most appropriate type of intersection traffic control (stop signs, traffic signal, roundabout, etc.) based on existing conditions and future needs. The ICE is based on analysis of safety, operations, cost efficiency, and constructability. A number of alternatives, including the existing intersection control, are analyzed in an ICE.

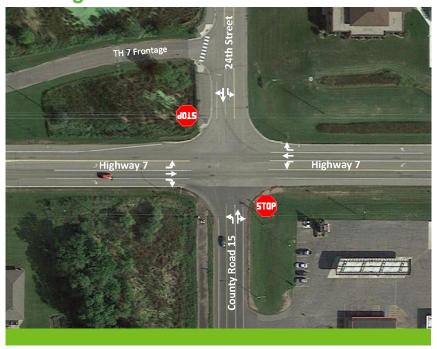
Existing intersection with stop signs on County Road 15 and 24th Street
