MIDTOWN CORRIDOR GENERAL BRIDGE MANAGEMENT PLAN

Hennepin County
Department of Community Works
701 4th Avenue South, Suite 400
Minneapolis, MN 55415

Prepared by: **Olson & Nesvold Engineers, P.S.C.**
 Gemini Research
 SRF Consulting Group, Inc.
 Braun Intertec
 MacDonald & Mack Architects

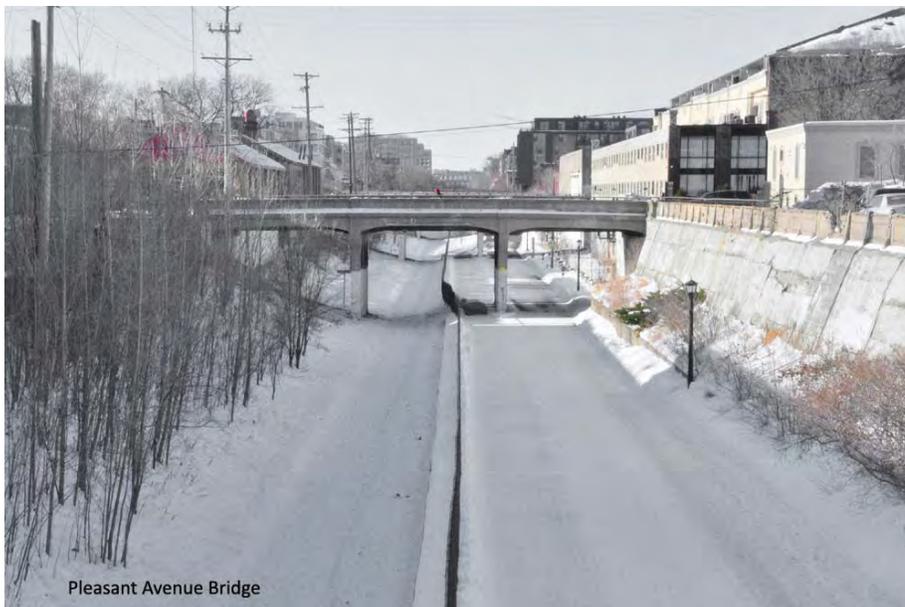
The trench is about 110 to 120 feet wide at the top and about 22 feet deep. Its uniform size contributes to the corridor's visual continuity. The floor, which served as the rail bed, was originally flat. From many locations outside of the corridor, the lower portions of the trench are hidden from view. The trench's earthen sides are moderately sloped at most locations. In some parts of the trench, the walls are vertical and supported by either tall retaining walls or the basement level of adjacent buildings. These vertical walls, along with several shorter track-level retaining walls and the bridge abutments, allowed the trench floor to accommodate spur tracks and are associated with the corridor's role as an industrial rail shipping facility. The trench is characterized by volunteer vegetation.

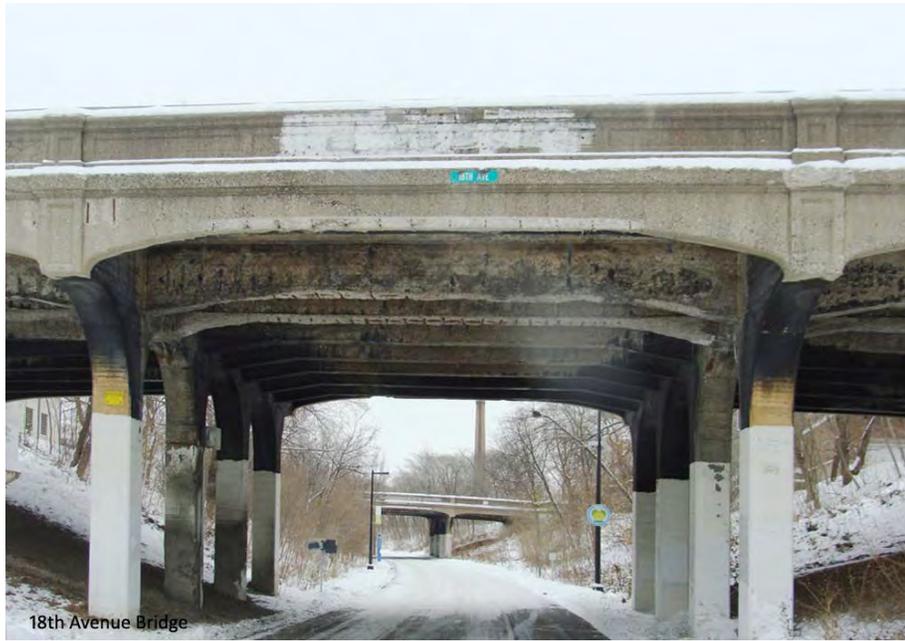
18th Avenue Bridge

The bridges have 36 inch tall concrete railings. Both posts and panels are divided into a classical base, shaft, and capital and have simple recessed panels. The railings move apart laterally, tracing the edge of the abutments, while the sidewalks widen correspondingly. The bridges were designed with unpainted concrete surfaces. There are board form lines on abutments, piers, beams, and the underside of the deck, while the fascia and railings have a smoother finish.

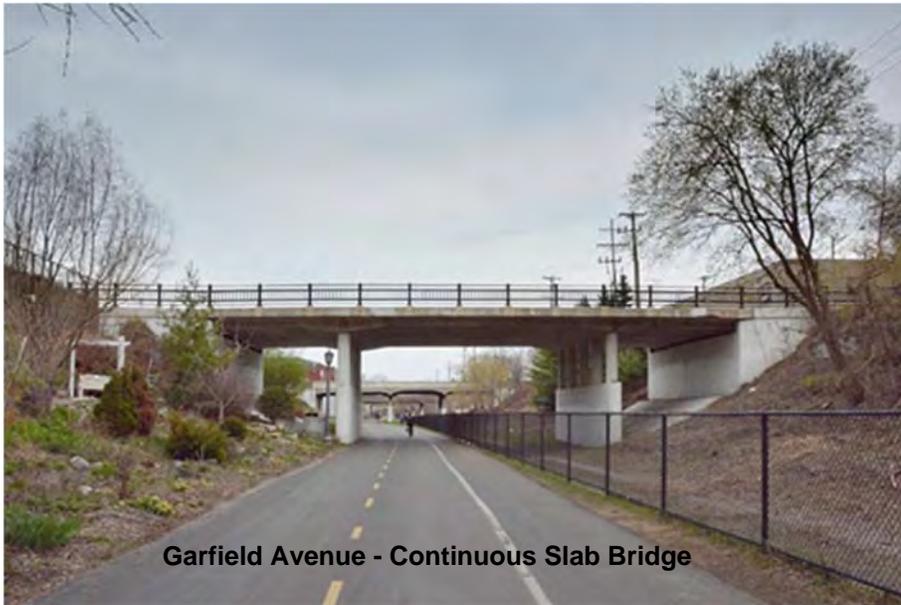
Garfield Avenue - Continuous Slab Bridge

The other ten bridges were replaced between 1980 and 2006. They consist of three concrete rigid frames, five continuous concrete slab bridges, one post-tensioned concrete slab bridge, and one steel girder bridge. Seven of these bridges are 3 spans supported by pier columns with a straight concrete cap, and two stub abutments. Five of the seven (the continuous concrete slab spans at Blaisdell, Dupont, Emerson, Garfield, and Lyndale Avenues) are similar in appearance (see photo of the Garfield Avenue Bridge below). The three rigid frames (Chicago, Hennepin, and Park Avenues) have only one span (Park Avenue is pictured below).

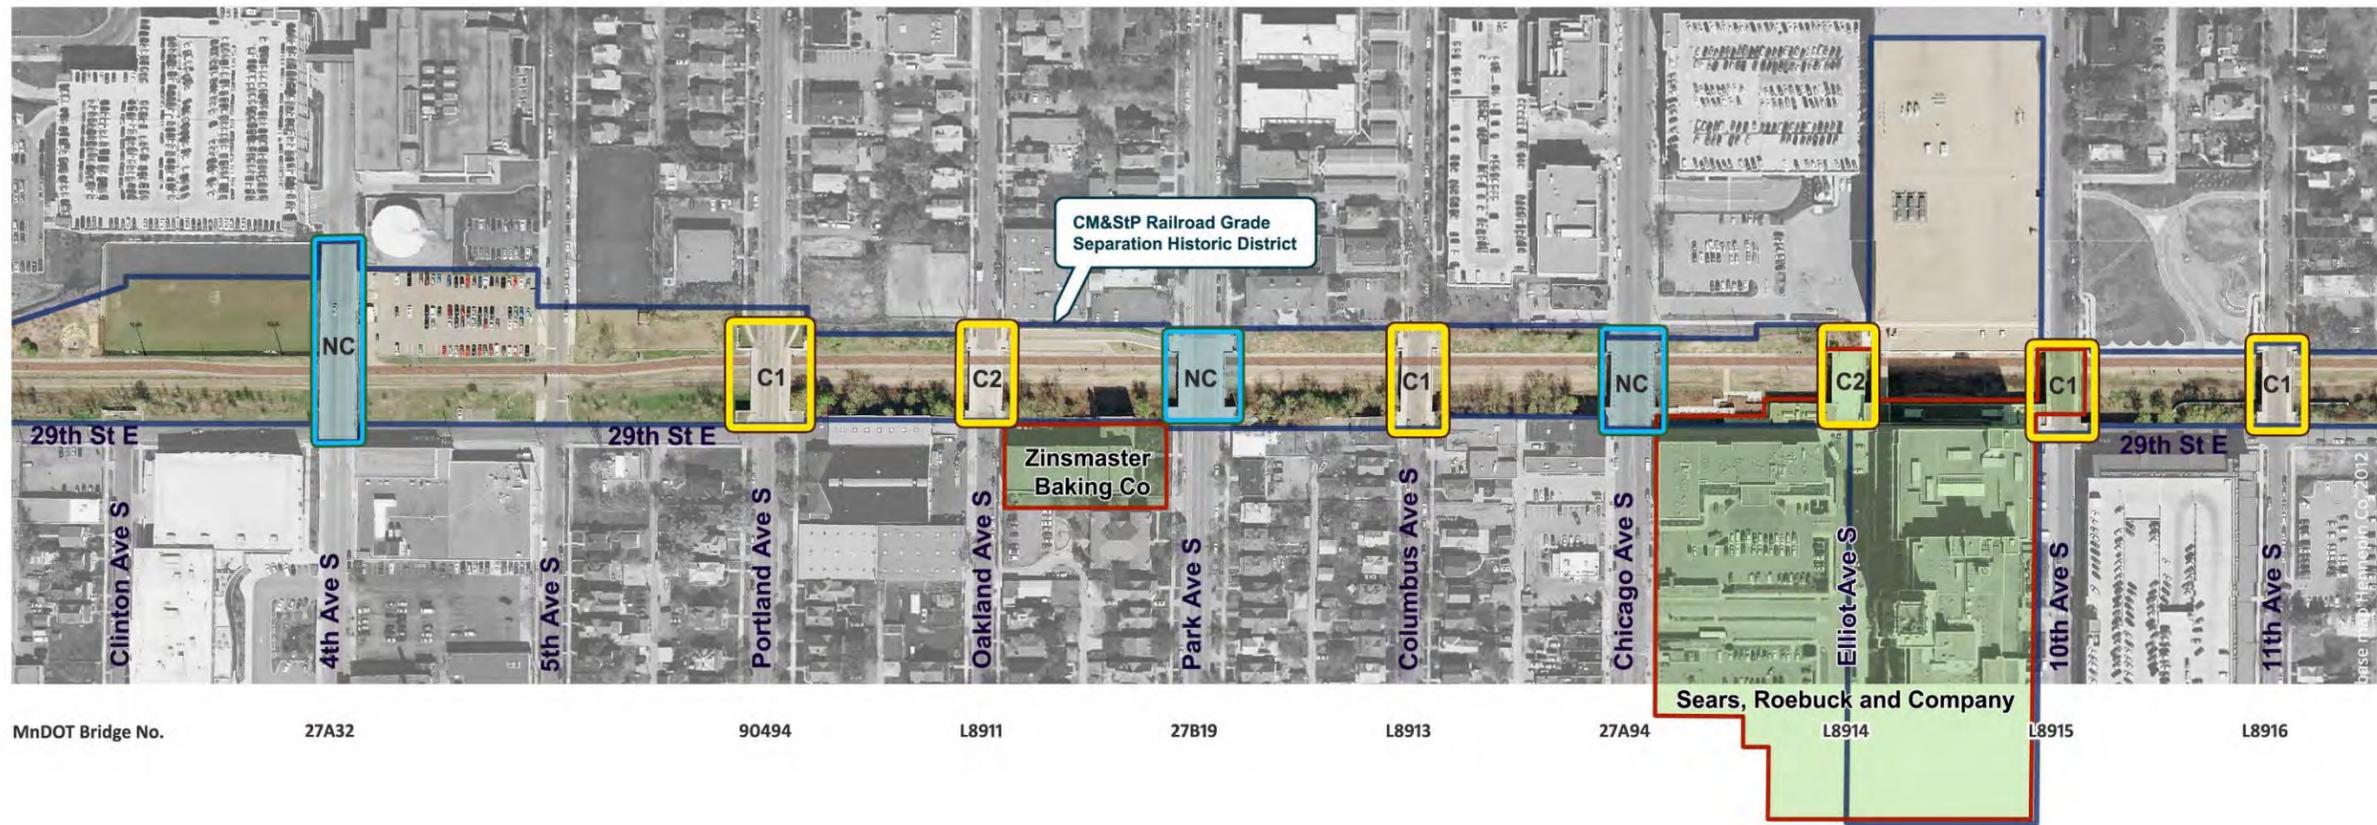
Key to Suggested Work

Abutment Height		
N	North	
S	South	
H	High	
M	Medium	
L	Low	
	Harriet Ave	NHSH
	Grand Ave	NHSH
	Pleasant Ave	NHSM
	Pillsbury Ave	NHSM
	Blaisdell Ave	NLSL
	Nicollet Ave	NHSH
	1st Ave	NHSL
	Stevens Ave	NHSL
	2nd Ave	NLSL

4th Ave	NC
	Portland Ave	C1
	Oakland Ave	C2
C1	Park Ave	NC
C2	Columbus Ave	C1
C3	Chicago Ave	NC
NC	Elliot Ave	C2
	10th Ave	C1
	11th Ave	C1

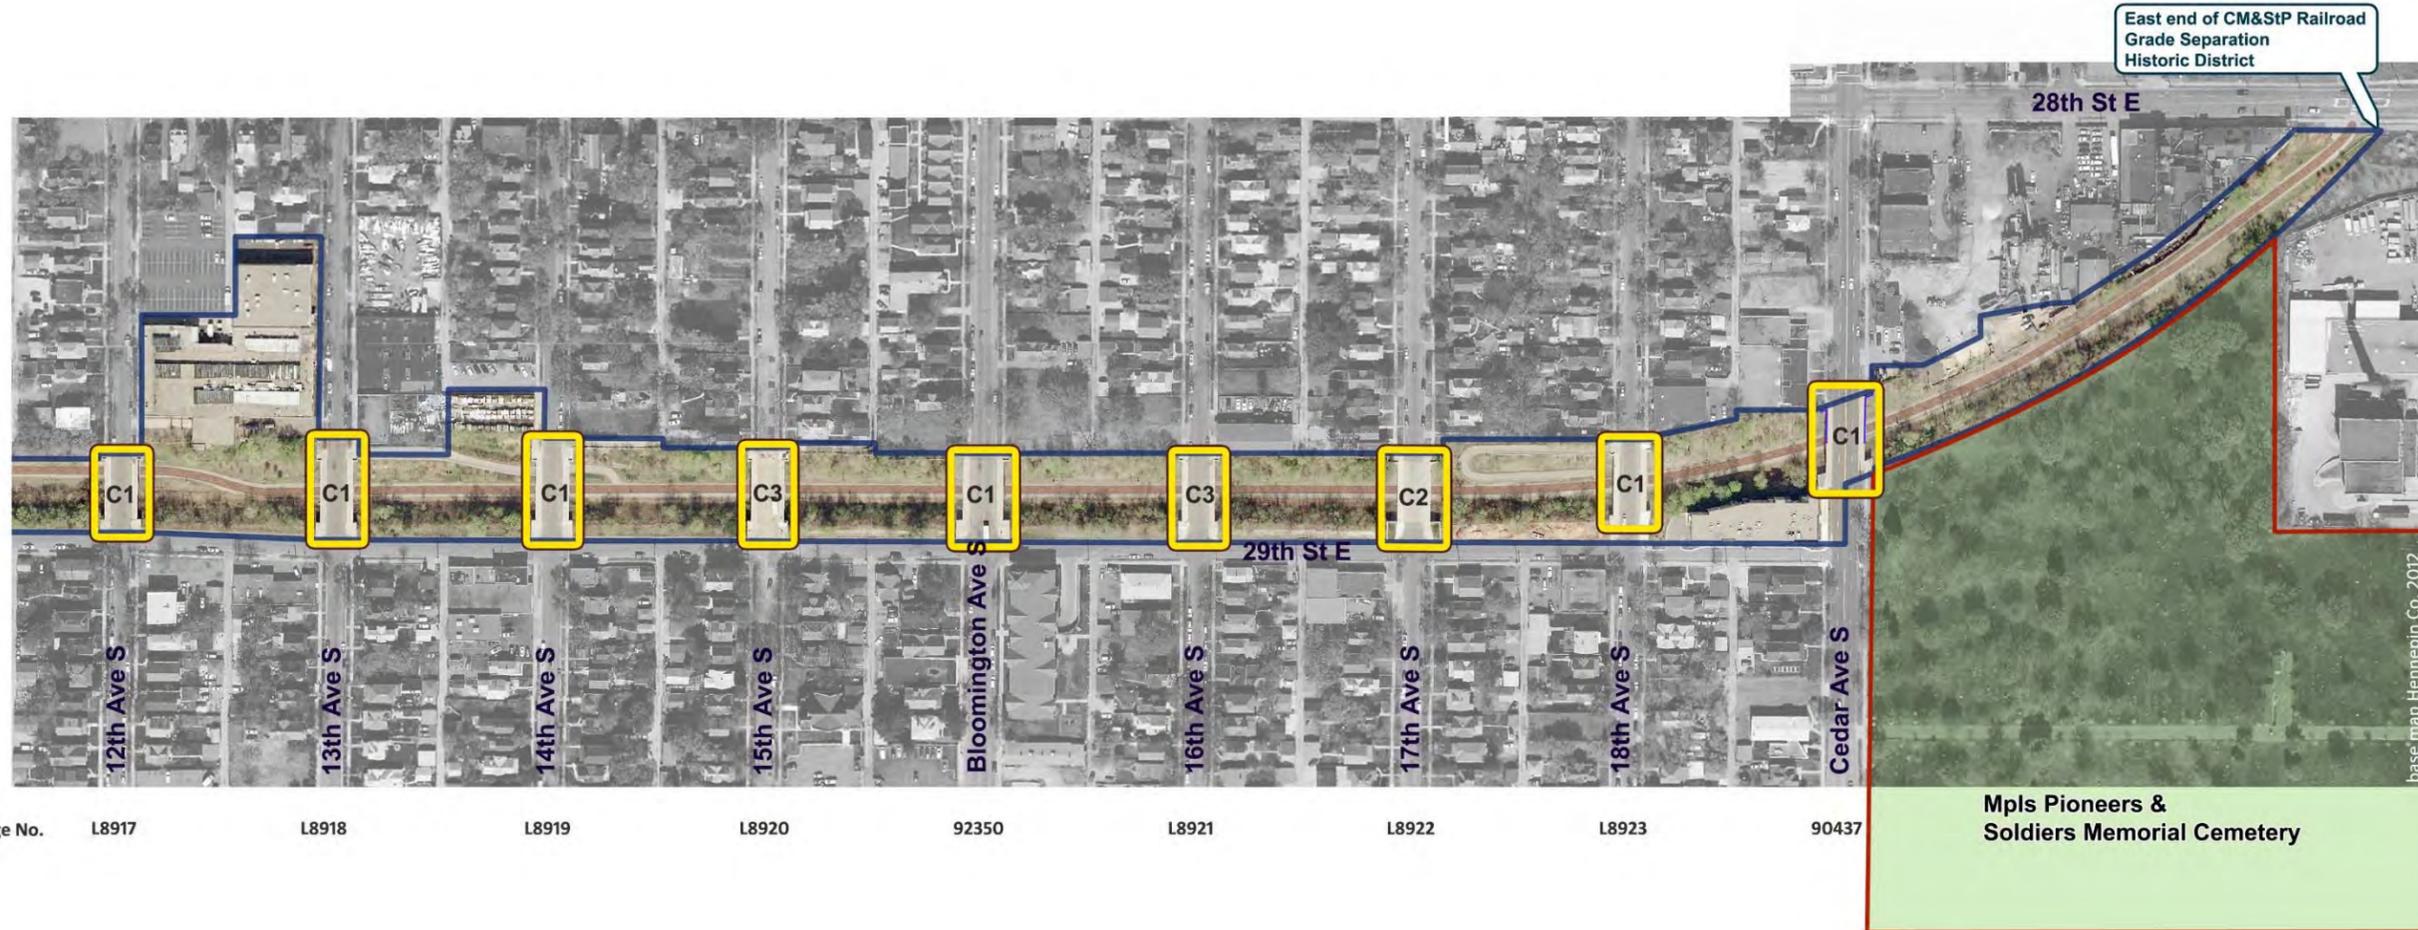
N = North	4th Ave	NHSH
S = South	Portland Ave	NHSH
	Oakland Ave	NHSL
	Park Ave	NHSH
H = High	Columbus Ave	NMSL
M = Medium	Chicago Ave	NHSH
L = Low	Elliot Ave	NHSH
	10th Ave	NHSH
	11th Ave	NHSL

Key to Suggested Work		
	12th Ave	C1
	13th Ave	C1
	14th Ave	C1
	15th Ave	C3
	Bloomington Ave	C1
	16th Ave	C3
	17th Ave	C2
	18th Ave	C1
	Cedar Ave	C1
C1	Contributing - Major Work Suggested	
C2	Contributing - Minor Work Suggested	
C3	Contributing - Rehabilitated 2013	
NC	Noncontributing - Minimal Work Suggested

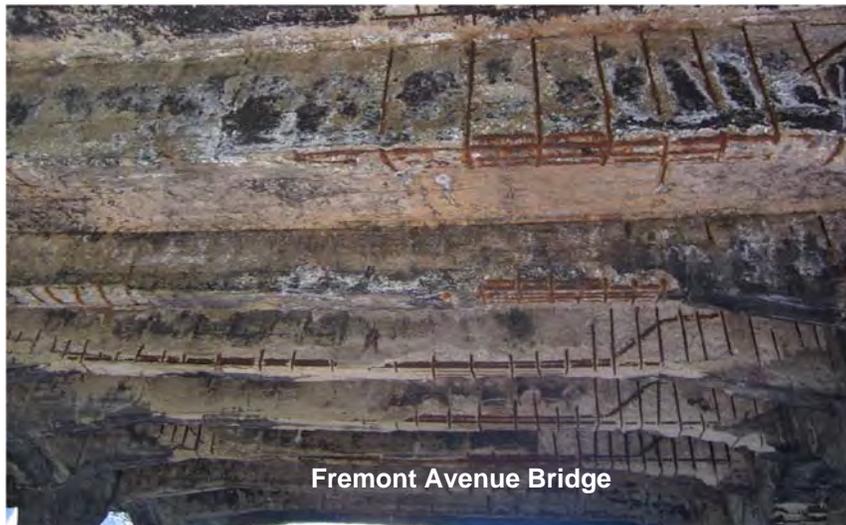
Bryant and Fremont Avenues: Fremont and Bryant Avenues were found to be so deteriorated that repair may be precluded. The original fabric of Fremont Avenue is extremely deteriorated. (A typical picture is shown below.) All of the beams are in poor condition with spalls and most with exposed, corroded reinforcement. There are also spalls on the underside of the deck. The substructure is cracked and spalled; the abutments are also settling. Repair of the historic fabric (including through the use of chloride extraction and deep spall repairs) is not believed to be feasible. Consultation among interested parties will be needed to arrive at a course of action that takes into account the future project's Purpose and Need, preservation of the historic district's overall integrity, additional environmental impacts, and other factors. One possibility is in-kind replacement of the bridge to original dimensions per the Secretary of the Interior's Standards for Reconstruction. While generally done only in special circumstances, it may be justified because interpreting or understanding the significance of the historic district relies on experiencing it as a designed collection of essentially identical bridges spaced one block apart. A second option is a new bridge closely modeled on the historic bridges to protect the district's important design integrity. The goal would be a bridge subtly or mildly differentiated from the historic bridge it replaces. (See the Fremont Avenue Bridge's individual bridge management plan for more information.)

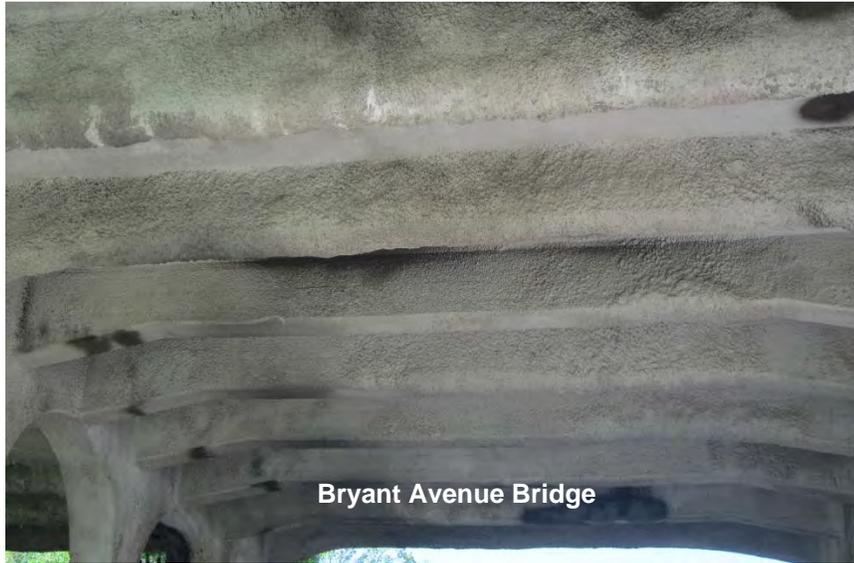
The original fabric of Bryant Avenue is covered with shotcrete and inspection photographs, taken prior to the application of shotcrete, show extremely deteriorated concrete and reinforcement. On the beams, water is leaching through the shotcrete in many locations and a few cracks are showing through. Cracks are also protruding through the shotcrete on the substructure. The condition of this bridge is believed to be serious; only about 5% of existing fabric is currently visible due to shotcrete applications. Again, consultation among interested parties will help determine the course of action. Preservation recommendations are the same as those described for the Fremont Avenue Bridge.

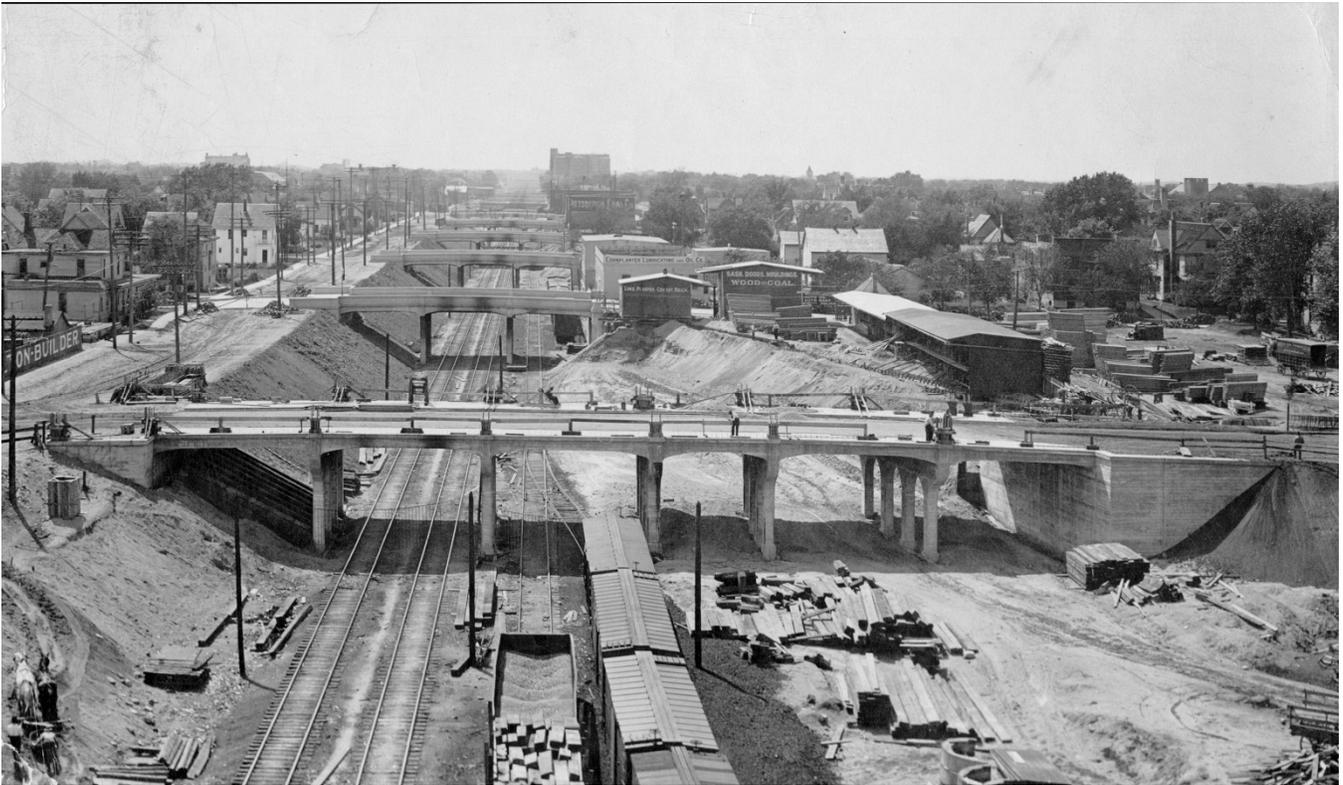
The CM&StP corridor was built over six construction seasons, 1912-1917. This ca. 1915 photo, which faces west, was taken near the middle of the 40-block-long project. In the foreground is the Clinton Avenue Bridge nearing completion. Unlike most of the historic bridges, Clinton had six spans to accommodate the west end of a rail yard on the north side of the trench. The 3rd, 2nd, and Stevens Avenue bridges are visible to the west. The Clinton, 3rd, and 2nd Avenue bridges are no longer extant. I-35W now crosses the corridor just west of 2nd Avenue (photo by C. J. Hibbard, ca. 1915, Minnesota Historical Society).

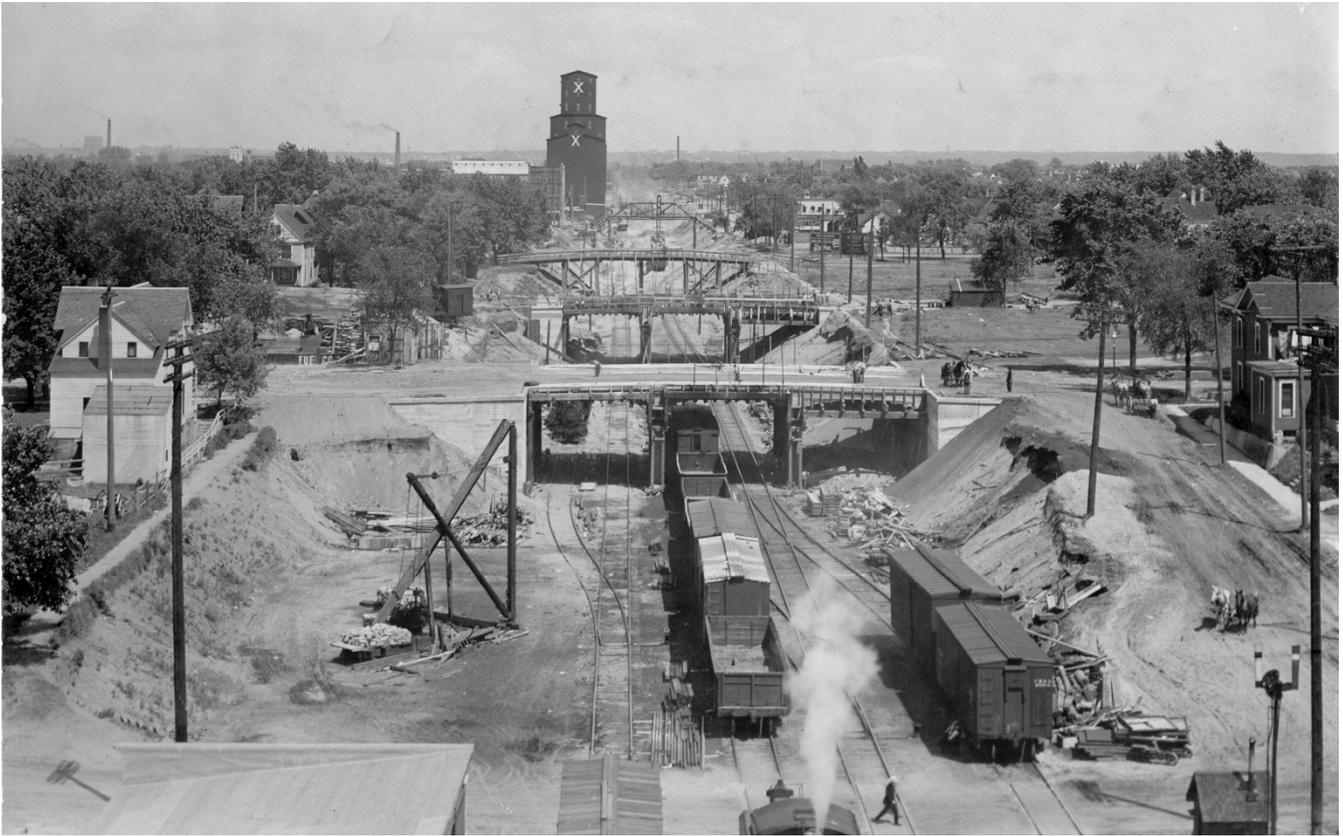
In the center of this ca. 1915 view is the Portland Avenue Bridge under construction. The Oakland and Park Avenue bridges are being built adjacent to the east. Farther east is Bagley Grain Company's Elevator X and a temporary foot bridge erected so the public could cross the corridor during construction. In the foreground is the corridor's only at-grade crossing at 5th Avenue (photo by C. J. Hibbard, ca. 1915, Minnesota Historical Society).

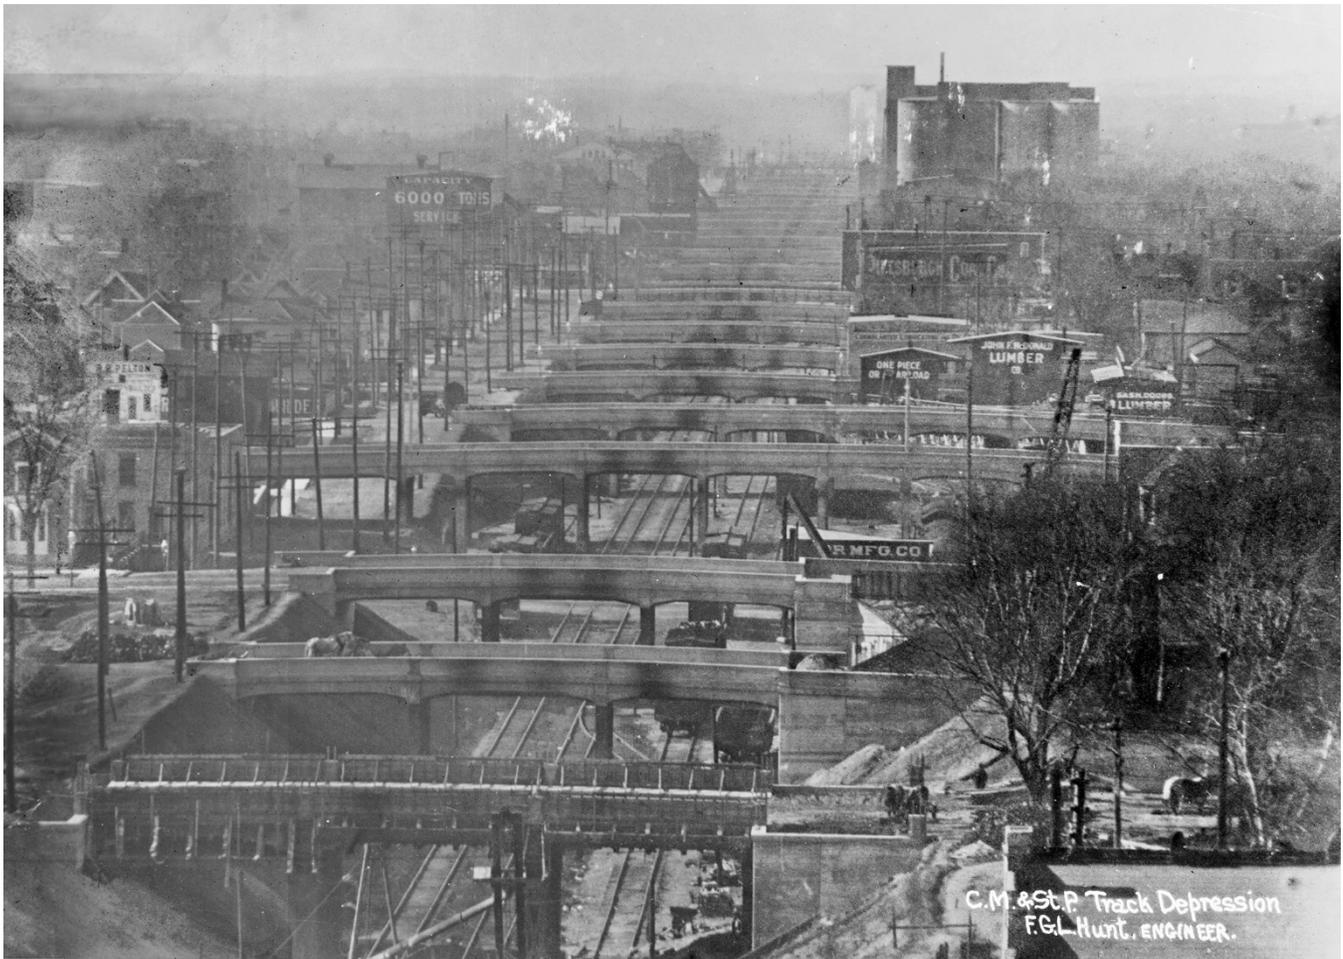
A long view, facing west, of the corridor's nearly identical Neoclassical Revival style concrete bridges spaced one block apart. The Park Avenue Bridge is under construction near the bottom of the photo, with the Oakland and Portland Avenue bridges adjacent to the west. The next two bridges, at 4th and Clinton Avenues, had extra spans to accommodate the rail yard (ca. 1915 photo from "Views of the 29th Street Track Depression Construction Project in Minneapolis," annotated photo album, Minnesota Historical Society).

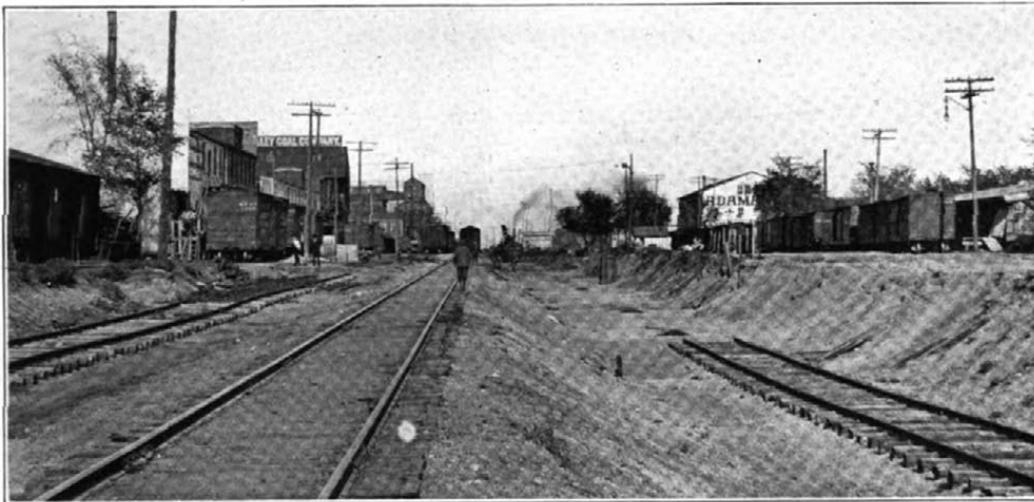
C. M. & St. P. Ry. Track Depression in Minneapolis, Fig. 1—First Cut of Shovel, Looking East from Emerson Ave.

The manner of excavation is that of cut and shift. The steam shovel makes a cut as deep as is permissible with loading of cars on main track, in some place to a depth of 8 ft. A new track is laid in the cut so made (see Fig. 1), to which traffic is then diverted, and the steam shovel is shifted to the other side and is put to cutting down under the old track. In this manner the work progresses, cutting and shifting from side to side until the desired level is reached, the entire excavation in different places being made in from five to seven cuts and shifts. For a usual thing the tracks have been depressed to full depth covering a stretch of about eight blocks at a time.

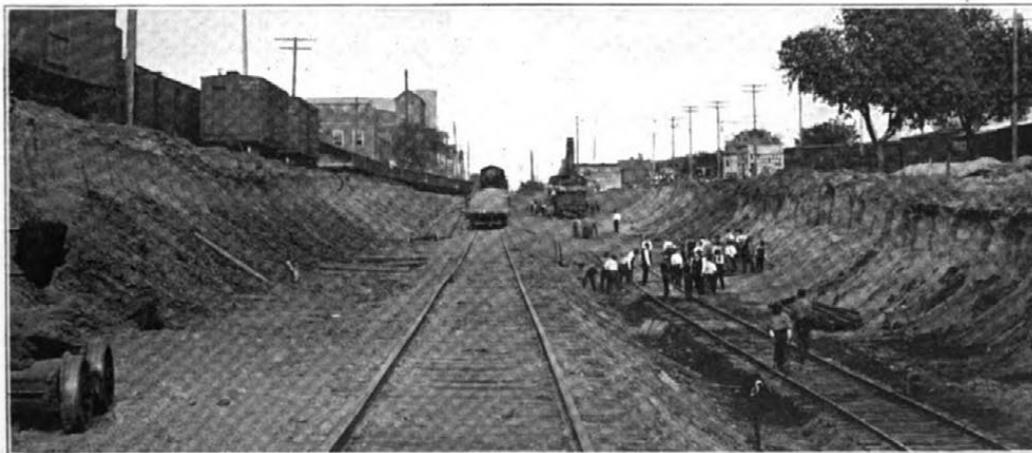
C. M. & St. P. Ry. Track Depression in Minneapolis, Fig. 2—Looking East on Temporary Main Track; Shovel in Third Cutting.

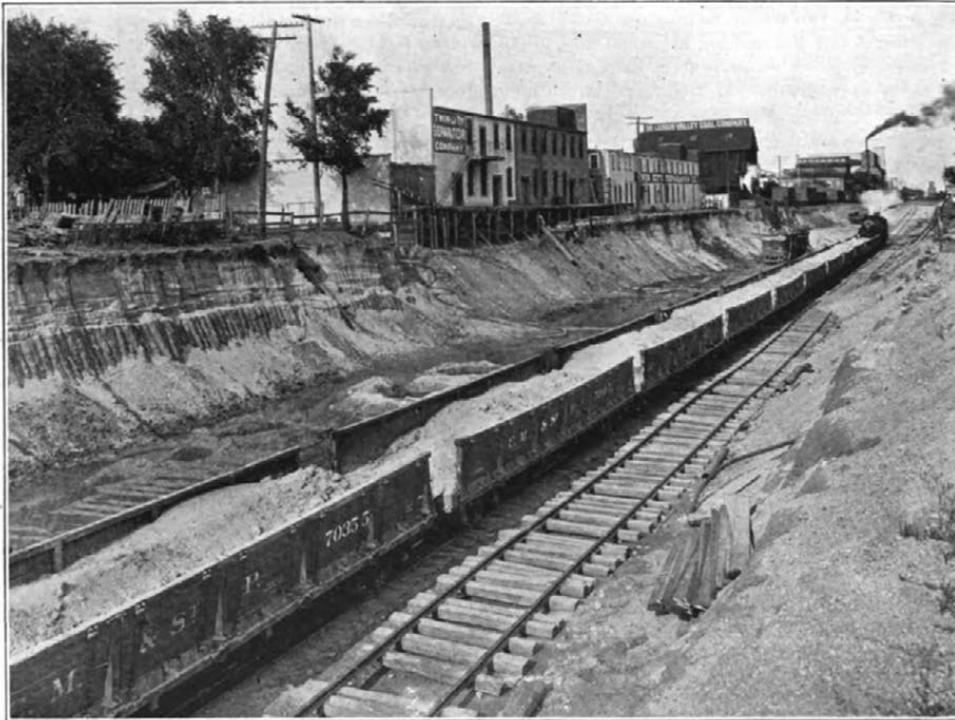
C. M. & St. P. Ry. Track Depression in Minneapolis, Fig. 3—Looking East from Center of Block Between Dupont and Emerson; Shovel in Final Cutting.

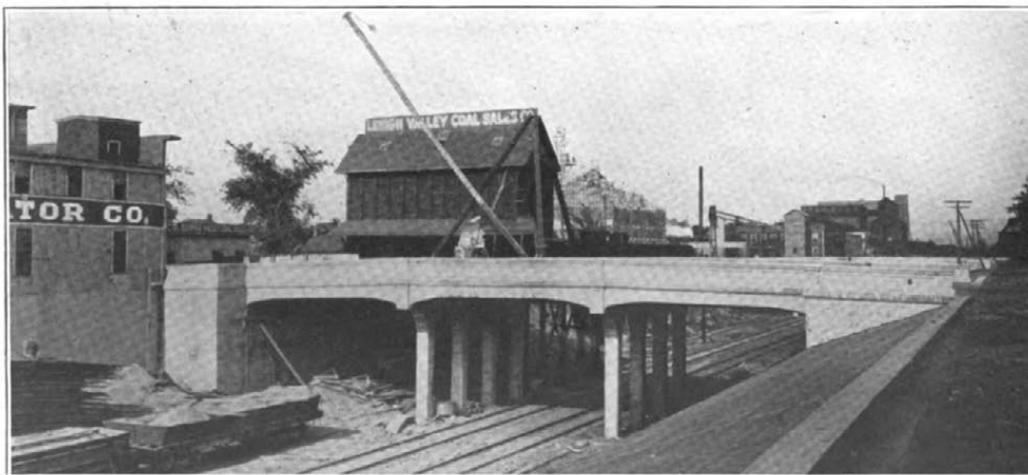
C. M. & St. P. Ry. Track Depression in Minneapolis, Fig. 7—Colfax Avenue Bridge.

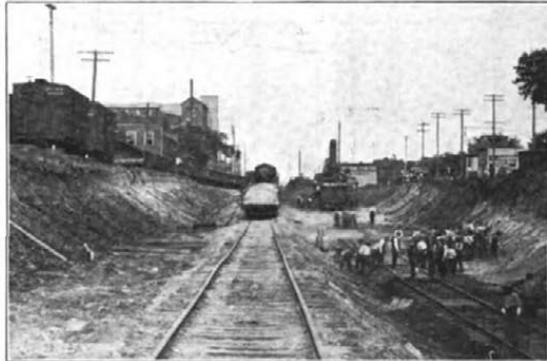
A Shovel Taking a Third Cut

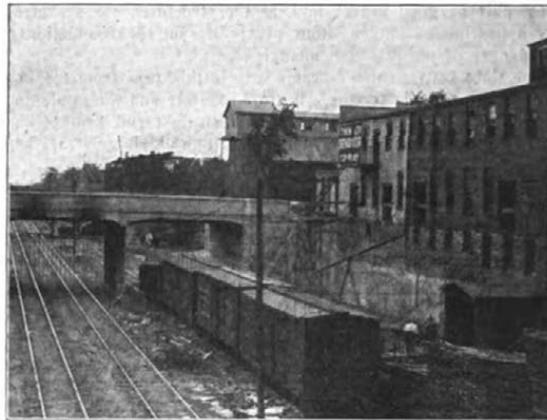
A Building Underpinned by a Masonry Wall
