UNDERWATER BRIDGE INSPECTION REPORT

STRUCTURE NO. 02545

RUM RIVER

SEPTEMBER 9, 2012

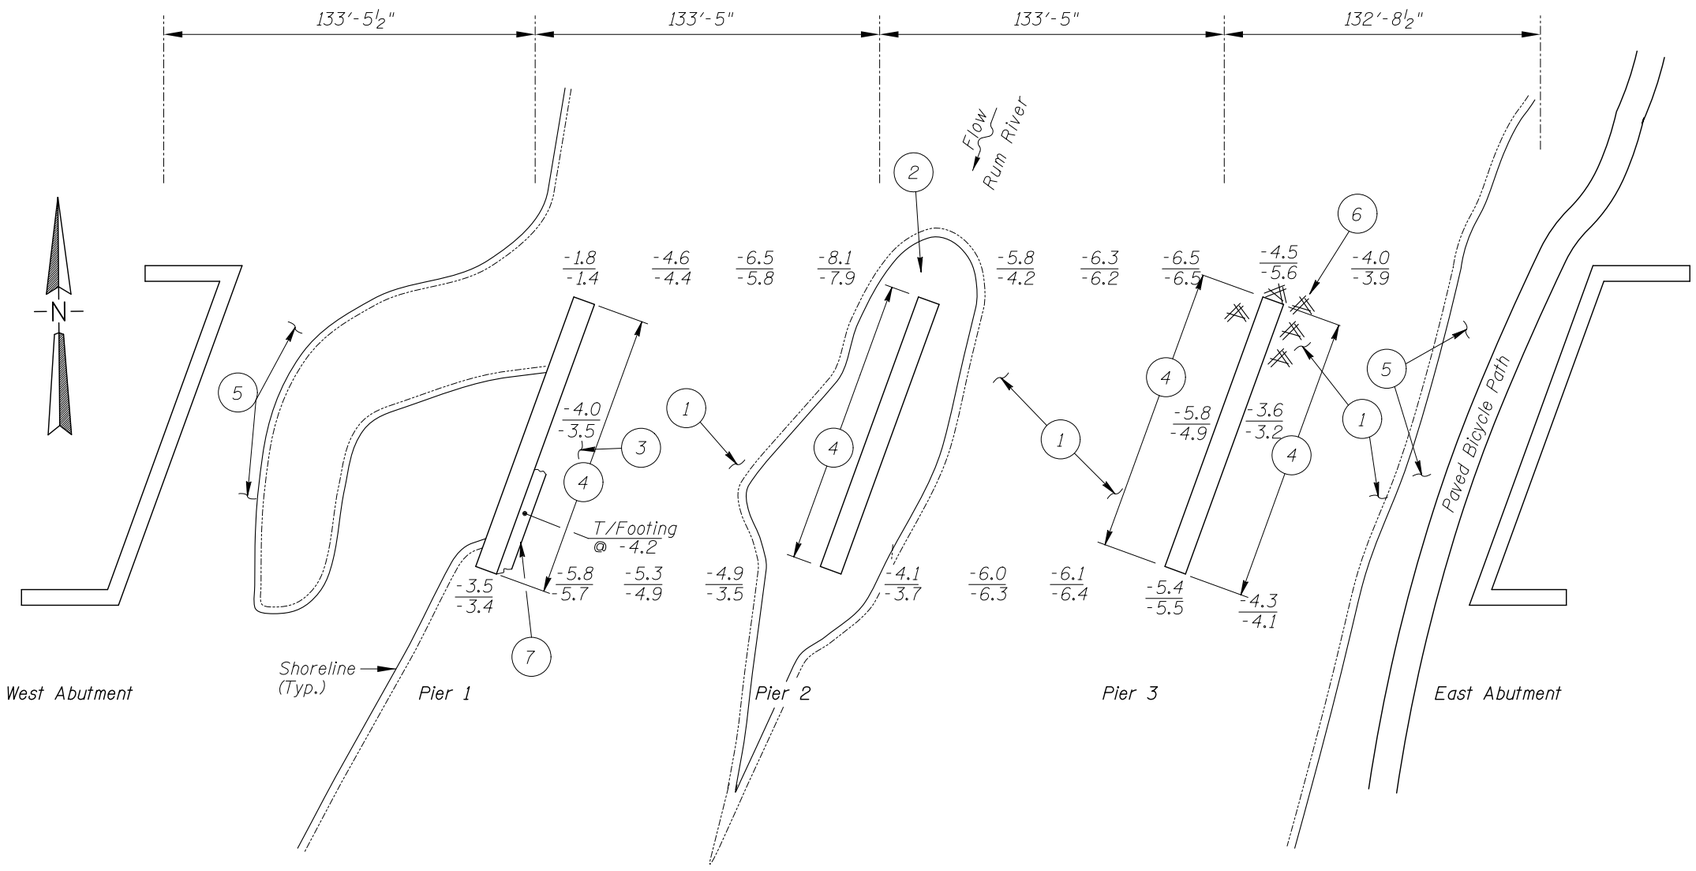
INSPECTION AND SOUNDING PLAN

1. The channel bottom consisted of sandy gravel with up to 1 foot of probe rod penetration.
2. 1 to 2 foot diameter riprap was observed at the upstream end of Pier 2.

3. The channel bottom around Pier 1 consisted of silty sand with up to 2 feet of probe rod penetration.
4. The concrete was smooth and sound.
5. The embankments consisted of grouted riprap in the immediate vicinity of both abutments.

6. A light accumulation of 18 inch diameter and smaller timber debris was observed from 5 feet downstream of the upstream nose on the east face, around the upstream nose, to 20 feet downstream of the upstream nose along the west face. The debris extending from the channel bottom up 2 feet and up to 4 feet off the faces and nose.

7. The top of footing was exposed at 4.2 feet below the waterline from the downstream nose to 15 feet upstream of the downstream nose along the east face of the pier with up to 4 inches of vertical exposure.
