Pavement Condition Report

Alexandria Municipal Airport (AXN)

December 2016

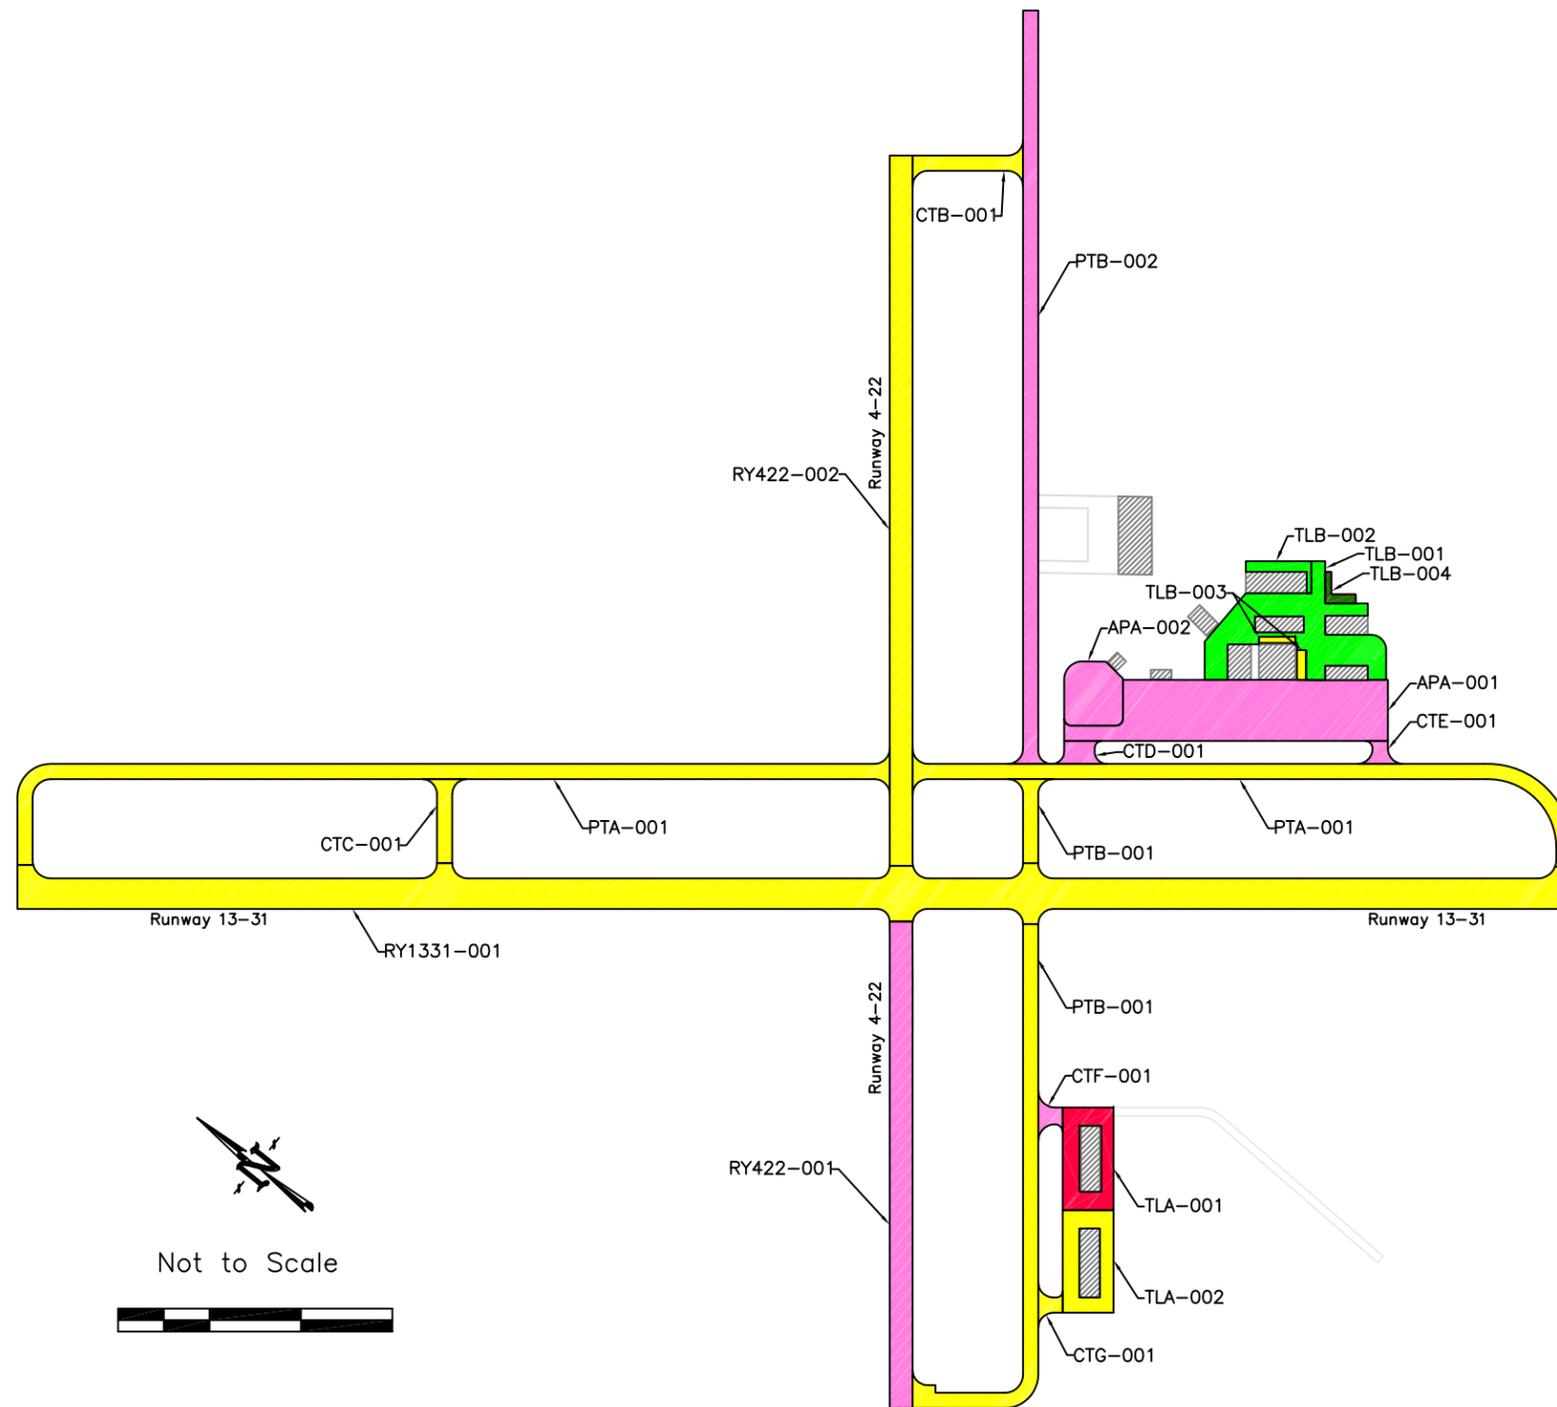
Figure 4. 2016 Pavement Condition Index Rating at Chandler Field Airport (AXN).

The results of the 2016 PCI inspection are presented in figure 4. The overall area-weighted, inspected PCI for AXN is 60. When summarizing PCI values, an area-weighted calculation is used instead of a straight mathematical average because the area-weighted calculations eliminate the skewing of the PCI due to the disparity of the section sizes.

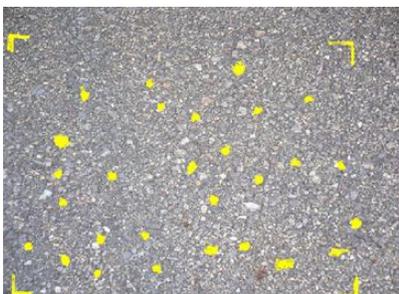
Example of Raveling/Weathering

Raveling and weathering are the wearing away of the pavement surface. Raveling is the condition where the mid- to large size aggregates are becoming dislodged; weathering is when the fine aggregate wears away exposing the edges of the larger aggregate. These distresses are usually evident over large areas and may occur together (pictured above) or separately. Raveling and weathering may indicate that the asphalt binder has hardened significantly.

Raveling – At low severity, the number of missing coarse aggregates (> 3/8 inch) is between 5-20 missing/yd², medium severity (pictured below where the missing coarse aggregates have been dotted with yellow paint) is 21-40 missing/yd², and high severity is > 40 missing/yd².

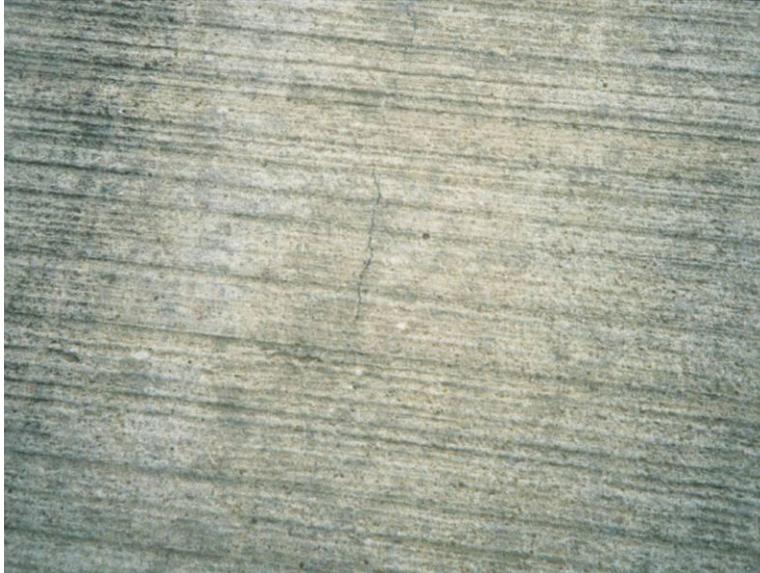
Example of Shrinkage Cracking

Shrinkage cracks are small, nonworking (no spalling along edge) cracks that are visible at the surface but do not penetrate through the full depth of concrete. Shrinkage cracks most commonly occur shortly after construction due to concrete shrinkage during the curing process. Shrinkage cracks are usually so small that they are not visible until staining or material loss at crack edges begins to take place. Shrinkage cracks do not represent a structural weakness, and no corrective action is prescribed.

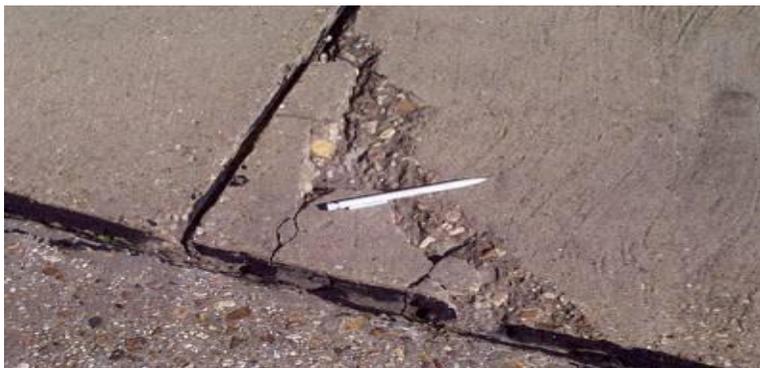
Example of Joint and Corner Spalling

Spalls at slab joints and corners are caused by excessive internal stress in the pavement. Spalls occur when these stresses exceed the shear strength of the concrete. Spalling usually results from thermal expansion during warm or hot weather. As slabs expand, they push against one another at joints. If the joints are filled with incompressibles, such as sand, or if adjacent slabs offset slightly, stresses can become severe, causing spalls. Spalling can be reduced significantly by conscientious maintenance of joint sealant.

Spall repair requires patching. The extent and severity of spalling on a pavement surface suggests appropriate action. For example, at low severity, spalled concrete remains securely in place in the slab. A low-severity spall should be monitored closely for further deterioration and should be patched when

spalled particles become loose in place, or at the next scheduled patching activity in the section. Medium- and high-severity spalls should be repaired immediately to prevent the incidence of FOD. If the pavement can be restored to serviceable condition, spalls should be carefully patched for long-term service. If the pavement is beyond repair, temporary patching should be considered to control FOD.

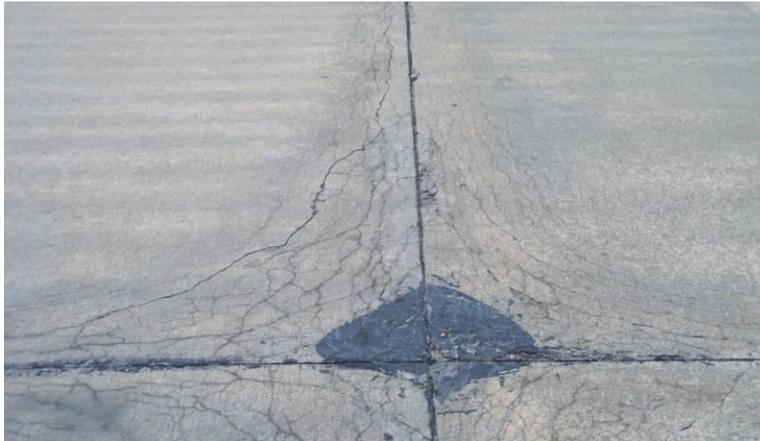
Example of Durability Cracking

Durability cracking (D-cracking) is caused by environmental factors, the most common of which is freezing/thawing. It usually appears as a pattern of hairline cracks running parallel to a joint or crack, or in a corner, where water tends to collect. This type of cracking eventually leads to disintegration of the pavement, creating FOD potential. At low severity, D-cracking is evident, but no disintegration has occurred. As the distress advances to medium severity, the distress pattern is evident over a significant area of the slab, and some disintegration and FOD potential exists. High severity durability cracking is evidenced by extensive cracking with loose and missing pieces and significant FOD potential.

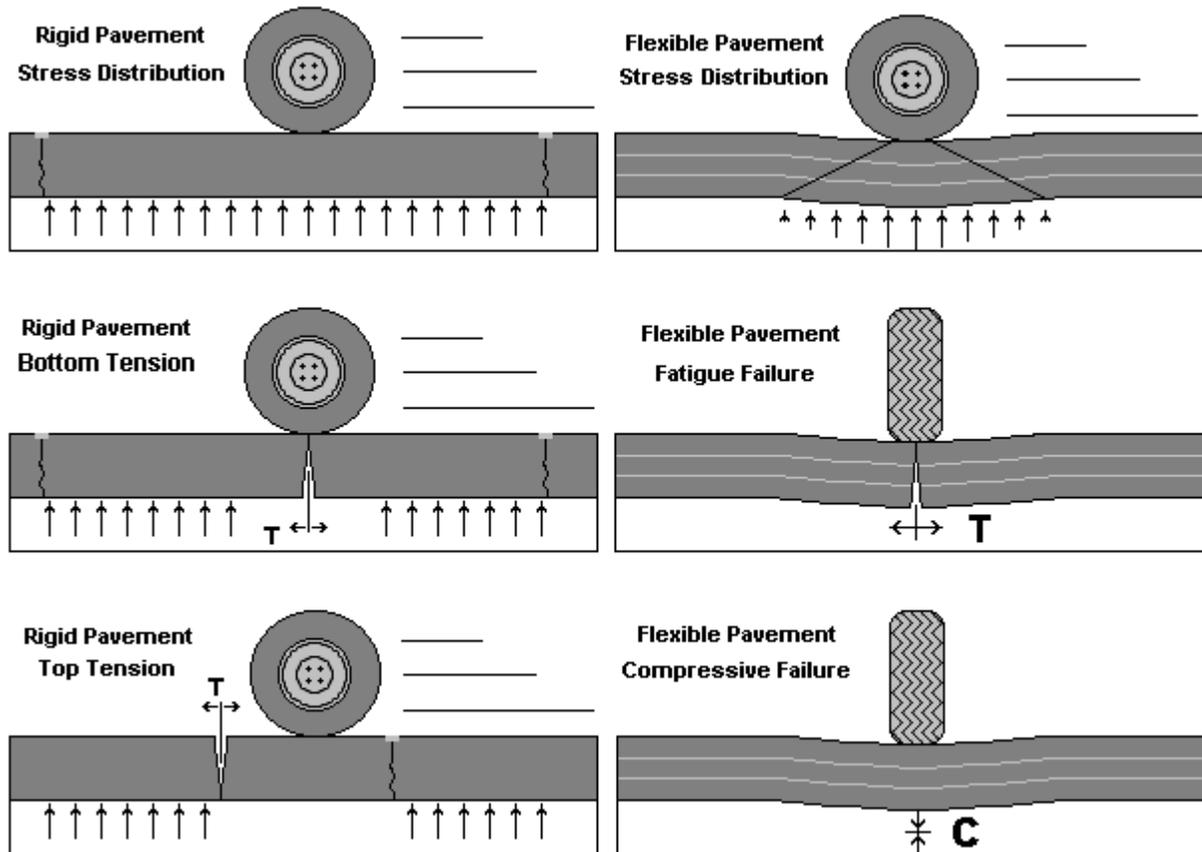
Figure 1. Pavement failure.

Load-related cracks can start at the top or bottom of a pavement section. In asphalt sections, load-related (fatigue) cracks start at the bottom. If a load-related crack reaches the surface, it usually indicates significant structural deficiency. In PCC pavement, corner breaks are caused by top tension, and the crack propagates downward. Mid-slab LTD cracks are examples of bottom tension.

Spalls can be caused by either wheel loads or environmental factors, anytime there is movement between adjacent slabs. If a small rock is allowed into a joint, a differential movement between adjacent slabs can cause a spall. Spalling can be minimized by keeping joint and crack sealant intact.
