Pavement Condition Report

Little Falls - Morrison County Airport (LXL)

December 2016

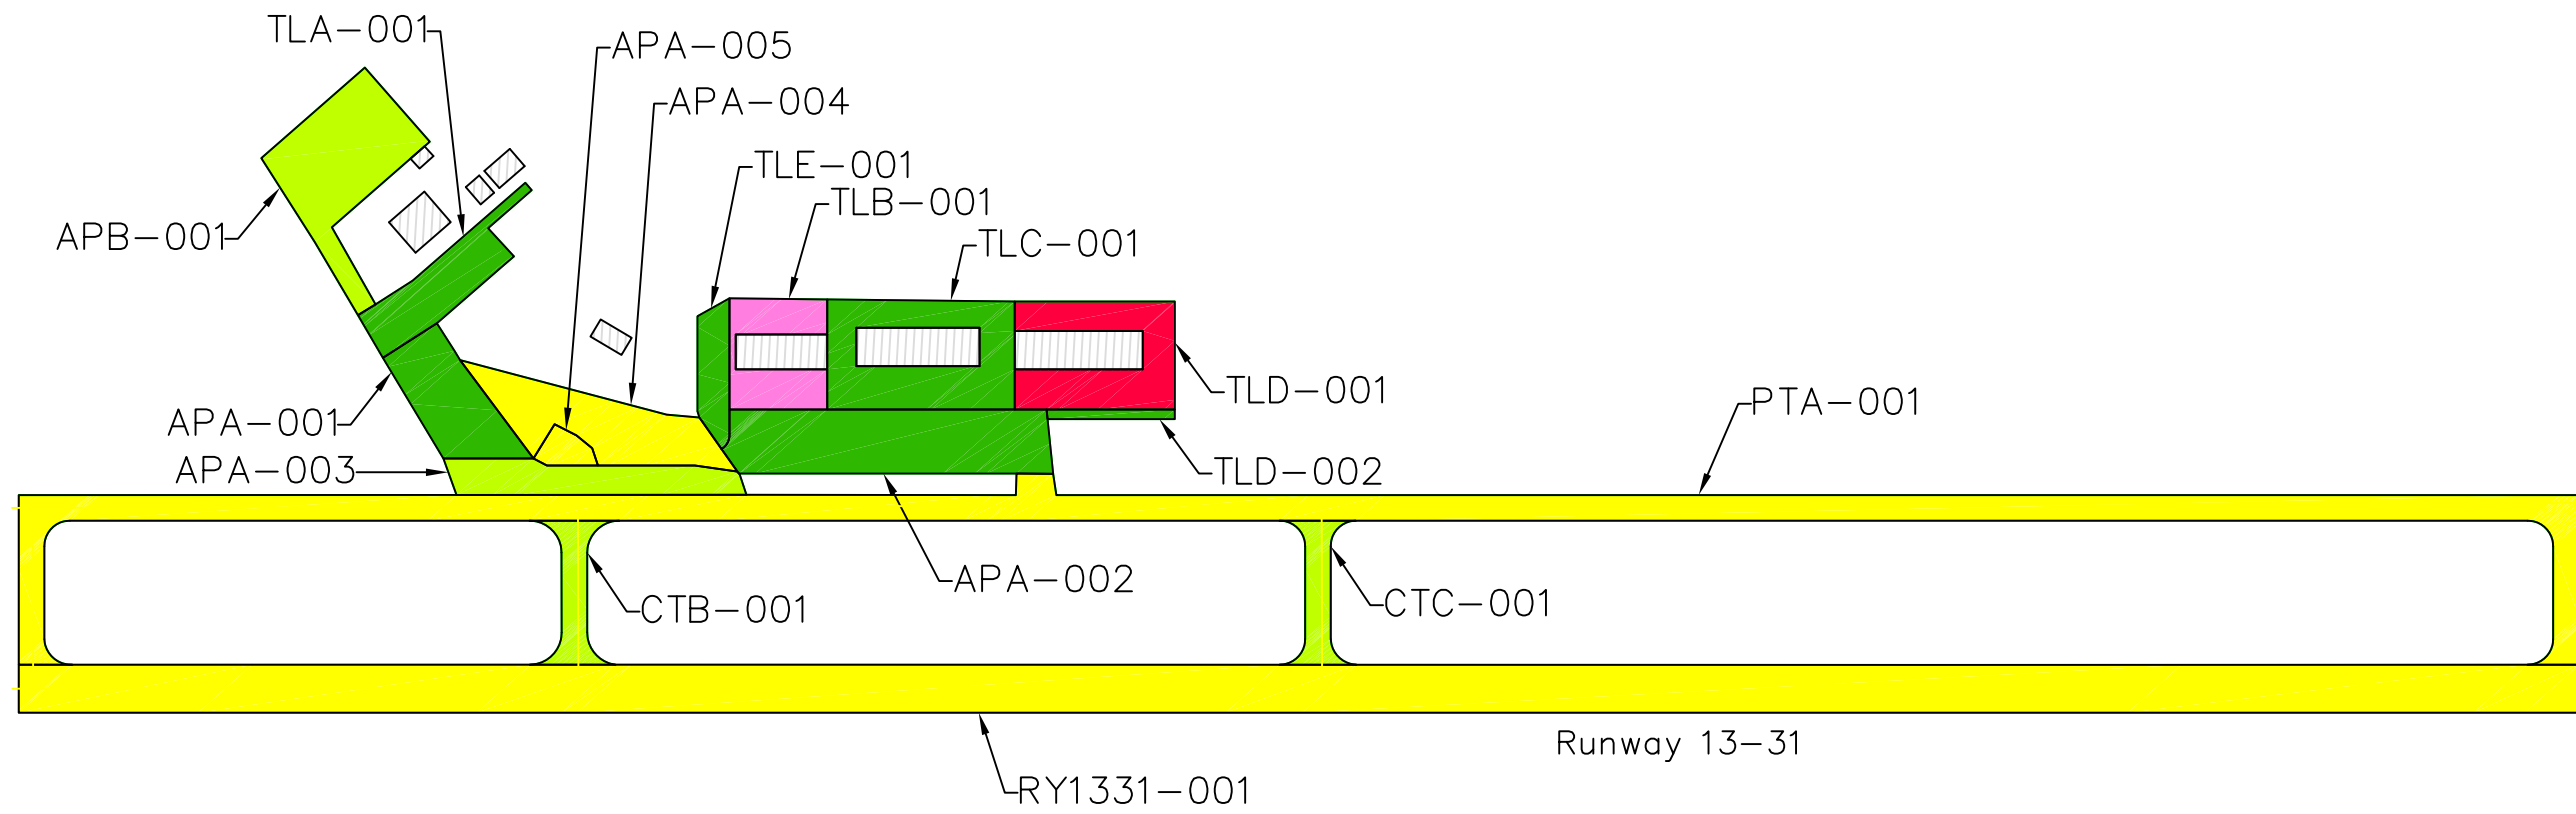
Figure 4. 2016 Pavement Condition Index Rating at Little Falls-Morrison County Airport (LXL).

The results of the 2016 PCI inspection are presented in figure 4. The overall area-weighted, inspected PCI for LXL is 72. When summarizing PCI values, an area-weighted calculation is used instead of a straight mathematical average because the area-weighted calculations eliminate the skewing of the PCI due to the disparity of the section sizes.
